Life Textile (Pvt) Ltd. (10140)

69,70,71 Bscic Industrial Estate, Konabari, Gazipur

15.APRIL.2014

ACCORD
on Fire and Building Safety in Bangladesh

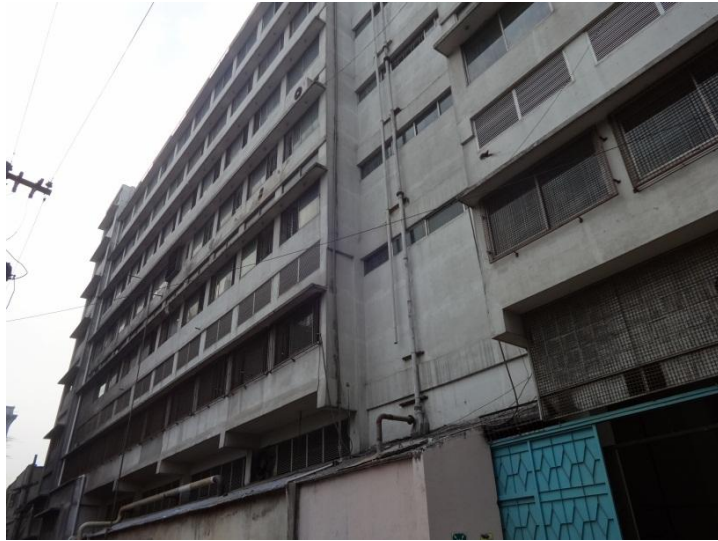
Priority 1 Concern

The central columns are significantly overloaded and have a factor of safety less than 1.25.

- The interior columns are overloaded and therefore we recommend the 4th, 5th, 6th, and roof slabs be evacuated and all imposed loading is removed down to 0 kPa.

- A detailed engineering assessment be carried out to more accurately determine the load carrying capacity of the columns.
- Load plan diagrams are prepared and posted.

- Remedial action be carried out as required to ensure the structural integrity of the building and the safety of its occupants.

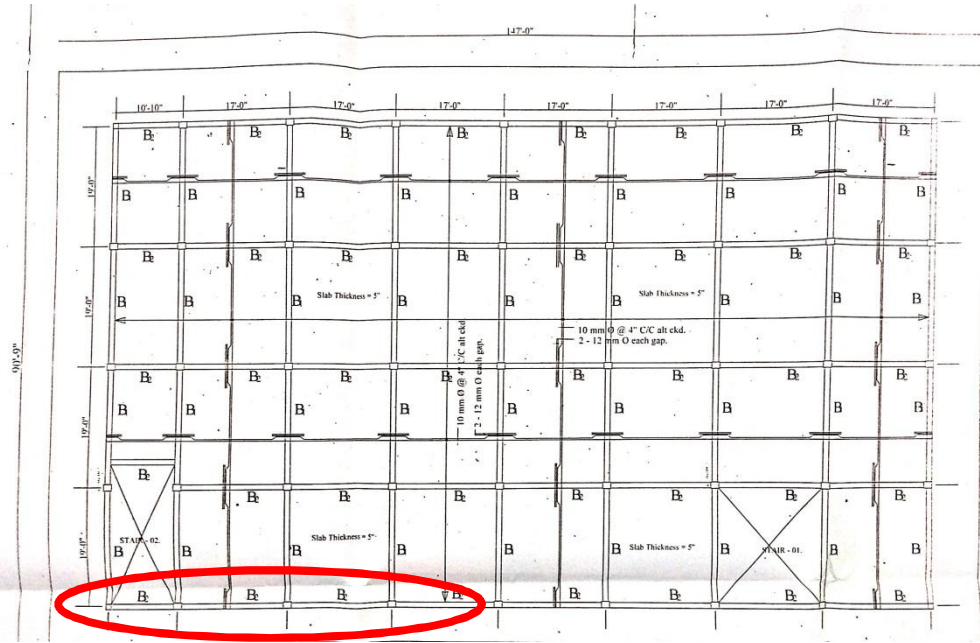
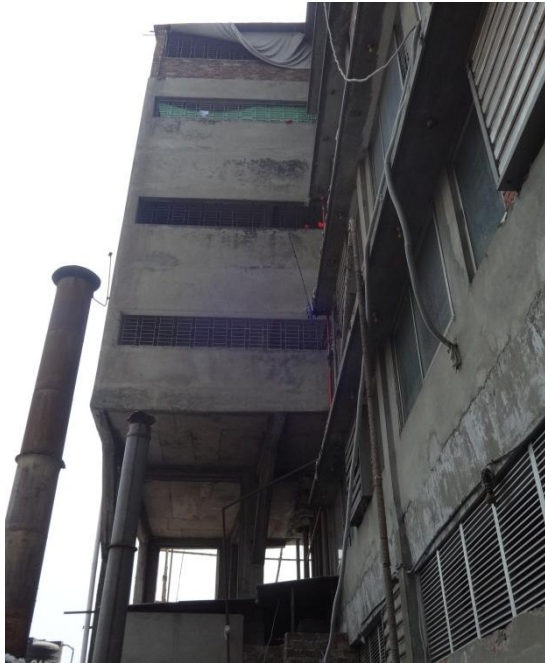
2nd Priority 1
Concern

Records drawings do not match as built conditions. Cantilevers were not shown on the as built drawings, the grid sizes are larger than the record drawings and the columns are larger than the record drawings.

- Structural Engineer to review the actual site conditions and configuration of the building and revise the drawings.

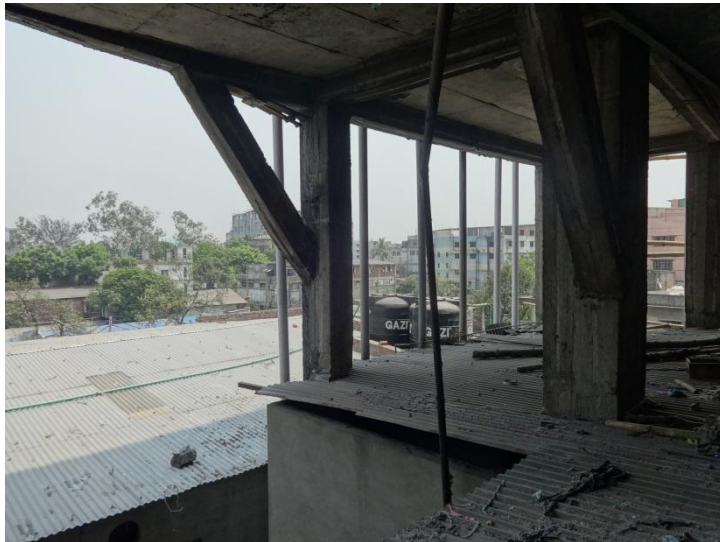
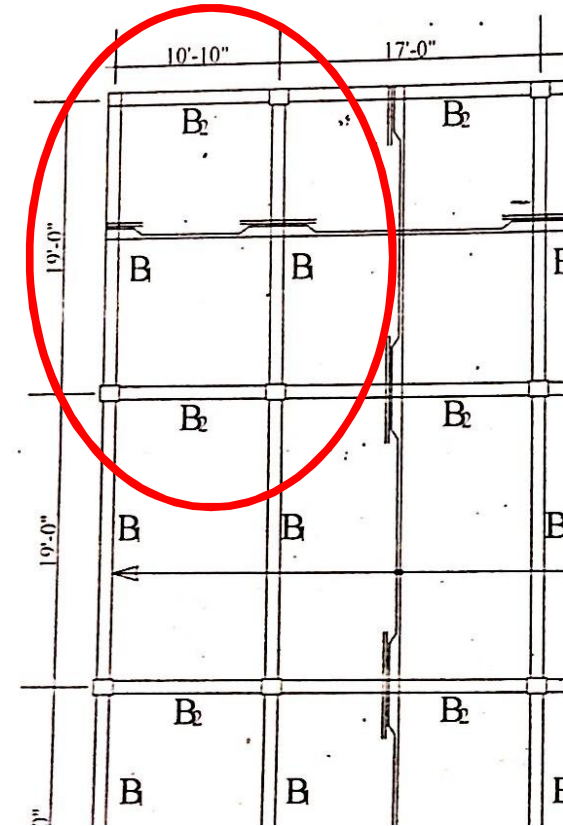
3rd Priority 1 Concern

The toilet block to East side of building is not built in accordance with the structural drawings. This cantilevers out by 3m with gallow brackets. There is visible significant deflection in the slab between supports.

- Due to the excessive slab deflection and the lack of information shown on the structural drawings we recommend the toilet block be evacuated and kept unoccupied.

- An engineering assessment be carried out to determine the structural integrity of the SE corner toilet block.

- Remedial action be carried out as required to ensure the structural integrity of the building and the safety of its occupants.

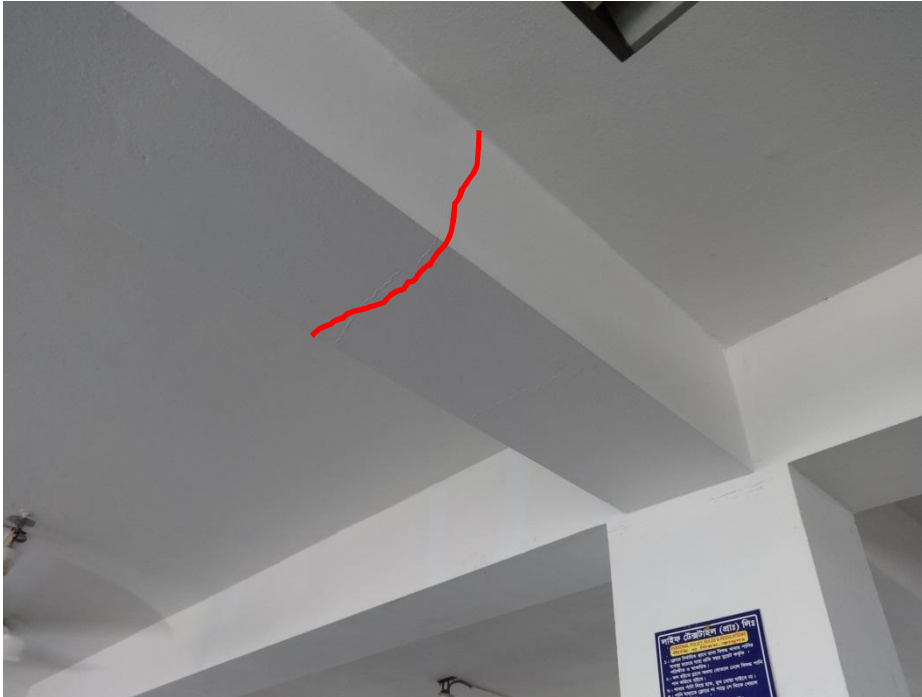
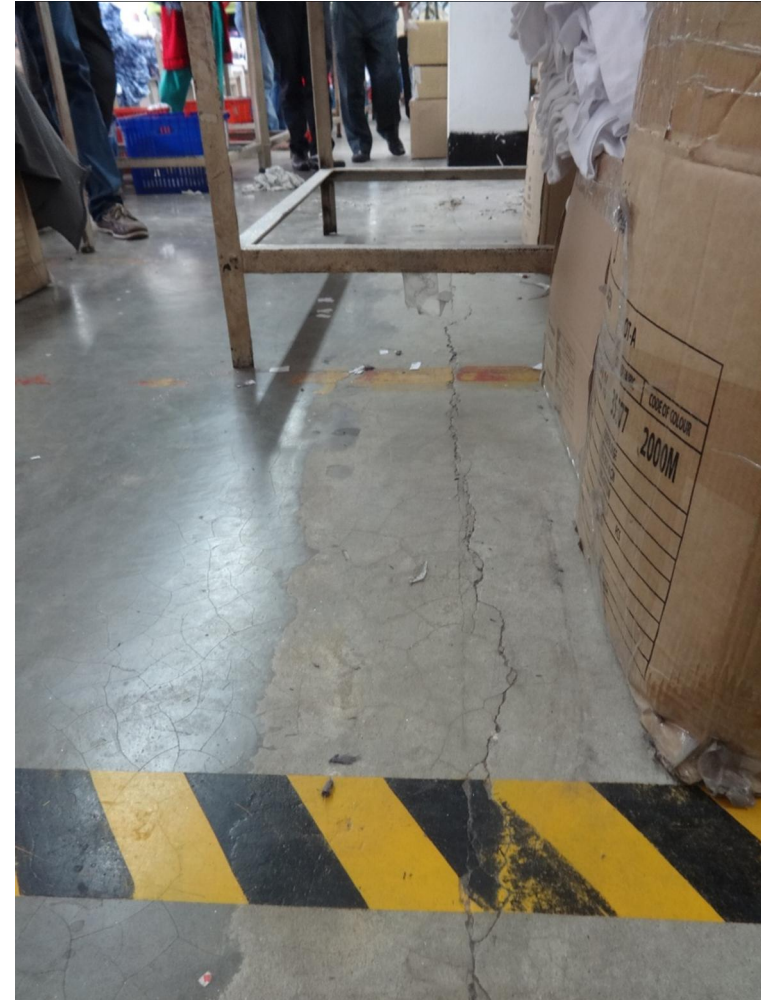
Multiple cracks to beam and slab were observed at all floors. The beams had shear and flexural cracks, suggesting overloading. The slabs were cracking over the beams, suggesting inadequate tensile reinforcement. Much of the factory had been recently decorated making it difficult to observe all of the cracking. The crack to the beam shown in red for clarity.

- An engineering assessment be carried out to determine the cause of cracking and to ensure structural integrity.

- Remedial action be carried out as required to ensure the structural integrity of the building and the safety of its occupants.

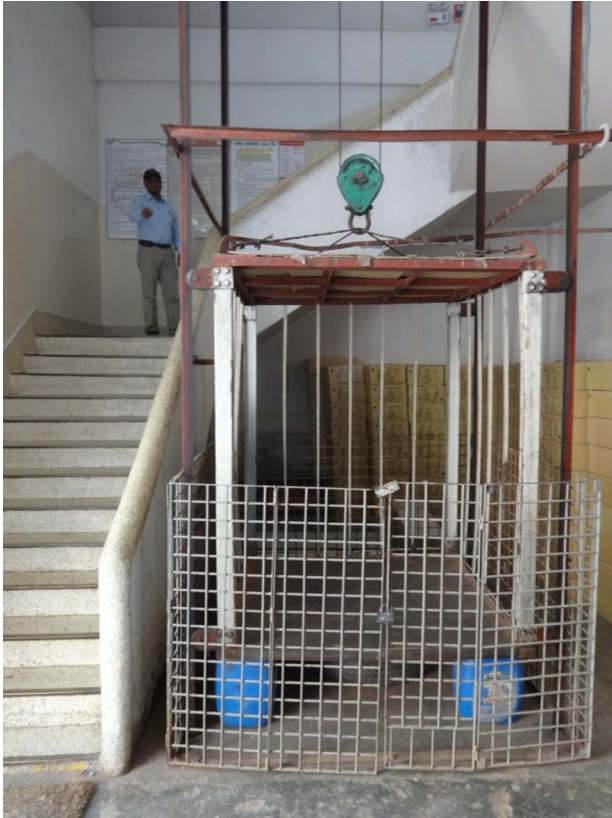
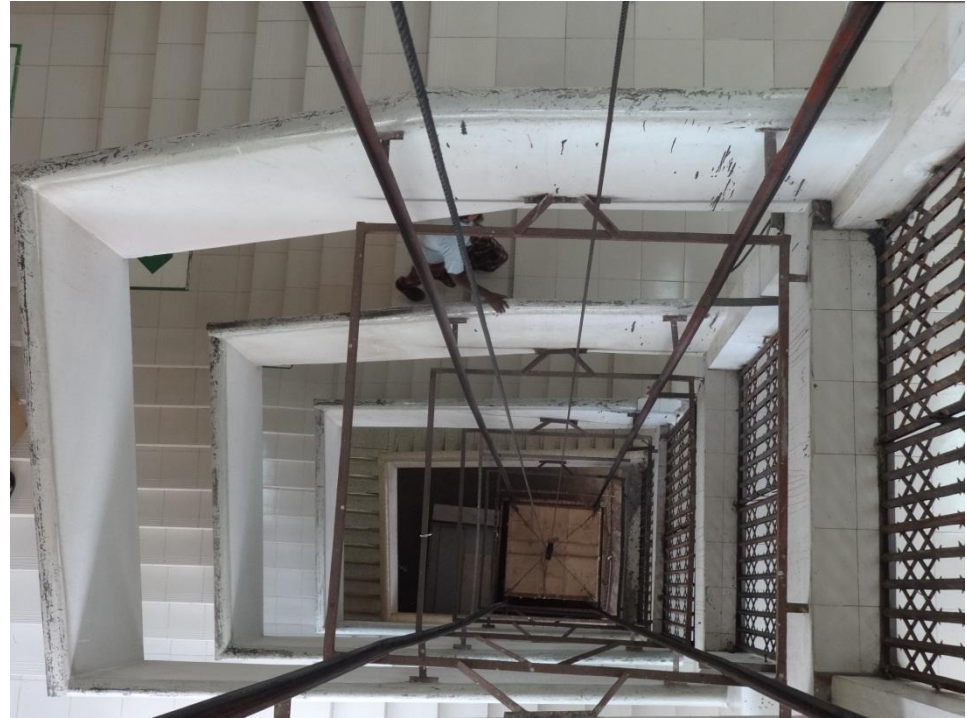
Materials lift did not appear to be adequately detailed or connected to primary structure. There was extensive damage and corrosion to the steelwork.

- An engineering assessment be carried out to determine the structural integrity of the materials lift.

- Remedial action be carried out as required to ensure the structural integrity of the lift.

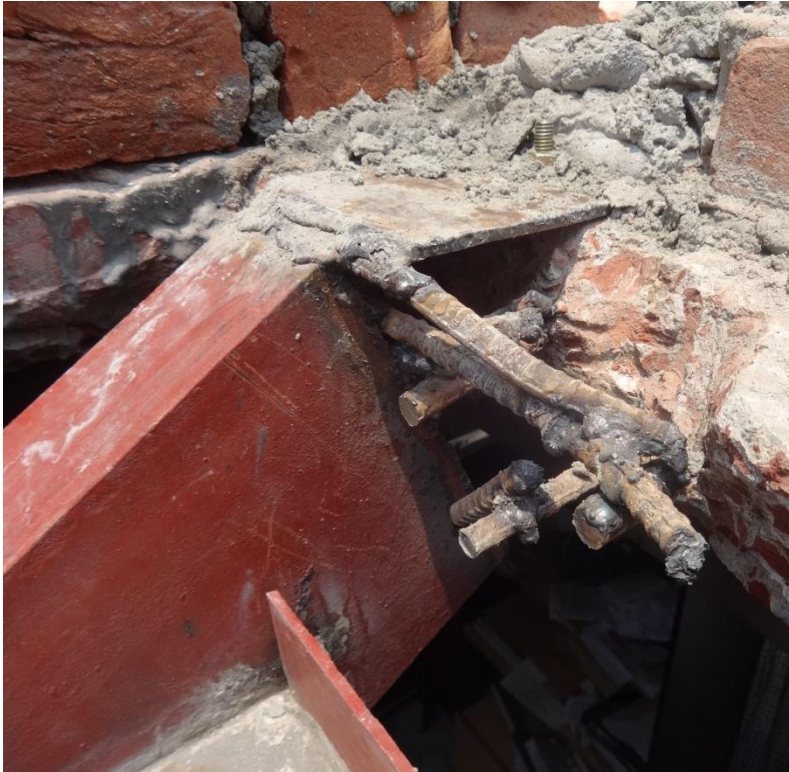
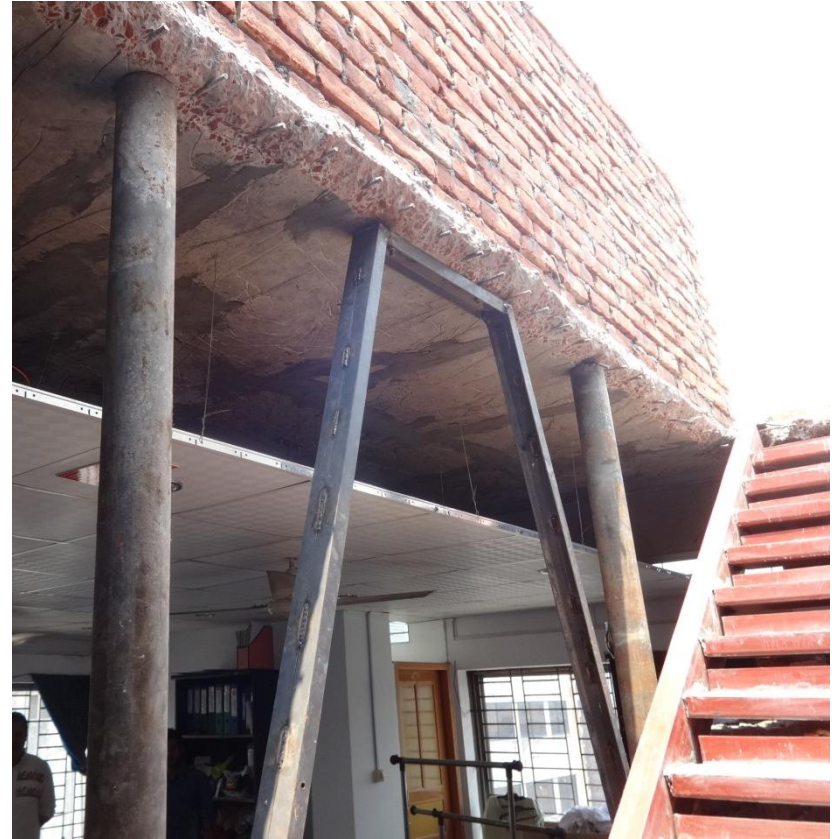
Steel staircase from sixth floor to roof at NW corner is not adequately detailed or connected to the slab. It would appear to be held by one M8 bolt and several tack welds to the reinforcement.

- An engineering assessment be carried out to determine the structural integrity of the steel staircase.

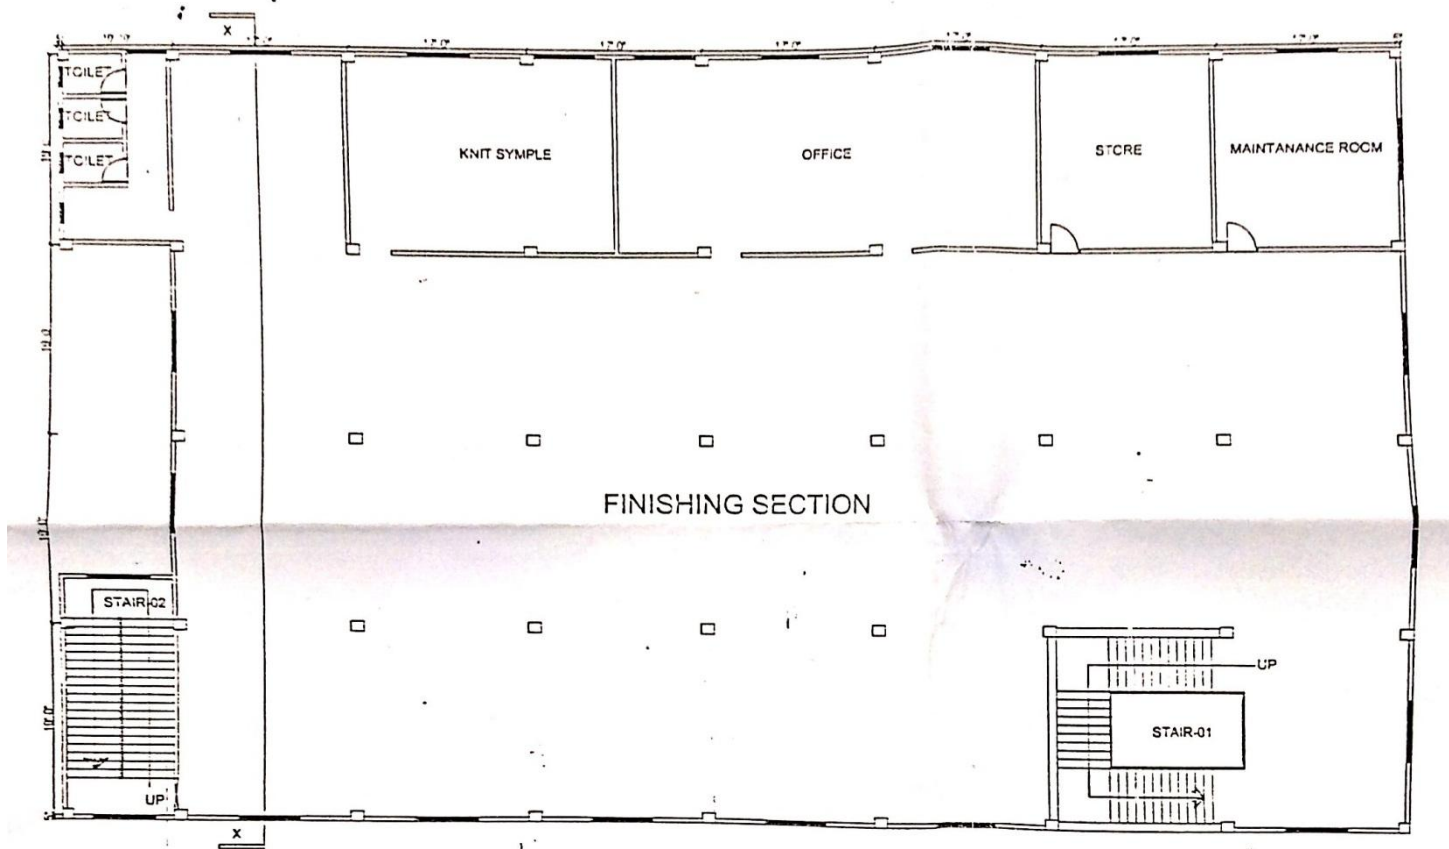
The building did not feature any core or shear walls. Stability was achieved through sway action between beams and columns and masonry infill walls.

We require that these items be investigated in a Detailed Engineering Assessment

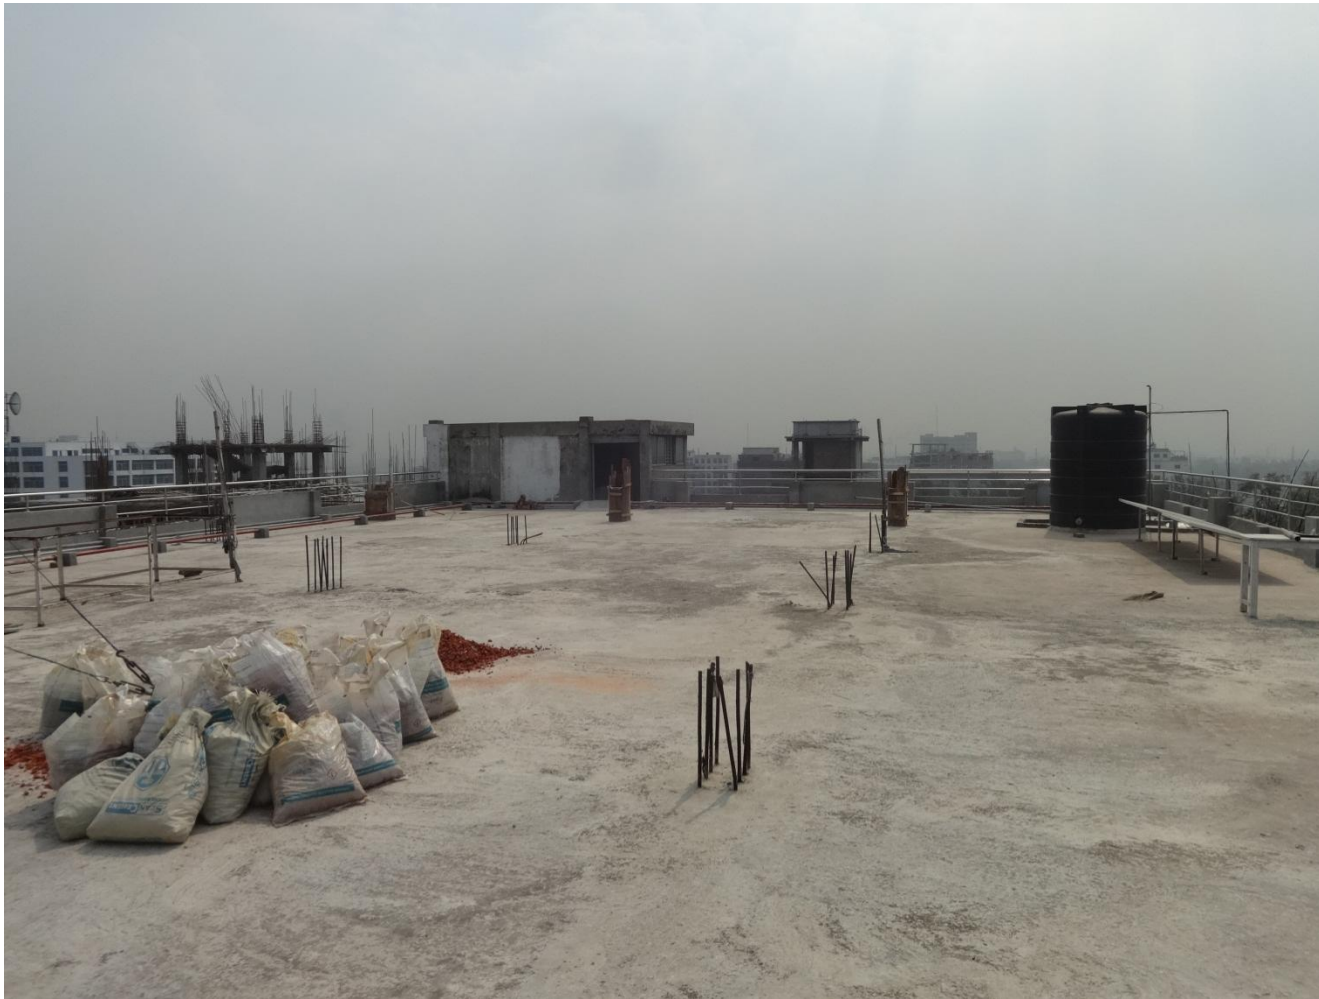
No waterproofing membrane was visible on the roof of the building. This means that any cracks in the surface finishes on the roof will allow water to seep into the concrete slab beneath the finishes, and cause long-term soaking of the slab.
