# K.C Bottom & Shirt Wear Company

K. C. Industrial Park, Ratuti, Katchkura, Uttarkhan, Uttara, Dhaka District.  
(23.859153N, 90.465239E)  
12<sup>th</sup> February 2017

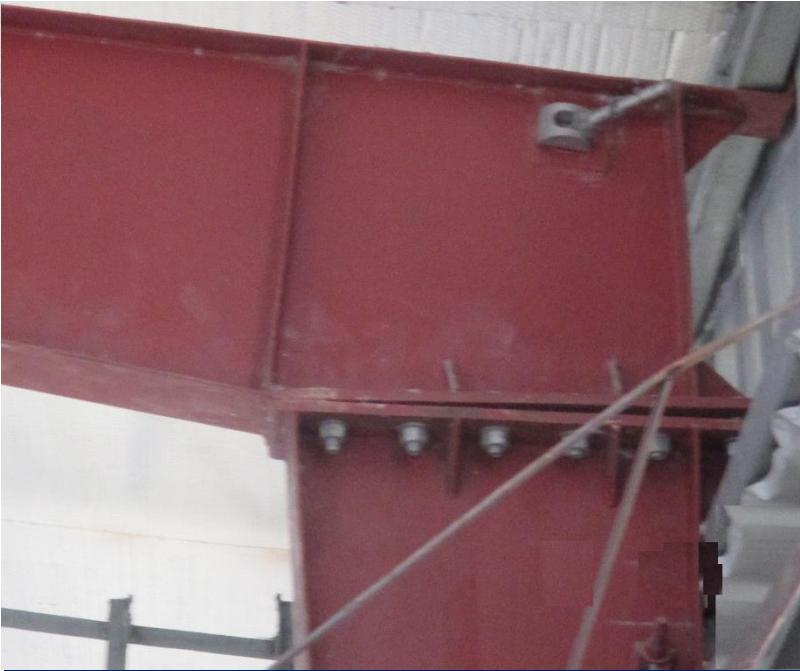
Gap at rafter & column connection

Gap at rafter & column connections observed throughout the shed. The vertical bracings also appeared to be loosely installed. Factory to tighten the loose connections and vertical bracings according to the suggestion given by the factory engineer.

| Item No. | Observation | Recommended Action Plan | Recommended Timeline |
|---|---|---|---|
| 1 | Loose bracings and existence of gap at connections | Factory to tighten the loose connections and also tighten the vertical bracings according to the suggestion given by the factory engineer. | 6-weeks |

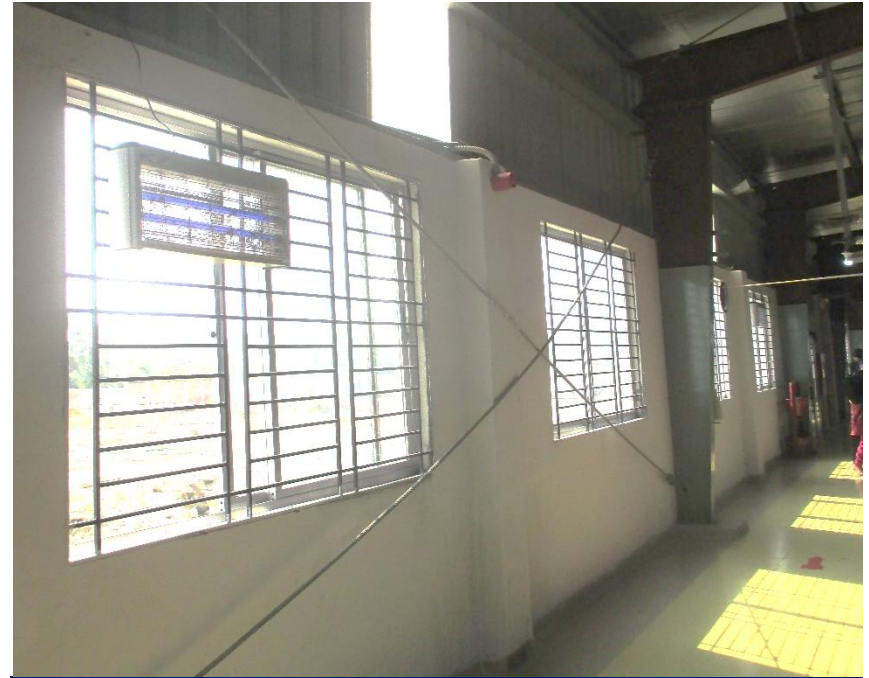
Loose vertical bracings

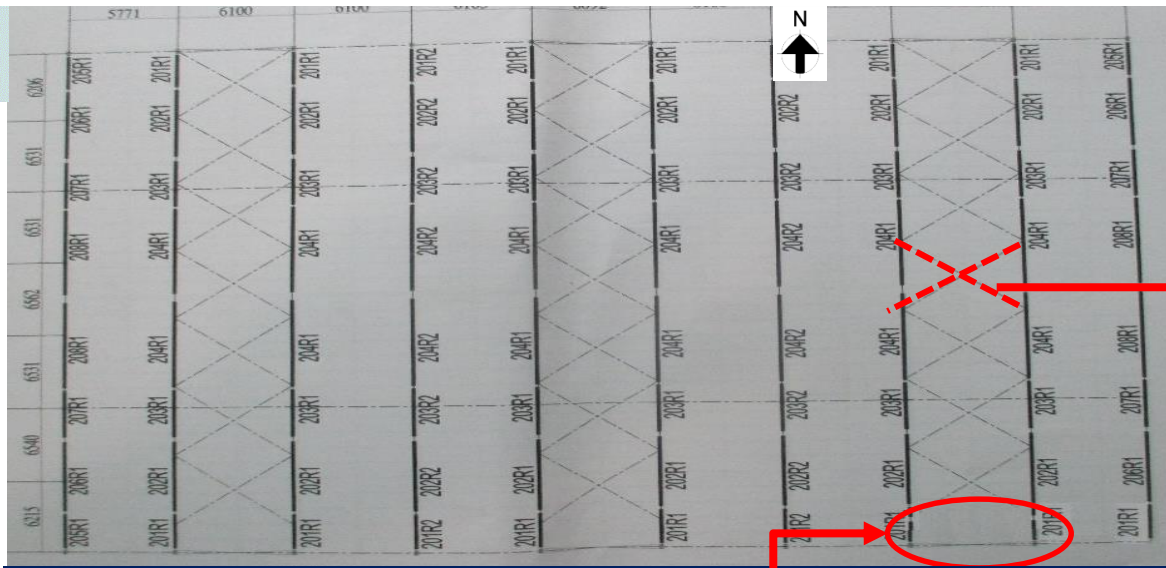
Typical bracing layout

Vertical bracing are missing in highlighted area and some of the horizontal bracings are appeared to be loosely installed. Sagging of bracings was also observed in the horizontal bracing. Factory to install missing bracing and tighten all loose bracing according to the suggestion by the factory engineer.

| Item No. | Observation | Recommended Action Plan | Recommended Timeline |
|---|---|---|---|
| 2 | loose and missing bracings | Factory to install missing bracing and tighten all loose bracing according to the suggestion by the factory engineer. | 6-weeks |

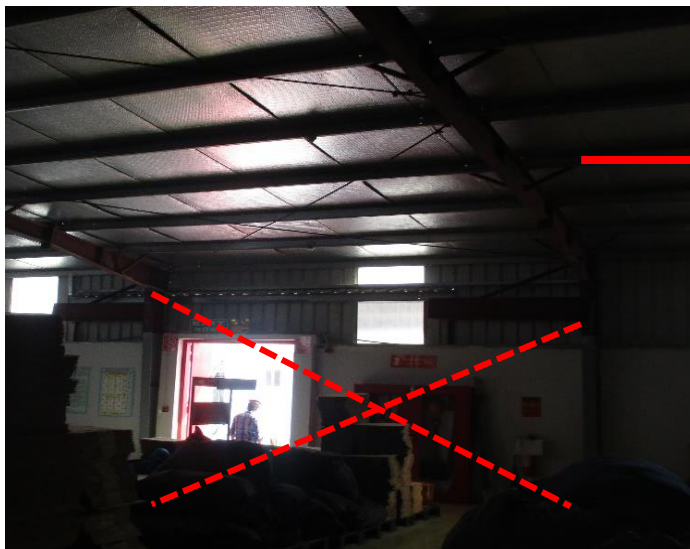
Untied bracings

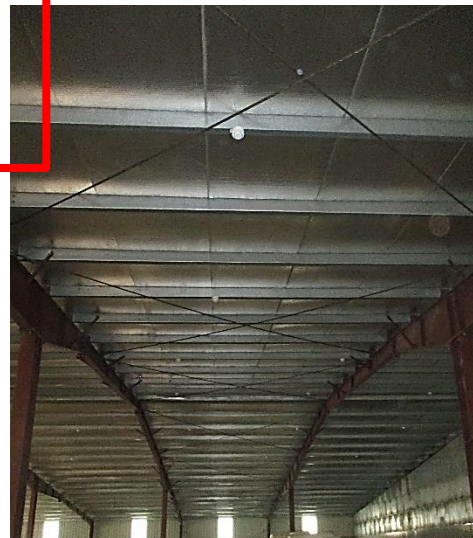
Sag in horizontal bracing

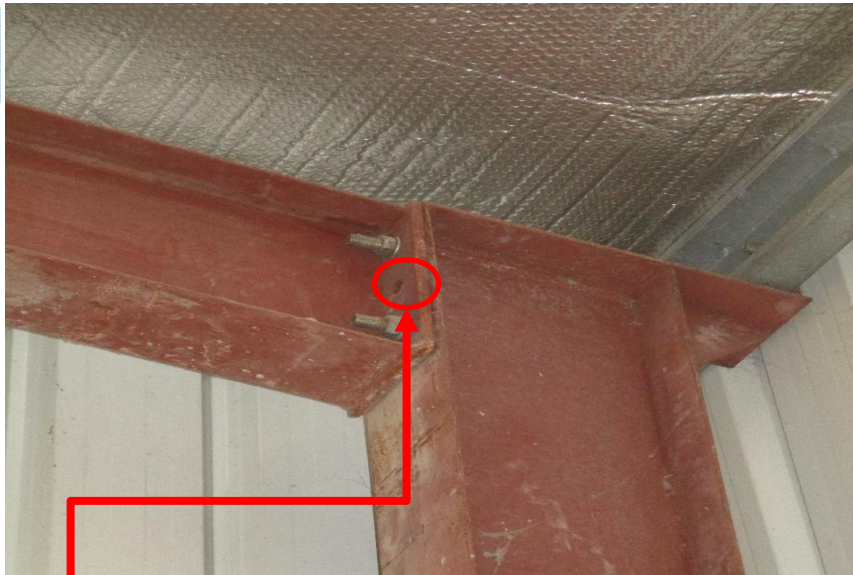
Missing bolt in column-rafter Joint

Some bolts were missing in rafter joint. Factory to install all missing bolts according to the suggestion given by the factory engineer.

| Item No. | Observation | Recommended Action Plan | Recommended Timeline |
|---|---|---|---|
| 3 | Missing Bolts | Factory to install all missing bolts according to the suggestion given by the factory engineer. | 6-weeks |

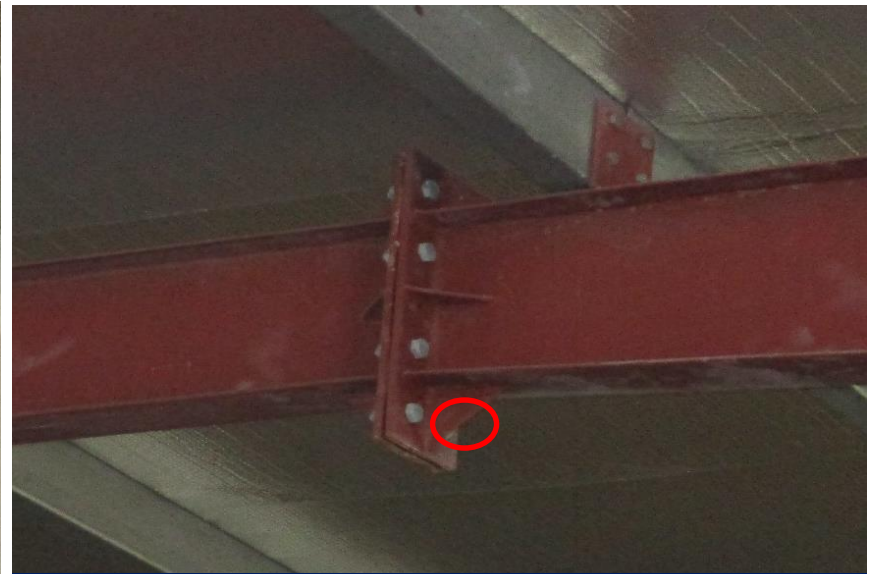
Missing bolt

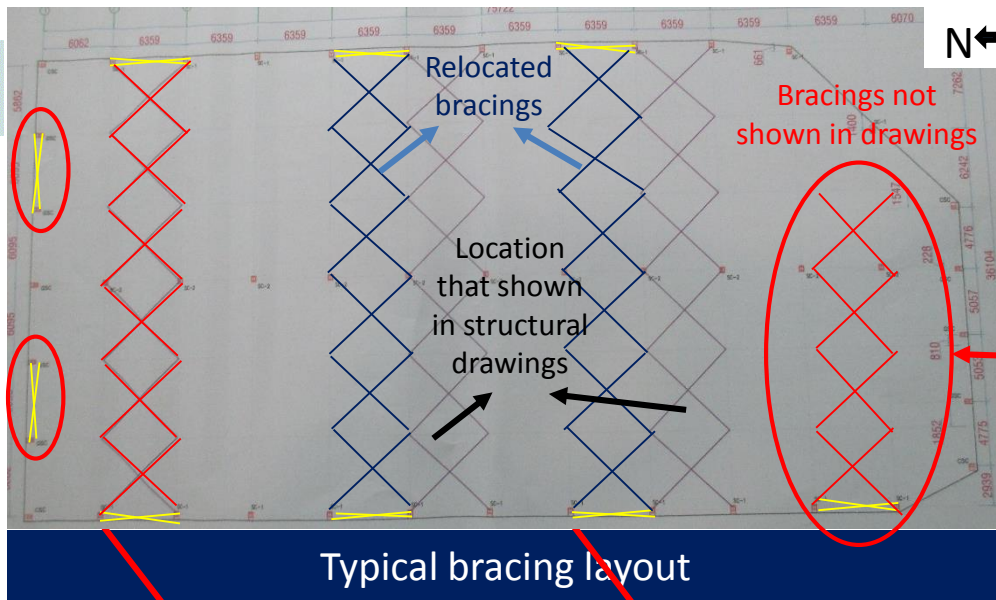
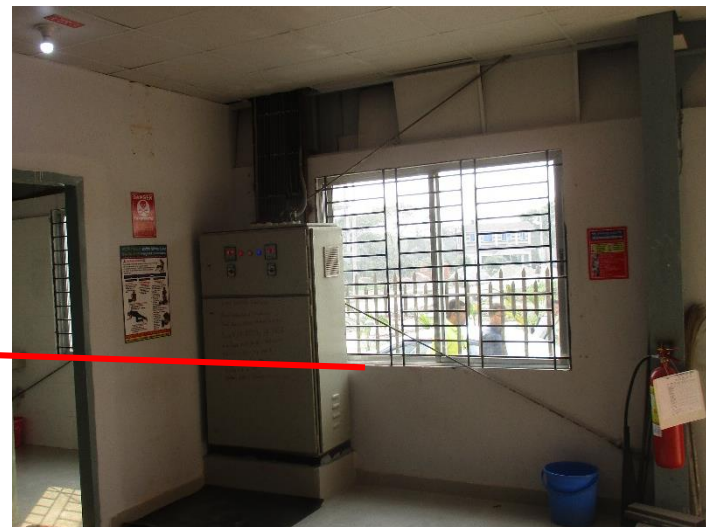
Vertical bracing not shown in drawing

Roof bracings at mid portion of the structure were found installed at different location. Red circled bracings were not shown in drawing. Factory engineer to update as-built drawing reflecting as constructed condition and also check the lateral stability of the shed.

| Item No. | Observation | Recommended Action Plan | Recommended Timeline |
|---|---|---|---|
| 4 | Discrepancy between provided drawing and as constructed condition | Factory engineer to updated as-built drawing reflecting as constructed condition. | 6-weeks |
| 5 | Discrepancy between provided drawing and as constructed condition | Factory engineer to check the lateral stability of the shed. | 6-weeks |

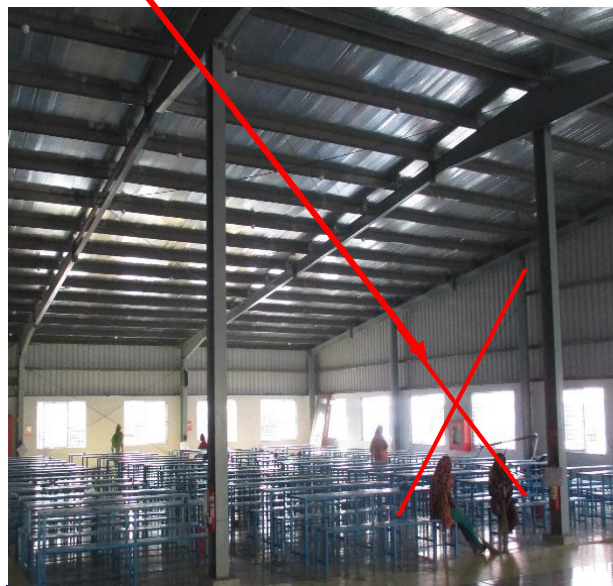
Vertical bracing not shown in drawing

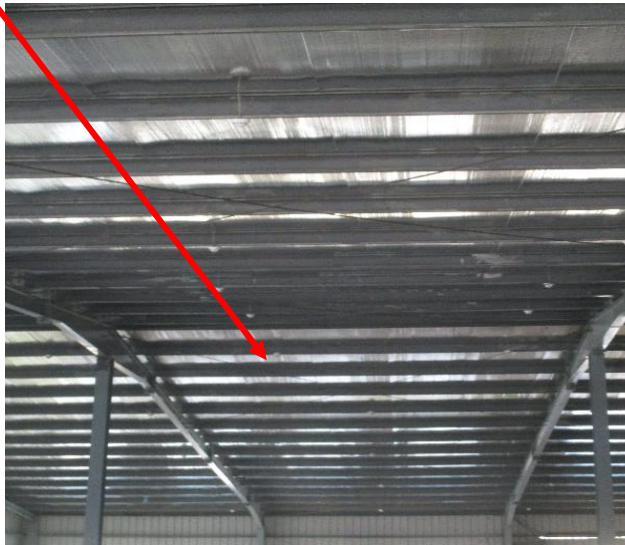
Bracing location are deviated from original layout

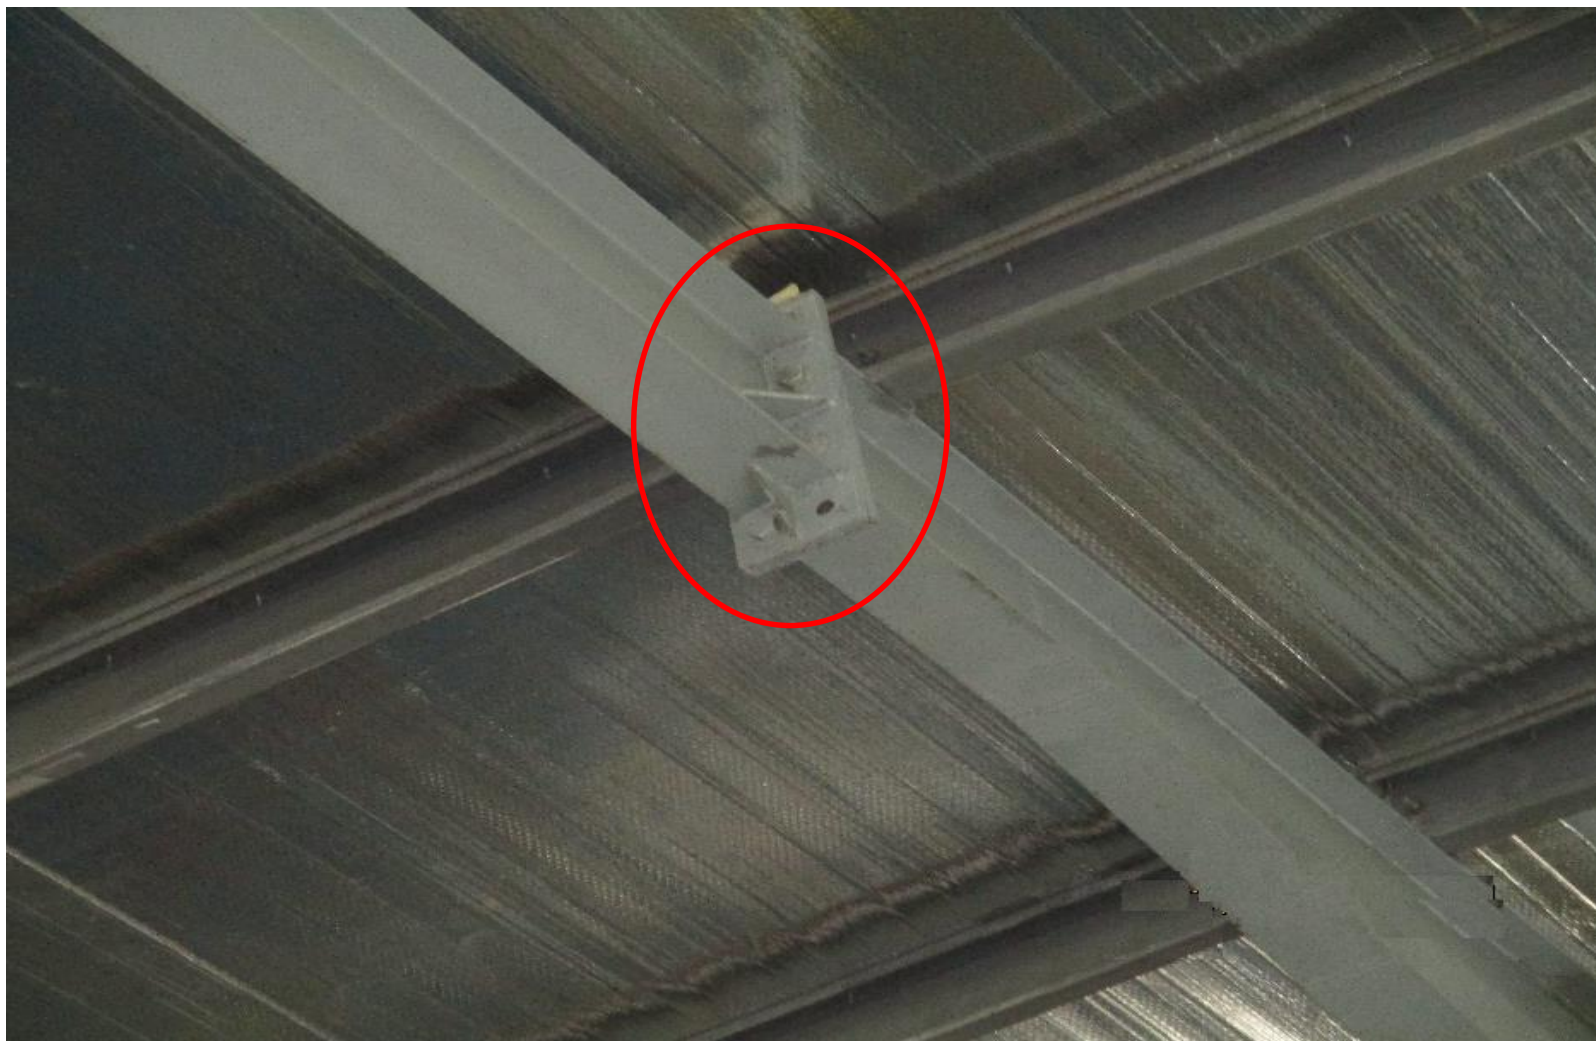
Bolts are missing in some connections of steel members. Factory to install all missing bolts according to the suggestion given by the factory engineer.

| Item No. | Observation | Recommended Action Plan | Recommended Timeline |
|---|---|---|---|
| 7 | Missing bolts<br>(Tin Shed-5) | Factory to install all missing bolts according to the suggestion given by the factory engineer | 6-weeks |

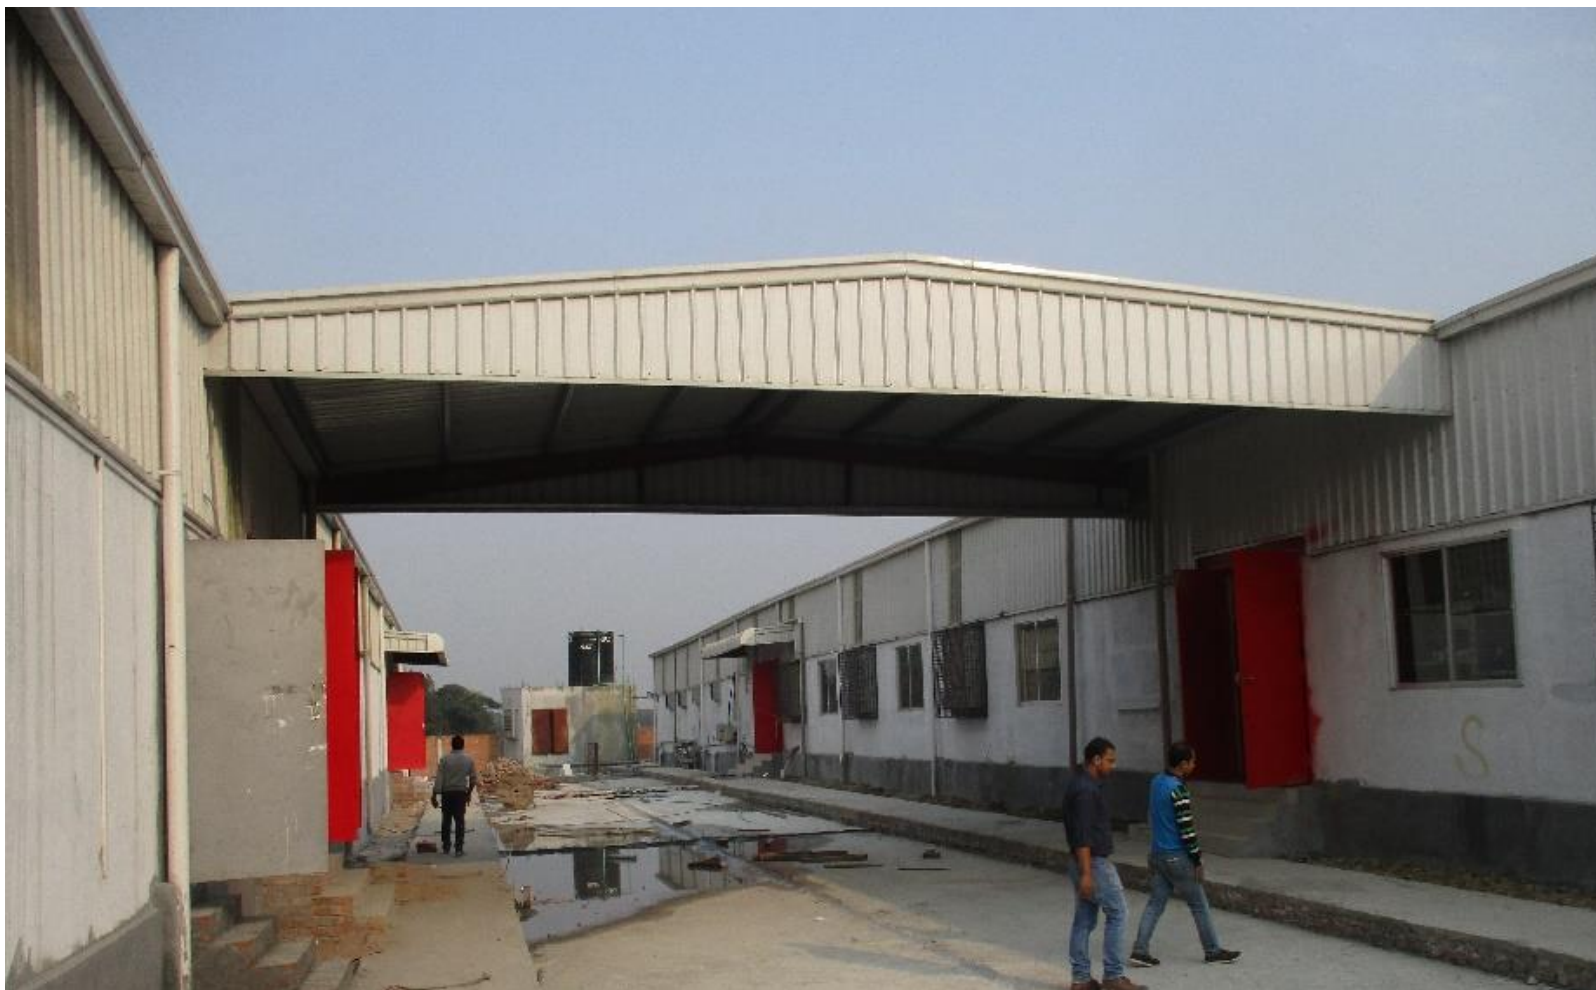
Undocumented canopy was observed connecting Tin Shed-3 and Tin Shed-4. Factory engineer to update the as-built drawing reflecting the as-constructed condition.

| Item No. | Observation | Recommended Action Plan | Recommended Timeline |
|---|---|---|---|
| 8 | Undocumented canopy | Factory engineer to update the as-built drawing reflecting the as-constructed condition. | 6-weeks |

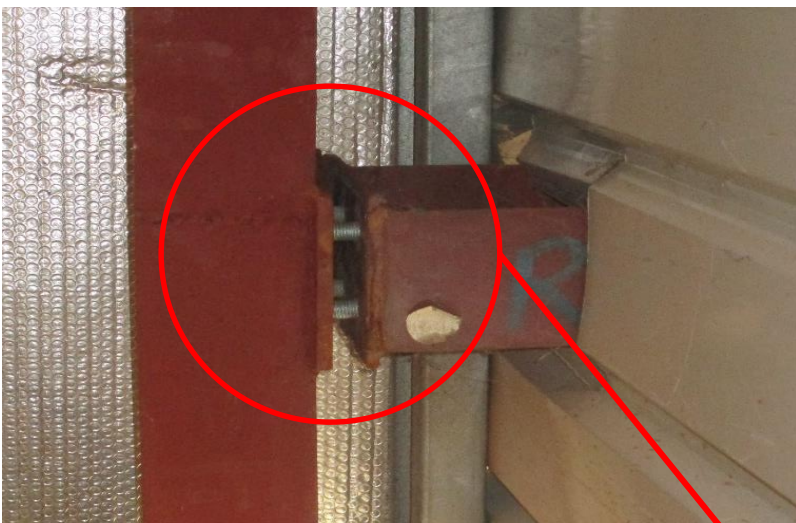
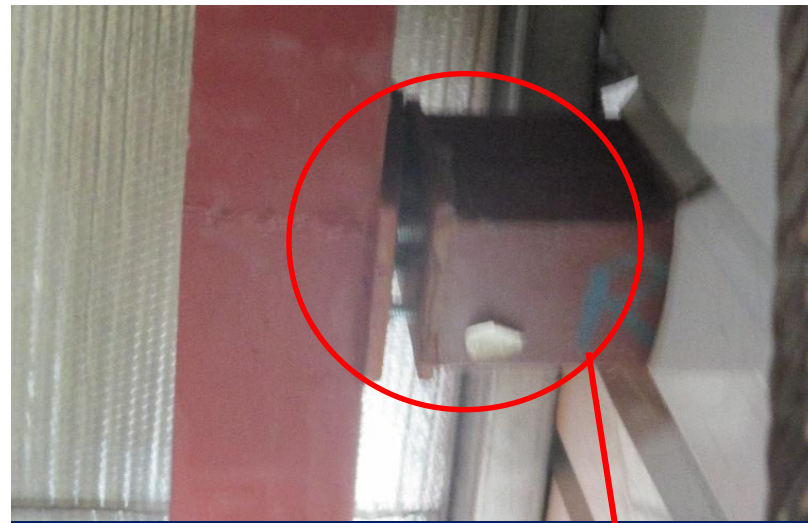
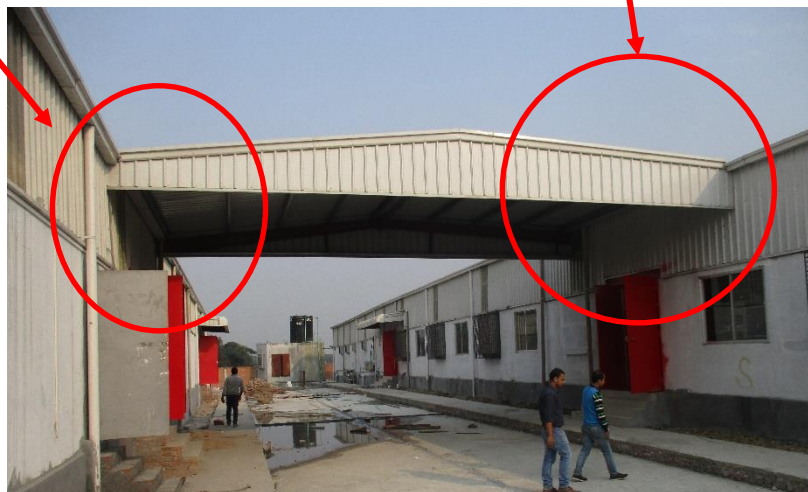
Canopy connects with Tin Shed-4

Canopy connects with Tin Shed-3

Canopy between Tin Shed-3 and Tin Shed-4

Gap at connections was observed in steel members of canopy connecting Tin shed-3 with Tin Shed-4. Factory to reduce the gap and tighten the connections according to the suggestion given by the factory engineer.

| Item No. | Observation | Recommended Action Plan | Recommended Timeline |
|---|---|---|---|
| 9 | Existence of gap at connections | Factory to reduce the connection gap and tighten the connections according to the suggestion given by the factory engineer | 6-weeks |
| 10 | Existence of gap at connections | Factory engineer to check the stability of the structure and adequacy of the connections. | 6-weeks |
