Helicon Ltd

Plot # 127, Dhaka EPZ (Old Area), Ganakbari, Savar, Dhaka, Bangladesh.

11th May 2014

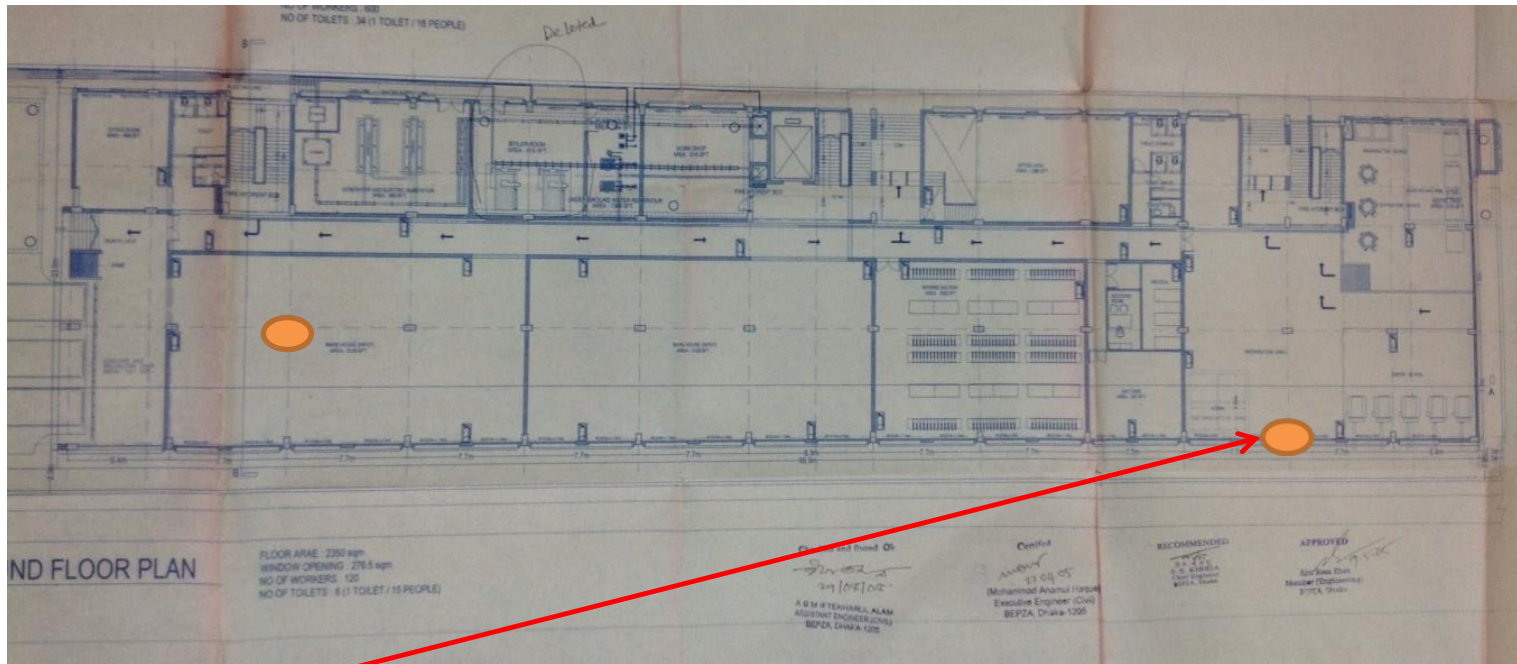
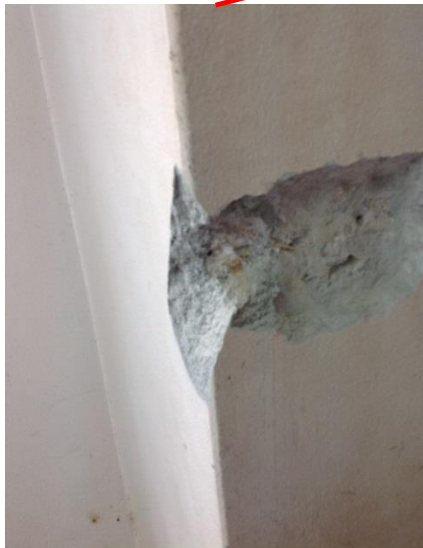
Column Stresses

Column Stress:

Cursory calculations indicate that columns may be stressed to high levels when the additional permitted 3 storeys are constructed. Columns highlighted were tested and stone aggregate confirmed. Reinforcement was investigated using a ferros scanner.

ITEM 1: Column stresses (if the building is extended to 6 storeys).

Item No.	Observation	Recommended Action Plan	Recommended Timeline
1	Column stresses (if building is extended to 6 storeys)	If factory is to be extended to 6 storeys Factory Engineer to review columns stresses in all columns using a model based design check to loading set out in BNBC-2006. Factory Engineer to verify insitu concrete strength by taking 100mm diameter cores from 4 columns .	6-months
2	Cracking in non structural masonry walls.	Factory Engineer to monitor cracking in masonry walls over an extended period (min 12 months) and advise on any remedial structural work required.	6-months
3	Cracking in Ground Floor Slab.	Factory Engineer to monitor settlement of the ground floor slab and note if any settlement occurs in foundations to the main structural elements.	6-months
4	Cracking in beams	Factory Engineer to investigate if the cracking is structural or exists only in the render.	6-months

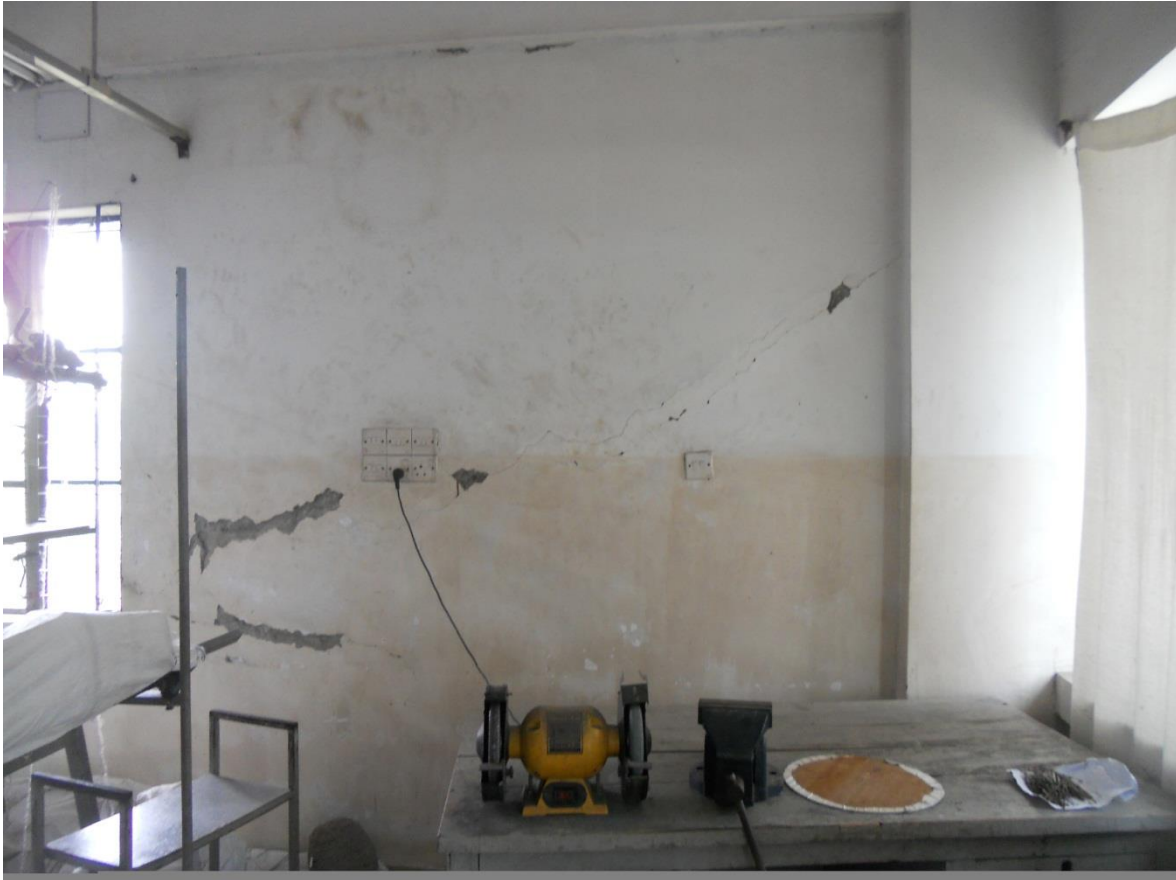
Cracking in masonry at West end of building

Cracking in masonry walls at West end of building.

Significant cracking was noted in masonry walls along Grid 1 and 3 between Grids A and B at Level 2.

Cracking may have been caused by thermal movement in the structure or by foundation settlement.

ITEM 2: Cracking in non structural masonry walls.

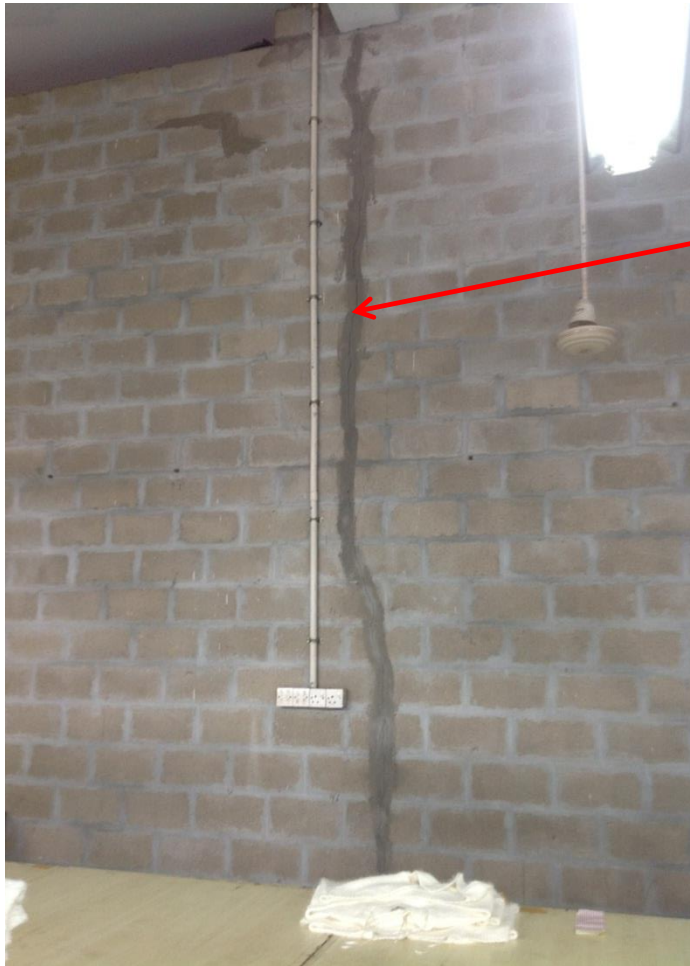
Cracking in internal masonry walls at Ground Floor Level.

Double height masonry walls have numerous full height cracks.
No movement or expansion joints were noted.
Top of wall is largely unrestrained.

Ground level to first floor masonry wall

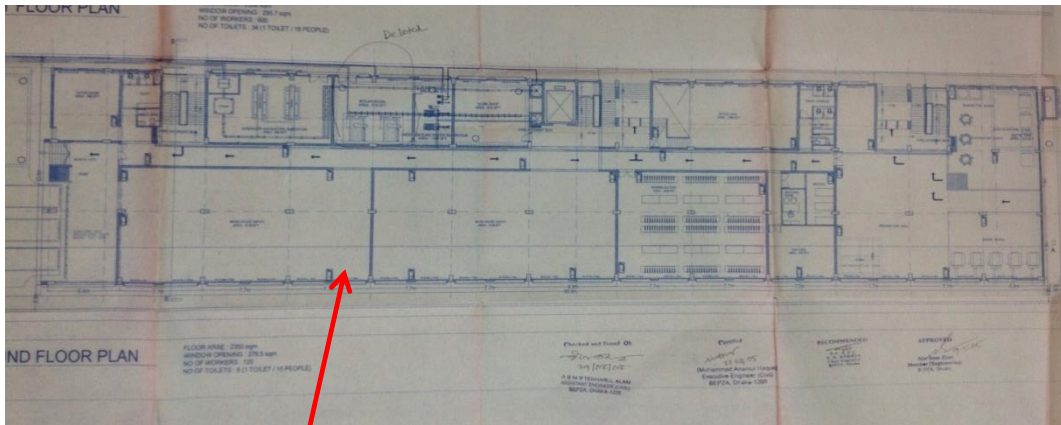
Cracks visible in exposed concrete areas (where no finishes exist)

Cracking is visible in areas without floor finishes.

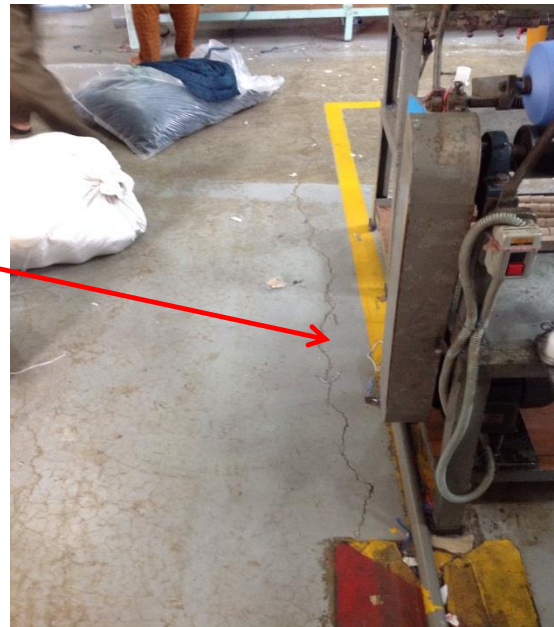
Crack over ground tie beams

Ground Floor Cracking:

Cracks along lines of ground beams may be the result of settlement of the filling under the floor slab.

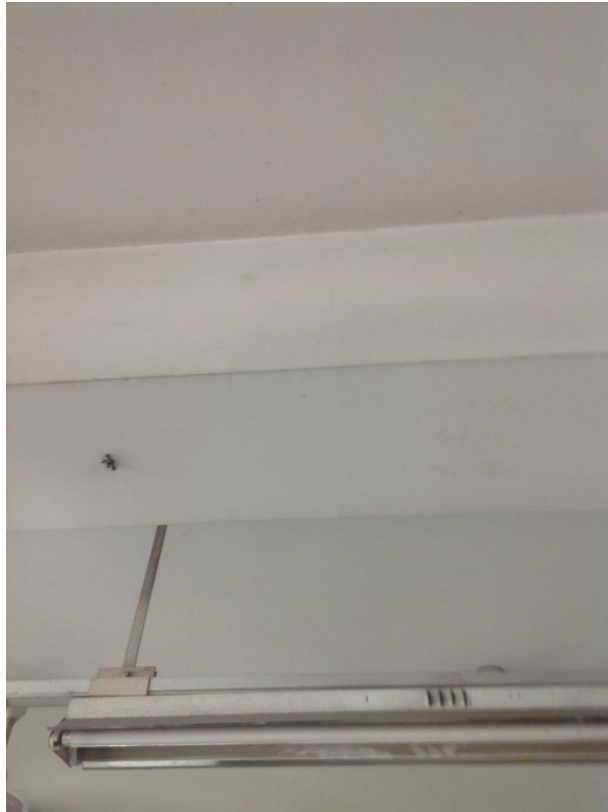
Hairline crack in beam

Hairline cracks were found in many beams throughout the building.

ITEM 4: Cracking in beams.

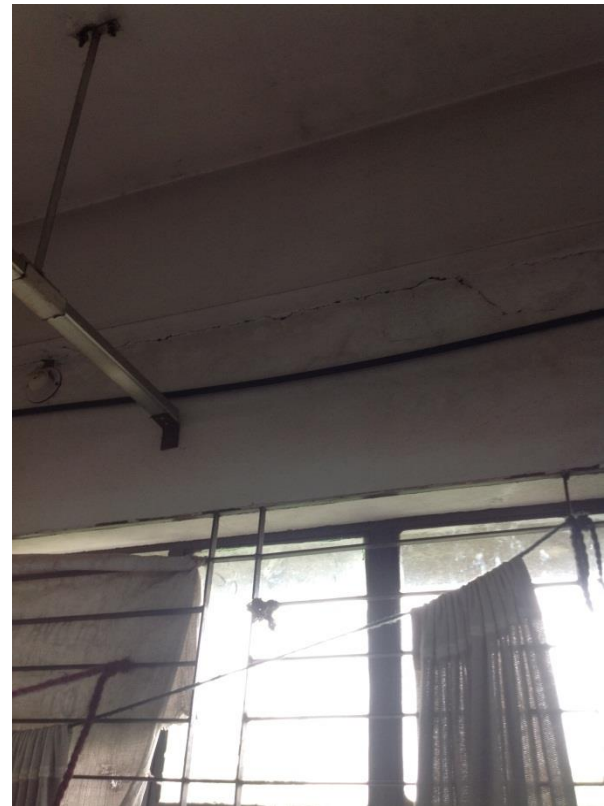
Cracking along edge beams
