# Jeans Plus Ltd

## Khalifa Apparels Ltd

Plot No-398, Sreepur Bus Stand, Ganakbari, Savar, Dhaka  
(23.960985N 90.269380E)

13 May 2014

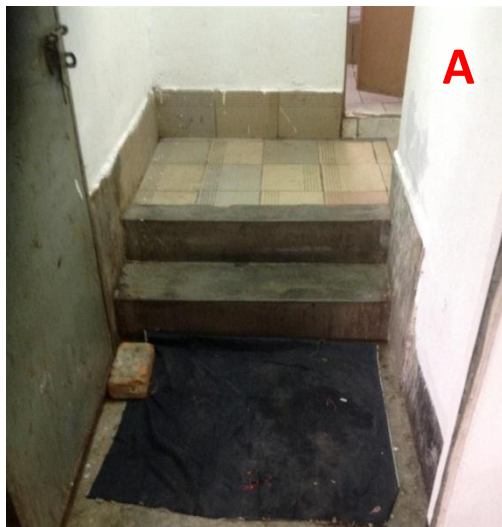
A

# **Heavy loading on slabs from finishes build-up in toilets, storage and water tanks**

- Heavy slab loading was noted in (A) toilet areas (up to 420mm average build-up) and (B) on 2<sup>nd</sup> floor slab (about 4-5 kPa).
- We were also advised that there was up to 14,000 litres of water tanks on the roof to the stairs, but this could not be verified as there was no safe access.

| Item No. | Observation | Recommended Action Plan | Recommended Timeline |
|---|---|---|---|
| 1 | Verify concrete strengths in columns supporting (a) toilets in NW corner of factory and (b) 2nd floor storage | 4m zone next to toilets on all floors in factory building to be emptied of all storage and equipment, with access only to toilet area, shown in full report. | <b>Immediate - Now</b> |
| 2 | Verify concrete strengths in columns supporting (a) toilets in NW corner of factory and (b) 2nd floor storage | Building Engineer to review design, loads and columns stresses in the area identified in Full report. | <b>Immediate - Now</b> |
| 3 | Verify concrete strengths in columns supporting (a) toilets in NW corner of factory and (b) 2nd floor storage | Verify insitu concrete stresses either by 100mm diameter cores or existing cylinder strength data for the identified columns. Building Engineer to determine a safe location for coring. | <b>Immediate - Now</b> |
| 5 | Verify concrete strengths in columns supporting (a) toilets in NW corner of factory and (b) 2nd floor storage | Produce and actively manage a loading plan for all floor plates within the factory giving consideration to floor capacity and column capacity. | <b>6-weeks</b> |

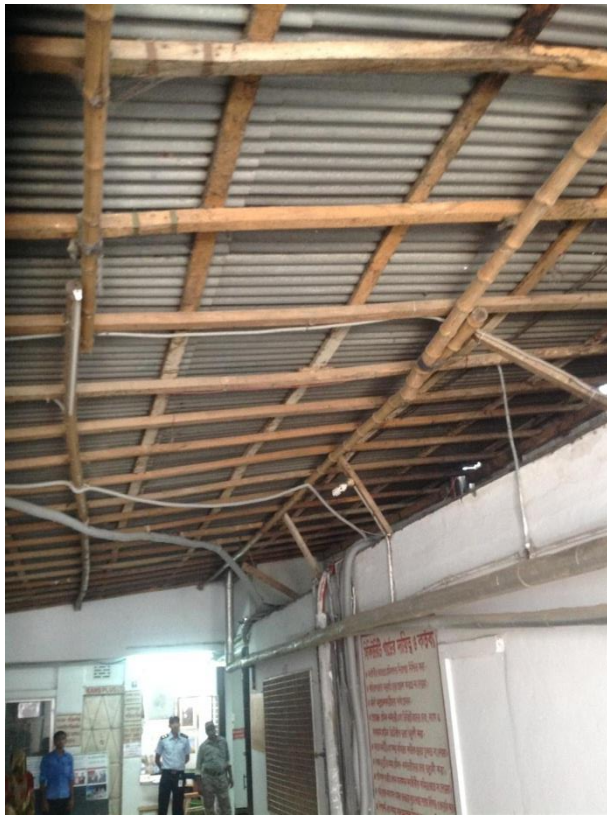
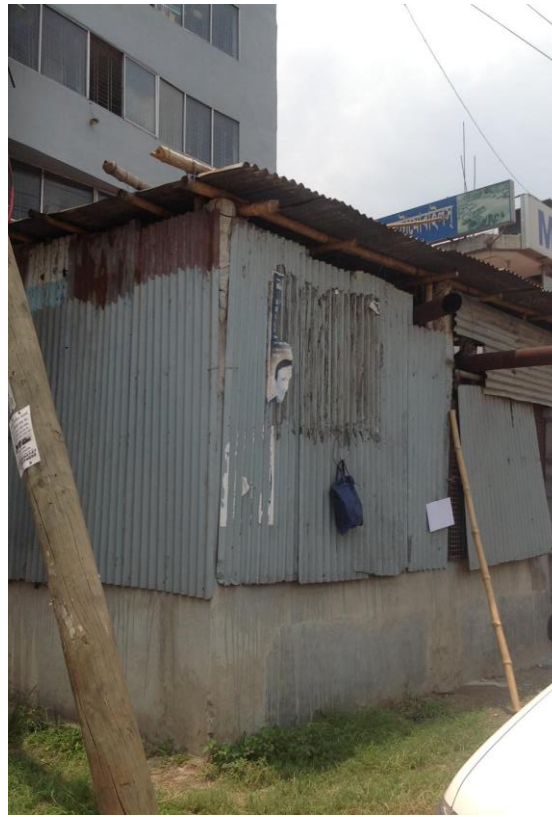
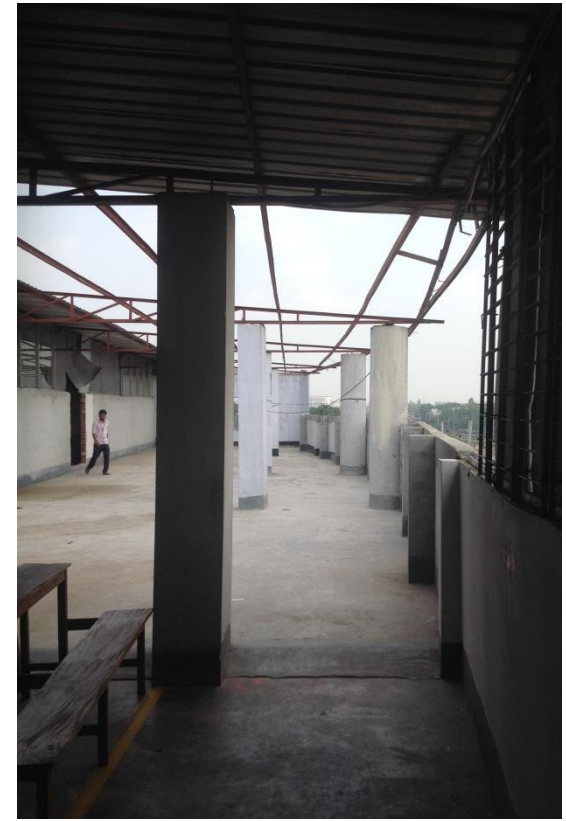
# **Non-engineered steel/bamboo sheds and roof**

- The roof to both the 5<sup>th</sup> floor and the various sheds round the building are non-engineered, and are unlikely to be able to withstand strong winds.

| Item No. | Observation | Recommended Action Plan | Recommended Timeline |
|---|---|---|---|
| 13 | Non-engineered 5th floor roof (Factory) and steel/bamboo sheds | Building Engineer to check design of 5th floor roof and steel/bamboo sheds against code vertical and wind loads | <b>6-weeks</b> |
| 14 | Non-engineered 5th floor roof (Factory) and steel/bamboo sheds | Structures to be upgraded as required following design check, or they should be vacated and removed. | <b>6-months</b> |

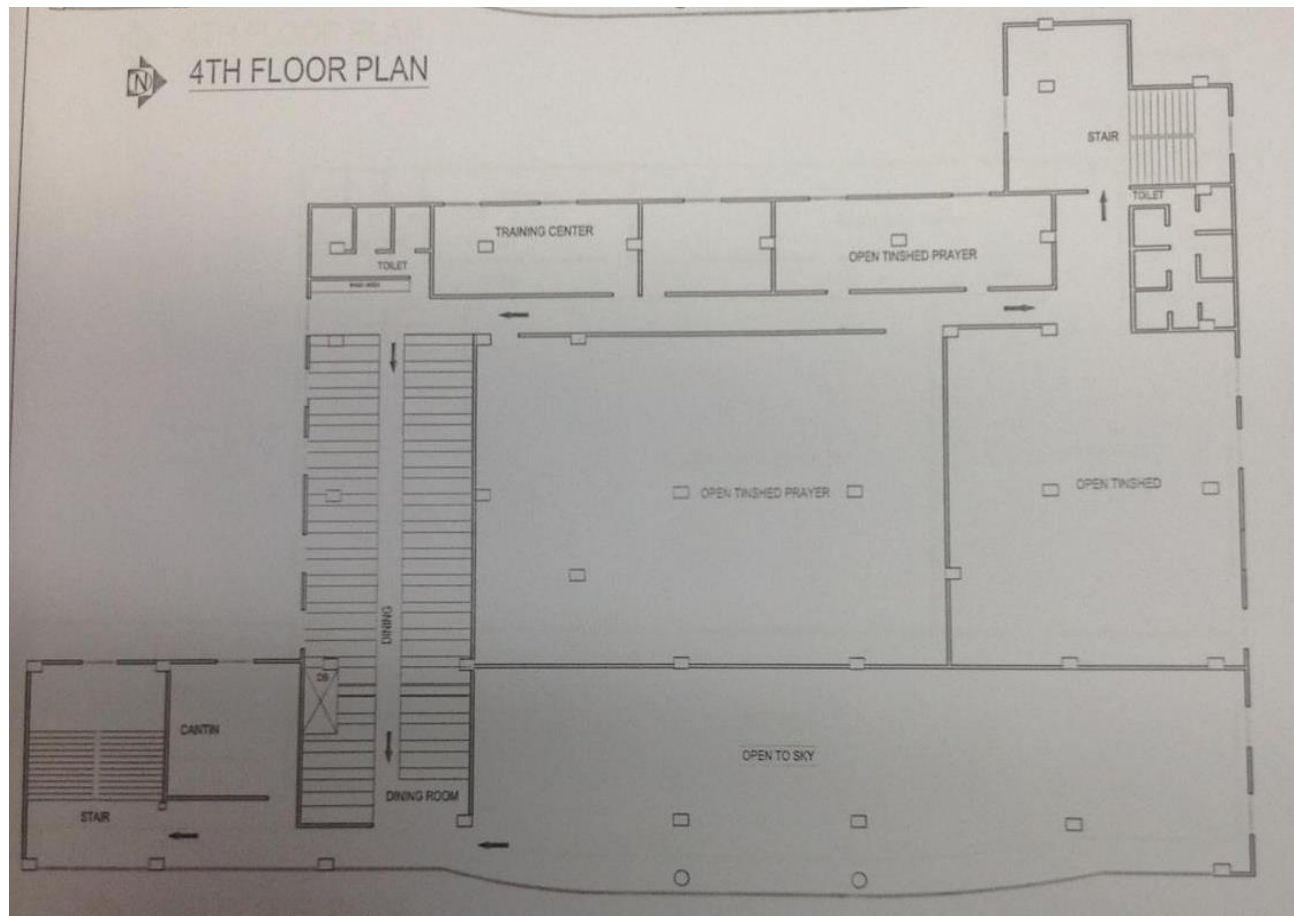
**Very irregular column layout**

- The column layout is highly irregular and there is also a huge variation in column sizes.
- The column layout does not precisely match the drawings
- The drawings were signed 3 years after construction
- Only part of the building shown on the drawings has actually been built

This all suggests that the building may not have been properly engineered.

| Item No. | Observation | Recommended Action Plan | Recommended Timeline |
|---|---|---|---|
| 4 | Verify concrete strengths in columns supporting (a) toilets in NW corner of factory and (b) 2nd floor storage | A Detail Engineering Assessment of Factory to be commenced, see attached Scope. | <b>Immediate - Now</b> |

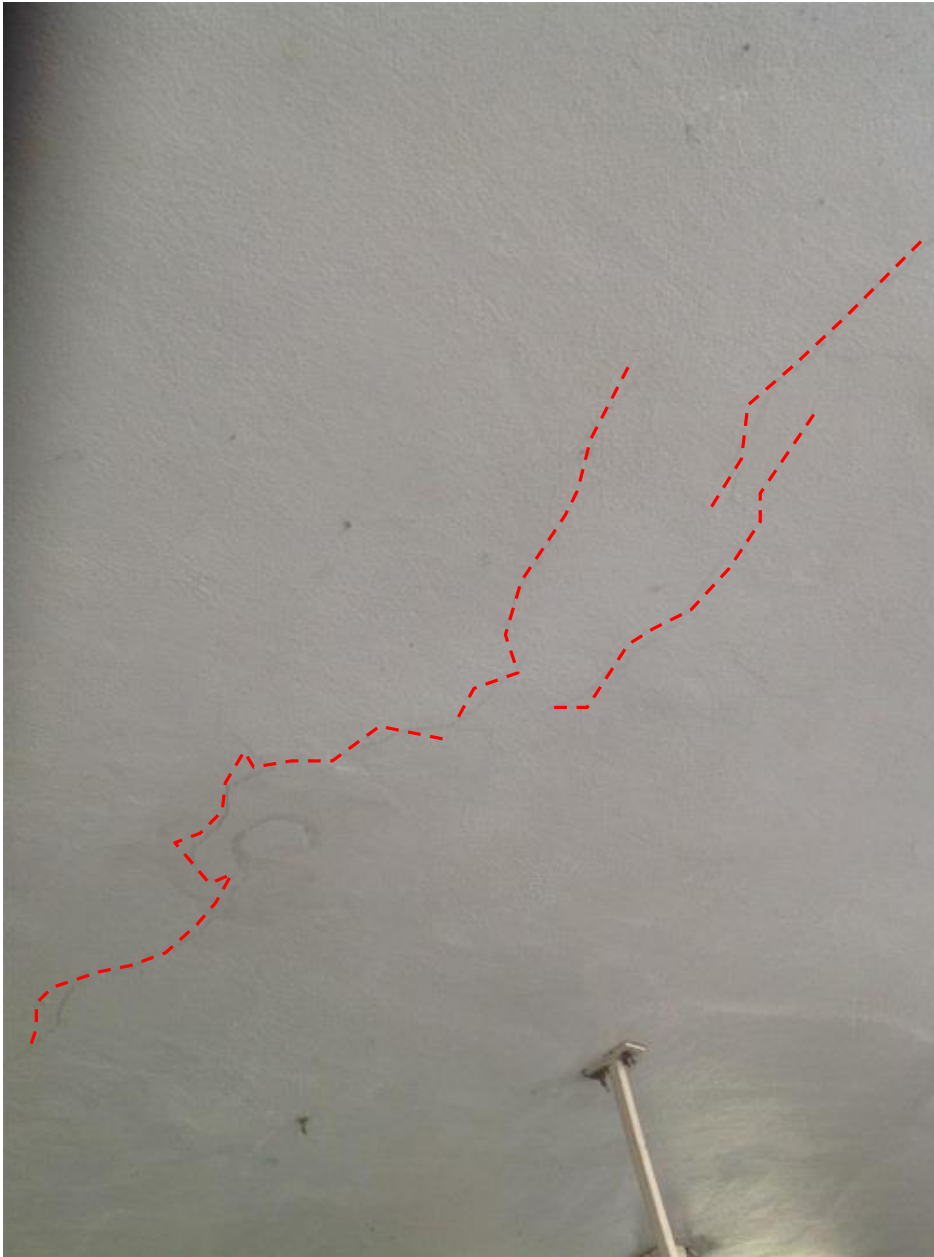
# **Flexural cracking to the 5<sup>th</sup> floor soffit**

There is  
hairline  
flexural  
cracking  
throughout  
the 5<sup>th</sup> floor  
soffit.

| Item No. | Observation | Recommended Action Plan | Recommended Timeline |
|---|---|---|---|
| 15 | Cracking to soffit of 5th floor slab in factory building | Building Engineer to assess cracking as part of Detail Engineering Assessment (see Item 1). | <b>6-weeks</b> |
| 16 | Cracking to soffit of 5th floor slab in factory building | Building Engineer to propose remedial work if necessary. | <b>6-months</b> |

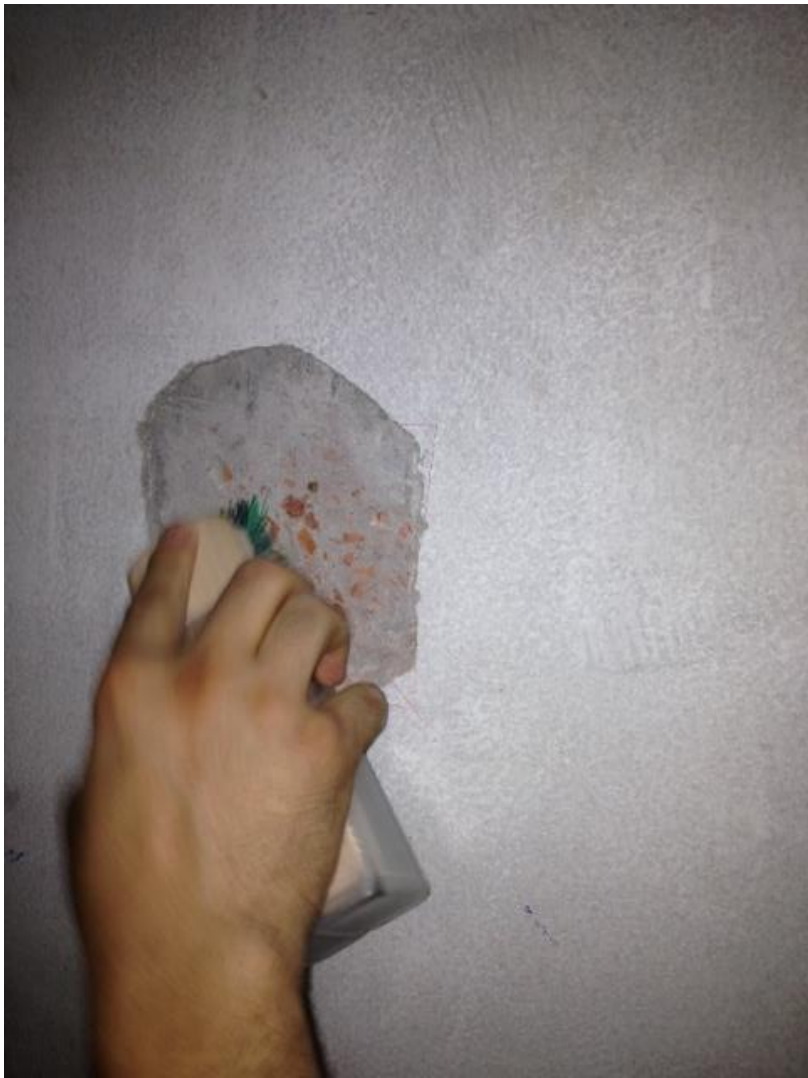
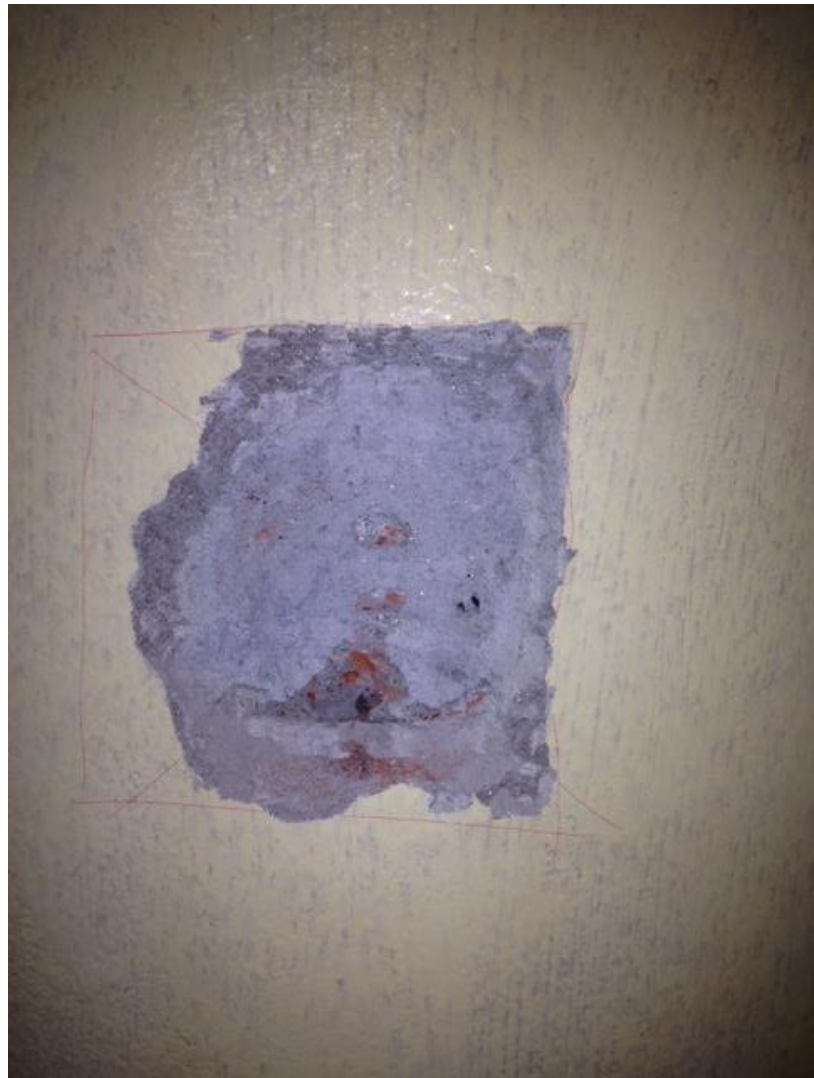
# Brick aggregate in columns

Removal of the plaster at ground floor revealed brick aggregate concrete.
