# Consumer Knitex (CMT Bangladesh) Ltd.

Dhamsur, Bhaluka, Mymensingh; Dhaka, Bangladesh

14 May 2014

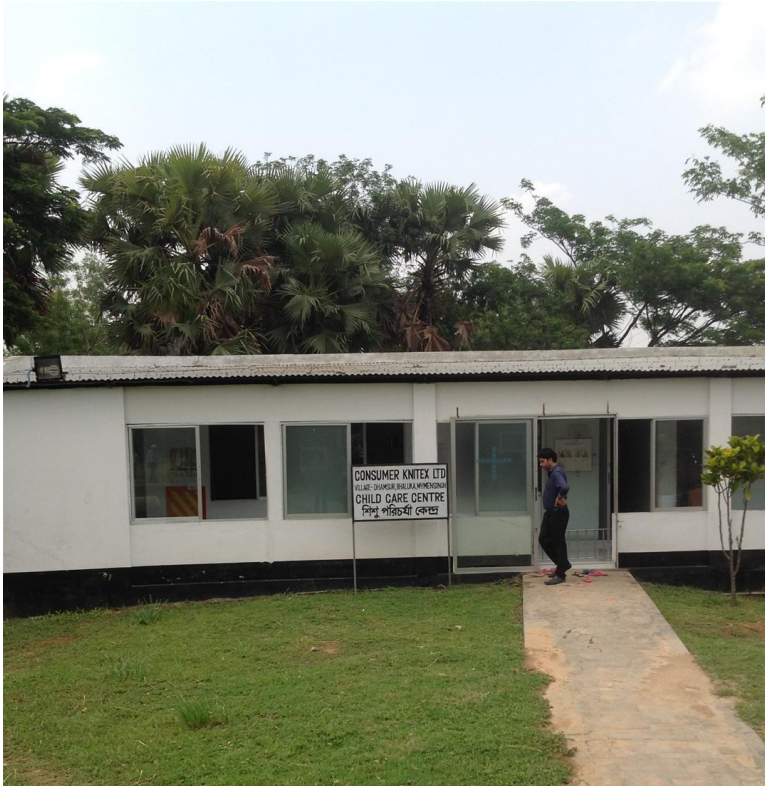
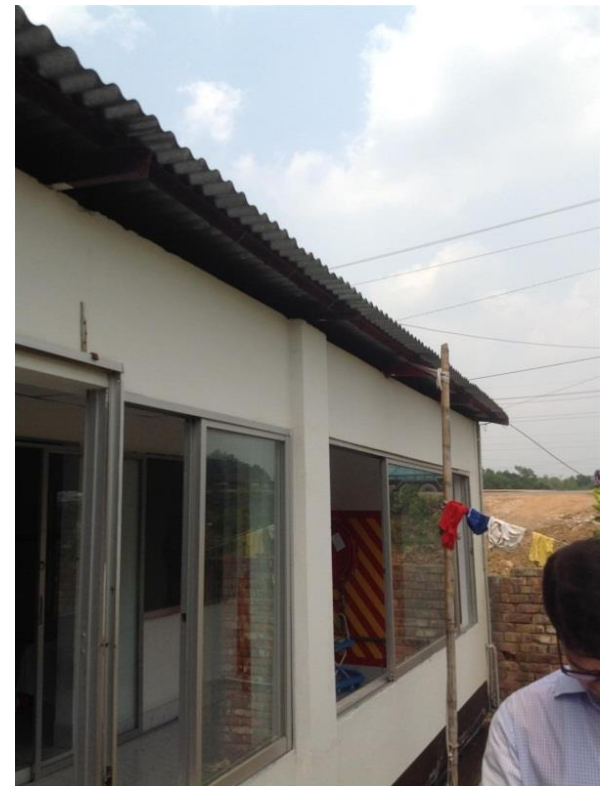
No drawings for the childcare building were presented and in general the structure appears to be non-engineered. The main issues observed were:

- Perimeter walls and columns acting as cantilevers, no foundation details presented.
- Overall stability of roof system not clear due to false ceiling.
- Adequacy of connection detail between roof truss and perimeter columns/walls.
- Section sizes used in roof system to be clarified.

| Item No. | Observation | Recommended Action Plan | Recommended Timeline |
|---|---|---|---|
| 1 | Structural stability of childcare building and lookout post (located along southern perimeter) | Structural Engineer to survey existing childcare building and propose any strengthening/remedial works if necessary. As-built drawings for the structure to be produced. | 6-months |

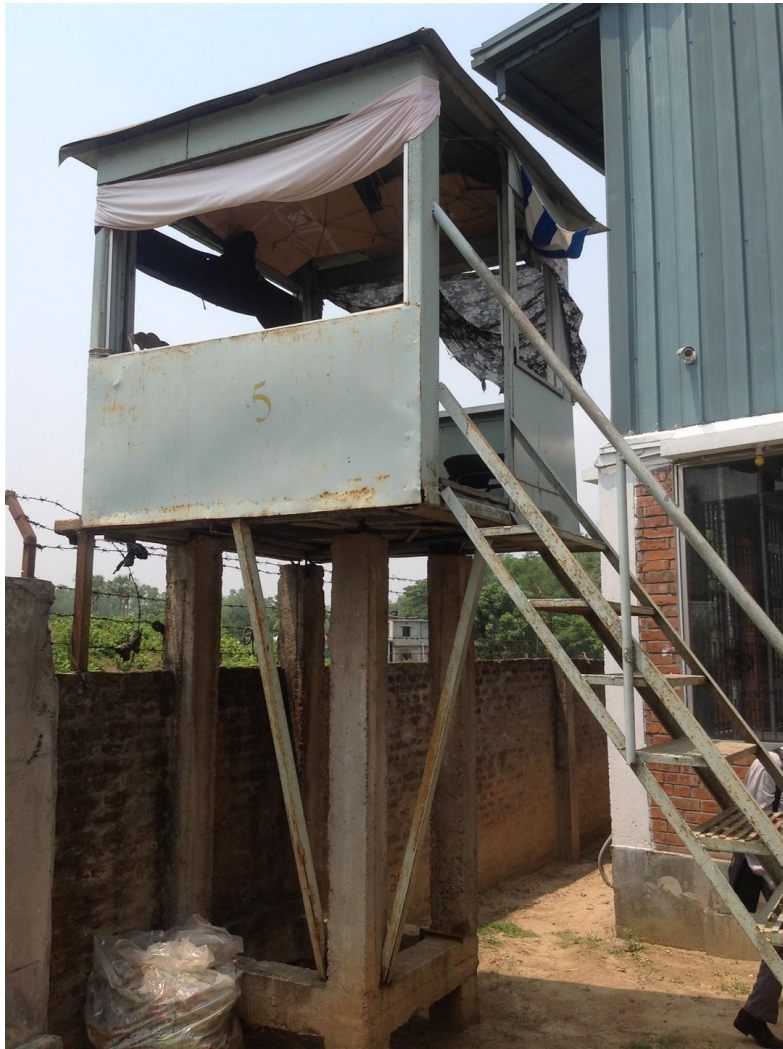
The lookout post located on the southern perimeter of the building appears to be non-engineered.

The building structure is connected to the support columns by welding the floor to the column's exposed rebar.

| Item No. | Observation | Recommended Action Plan | Recommended Timeline |
|---|---|---|---|
| 2 | Structural stability of childcare building and lookout post (located along southern perimeter) | Structural Engineer to survey the lookout post, in particular how the building structure is connected to the columns and propose any strengthening/remedial works if necessary. | 6-months |

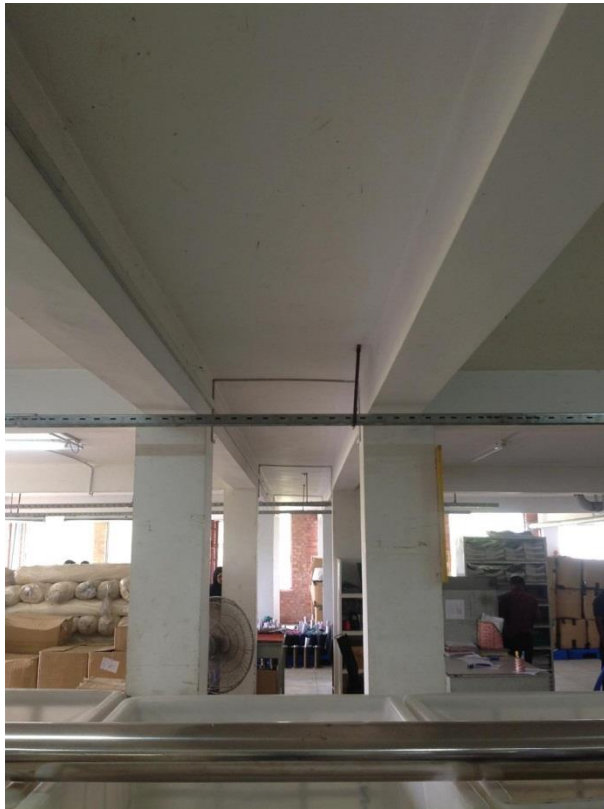
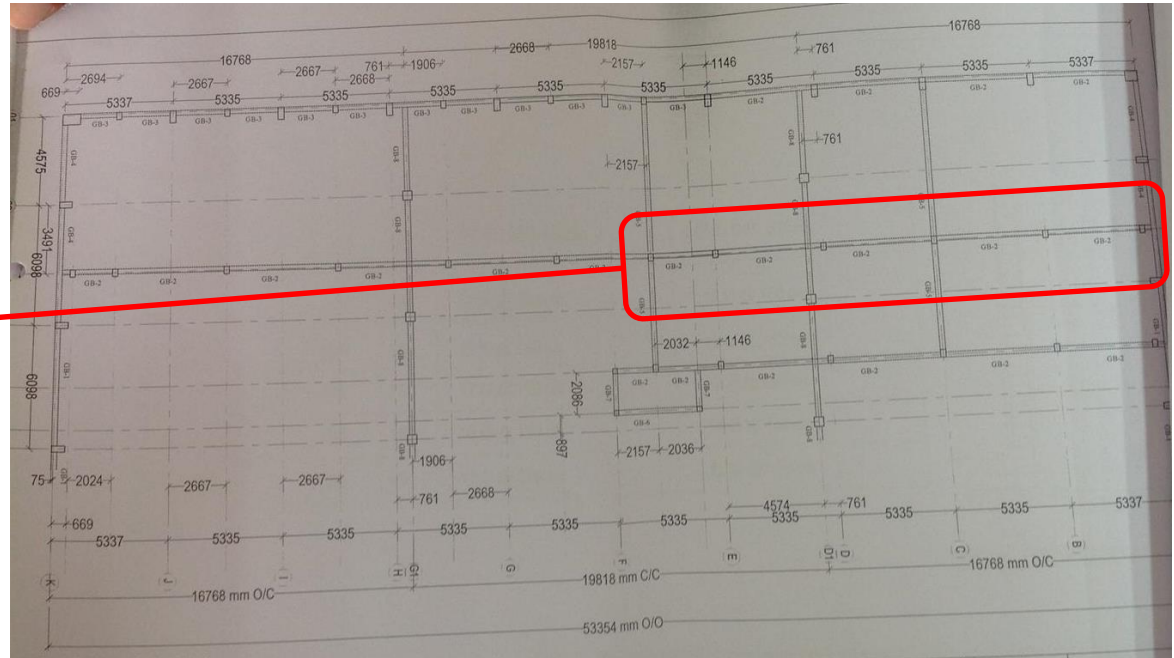
Inconsistencies observed between design drawings and what was constructed.

Additional line of beams and columns provided to mezzanine structure on south west side of building which were not shown on the structural drawings.

| Item No. | Observation | Recommended Action Plan | Recommended Timeline |
|---|---|---|---|
| 3 | Discrepancies between the Dye house built structure and design drawings. | Structural engineer to review existing structure and update the drawings to reflect as-built design. | 6-months |

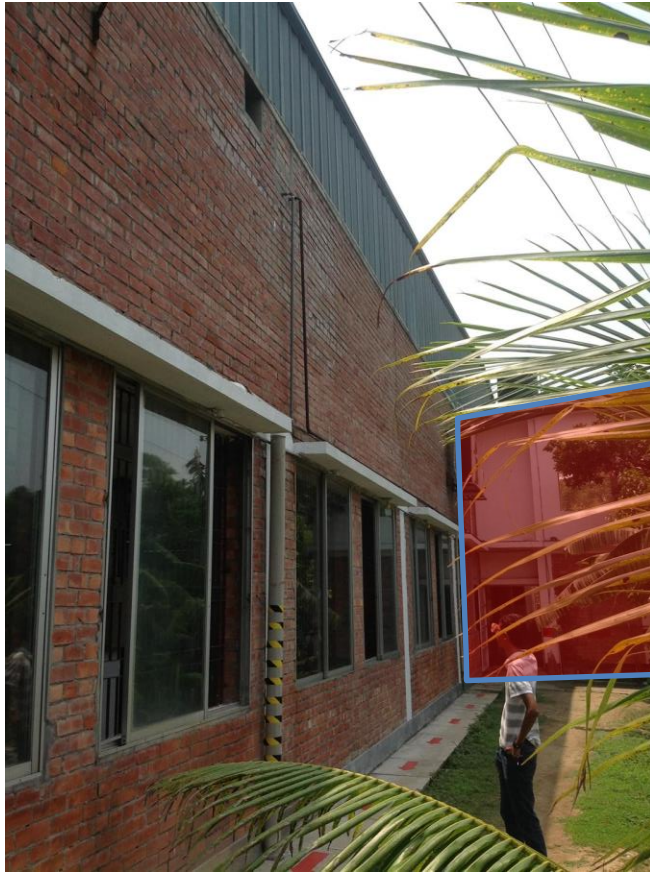
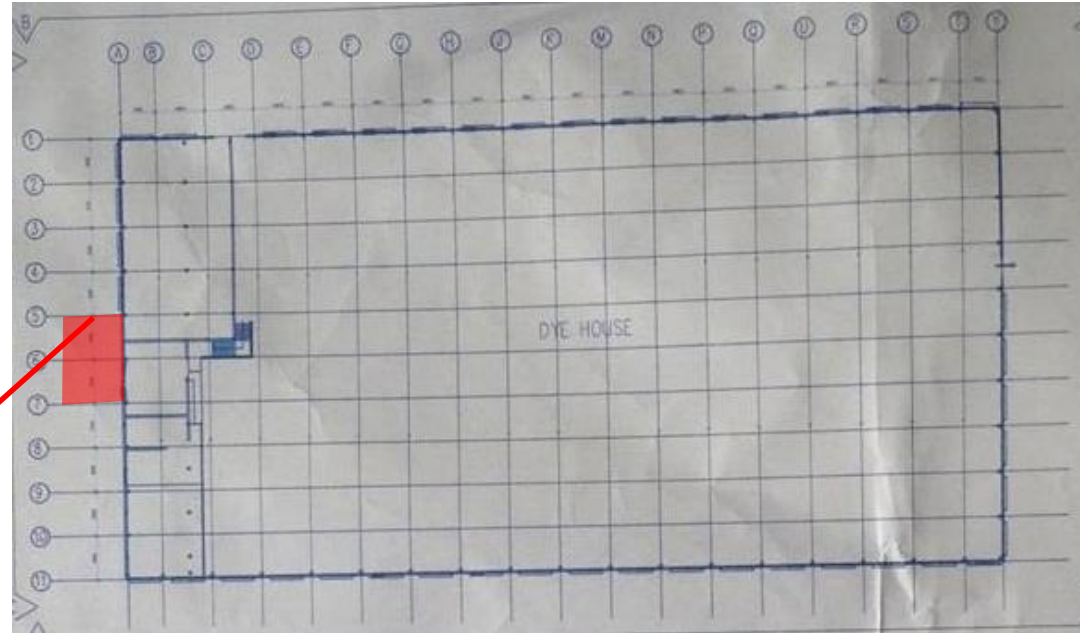
A toilet block was observed at the south west gable end of the dye house structure. This building was not present on either the structural or the permit drawings.

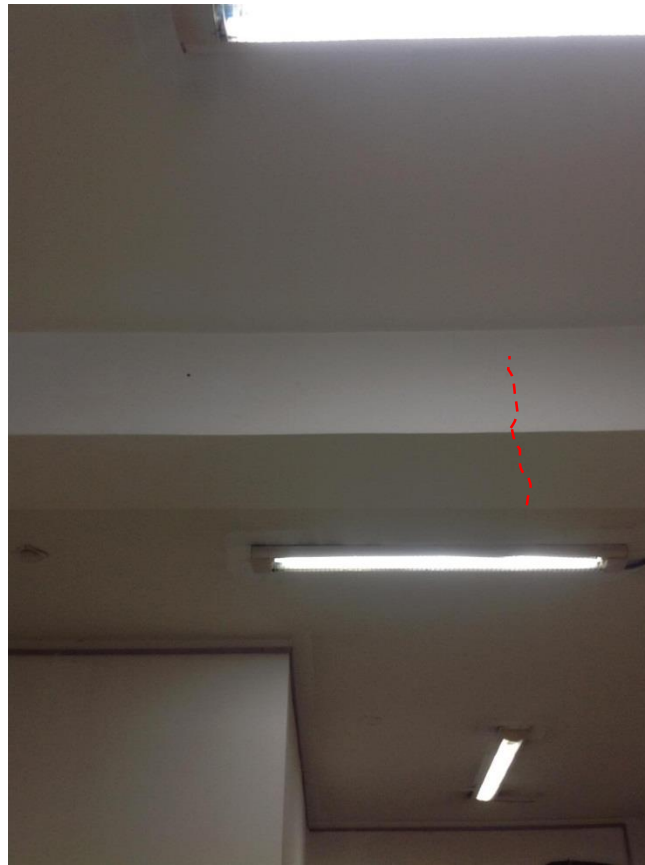
Beam

Hairline cracking was observed on the soffit of the roof slab and supporting beams in the administration building. The size and location of the cracks is consistent with flexural cracking.

| Item No. | Observation | Recommended Action Plan | Recommended Timeline |
|---|---|---|---|
| 4 | Flexural cracking in Administration building | Building engineer to monitor cracking, should cracks increase in size or length, Engineer to undertake detailed checks of strength and capacity and propose remedial works if necessary. | 6-months |

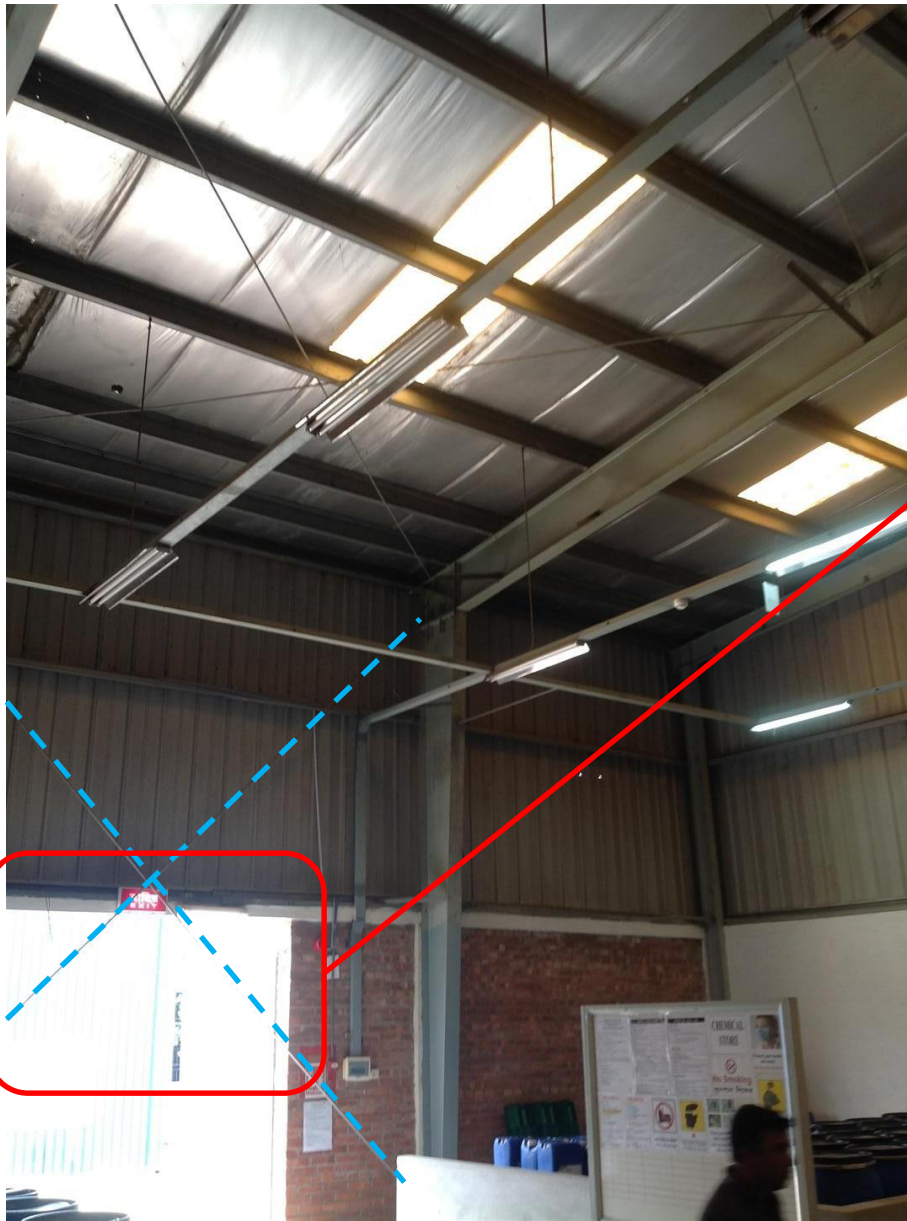
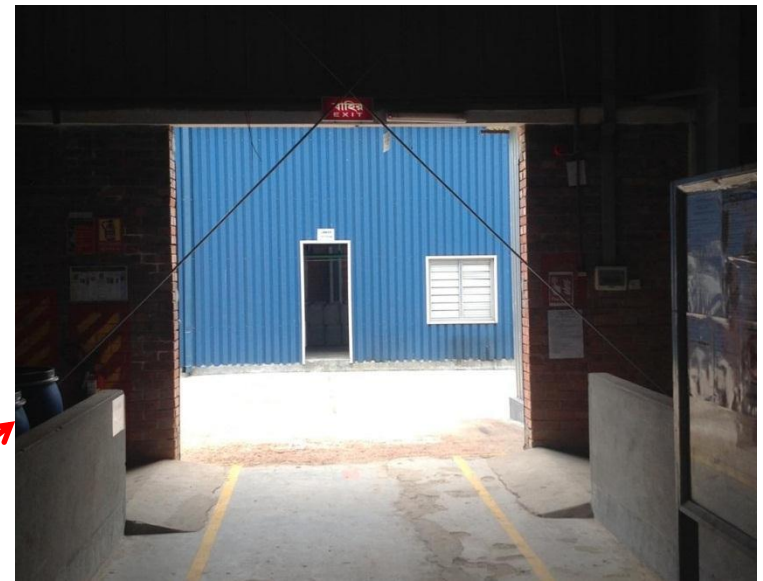
In the utility building, bracing was observed in a doorway on the southern side of the building. This bracing obstructs the upper corners of the opening and could cause a collision with a fork truck.

| Item No. | Observation | Recommended Action Plan | Recommended Timeline |
|---|---|---|---|
| 5 | Exposed bracing in Utility building. | Structural Engineer to propose alternative bracing configuration which does not obstruct door opening whilst maintaining building stability. | 6-months |

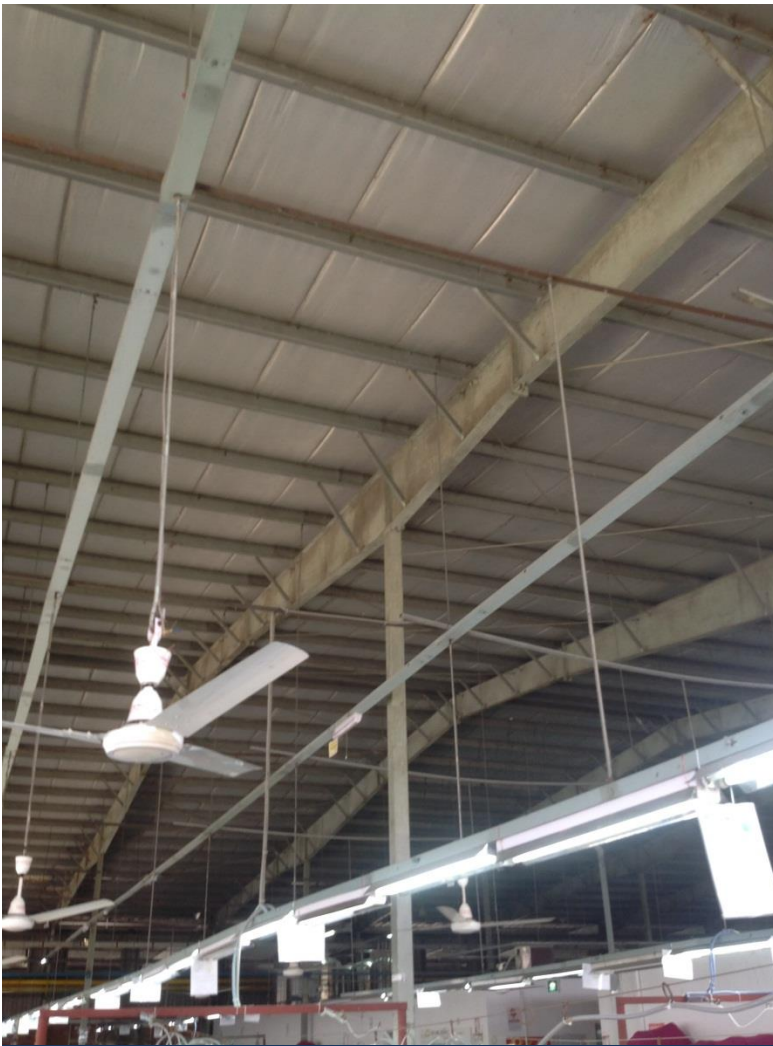
Single storey steel frame

In each of the steel buildings there was no evidence of fire protection.
