**Sayam Knit Fab  
Rose Tex Knitting  
Vaivai Printing  
Rahman Sports  
Paisley Printers**

A/88,BSCIC 1/A, Shasongaon, Enayetnagar, Fatullah, Narayangonj, Bangladesh  
( 23.62304N 90.47902E)

14 May 2014

# Observations - Building 2

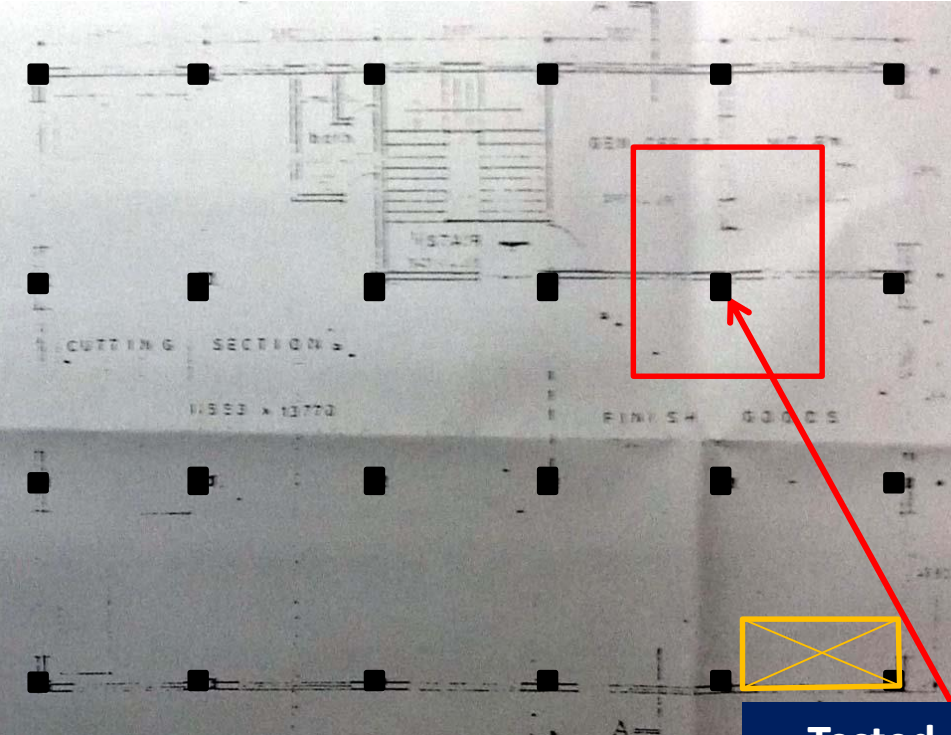
Typical column layout – Building 2

**Columns appear to be stressed to a  
high level and require immediate  
review**

Outline calculations indicate that columns are stressed to a high level and require immediate review.

Building Engineer to perform detailed calculations including a Detail Engineering Assessment (see attached scope) and concrete tests to prove adequacy of column sizes, and (if required):

- Reduce loads by vacating floors
- Reinforce columns

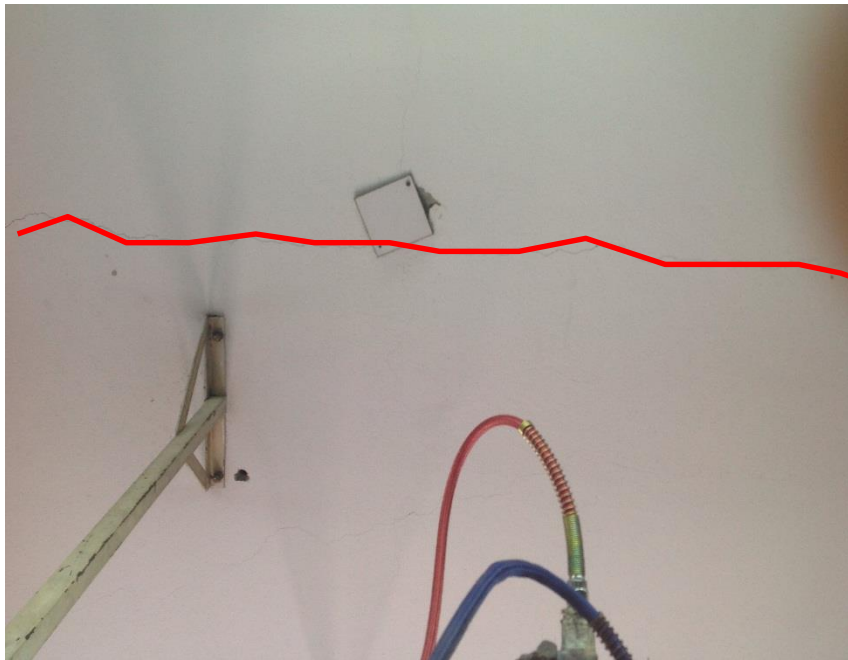
Location of beam crack on 4<sup>th</sup> floor soffit

Crack on Beam

Cracking to beam on 4th floor to be reviewed by removing plaster to assess whether crack extends into structure.

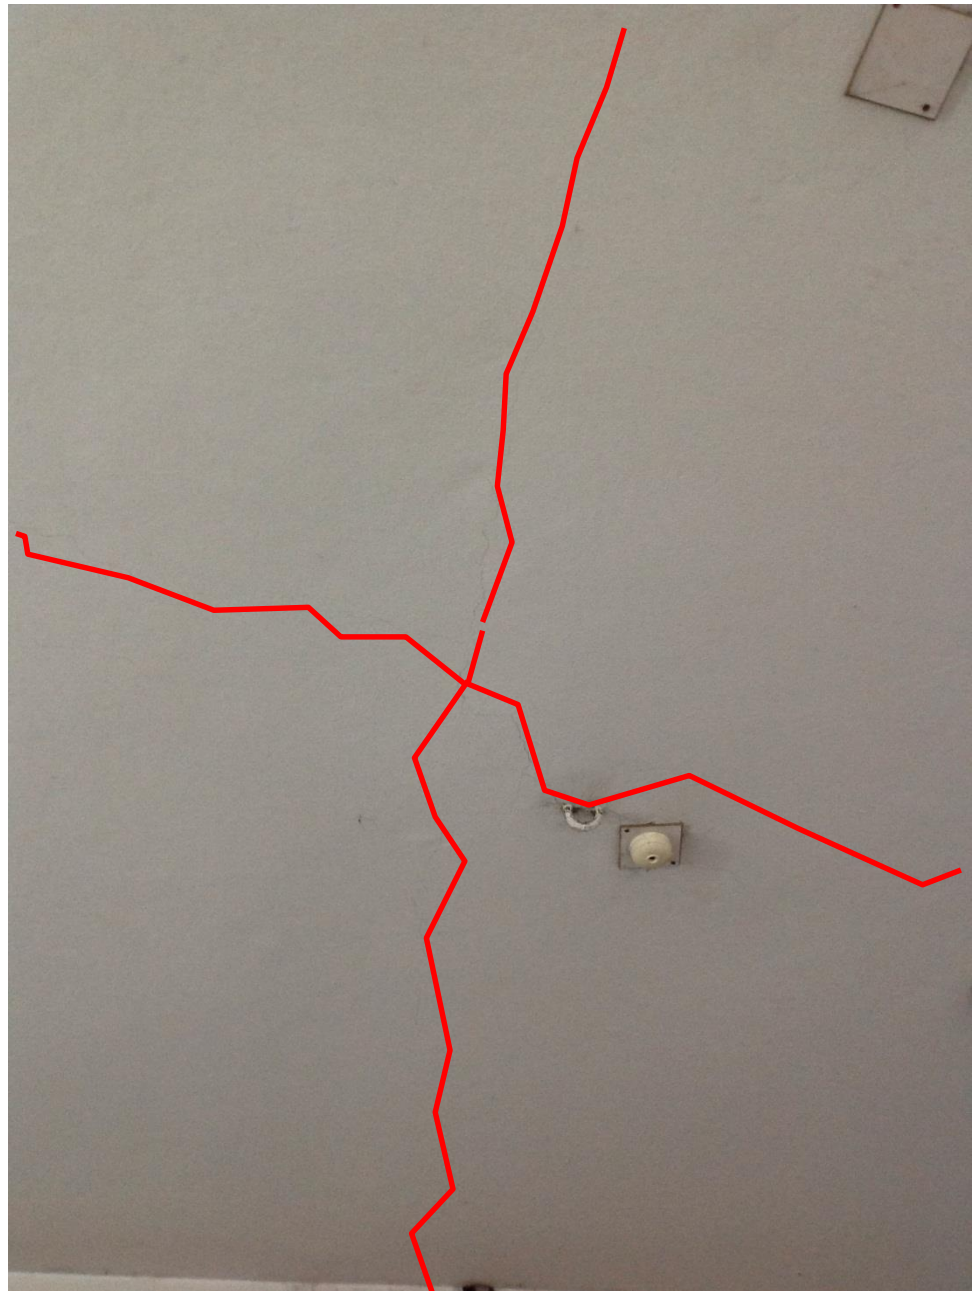
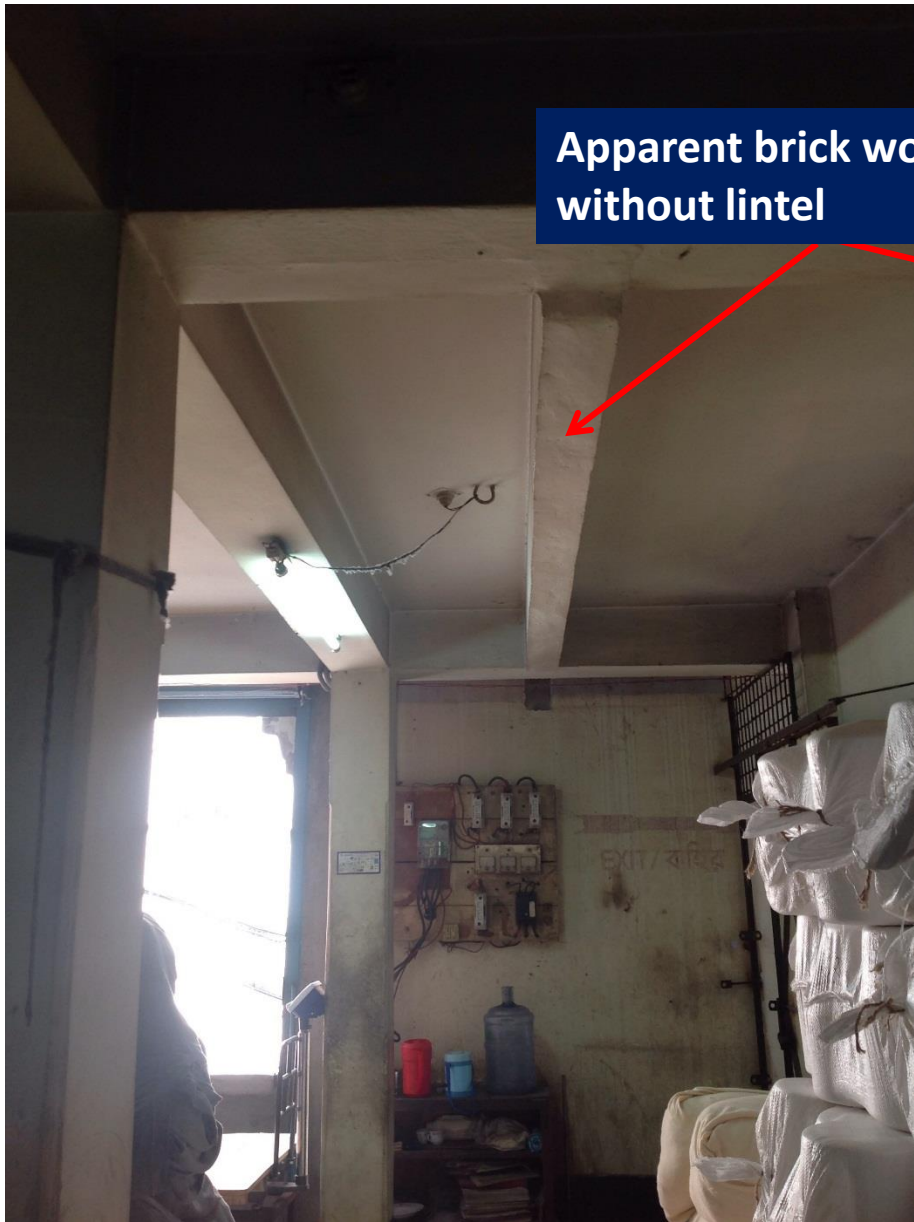
## Cracking of Roof Slab Soffit

Signs of cracking in a number of locations on the roof slab soffit.

Cracking in soffit of flat slab to be reviewed by removing plaster to assess whether cracks extend into structure. Building Engineer to confirm flat slab imposed design load capacity.

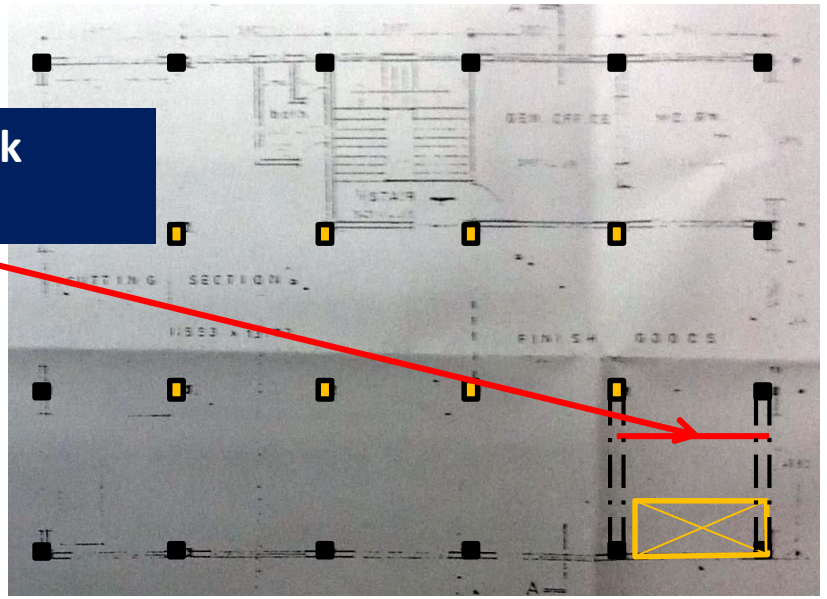
**Apparent hanging Brickwork on 2<sup>nd</sup> Floor Soffit**

**Apparent brick work without lintel**

**Evidence of a demolished wall remain hanging from the slab soffit. Building Engineer to review if this is of concrete or brick construction. If constructed of brickwork these works should be removed.**

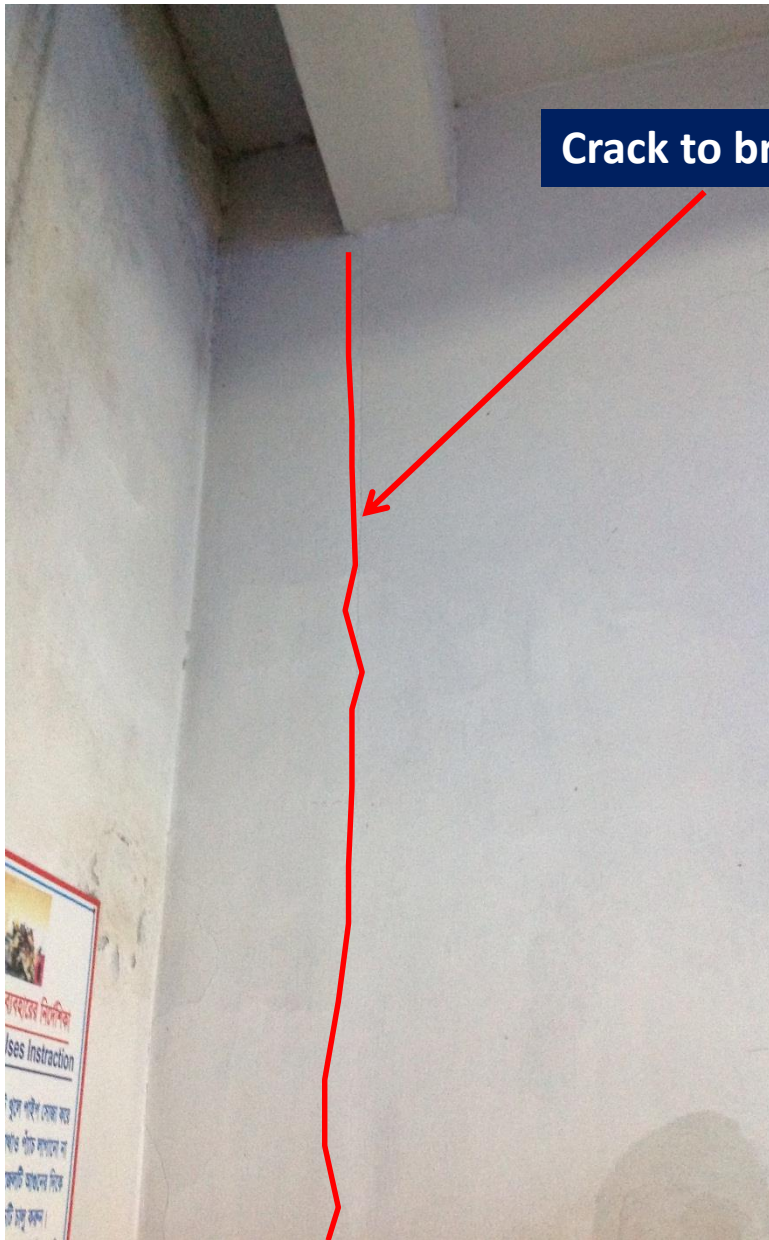
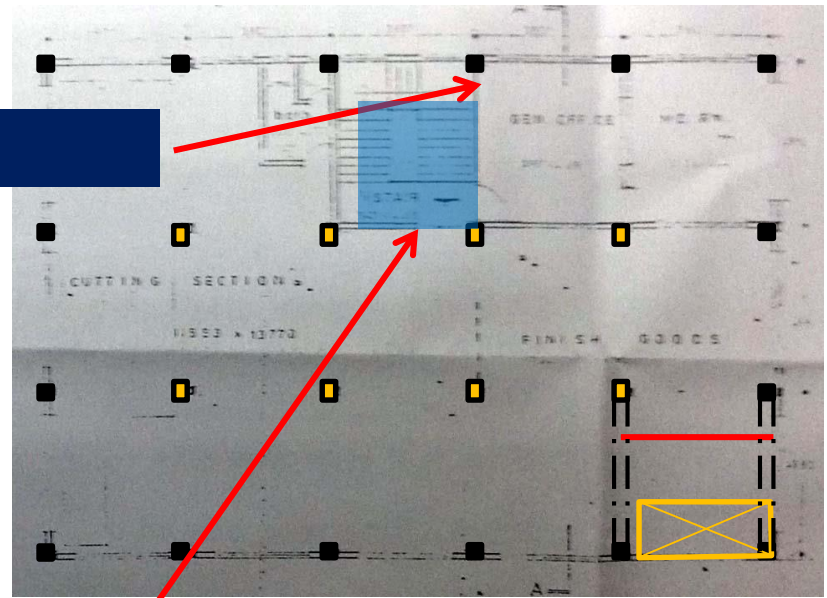
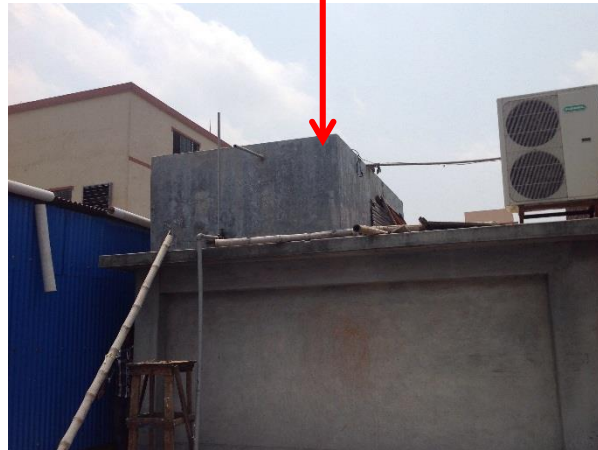
## **Water Tank Support**

**Crack to brick wall**

**Water Tank**

**Concrete Water Tank may be supported on brick work on one side resulting in cracking – Building Engineer to review and confirm adequacy of water tank support structure.**

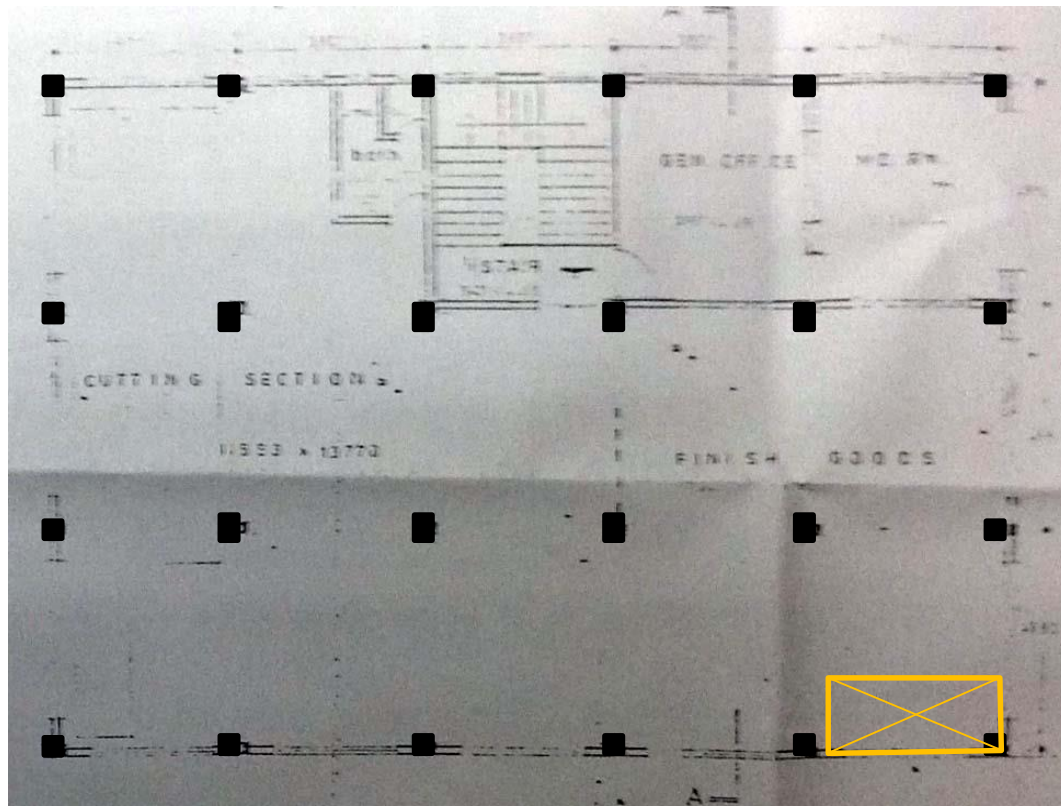
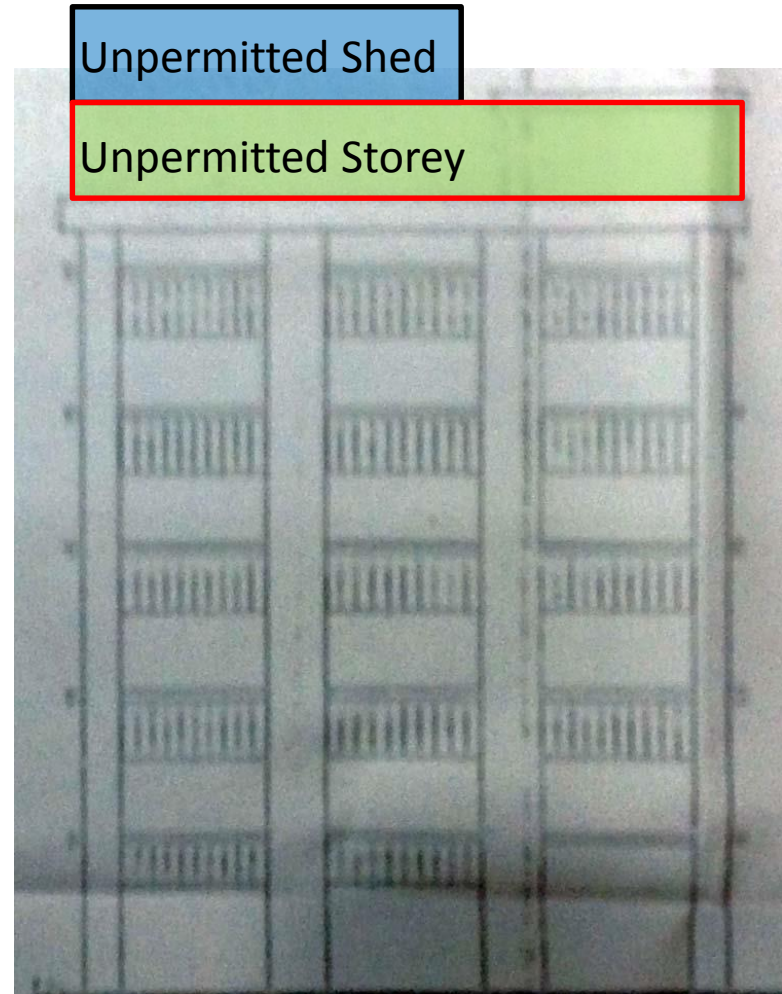
Typical floor level

Permit structural drawings were provided. These do not show details of roof flat slab construction. Building Engineer to update drawings with as-constructed survey.

Permit drawing shows 5 storeys, but 6 storeys plus sheds at roof level are constructed.

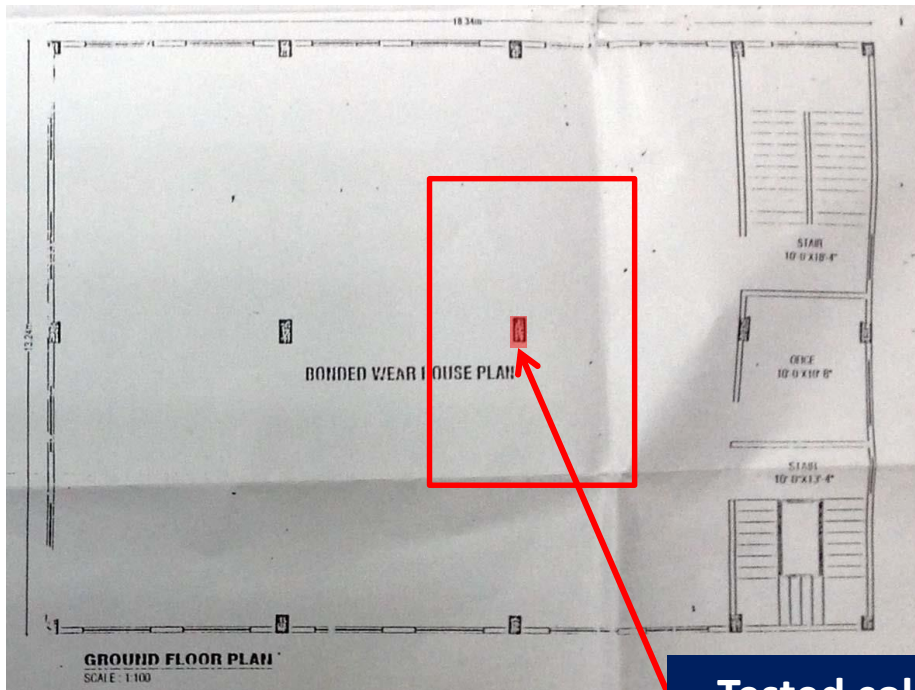
Typical column layout – Building 1

**Columns appear to be stressed in  
excess of normal design limits**

Outline calculations indicate that columns are stressed in excess of normal design limits.

Building Engineer to perform detailed calculations and concrete tests to prove adequacy of column sizes, and (if required):

- Reduce loads by vacating floors
- Reinforce columns

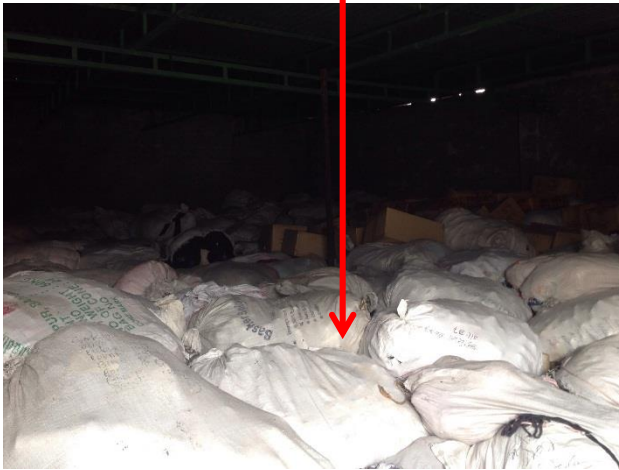
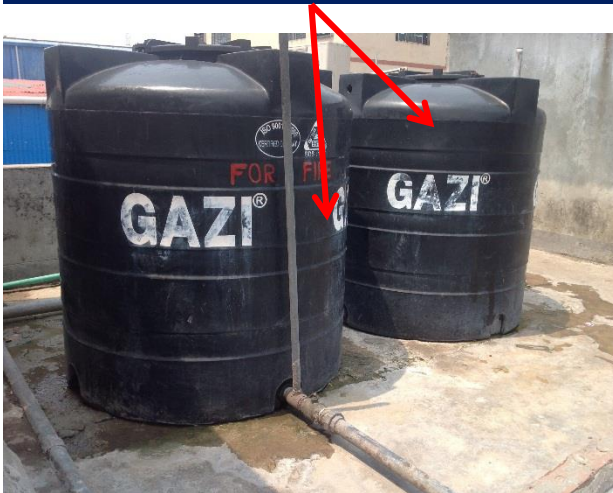
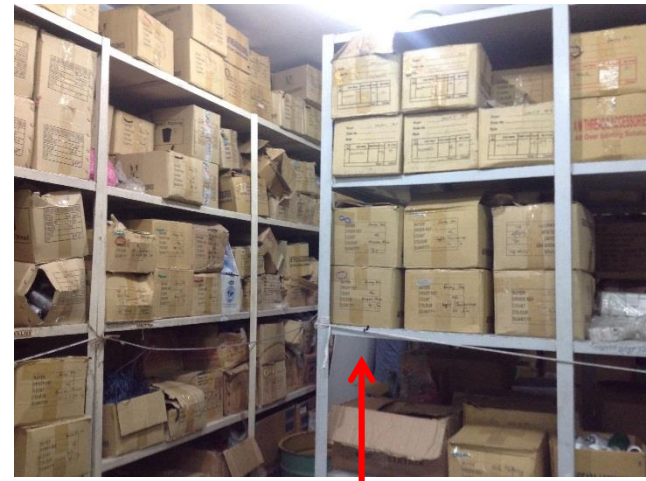
Loads on 2<sup>nd</sup> floor

2 x 2,000 litre plastic water tanks at roof level

Building Engineer to prepare controlled loading plans, based on floor slab (including punching shear) and column capacity, for all floors which will designate allowable storage density and where storage may be placed.

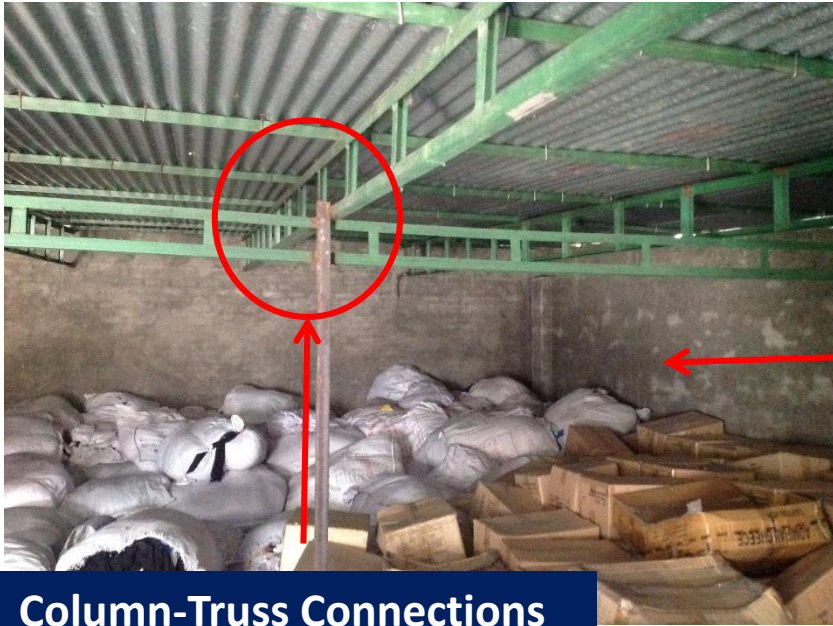
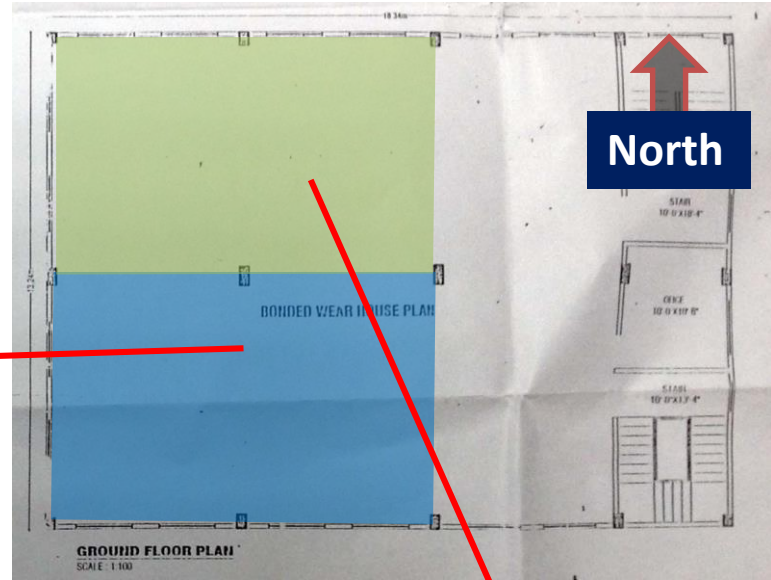
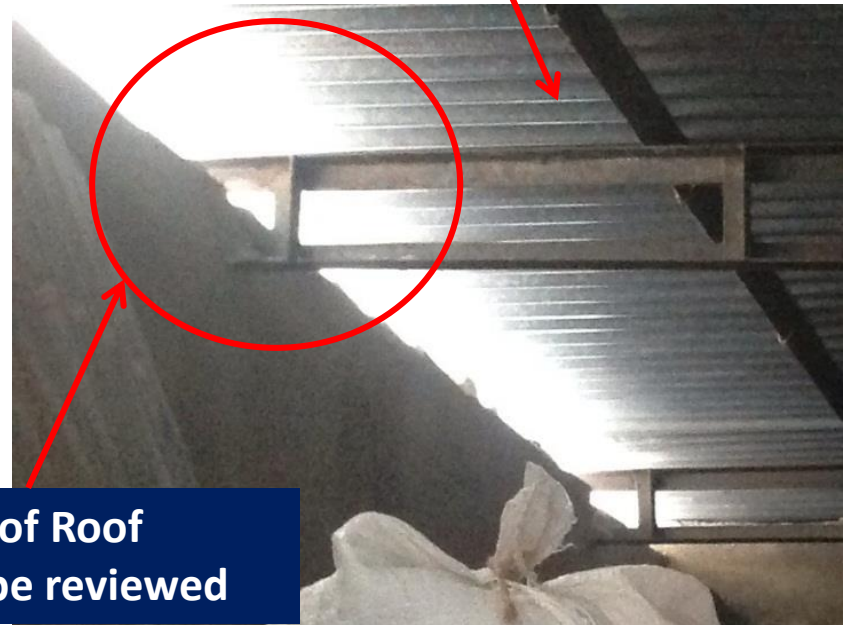
## **Steel Roof Structures**

**Column-Truss Connections to be reviewed**

**Anchorage of Roof Trusses to be reviewed**

**Building Engineer to check adequacy of the steel roof structure and connections for code specified live load and wind loads**

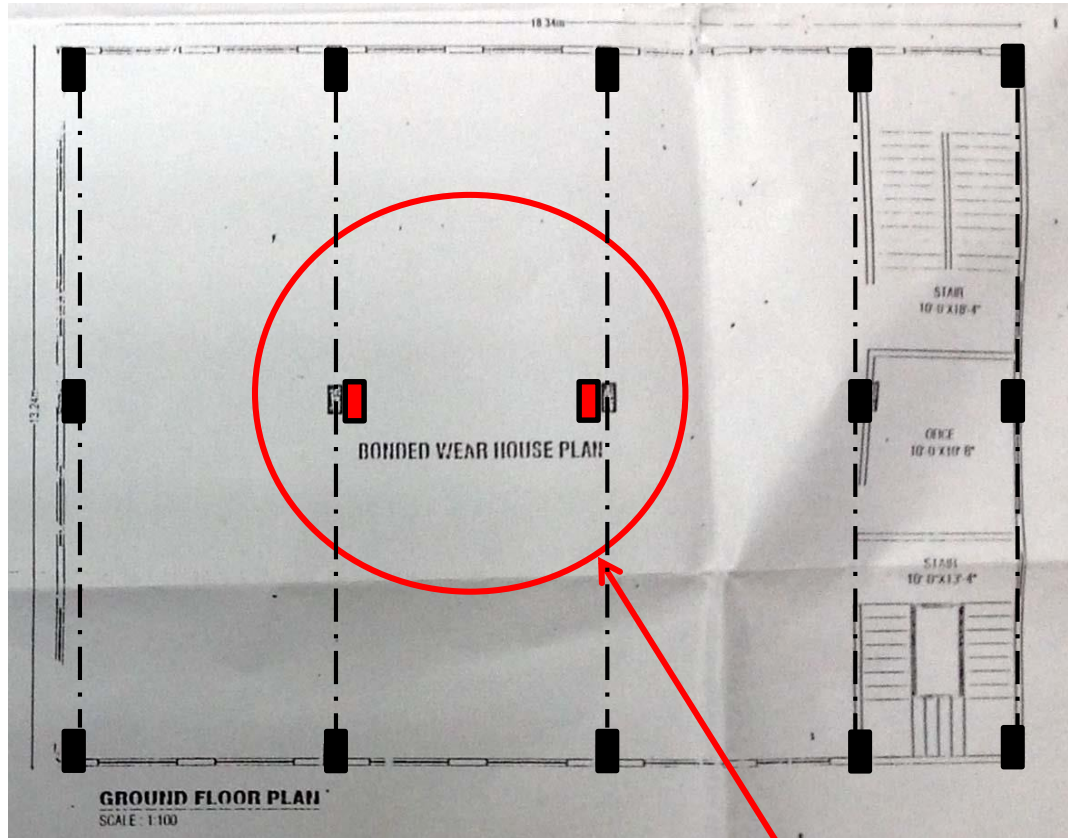
Typical floor level – Building 1

Central columns are not in line with the perimeter columns

Column do not line up contrary to layout shown on the survey drawings

Structural drawings show beam & slab construction. The as-constructed structure is flat slab on all floors except 1<sup>st</sup> floor.

Building Engineer to update drawings to match as-constructed structure
