# Debonair Ltd Unit-2

Plot 356, Ozarpara, Sharifpur Road, Maleker Bari, Gazipur  
(23.963308N, 90.366508E)  
17<sup>th</sup> May 2014

# Observations

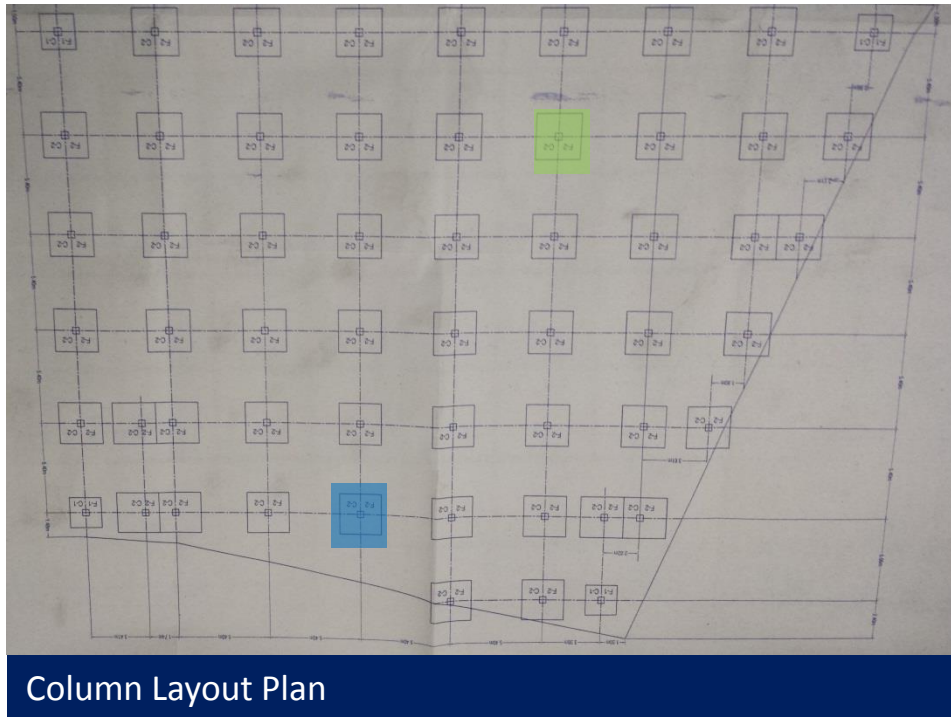
Column schedule

Cursory calculations indicate that the working stresses to the Ground Floor and First floor columns are at a high level. Building Engineer to review design, loads and columns stresses.

Column sizes in schedule are bigger than those observed on site

| Item No. | Observation | Recommended Action Plan | Recommended Timeline |
|---|---|---|---|
| 1 | Stress levels in Columns | Factory Engineer to review design, loads and columns stresses in all columns. | <b>Immediate - Now</b> |

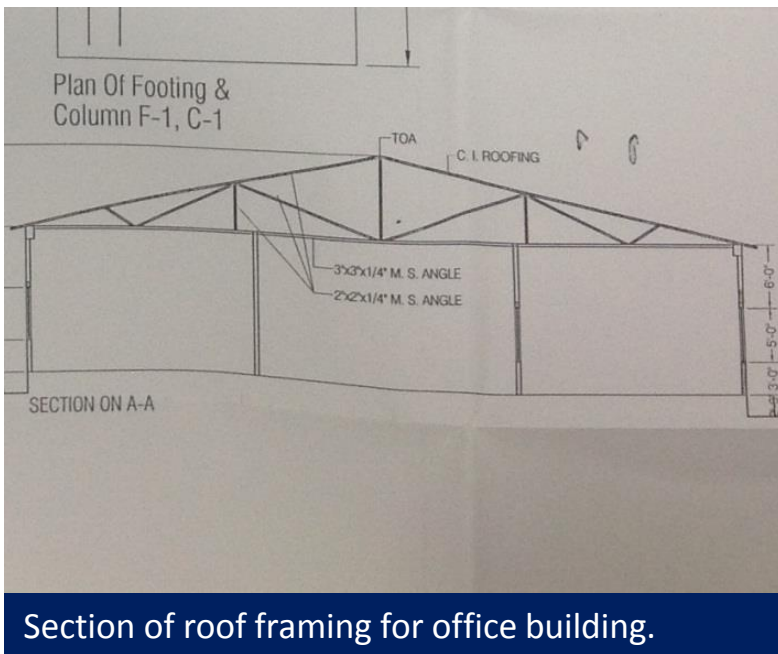
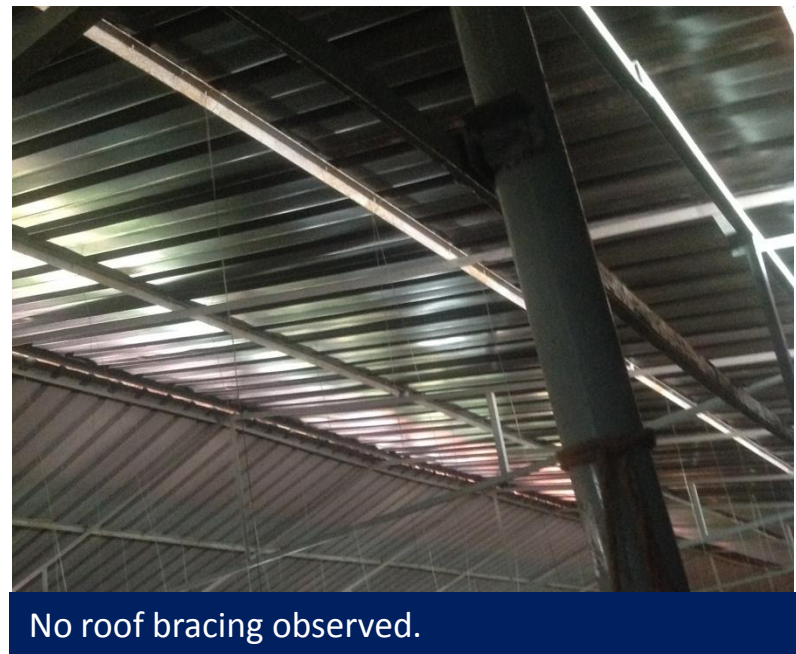
The lateral stability system to the steel roofed buildings on the site is unclear – vertical and horizontal bracing has not been provided. Note that provision for lateral stability is not highlighted in the as-built drawings. It is likely that the reinforced columns currently provide lateral stability through cantilever action. Building Engineer to carry out a lateral stability analysis of the buildings to review the design of the cantilevered columns to ensure they can adequately resist the horizontal loads imposed or if necessary, provide details of remedial works for the provision of vertical and horizontal bracing.

| Item No. | Observation | Recommended Action Plan | Recommended Timeline |
|---|---|---|---|
| 8 | Lateral stability system unclear | Building Engineer to review the design of all the buildings on the site with regard to lateral stability. The Building Engineer should either confirm that the cantilever concrete columns are adequate to carry the horizontal loads or advise on an appropriate vertical bracing system. In addition the Building Engineer is to provide guidance on the requirement for horizontal bracing in the plane of the roof. | 6-weeks |
| 9 | Lateral stability system unclear | Carry out any remedial works as determined by the Building Engineer | 6-months |

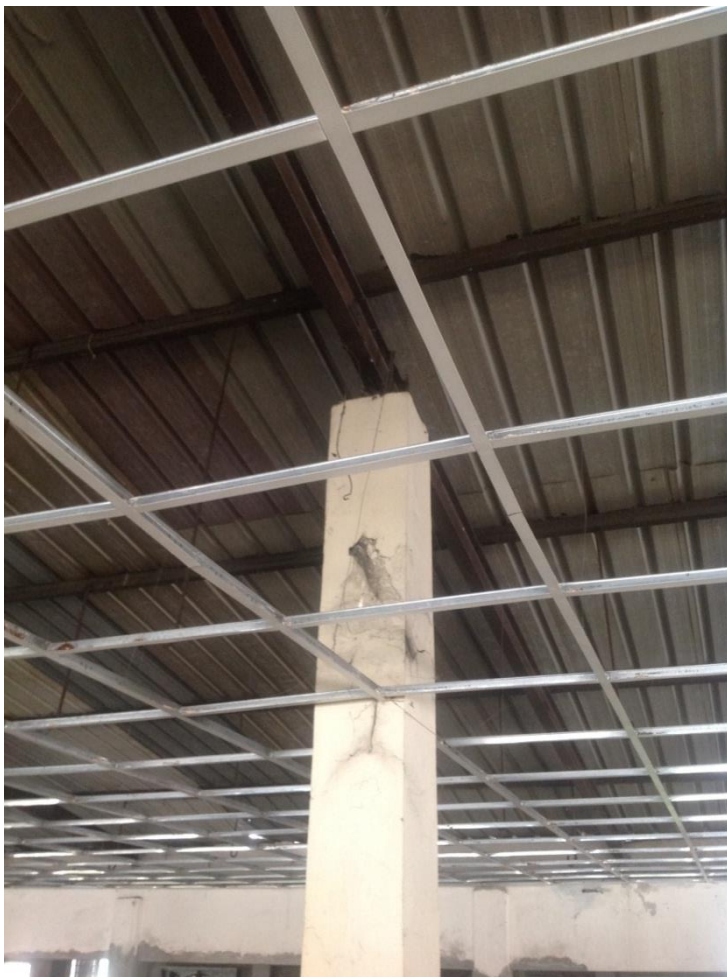
Pin connection between portal frame and cantilevering RC columns – The horizontal force transferred into the top of the columns will need to be transferred into the foundation through cantilever action

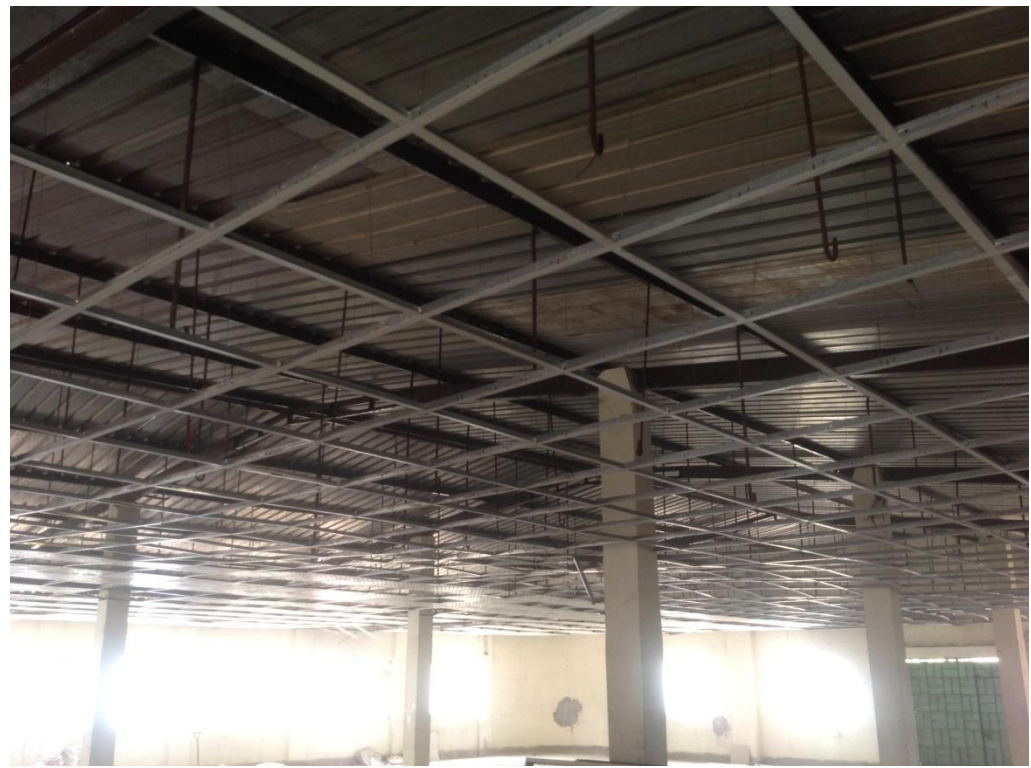
No horizontal bracing observed in the new extension.

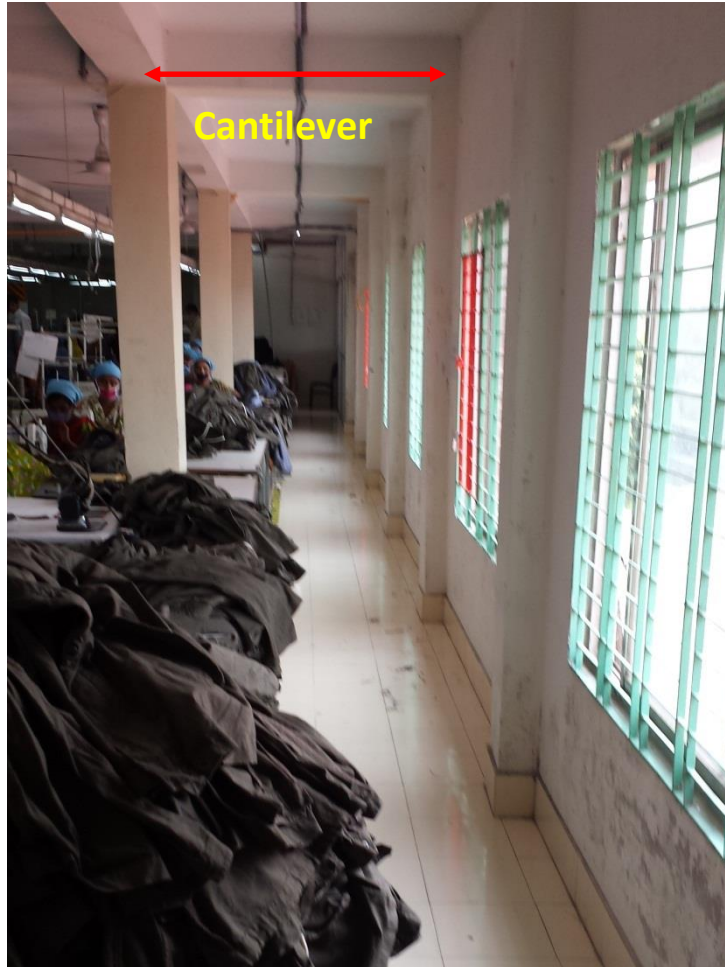
Cantilever slabs were observed on the South elevation of the building. Building Engineer to check structural adequacy of the cantilever and propose and implement any strengthening works if required.

Cantilever on South elevation (internal view)

| Item No. | Observation | Recommended Action Plan | Recommended Timeline |
|---|---|---|---|
| 10 | Floor Cantilevers | Building Engineer to confirm that the cantilever slabs have been designed to take the floor and façade loads applied, as part of DEA (See Item 1) | 6-weeks |

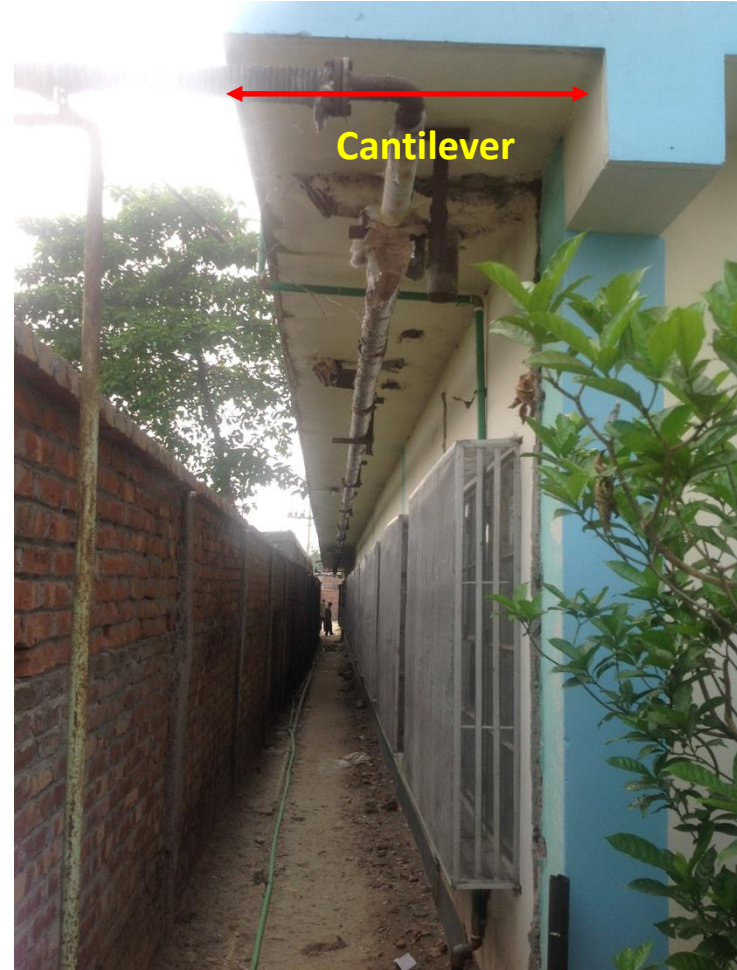
Cantilever on South elevation (external view)

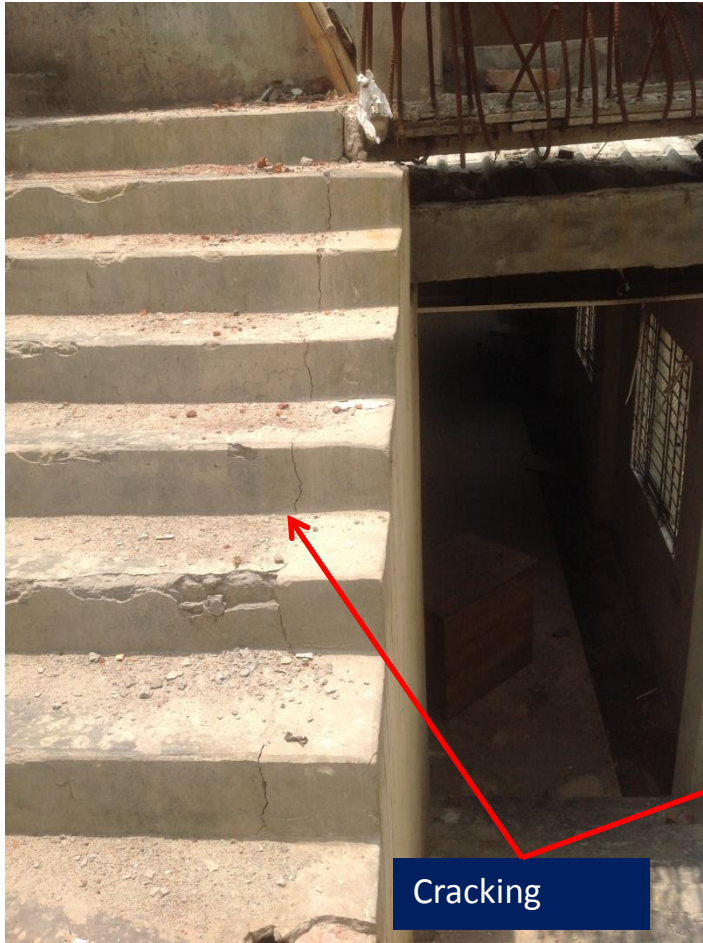
Cracking was observed to the stairs of the building under construction at the connection with the supporting masonry wall. Building Engineer to investigate the cause and extent of cracking. Building Engineer to advise if load reduction, repair and strengthening of the stairs is required.

Cracking

Cracking of stairs

| Item No. | Observation | Recommended Action Plan | Recommended Timeline |
|---|---|---|---|
| 14 | Cracking to stairs | Building Engineer to investigate the cause and extent of cracking. | 6-months |
| 15 | Cracking to stairs | Building Engineer to advise if load reduction, repair and strengthening of the stairs is required. | 6-months |

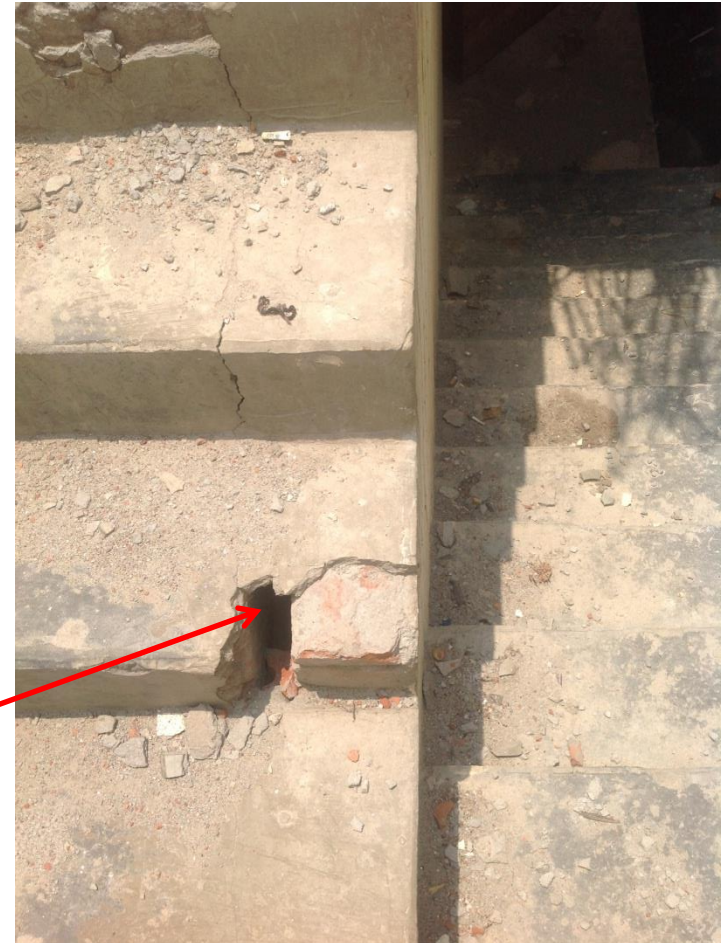
Cracking of stairs

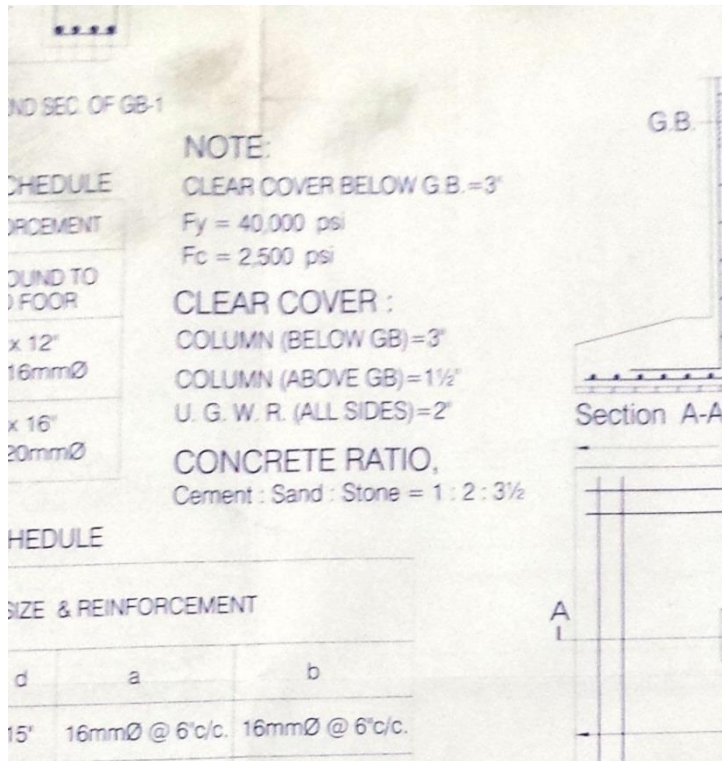
Stone chip aggregate specified.

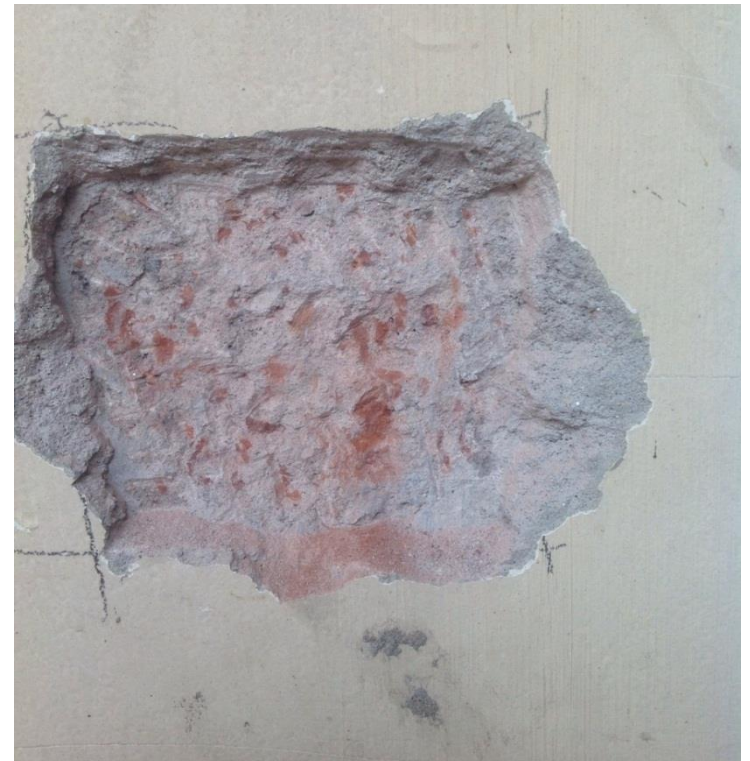
There are a number of inconsistencies between the permit drawings and the constructed buildings, principal of which are that brick aggregate was used where stone aggregate is specified and column sizes are smaller than specified. There were also differences between the observed floor occupancy and that shown on drawings. Building Engineer to provide an updated Permit drawing and a full set of as-built structural and architectural drawings for all of the buildings on the site.

Brick aggregate was observed on site.

| Item No. | Observation | Recommended Action Plan | Recommended Timeline |
|---|---|---|---|
| 16 | Inconsistencies in Documents Provided and Absence of Loading Plan | Building Engineer to update the structural and architectural drawings to reflect the as-built layouts as part of the Detailed Engineering Assessment (see Item1). | 6-weeks |

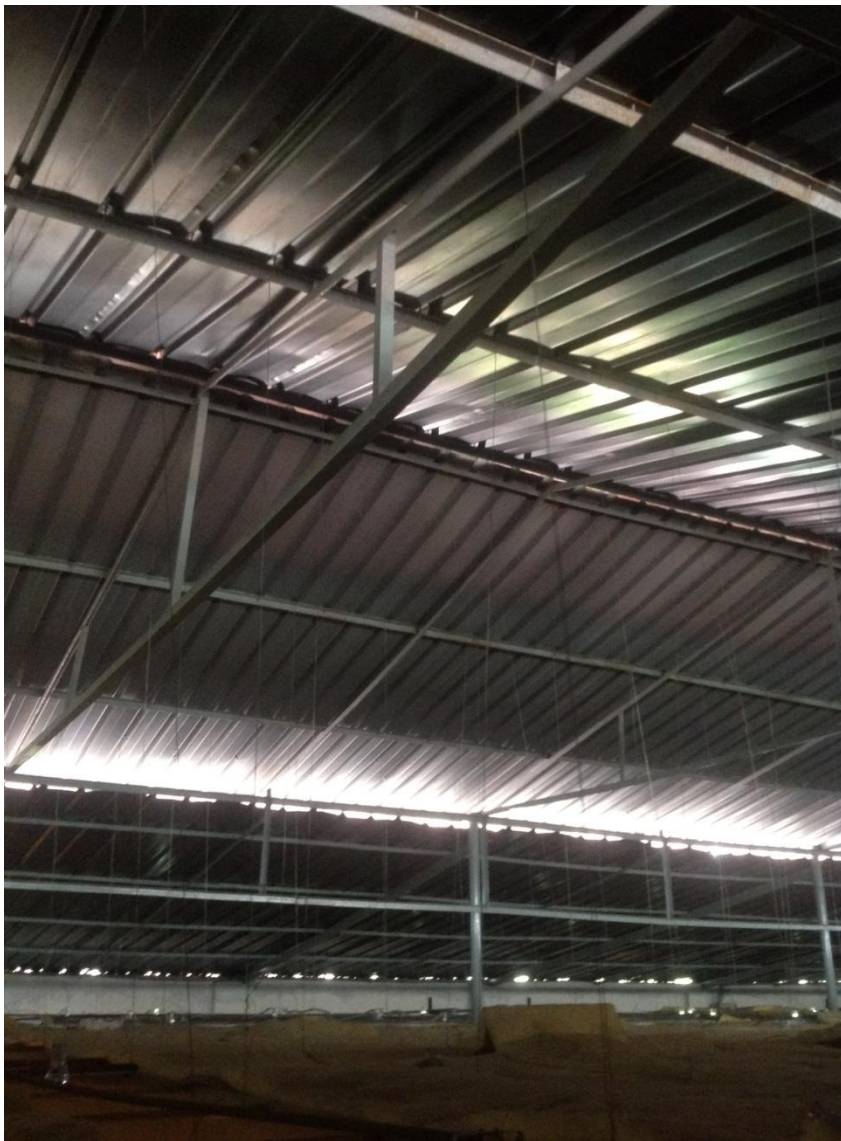
Diagonals missing from office building roof truss.

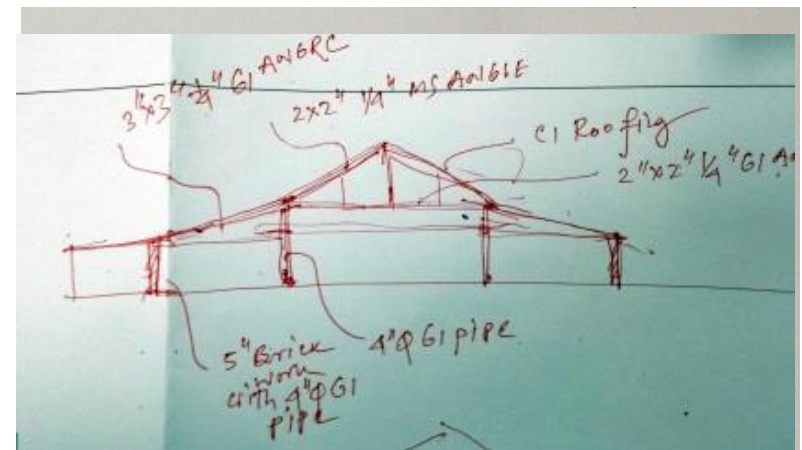
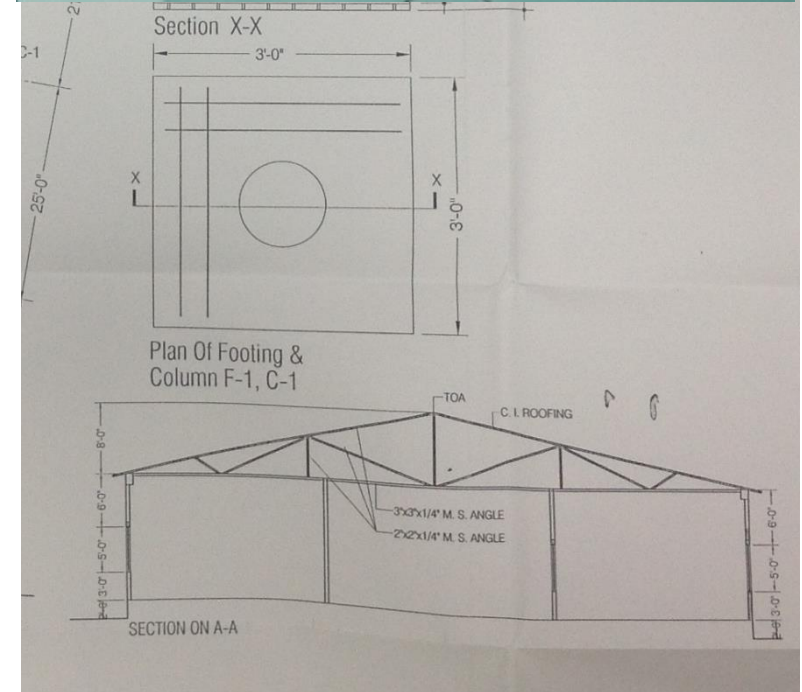
Drawing specifying diagonals in roof truss.

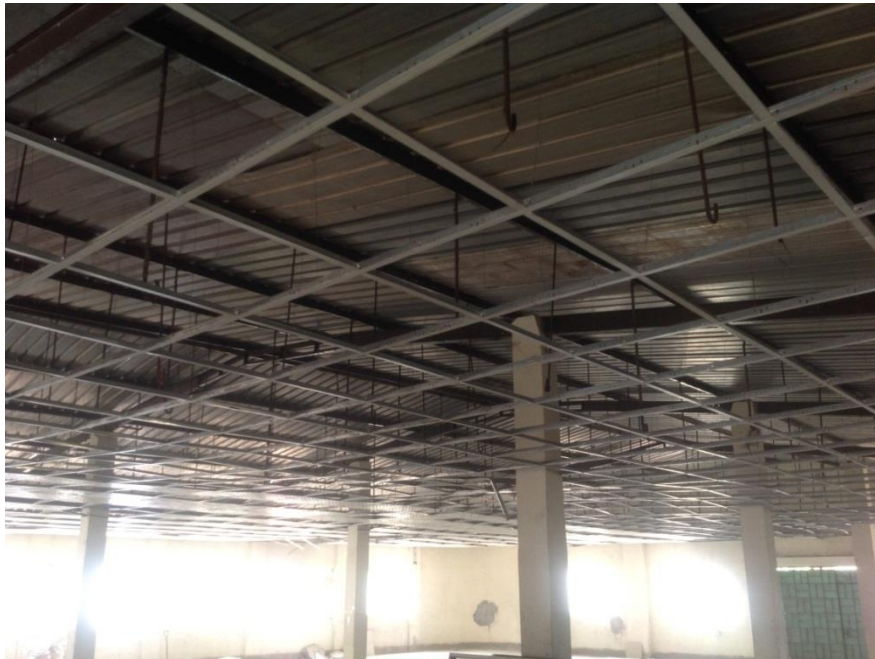
No roof trusses were observed in the Shed 2.

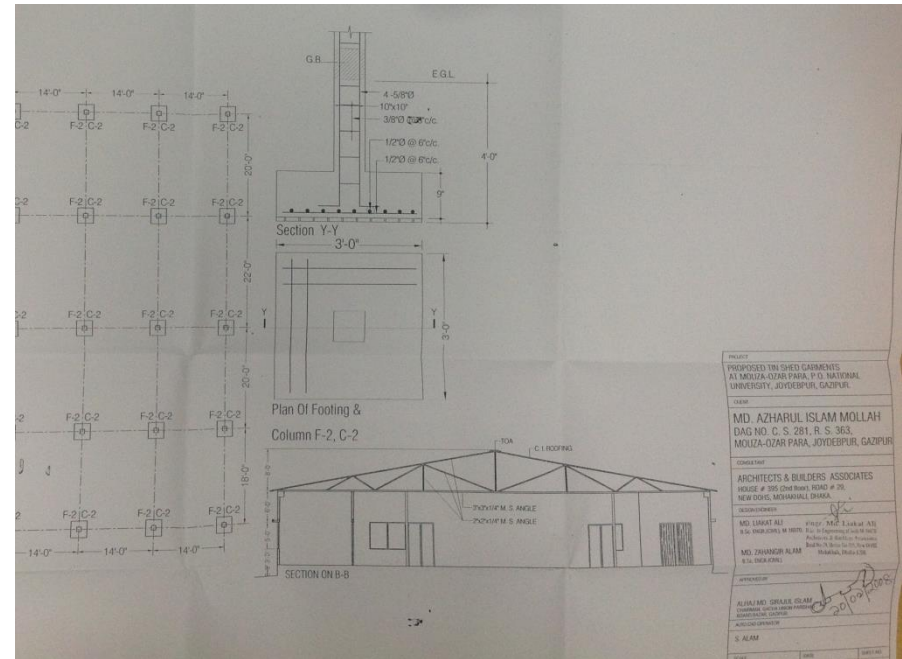
Drawing specifying trusses in roof.
