# Denim Expert Ltd.

Plot #96-100, Sector #3, Kepz, North Patenga, Chittagong.  
(22.27350E, 91.79150N)

20 May 2014

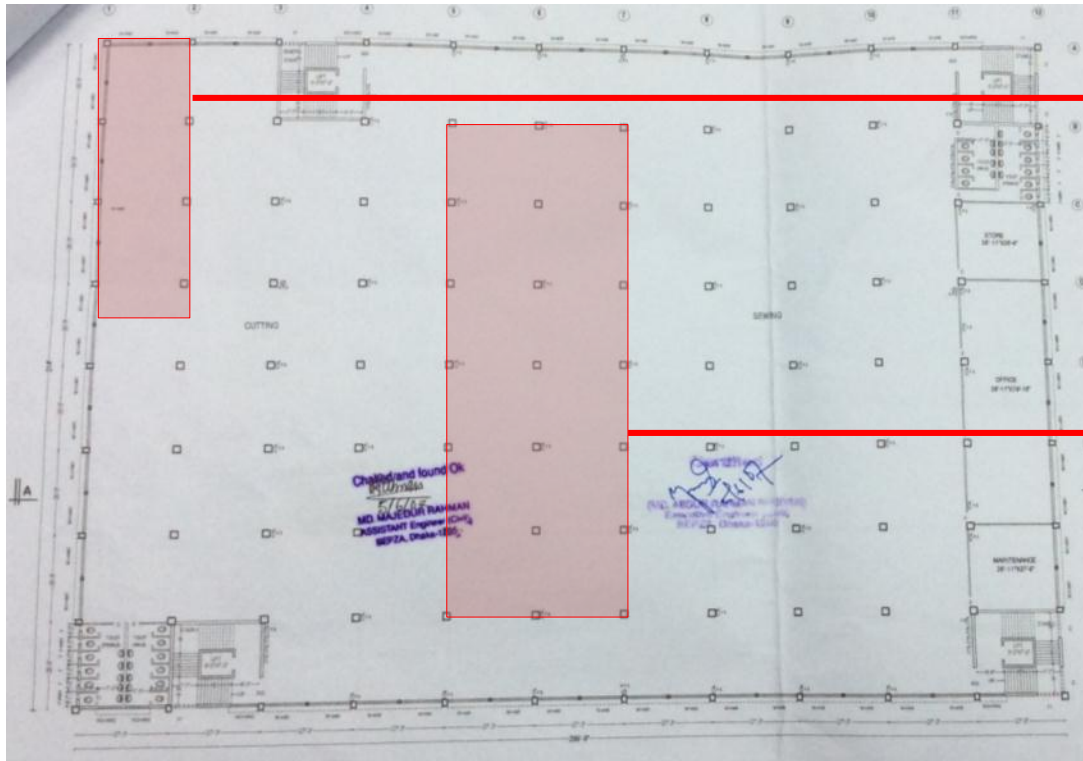
1<sup>st</sup> Floor Plan

Localised areas of 1st floor were heavily loaded with storage loads. No load management system in place.

| Item No. | Observation | Recommended Action Plan | Recommended Timeline |
|---|---|---|---|
| 1 | Localised Areas of High Loading | Produce and actively manage a loading plan for all floor plates within the factory giving consideration to floor capacity and column capacity. This should include a safe level to which any water tanks can be filled. | 6-months |
| 2 | Localised Areas of High Loading | Continue to implement load management plan. | 6-months |

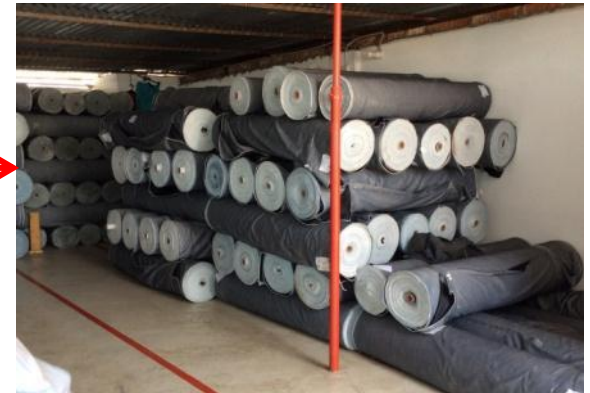
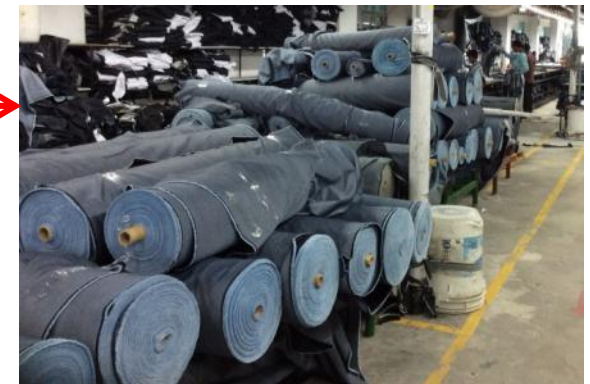
Uncontrolled stacking of materials.

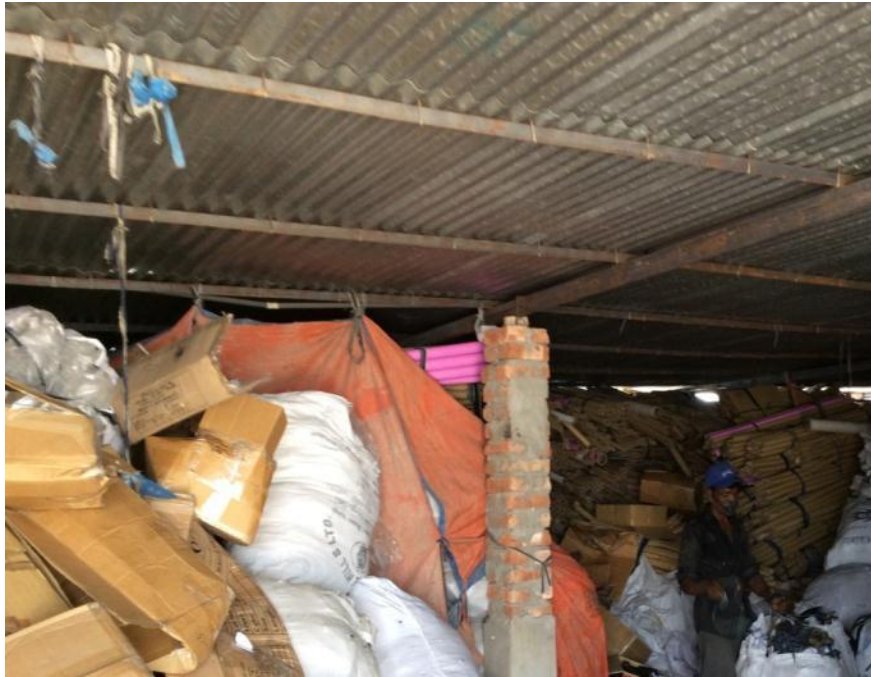
Off-cut material store

Apparently Non engineered light weight roof structures

| Item No. | Observation | Recommended Action Plan | Recommended Timeline |
|---|---|---|---|
| 3 | Non-engineered lightweight roof structures. | Building engineer to check the capacity of non-engineered lightweight roofs under horizontal and vertical loading and make any necessary alterations. | 6-months |

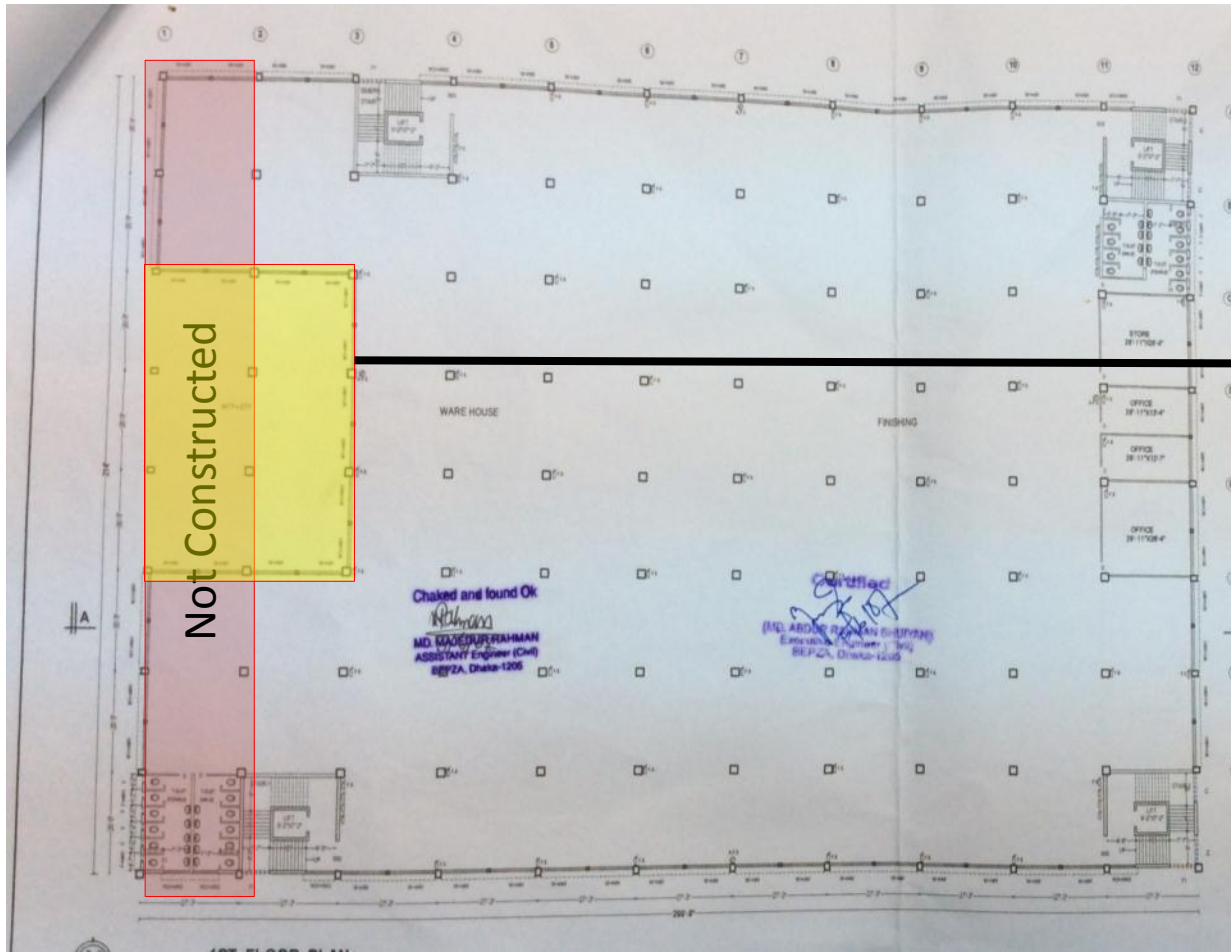
Extra bay on permit drawing does not match as built construction or structural drawings

EPT located in separated building to main factory building

Structural Drawings:  
Internal and external columns 840mm x 840mm on structural drawings. Measured as built columns (including finishes) typically <790mm. (observed finishes 20m)

Inconsistencies noted on Structural and Permit drawing

| Item No. | Observation | Recommended Action Plan | Recommended Timeline |
|---|---|---|---|
| 4 | Inconsistencies noted between drawings and as built construction with drawings. | Building engineer to prepare a set of “as built” drawings for all structures linked to the factory’s activities. Permit documentation and drawings also to be updated. | 6-months |

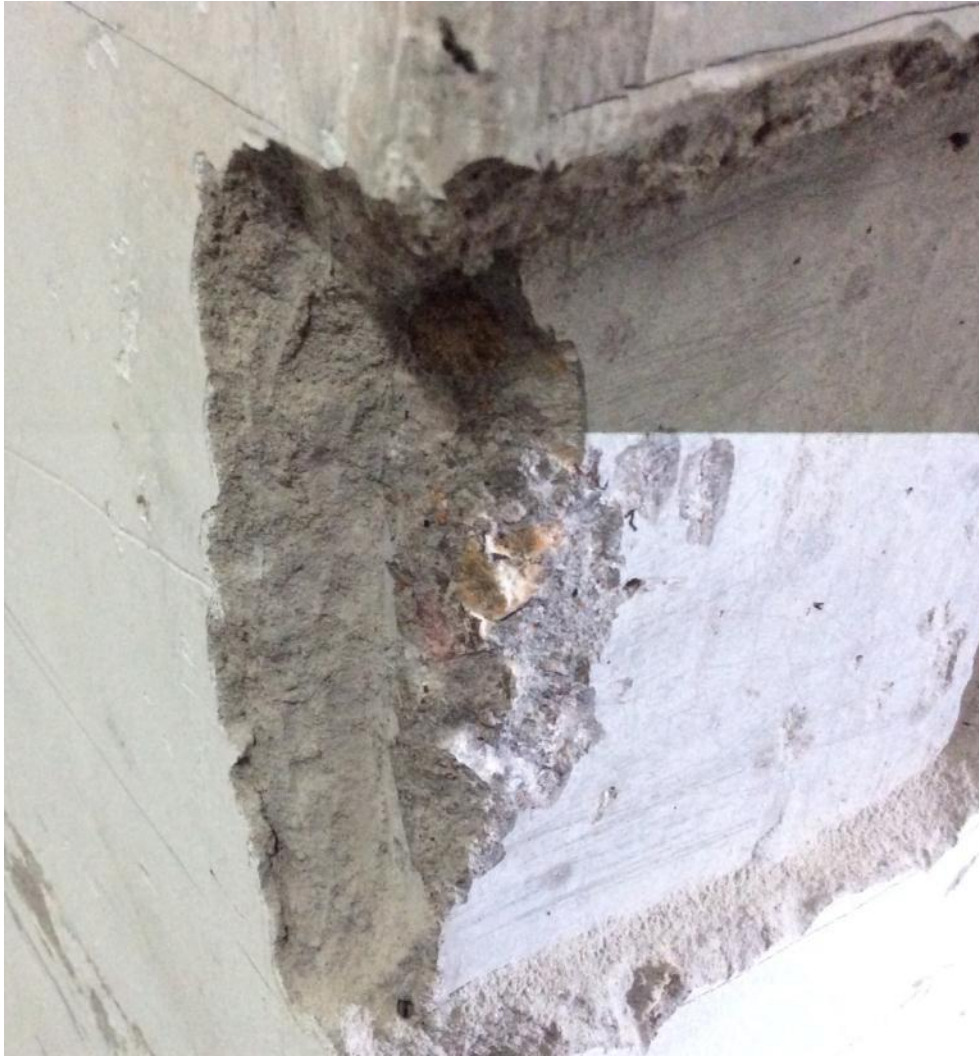
Testing of columns confirmed stone aggregate.

Cursory calculations indicate that working stress would exceed normal acceptable levels in columns if the building was extended to the permitted 6 storeys.

| Item No. | Observation | Recommended Action Plan | Recommended Timeline |
|---|---|---|---|
| 5 | Capacity of columns to support the 6 story building indicated on the drawings | Capacity calculations were completed on the columns for the vertical expansion of the building and showed that the column stresses are in excess of the calculated capacity should the building be extended above 5th floor. | 6-months |
| 6 | Capacity of columns to support the 6 story building indicated on the drawings | Detailed engineering calculations and confirmatory testing of the concrete strength is to be completed to verify future expansion above 5th floor | 6-months |

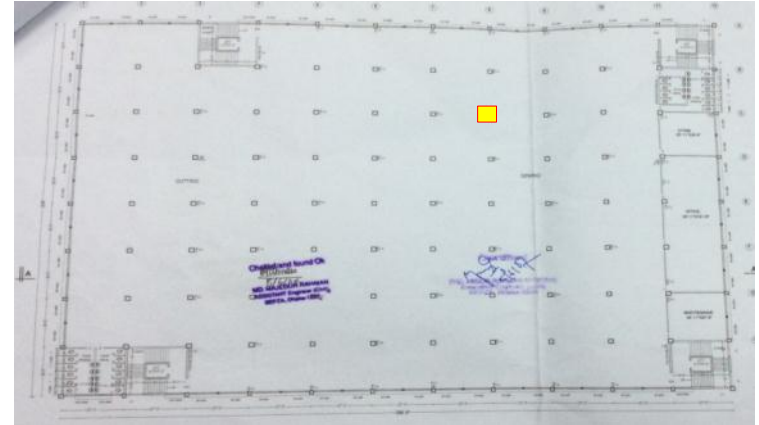
Typical as Built column size 790x790 (incl finishes ) do not match structural drawings 840mm x 840mm.
