# **FIRE SAFETY INSPECTION REPORT**

Pakiza Knit Composite Ltd (23.842791,90.257397)

**ACCORD ID: 12479**

**Inspected By: Md. Sabbir Ahmed Shourav, Nasif Javed Tofa**  
**Date: 30th March, 2017**

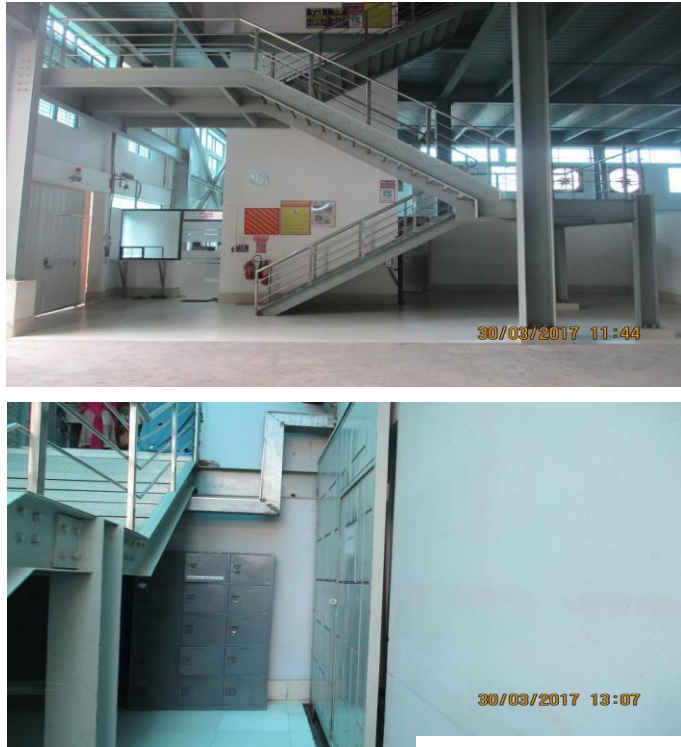
| Sl No. | Category | Findings | Required Action | Remediation Time Frame | Pictorial Evidence |
|---|---|---|---|---|---|
| 1 | Fire Rated Construction | <p>The exit stairs are not separated on each floor by fire-rated construction.<br/> <b>Location: Building 1 &amp; 2</b></p> | <p>Provide minimum 1.5-hr fire rated doors and seal all unprotected openings to separate the exit stairs from work areas and other building spaces on all floor levels. Ensure that the fire rated doors are self-closing and positive latching and that they are provided with fire exit (panic) hardware where serving production floors.</p> <p>If fire rated doors are required to be held open for functional reasons, provide automatic closing devices tied to the fire alarm system.</p> | Within 3 months | <p>The top photograph shows a staircase area with a fire-rated door that is not properly sealed or latched. The bottom photograph shows a staircase area with a fire-rated door that is not properly sealed or latched.</p> |

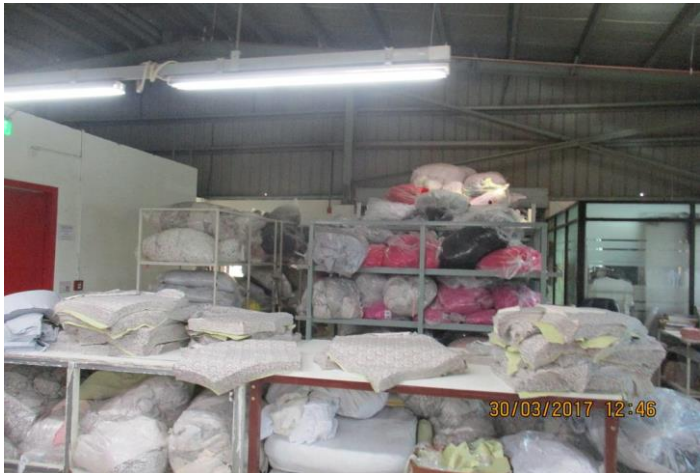
| Sl No. | Category | Findings | Required Action | Remediation Time Frame | Pictorial Evidence |
|---|---|---|---|---|---|
| 2 | Fire Rated Construction | Areas used for in-process storage of combustible materials are open to the surrounding occupancy.<br><b>Location: Building-2</b> | <p>Provide defined storage areas and limit the storage arrangement as follows:-</p> <ol style="list-style-type: none"> <li>1. General Condition: Maximum height of 2.4m and maximum area of 23m<sup>2</sup>. Separate areas of unenclosed combustible storage by a minimum clear distance of 3m.</li> <li>2. If sprinkler protected: maximum height of 3.66m and maximum area of 93m<sup>2</sup>. Separate areas of unenclosed combustible storage by a minimum clear distance of 3m.<br/>or</li> <li>3. Enclose the storage area from the surrounding occupancy with a minimum 1 hour construction.</li> </ol> | Within 3 months | |

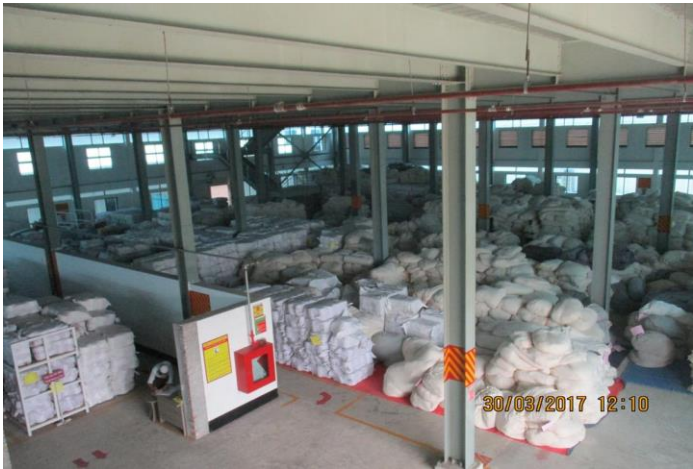
| Sl No. | Category | Findings | Required Action | Remediation Time Frame | Pictorial Evidence |
|---|---|---|---|---|---|
| 3 | Fire Rated Construction | Rooms used for storage of combustible materials are not separated from the surrounding occupancy/areas. <b>Location: Building 1 (Ground floor)</b> | Rooms used for storage of combustible materials shall be separated from the surrounding occupancy with a minimum 1 hour construction. | Within 3 months | |

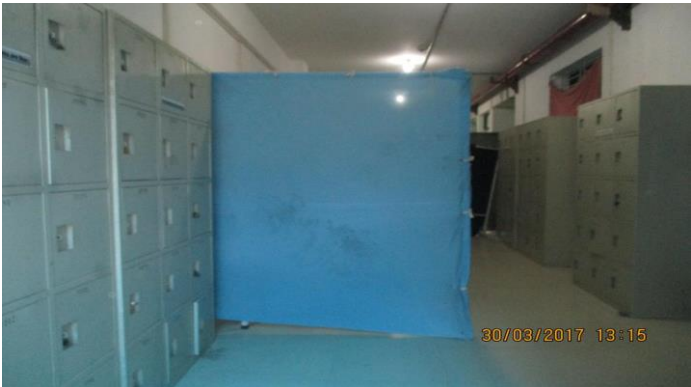
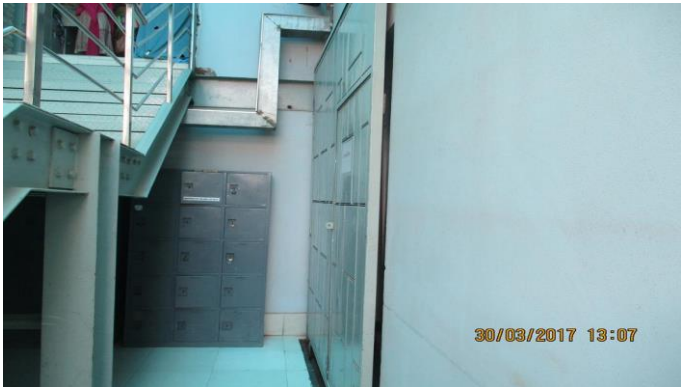
| Sl No. | Category | Findings | Required Action | Remediation Time Frame | Pictorial Evidence |
|---|---|---|---|---|---|
| 4 | Fire Rated Construction | Exit access corridor serving more than 30 occupants is not separated by fire rated construction.<br><b>Location: Building-2</b> | Separate the corridor by a minimum 1-hr fire rated construction. | Within 3 months | |

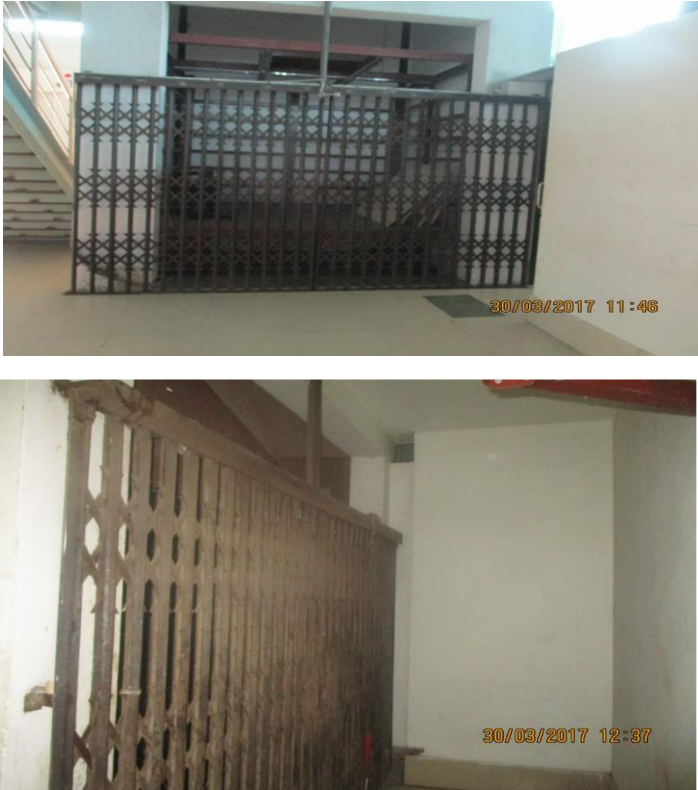
| Sl No. | Category | Findings | Required Action | Remediation Time Frame | Pictorial Evidence |
|---|---|---|---|---|---|
| 5 | Fire Rated Construction | Unsealed elevator shafts are located inside the working place in <b>Building-1</b> and unprotected openings with floor were found at elevator shaft of <b>Building-2</b> . | Provide a minimum 2-hr fire-rated elevator shaft to separate from each floor level and seal all penetrations in floor/ceiling assemblies to maintain the fire separation. | Within 3 months | |

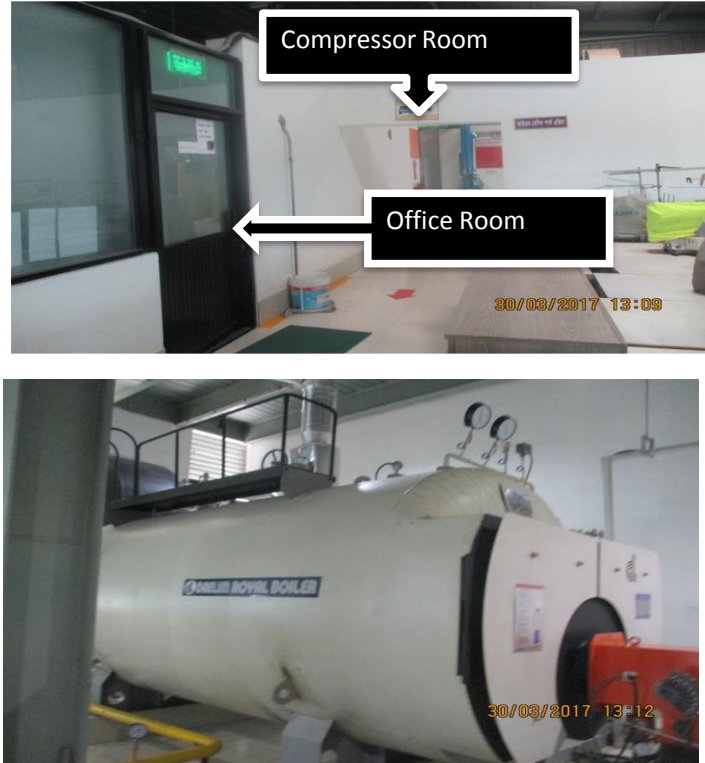
| Sl No. | Category | Findings | Required Action | Remediation Time Frame | Pictorial Evidence |
|---|---|---|---|---|---|
| 6 | Fire Rated Construction | Boiler and compressor room is not separated by fire rated construction (openings, non-rated doors, penetrations).<br><b>Location: Utility Building</b> | Separate the Compressor and Boiler room by a minimum 2-hr fire rated construction. Seal and/or protected all openings to maintain fire separations. | Within 3 months | <p>The top photograph shows an interior view of a utility building with a doorway. Two white arrows point from text labels to the doorway: 'Compressor Room' points to the upper part of the doorway, and 'Office Room' points to the lower part. The bottom photograph shows a large, white, cylindrical industrial boiler with the label 'OMAR ROYAL BOILER' on its side. Both photographs have a timestamp '30/03/2017 13:09' in the bottom right corner.</p> |

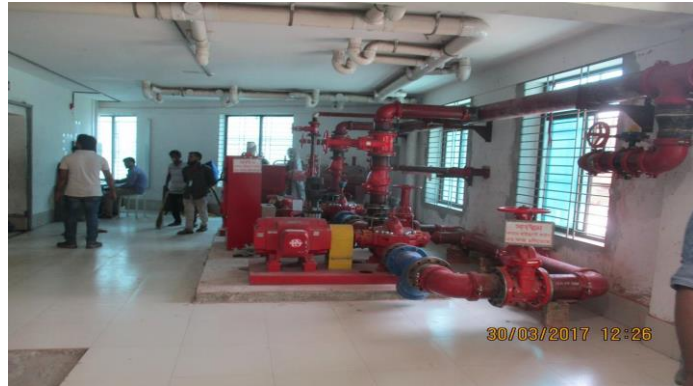
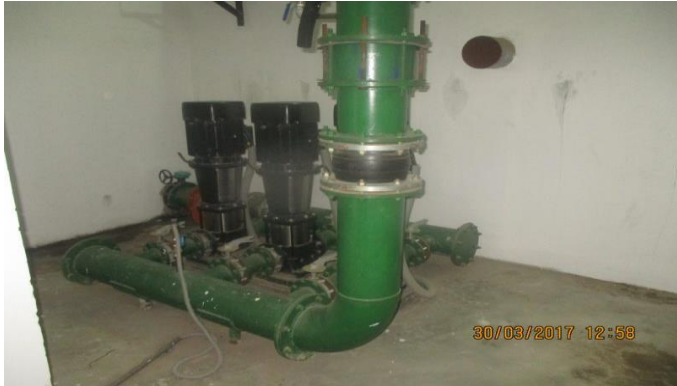
| Sl No. | Category | Findings | Required Action | Remediation Time Frame | Pictorial Evidence |
|---|---|---|---|---|---|
| 7 | Fire Rated Construction | The pump rooms (two) are not provided with adequate fire separation. <b>Location: Building-2</b> | Provide fire pump room with 2 hr rated fire separation when not sprinklered and 1 hr rated fire separation when provided with automatic sprinklers, in accordance with NFPA 20. In the case exterior it shall be 50 ft. away from another occupancy. | Within 3 months | |

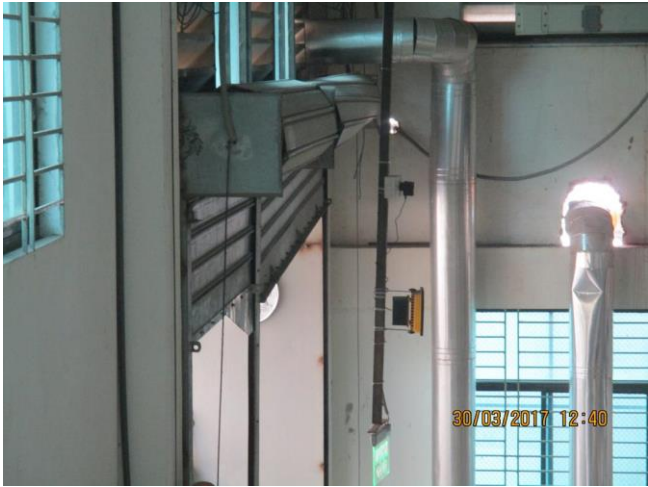
| Sl No. | Category | Findings | Required Action | Remediation Time Frame | Pictorial Evidence |
|---|---|---|---|---|---|
| 8 | Means of Egress | Shutter type doors are provided along means of egress [building exit]<br><b>Location: Building-2</b> | Replace all collapsible/sliding/shutter type doors & gates by the side-hinged swinging type doors.<br><br>If locks are required for security reasons, utilize special door locking features complying with NFPA 101. | Immediate | |

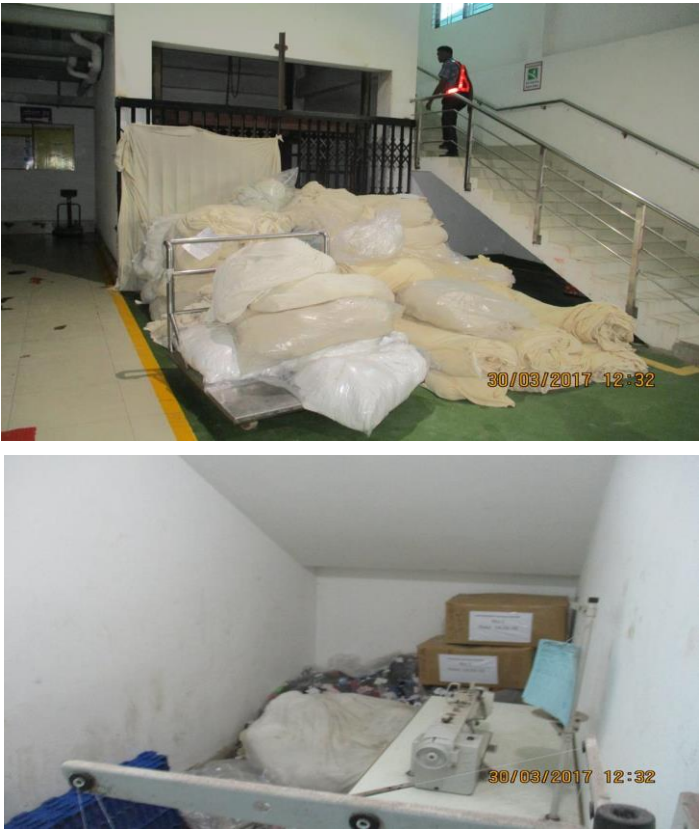
| Sl No. | Category | Findings | Required Action | Remediation Time Frame | Pictorial Evidence |
|---|---|---|---|---|---|
| 9 | Means of Egress | Storage was located in the egress path & under exit stair. <b>Location: Building-2</b> | Keep egress paths and stairs clear of storage. | Immediate | |

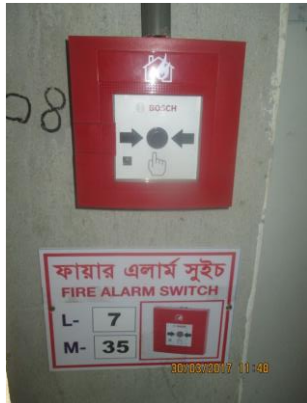
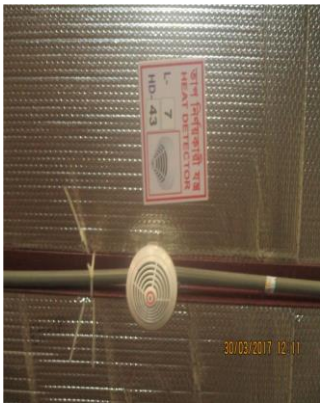
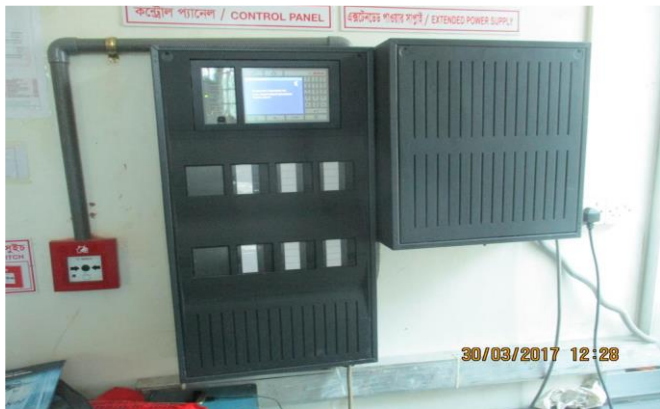
| Sl No. | Category | Findings | Required Action | Remediation Time Frame | Pictorial Evidence |
|---|---|---|---|---|---|
| 10 | Fire Detection System | <p>Fire alarm system installation requires detailed review to confirm compliance with NFPA 72 and ACCORD standards.</p> <p><b>Location: Building 1 &amp; 2</b></p> | Submit as-built drawings, testing records, equipment certification and other relevant documentation to the ACCORD for review and approval | Design within 3 months, Install within 9 months | |

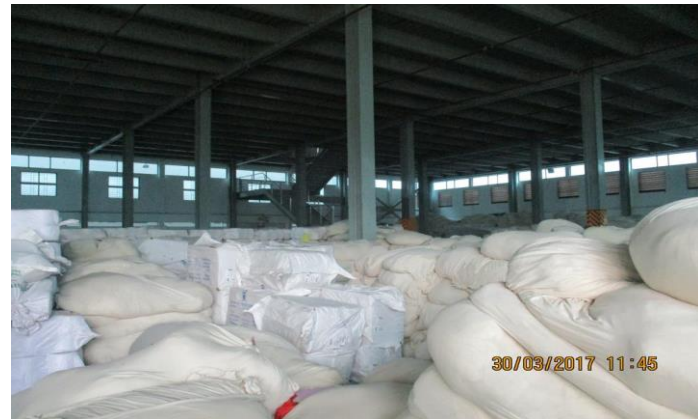
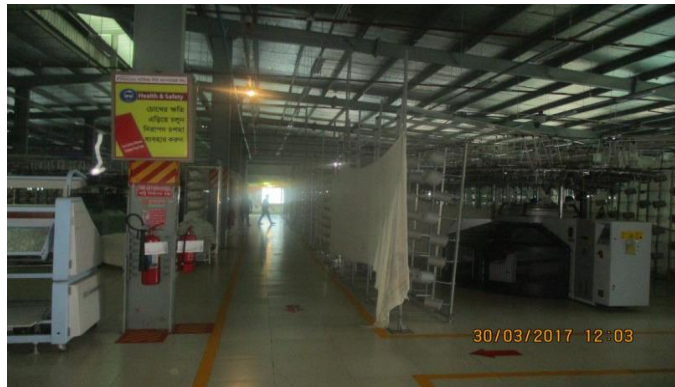
| Sl No. | Category | Findings | Required Action | Remediation Time Frame | Pictorial Evidence |
|---|---|---|---|---|---|
| 12 | Inadequate Lighting | Based on the number and location of emergency lights observed, adequate illumination levels are not anticipated along egress routes. <b>Location: Building 1 &amp; 2</b> | Test the emergency lighting system on each floor and provide additional emergency fixtures to provide adequate illumination along the means of egress. Provide a minimum illumination of 10 lux at the floor level within exit stairs and exit discharge paths and minimum 2.5 lux along exit access aisles. | Within 3 months | |

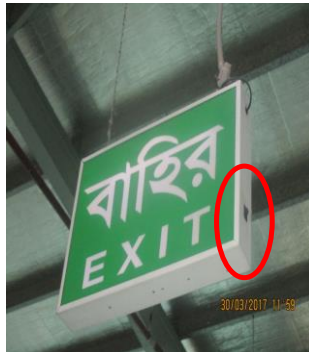
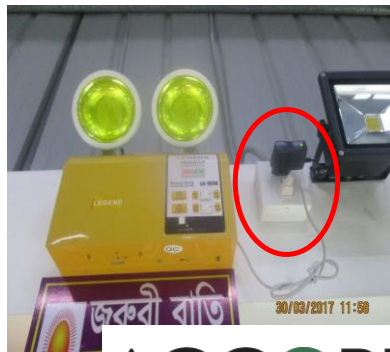
| Sl No. | Category | Findings | Required Action | Remediation Time Frame | Pictorial Evidence |
|---|---|---|---|---|---|
| 13 | Egress Lighting | Manual on-off switch is provided for exit signage and emergency lighting units. <b>Location: Building 1 &amp; 2</b> | Remove manual on/off switches from exit signage & emergency lighting units to prevent them from being switched off. | Within 3 months | |
