# AKH Apparels Ltd.

133-134, Hernayetpur, Savar, Dhaka, Bangladesh  
(23.794784N, 90.273399E)

21 June 2014

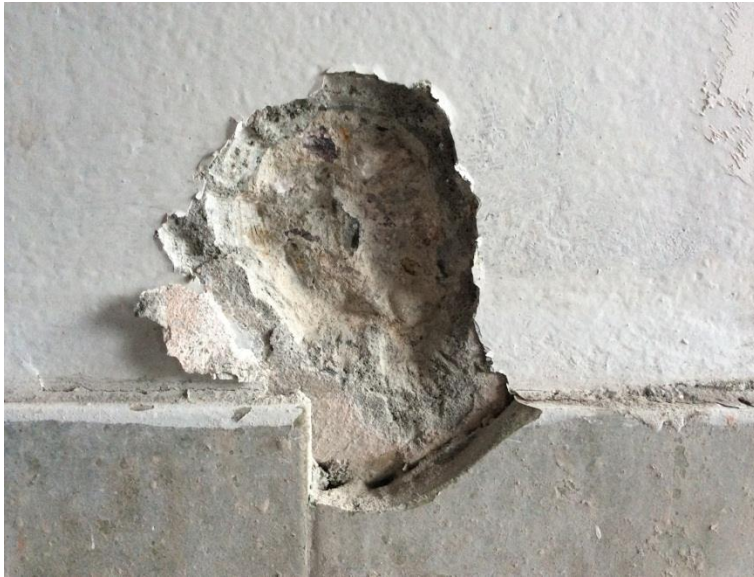
Stone aggregate visible in column at G Floor

| Item No. | Observation | Recommended Action Plan | Recommended Timeline |
|---|---|---|---|
| 1 | Highly Stressed Columns<br>Building 1 | Factory Engineer to review design, loads and columns stresses in all columns. | Immediate - Now |
| 2 | Highly Stressed Columns<br>Building 1 | Verify insitu concrete strength by taking 100mm diameter cores from 4 No. basement columns. Verify reinforcement grade, diameter and number of bars in columns. | Immediate - Now |
| 3 | Highly Stressed Columns<br>Building 1 | A Detail Engineering Assessment of Building 1 to be commenced, see attached Scope | Immediate - Now |

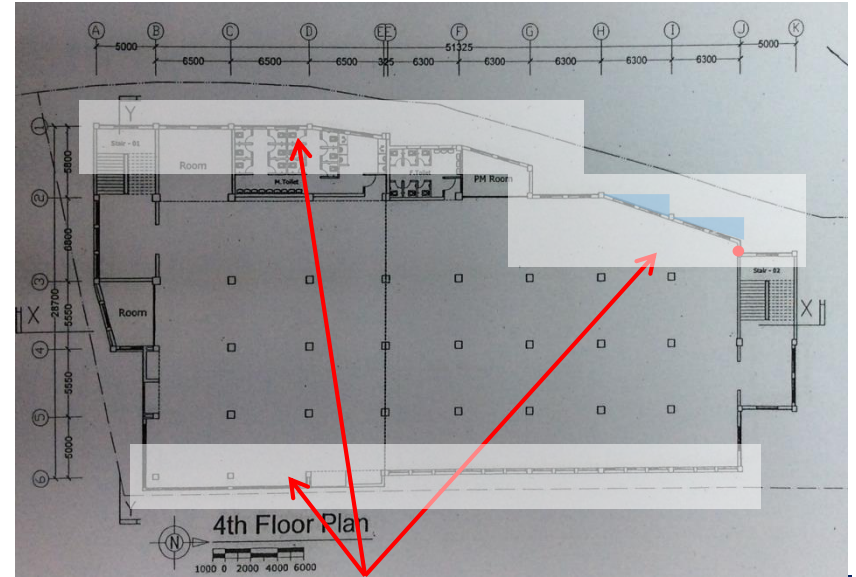
Column at cantilevers and at building edge appear stressed at levels that require immediate review

| Item No. | Observation | Recommended Action Plan | Recommended Timeline |
|---|---|---|---|
| 4 | Highly Stressed Columns<br>Building 1 | Produce and actively manage a loading plan for all floor plates within the factory giving consideration to floor capacity and column capacity. | 6-weeks |

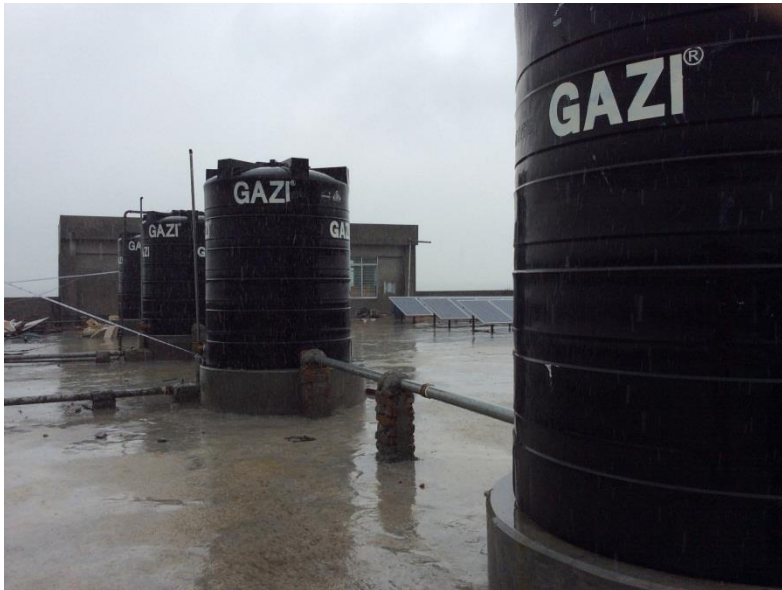
4 x 5000L water tanks with 485mm build up

| Item No. | Observation | Recommended Action Plan | Recommended Timeline |
|---|---|---|---|
| 7 | High loading from water tanks<br>Building 1 | Building engineer to verify that column/beam/slab has sufficient capacity to support water tank as part of Detail Engineering Assessment. | 6-weeks |
| 8 | High loading from water tanks<br>Building 1 | Produce and actively manage a loading plan for all floor plates within the factory giving consideration to floor capacity and column capacity. | 6-weeks |

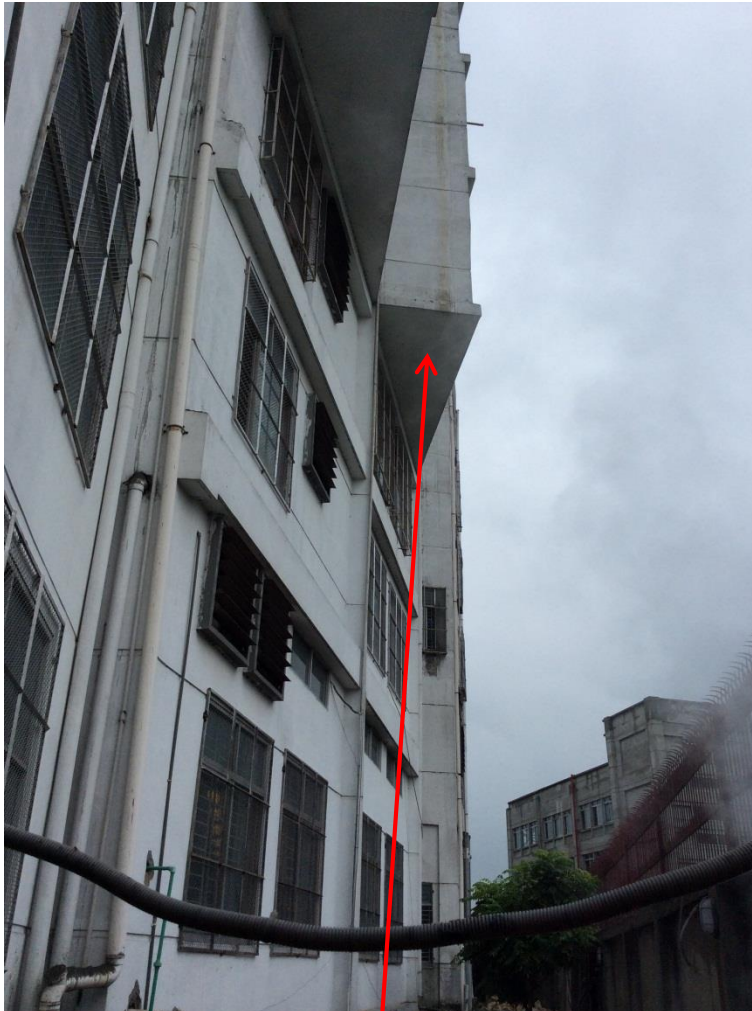
Cantilevers from L3 on West façade

| Item No. | Observation | Recommended Action Plan | Recommended Timeline |
|---|---|---|---|
| 10 | Stepped cantilever on West façade in Building 1 | Building engineer to provide detailed calculations that show that column/beam/slab has sufficient capacity to support cantilever load as part of Detail Engineering Assessment. | 6-weeks |
| 11 | Stepped cantilever on West façade in Building 1 | Building engineer to check, collect information and produce accurate and complete as-built documentation as part of Detail Engineering Assessment. | 6-weeks |

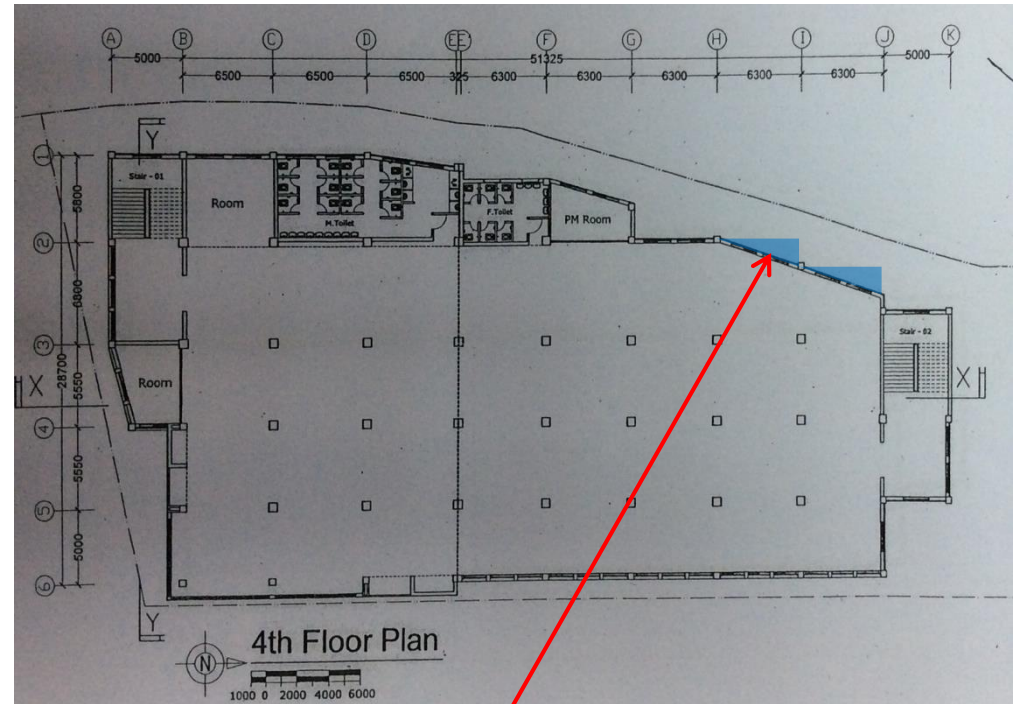
Cantilevers on L3 – Roof not shown on drawings

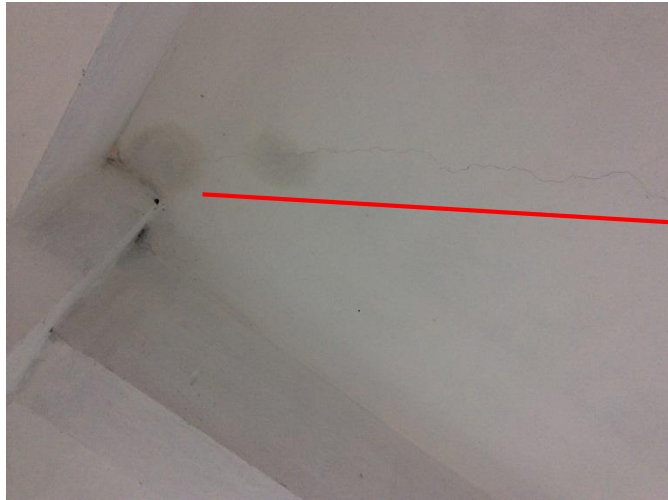
Cracking and damp patch at column supporting water tank on roof

| Item No. | Observation | Recommended Action Plan | Recommended Timeline |
|---|---|---|---|
| 12 | Cracking in Building 1 | Sections of plaster finish to beams to be removed to investigate if cracks penetrate the building structure. | 6-weeks |
| 13 | Cracking in Building 1 | Building Engineer to carry out design check on beams as part of the Detail Engineering Assessment. | 6-weeks |
| 14 | Cracking in Building 1 | Carry out any remedial actions as directed by the Building Engineer. | 6-months |

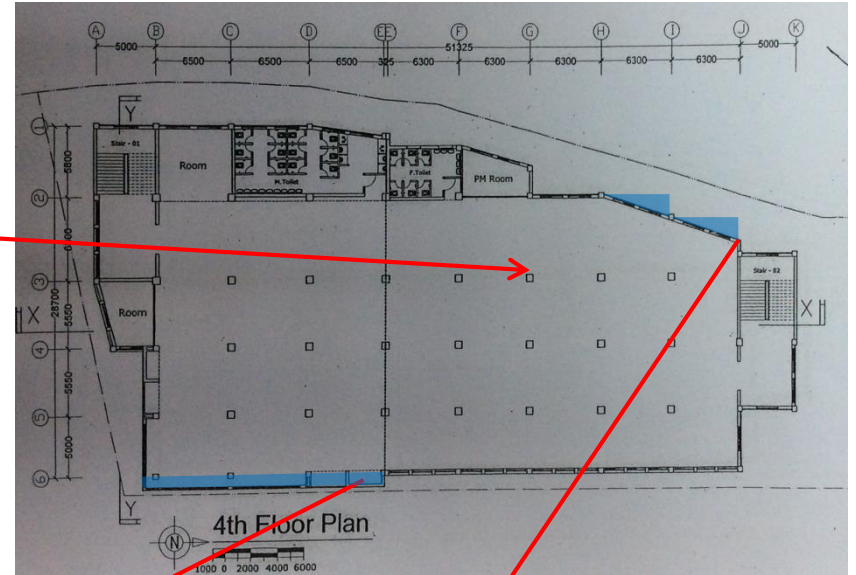
Cracking at cantilever east façade

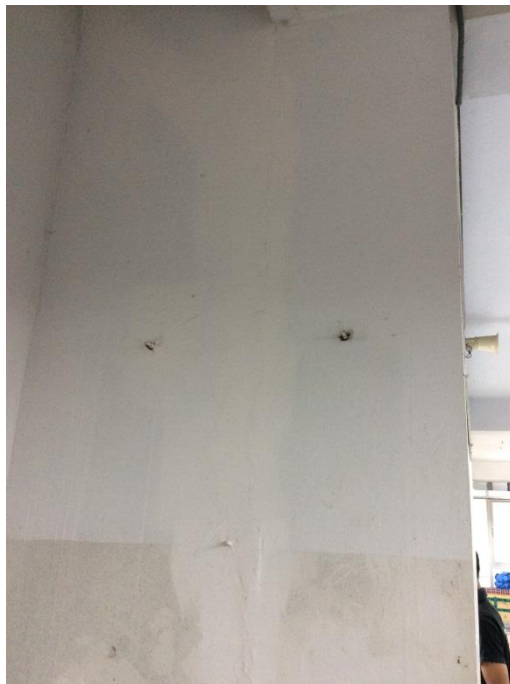
Cracking in wall/beam at cantilever L5

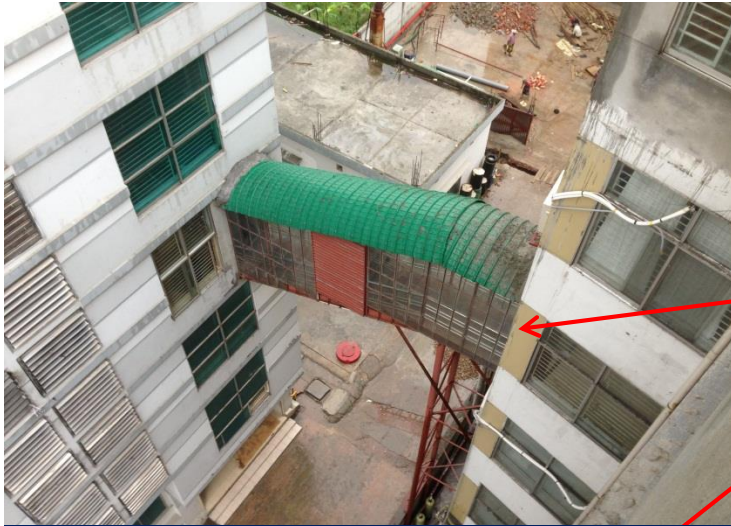
**Steel bridge between Building 1 and other building (inspected by Alliance) - No drawings available**

| Item No. | Observation | Recommended Action Plan | Recommended Timeline |
|---|---|---|---|
| 15 | Existing bridge and bridge under construction between buildings | Building engineer to provide detailed calculations that show the bridges are structurally adequate as part of Detail Engineering Assessment. | 6-weeks |
| 16 | Existing bridge and bridge under construction between buildings | Building engineer to check, collect information and produce accurate and complete structural drawings as part of Detail Engineering Assessment. | 6-weeks |
| 17 | Existing bridge and bridge under construction between buildings | Carry out any necessary structural alterations as advised by the Building Engineer. | 6-months |

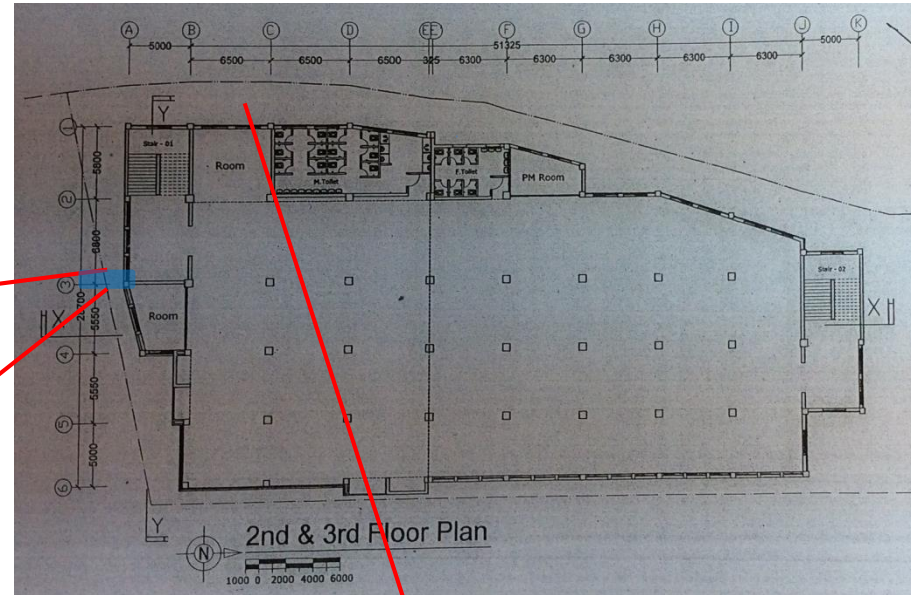
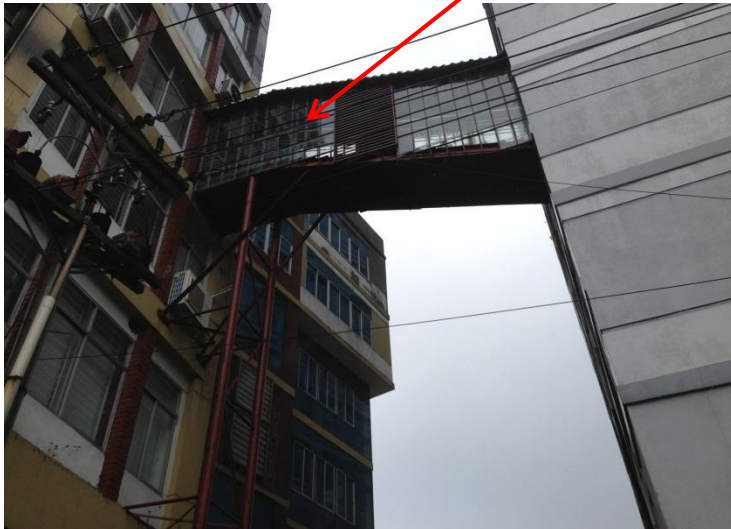
**Currently constructing bridge between Building 1 and Building 2 – No structural drawings available**

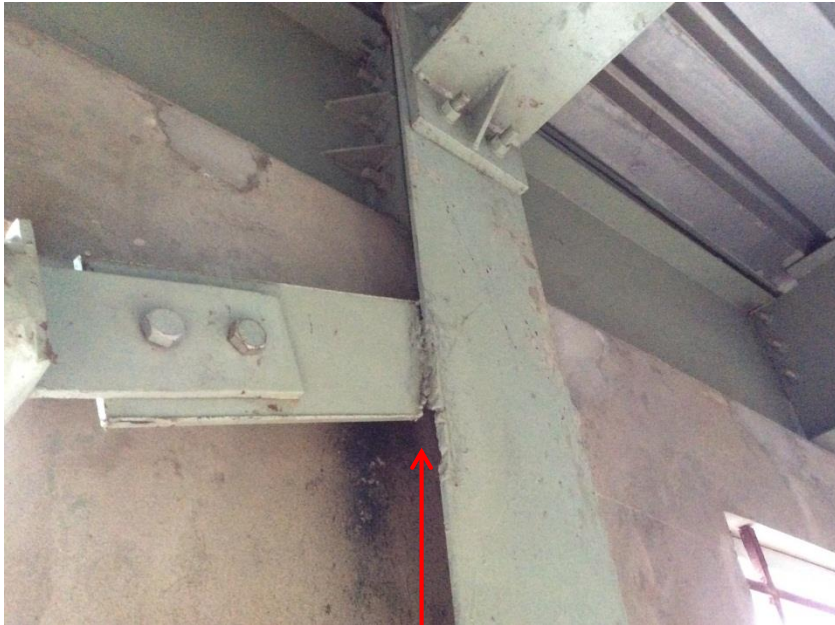
Poorly welded bracing onto column

Bracing not in accordance with structural drawings:  
Diagonal brace elements do not connect at nodes  
Cross brace CHS replaced with cable

| Item No. | Observation | Recommended Action Plan | Recommended Timeline |
|---|---|---|---|
| 18 | Steel connections Building 2 | Building engineer to check connection capacities including gusset bending and shear of bracing system and propose additional strengthening, if required. | 6-weeks |
| 20 | Steel connections Building 2 | Implement connection strengthening and any other remedial structural works if directed by the Building Engineer. | 6-months |

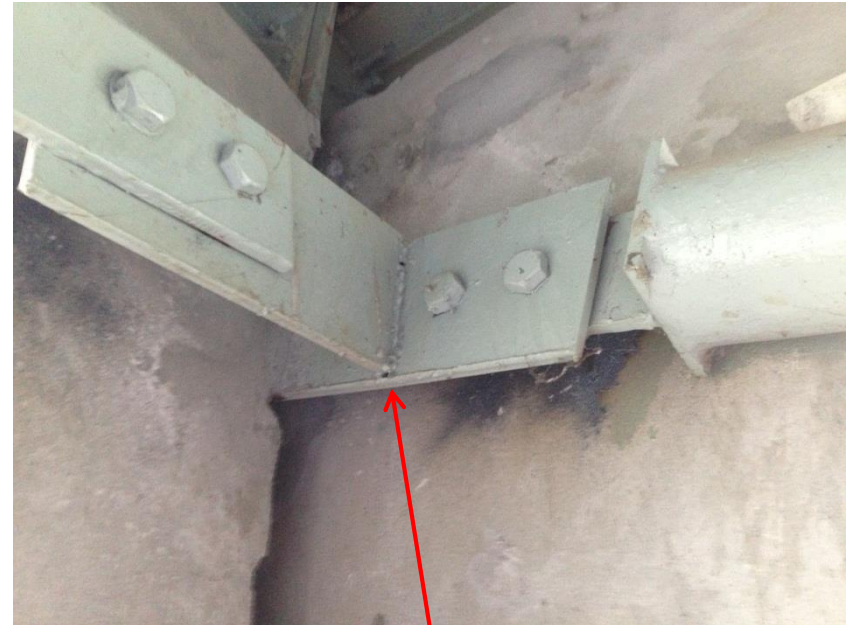
Bracing welded onto gusset plate of bracing in orthogonal direction

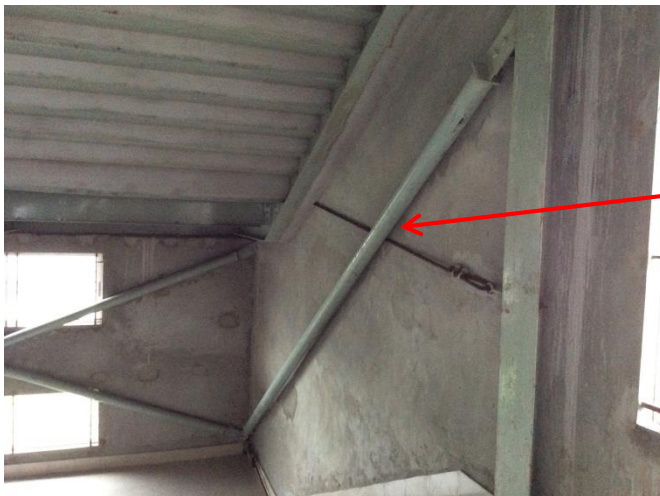
Typical bracing system - Tie not connected to column node

| Item No. | Observation | Recommended Action Plan | Recommended Timeline |
|---|---|---|---|
| 19 | Steel connections Building 2 | Review adequacy of cable bracing in stair core. | 6-weeks |

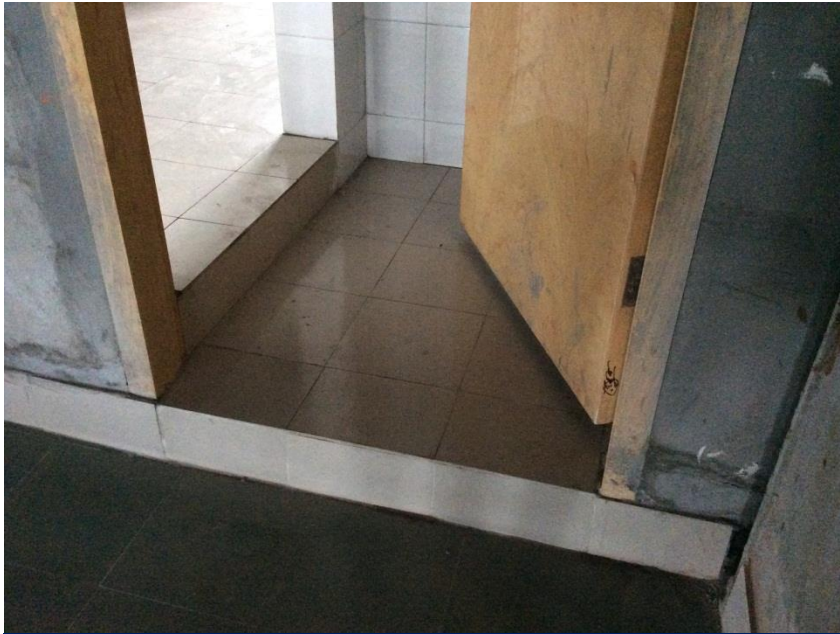
Heavy loading from toilet plinths 210mm+170mm

| Item No. | Observation | Recommended Action Plan | Recommended Timeline |
|---|---|---|---|
| 21 | Heavy Loading Building 2 | Building engineer to check slab, beam and column capacity. | 6-weeks |
| 22 | Heavy Loading Building 2 | Produce and actively manage a loading plan for all floor plates within the Building giving consideration to floor capacity and column capacity. | 6-weeks |

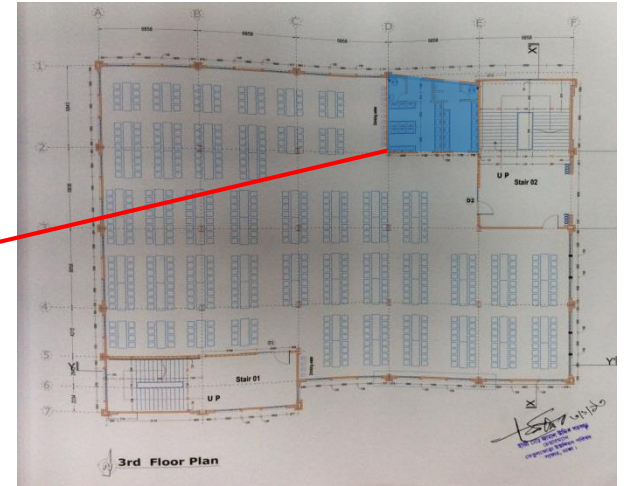
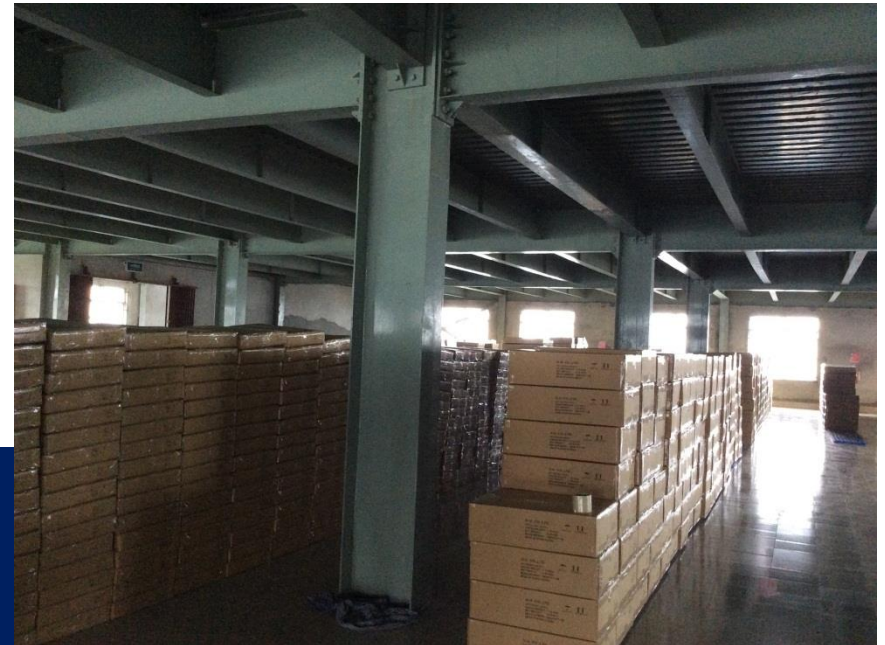
Warehouse loading on GL, L2, and L3

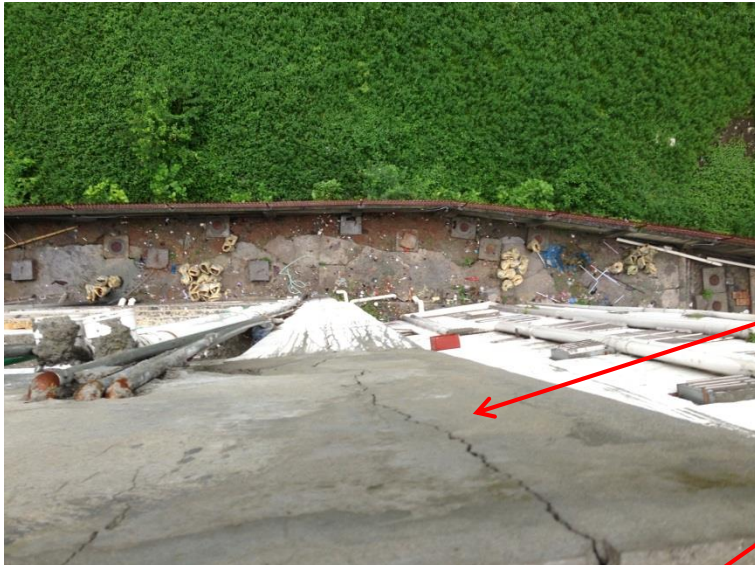
Uncontrolled cracking MJ in façade

| Item No. | Observation | Recommended Action Plan | Recommended Timeline |
|---|---|---|---|
| 24 | Uncontrolled Cracking - Movement Joint - Building 1 | Carry out remedial work to movement joint as directed by the Building Engineer. | 6-months |

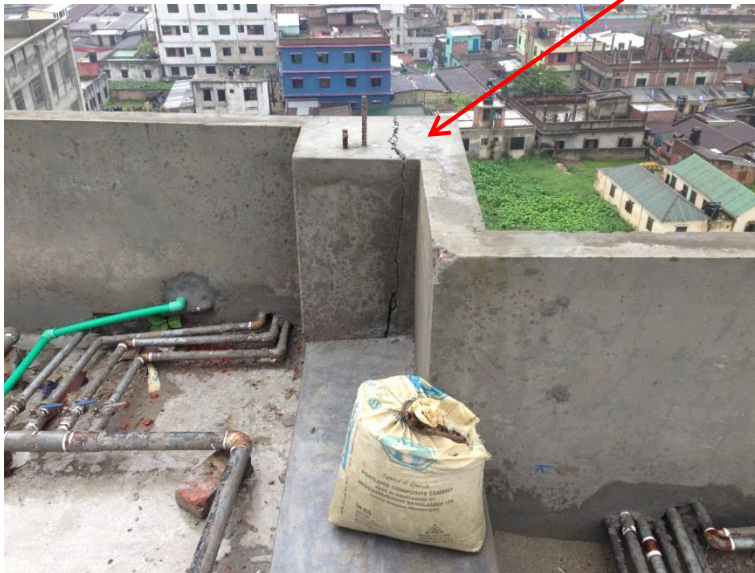
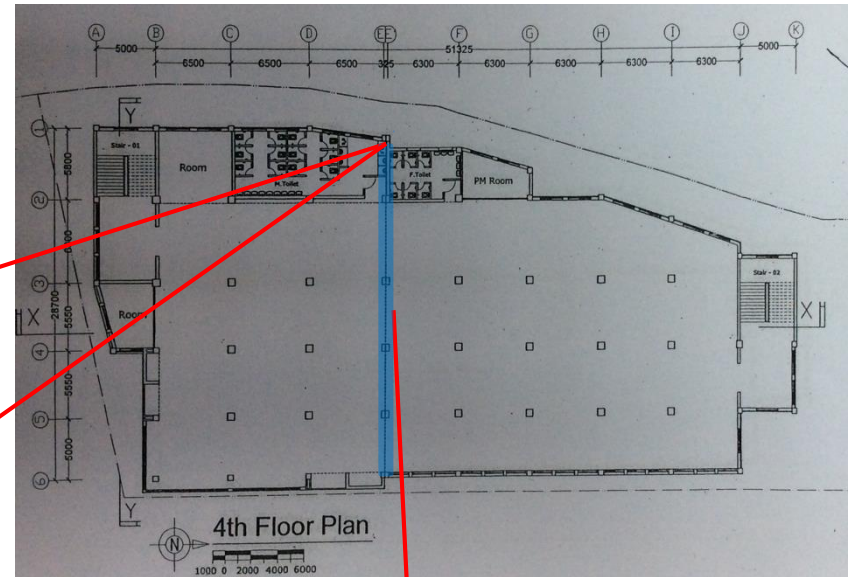
Highlighted area indicates movement joint
