Sharmin Apparels Ltd. Sharmin Fashions Ltd. Ha-Meem Washing Plant Ltd. Sharaf Apparels Ltd.

Narashingapur, Ashulia, Savar, Dhaka

08 April 2014

Observations

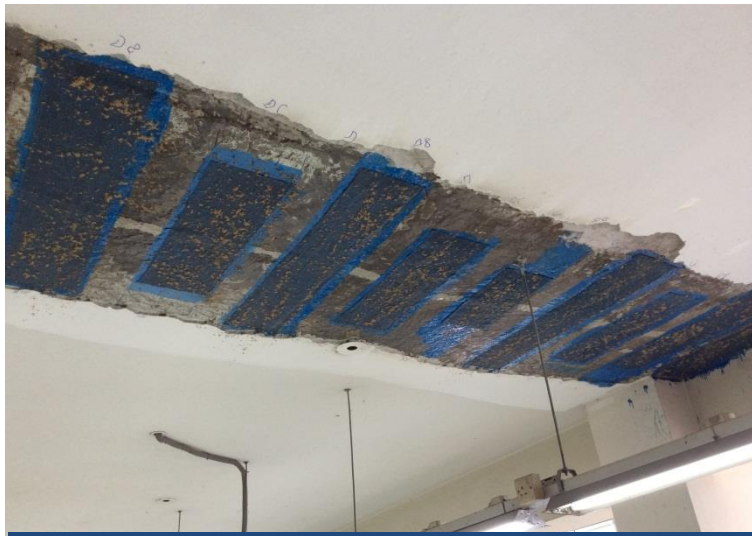
Repairs to cracking on soffit of 5th floor

Building Engineer to carry out a Detail Engineering Assessment including:

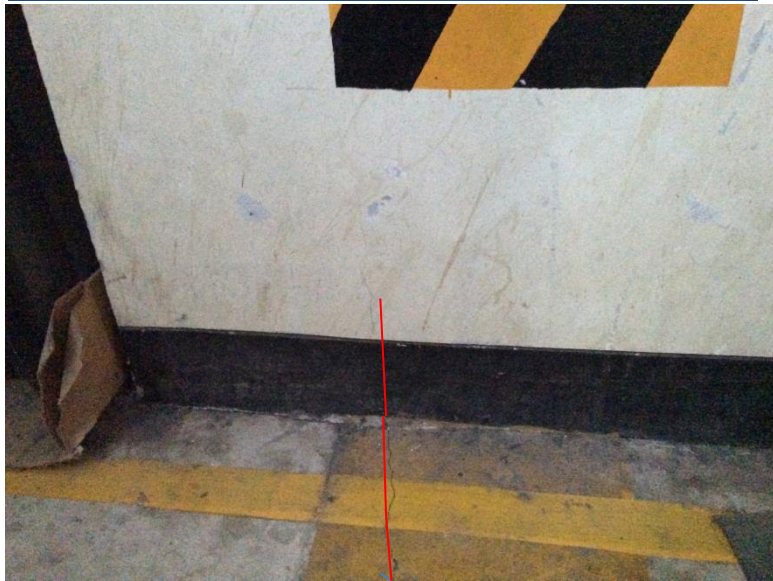
Cracking on ground floor adjacent to column

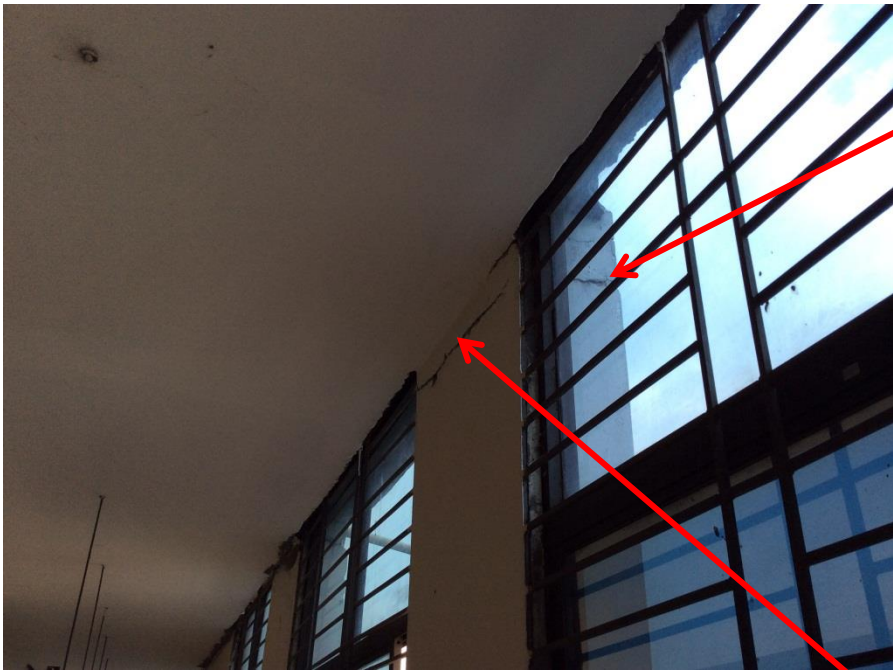
Crack penetrates to outside face of pier at underside of 5th floor

Building Engineer to check that the piers have adequate capacity to resist lateral loads

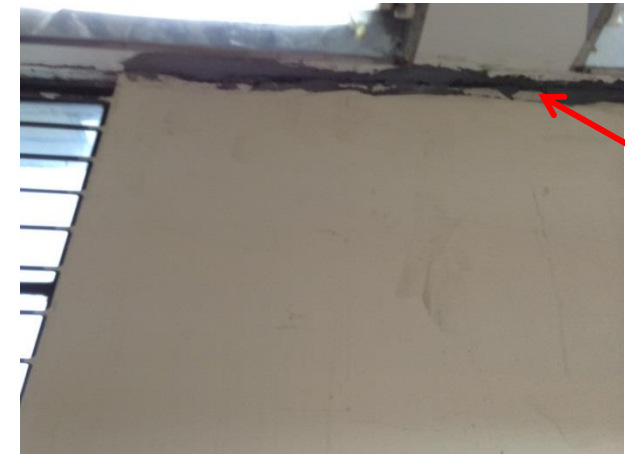
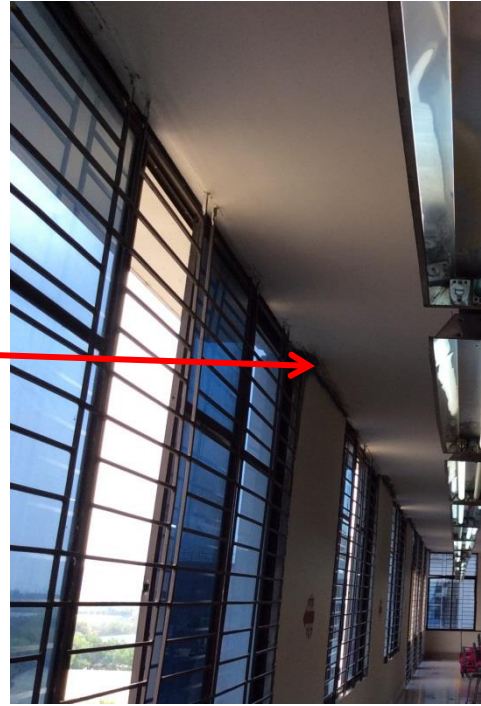
4th floor appears to be deflecting more relative to the 5th floor (roof) causing the pier to separate from the underside of the roof.

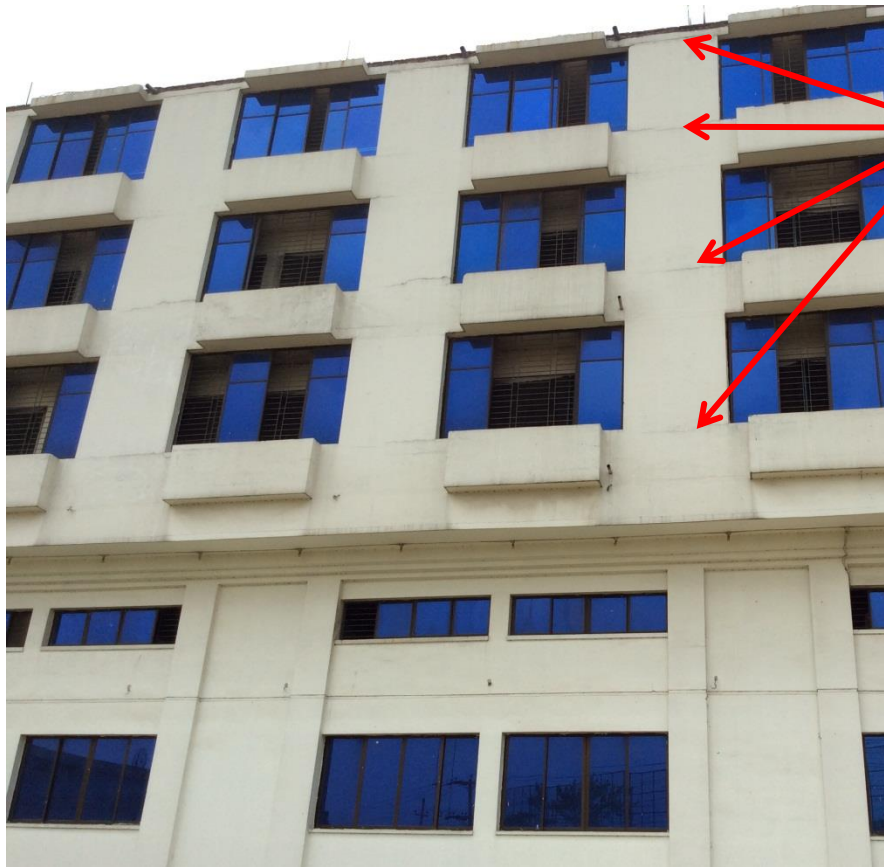
Main Garment Factory - East Elevation

**Cracking in the pier
observed throughout**

**Building Engineer to check that the
piers have adequate capacity to
resist lateral loads.**

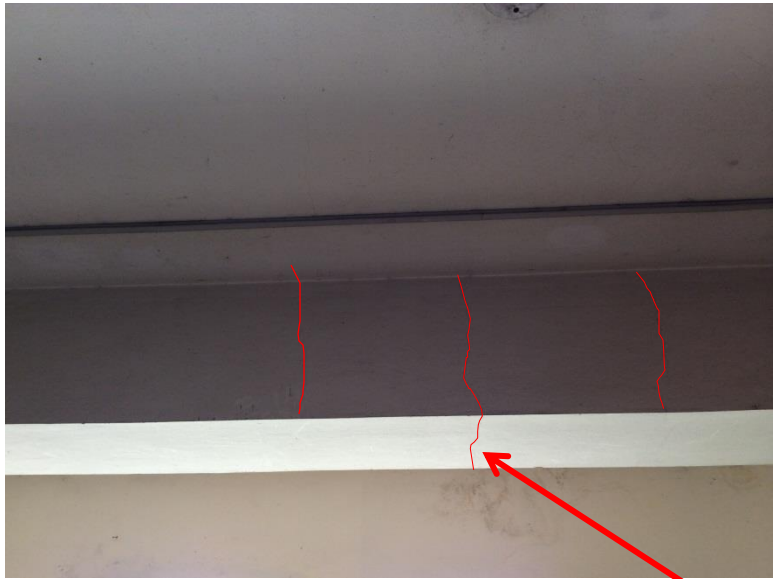
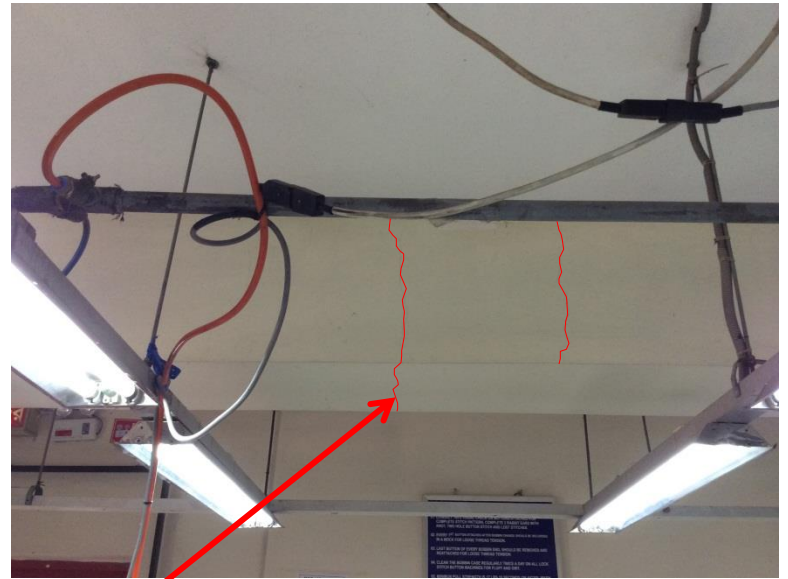
Cracking in RC Beams

Numerous examples of cracking in RC perimeter beams

Cracking in beams to be reviewed by removing plaster to confirm that cracks do not extend into structure.

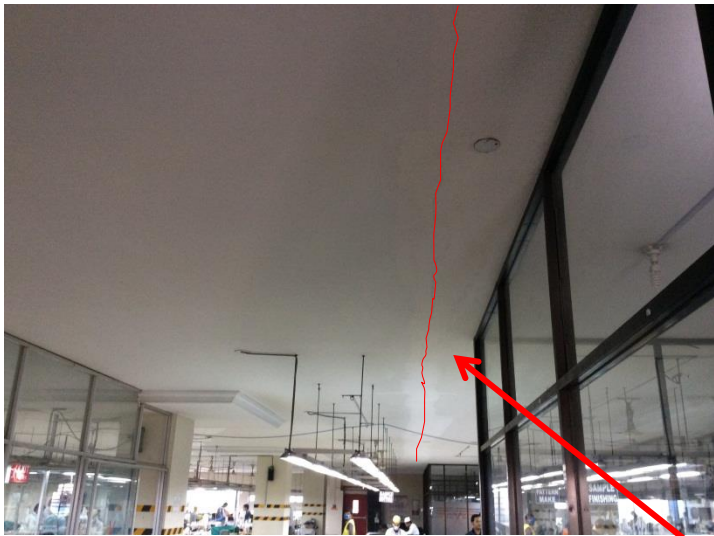
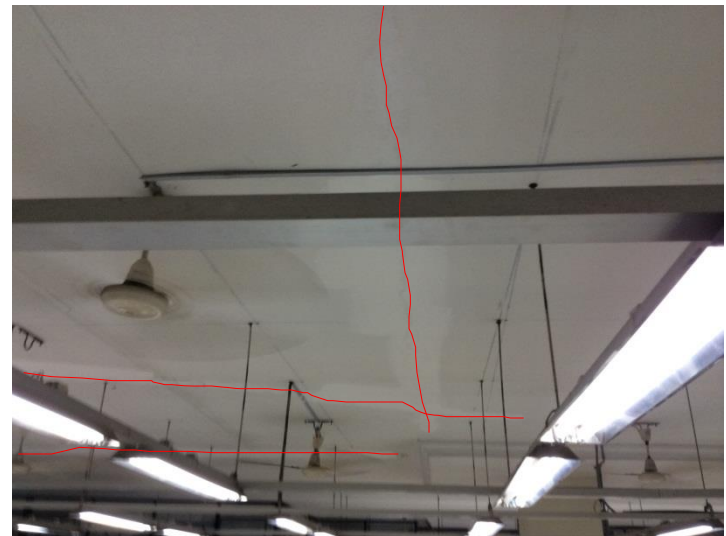
Numerous examples of cracking and evidence of repair to cracking on soffit of floor slabs

Cracking in soffit of flat slabs to be reviewed by removing plaster to confirm that cracks do not extend into structure.

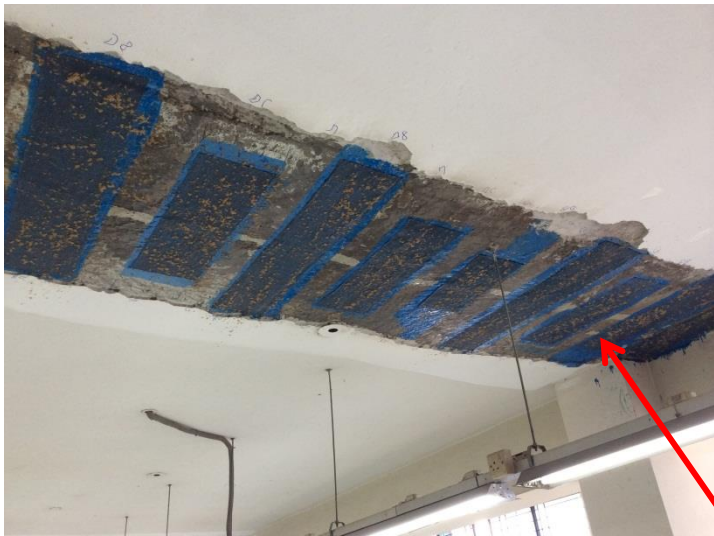
Cracking to underside of PT slab

Underside of roof being strengthened as recommended by BUET

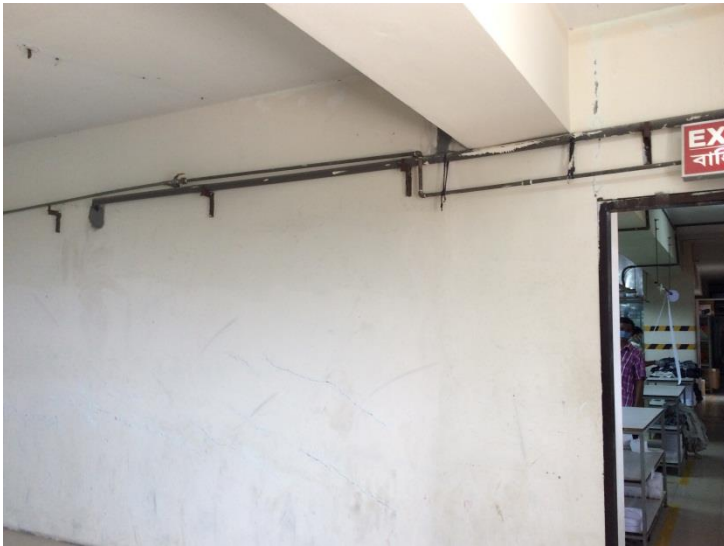
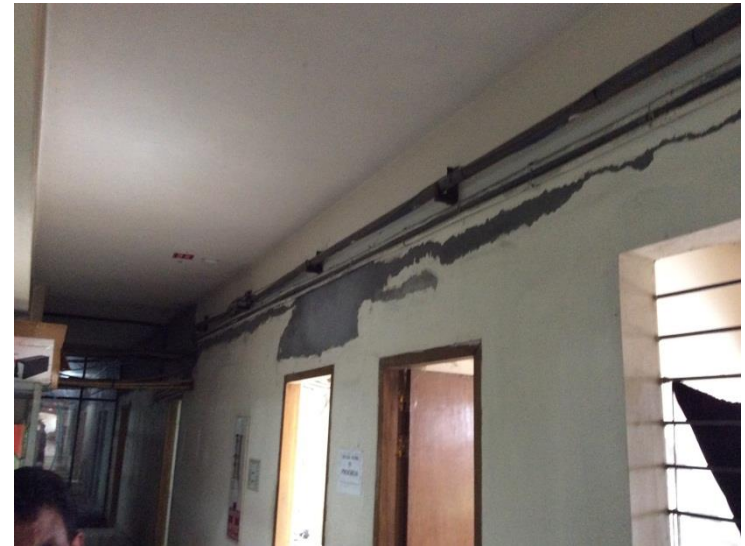
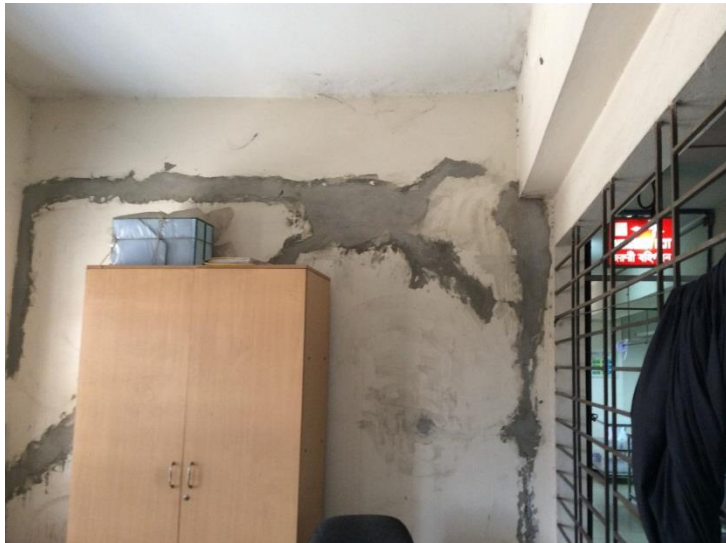
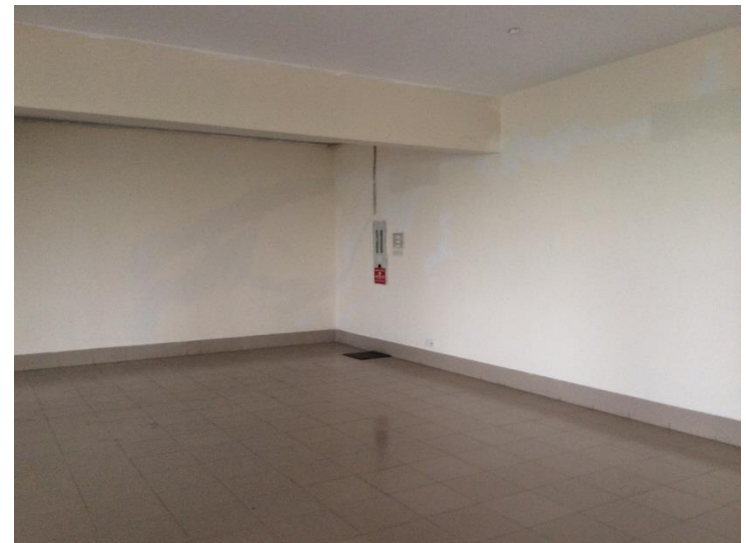
Cracking in internal brickwork wall

Numerous examples of cracking and evidence of repair to cracking

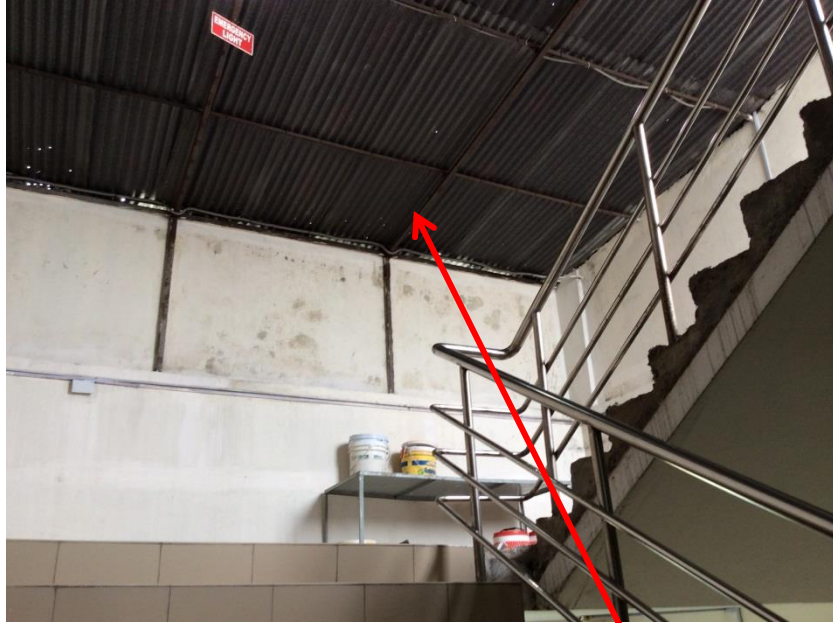
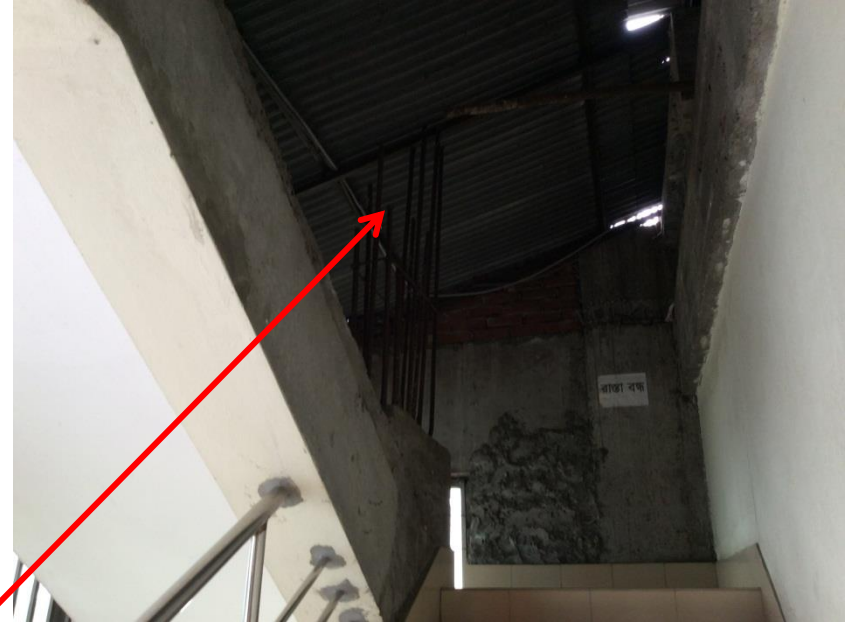
Lightweight Roof Construction

Lightweight steel roof structure.
Building Engineer to review adequacy of
roof structure to resist high wind loading

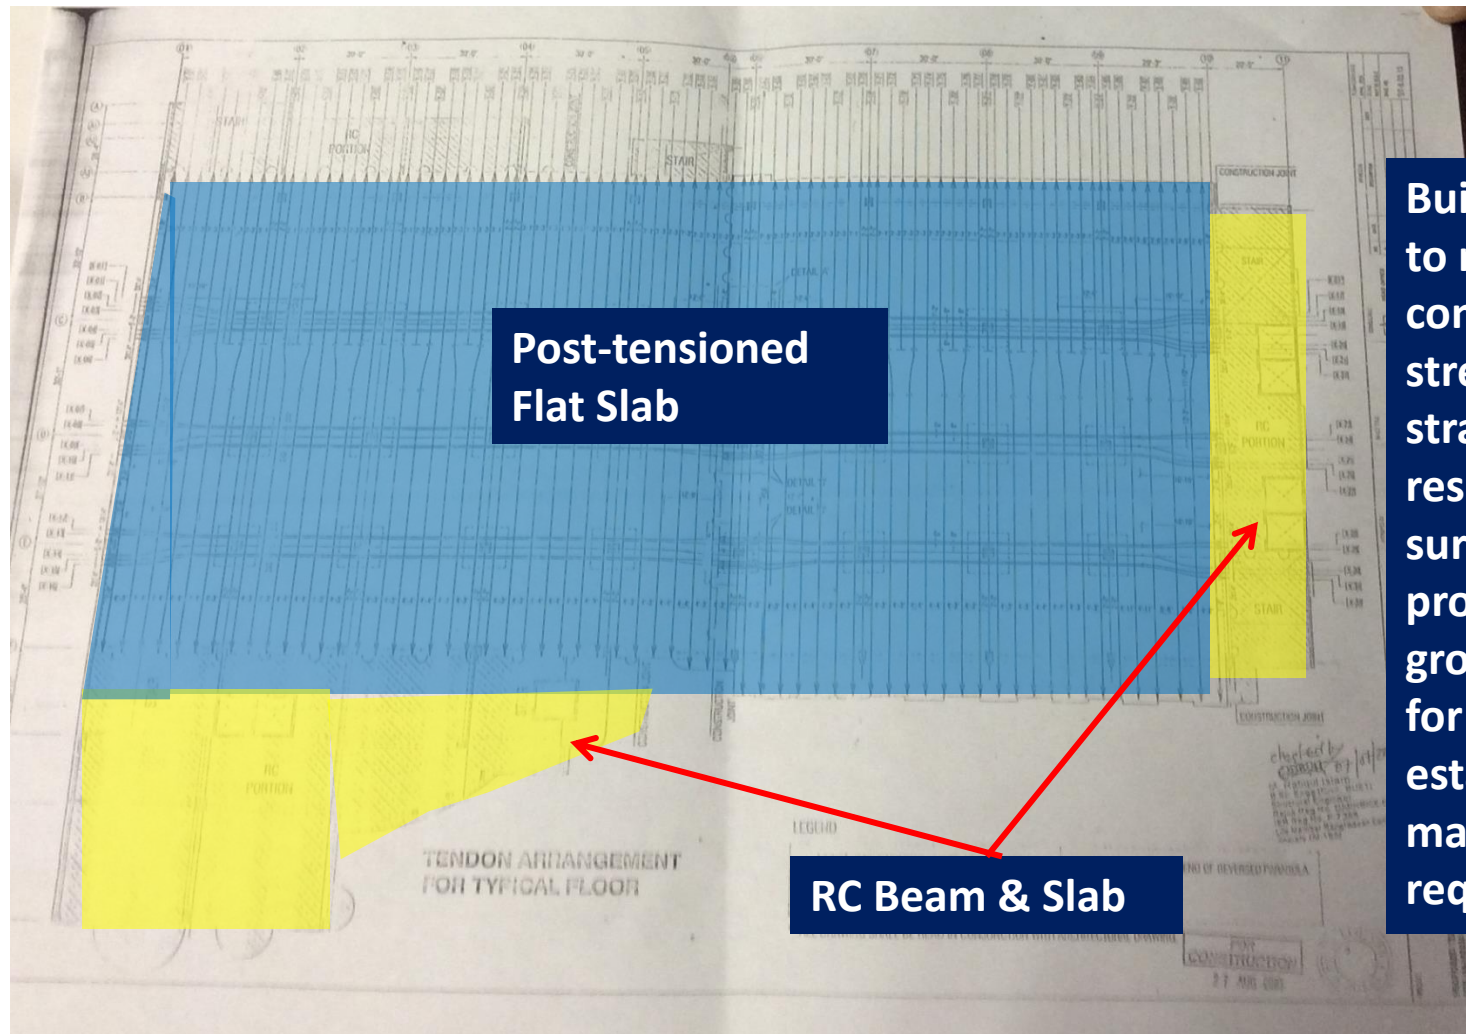
Typical Floor Slab and Tendon Layout

**Post-tensioned floor slab
construction requires a high level
of quality control during
construction**

Building Engineer to review concrete cylinder strength records, strand extension results, as-surveyed cable profiles and grouting records for PT slabs to establish if these match design requirements

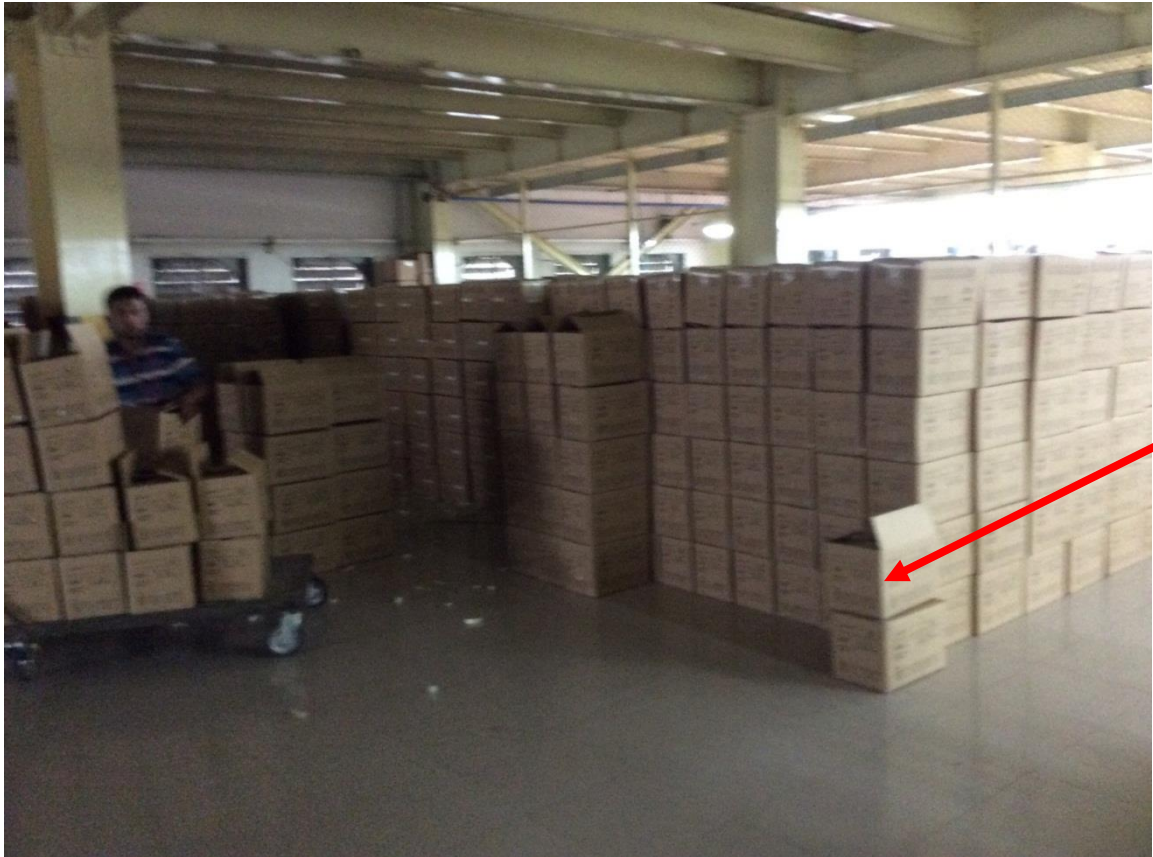
Storage of Finished Goods

Management of storage loads

Building Engineer to prepare controlled loading plans, based on floor slab and column capacity, for all floors which will designate storage density and where storage may be placed.
