**Sumi Apparels (Pvt) Ltd. #9920**  
**Disari Poly Print & Packaging Ind. Ltd.**  
**Disari Washing Plant**

A-112, 113, (West side) BSCIC, Tongi, Gazipur  
(+23.895039N, 90.414413E)

17.APRIL.2014

## Identified Priority 1 Concerns

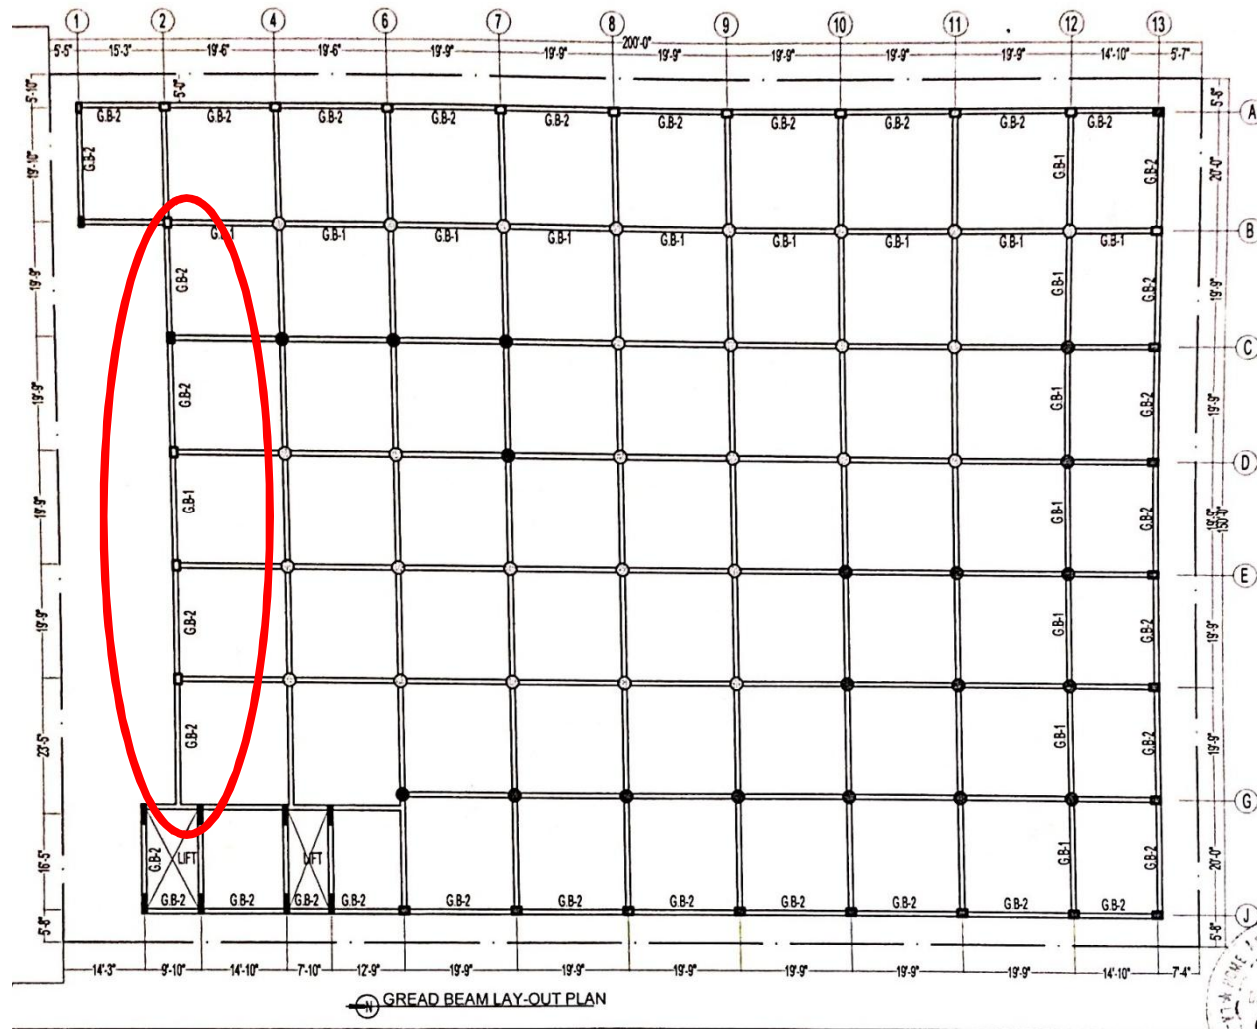
Priority 1 Concern

Structural drawings do not match current state or permit drawings. Cantilevers not shown. A courtyard shown on the permit drawings has been built over.

**ITEM 1: Structural drawings do not match current state.**

**ITEM 2: Permit drawings do not match structural drawings or current state.**

Structural drawings do not match current state. Reinforcing steel in columns and beams, cantilever lengths, and mezzanines observed do not match structural drawings. In particular, two mezzanines (one 1st story and one 2nd story) were discovered, neither of which was properly shown on structural drawings.

Permit drawings do not match structural drawings or current building. The permit drawings were designed for an 8 storey building, however the structural drawings were designed for a six storey building. In addition, an atrium is shown on the permit drawings, which was not built.

- The factory Structural Engineer stated that the columns and footings were designed for 8 floors (5 floors, 2 mezzanines, and a roof slab), however this is not shown on structural plans and plans to build more were observed.
- The Structural Engineer is to review the site conditions and modify drawings to suit existing conditions.

- The structural drawings were designed for 6 storeys (plus two mezzanines) however permit drawings indicate 8 storeys (plus two mezzanines).
- No more floors should be constructed until a full Detailed Engineering Assessment is carried out.

- Submit updated drawings for revised permit drawings.

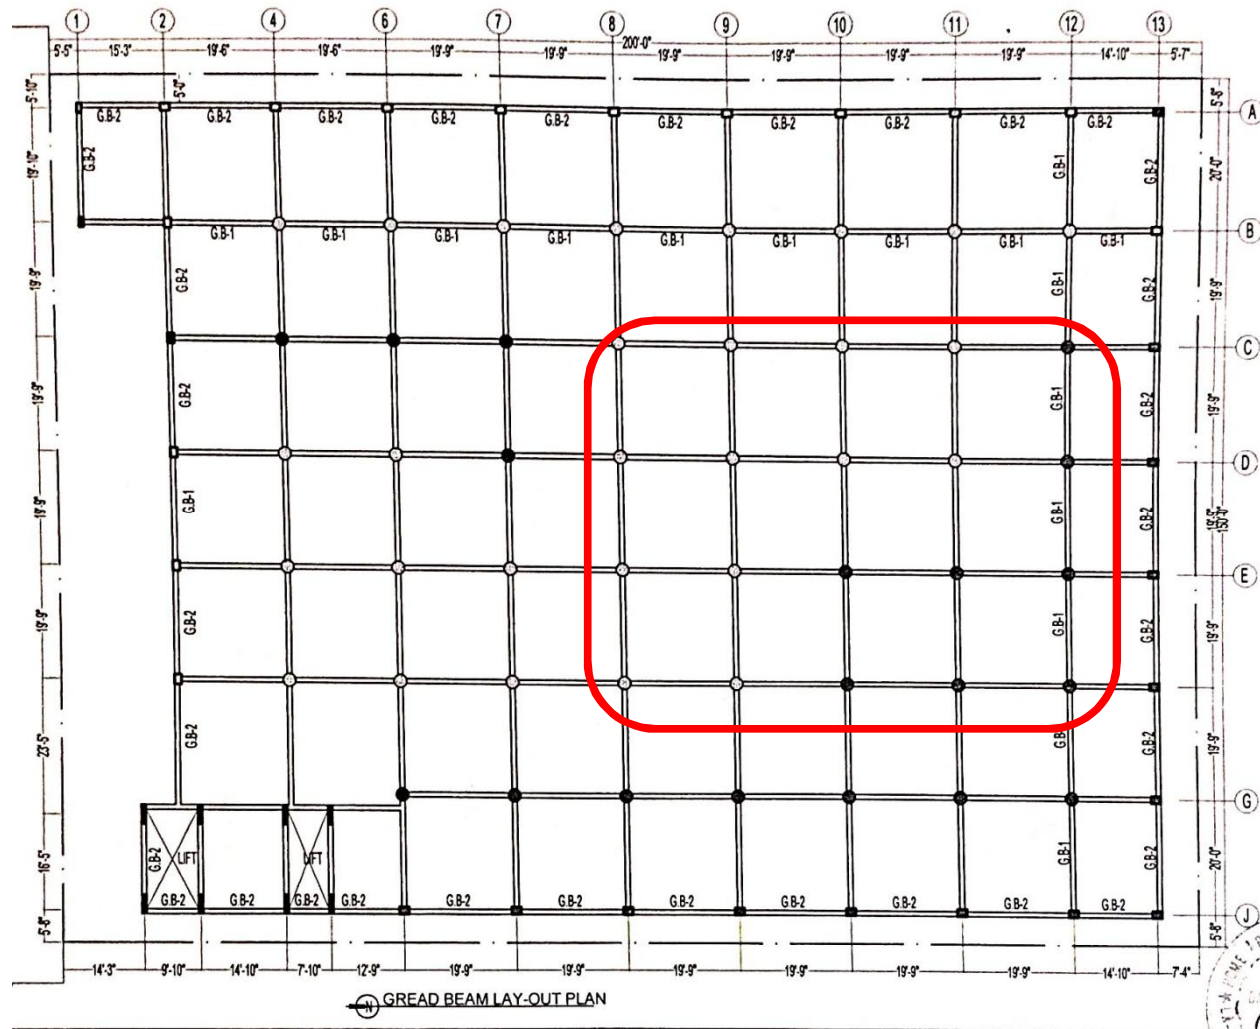
Major Concern

Structural drawings do not match current state or permit drawings. Courtyard shown on permit drawings has been built over. The two existing mezzanines are not shown on the permit drawings.

High storage loads on two floors. The rolls of yarn were calculated as 12kPa.

**ITEM 3: High storage loads on two floors.**

Storage was discovered on the 1<sup>st</sup> storey mezzanine and the 1<sup>st</sup> floor in excess of 12kPa. No loading plans were made available, and in addition the mezzanine was not shown on the structural drawings.

- Storage loading to be removed from these two floors down to 5kPa maximum until an engineering assessment is carried out to determine the load carrying capacity.

- Loading plans be drawn and provided to owner/management for use.

- Continue to implement the Loading Plan.

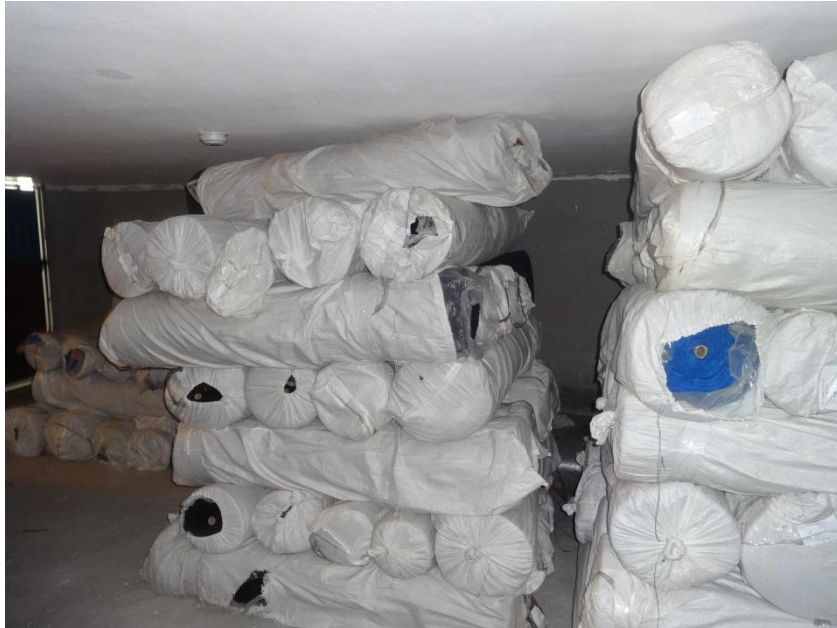
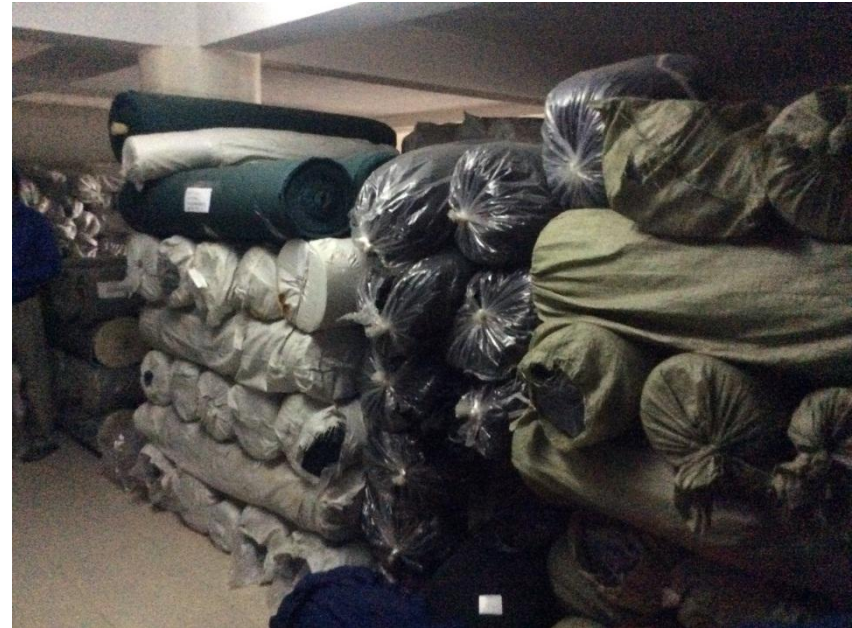
3<sup>rd</sup> Priority 1 Concern

Cracking in beams, slabs and one isolated crack in column. Cracks are shown in red for clarity

**ITEM 4: Cracking in beams, slabs and one isolated crack in column.**

Hairline to small cracking was observed in the slabs and beams on several floors. One isolated vertical hairline crack was observed on a 1<sup>st</sup> storey mezzanine column extending from slab to slab.

- Engineering assessment be carried out to determine the cause of the cracks.

- Remedial work be carried as required to repair cracking.

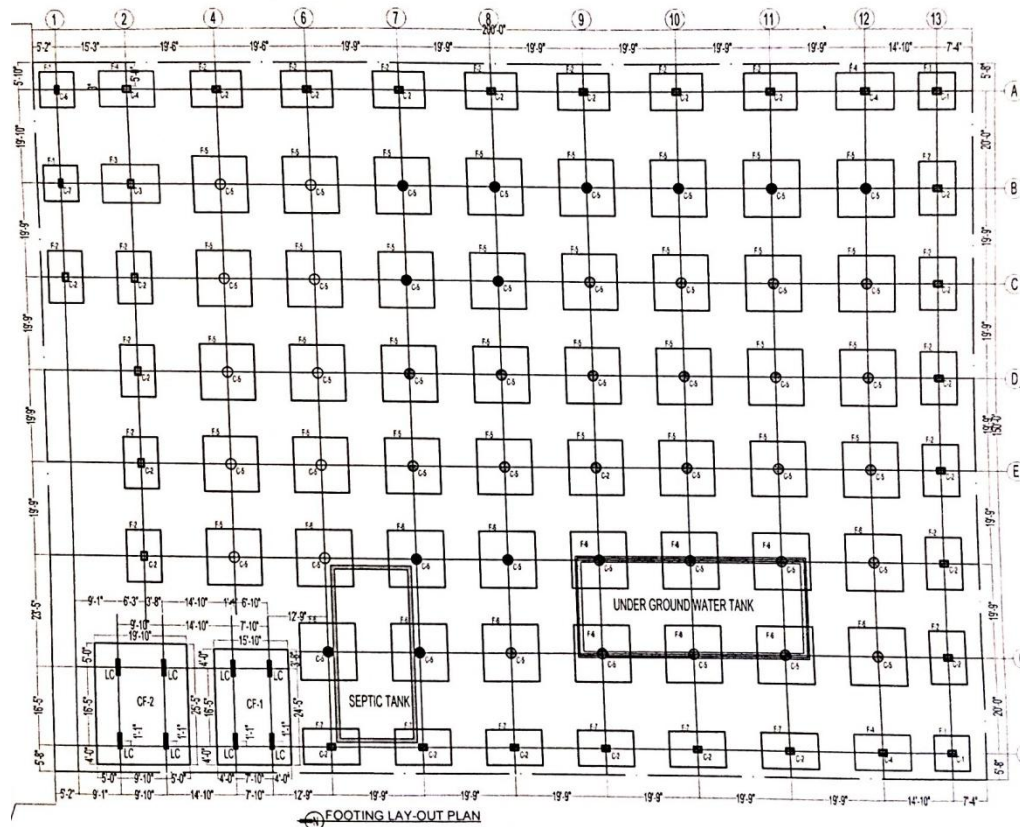
# Overall Stability System

The building did not feature any core or shear walls. Stability was achieved through sway action between beams and columns and masonry infill walls.

We require that these items be investigated in a Detailed Engineering Assessment

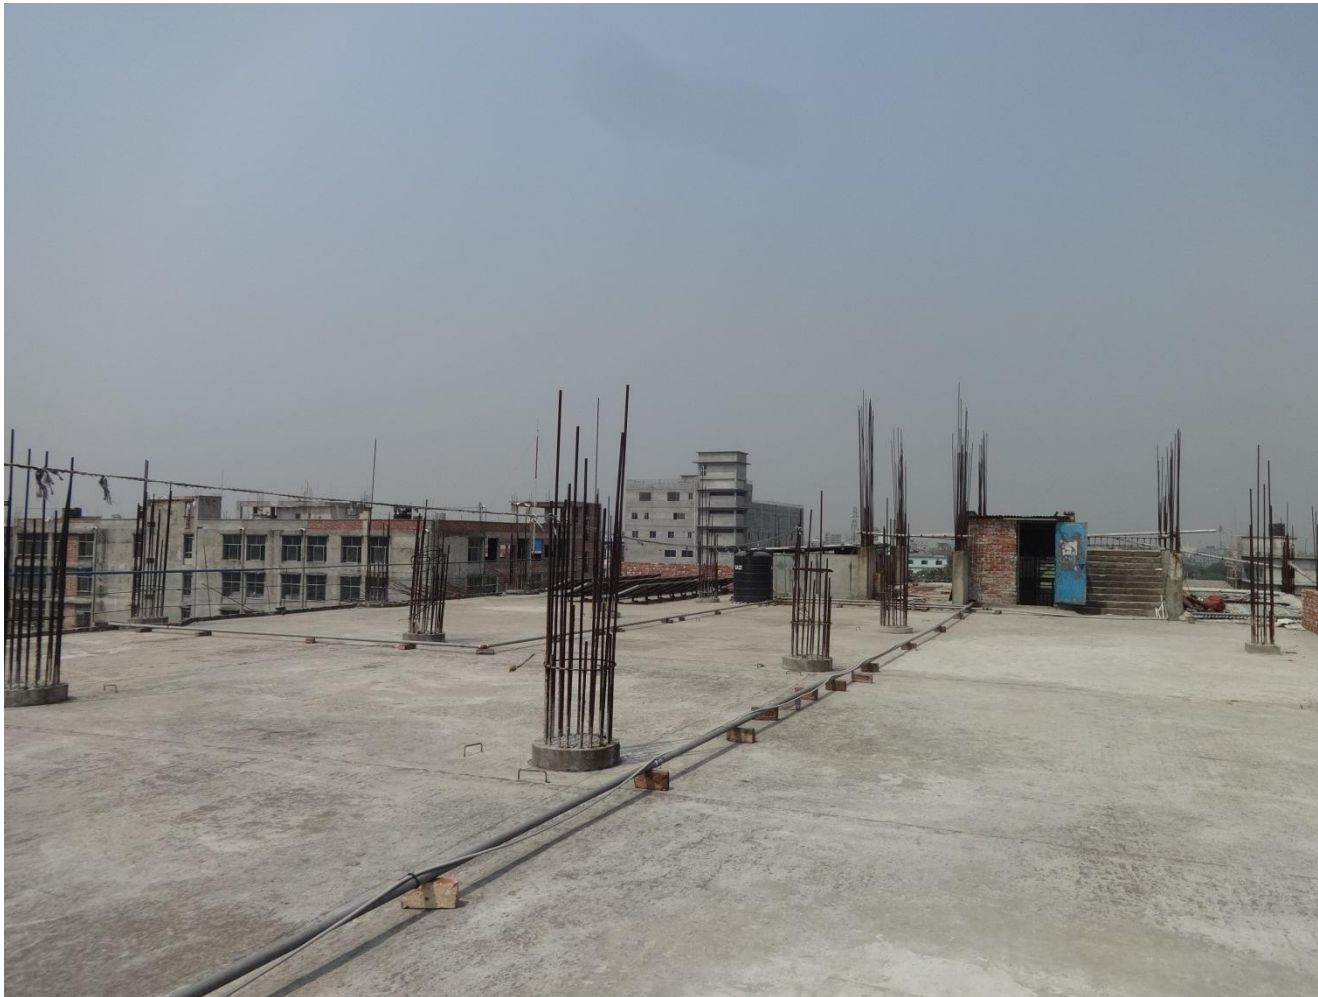
## Water Ingress at Roof Level

No waterproofing membrane was visible on the roof of the building. This means that any cracks in the surface finishes on the roof will allow water to seep into the concrete slab beneath the finishes, and cause long-term soaking of the slab.
