# Abloom Design Ltd

37, South Sastapur, Upazila Road, Fatullah, Narayangonj-1420  
(+23.638196N, 90.492288E)

10<sup>th</sup> June 2014

# Executive Summary

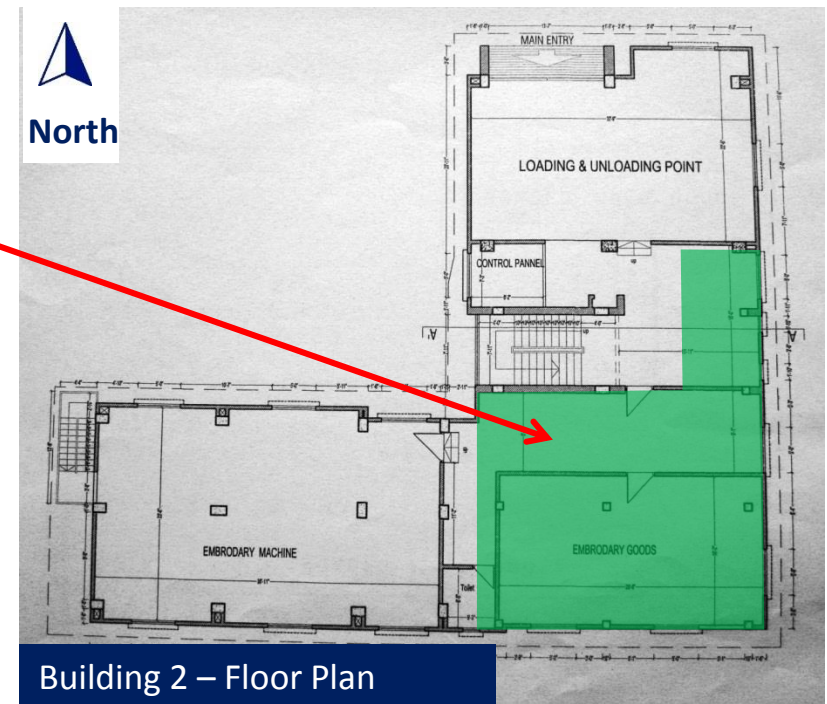
We do have important and urgent concerns in relation to Building 2 and Building 1. Columns within Building 2 appear to be stressed to levels that require immediate review. In addition, columns within Building 1 are stressed in excess of the normal design limits and a significant number of discrepancies are evident between the drawings and the as-built structure. Detail Engineering Assessments for Building 2 and Building 1 should be carried out immediately to the requirements of the scope attached and addressing the concerns as noted within this report and this needs to be addressed immediately and completed within 6 weeks of receiving this report. In addition, the following **immediate action in relation to Building 2** is required:

If the building owners are not in a position to complete this action immediately, the factory building should be re-classified as **Category Red** and evacuated in its entirety.

**Immediate Action;**  
Imposed loading in the area highlighted, including personnel, equipment and storage loads, is to be cleared at all floor levels with immediate effect.

| Item No. | Observation | Recommended Action Plan | Recommended Timeline |
|---|---|---|---|
| 1 | Columns in Building 2 appear to be stressed to a high level and require review including immediate action as detailed on page 4 of this report and preparation of a Detail Engineering Assessment | Area of Building 2 highlighted on page 4 of this report to be immediately cleared of all personnel, equipment and storage at all floor levels. | <b>Immediate - Now</b> |

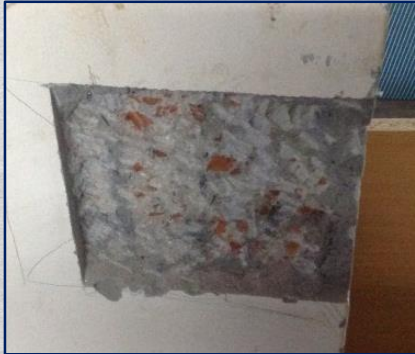
Tested Column

Cursory calculations indicate that the working stress in the columns of Building 2 is at a level which requires immediate review. **Area of Building 2 to be vacated immediately (Refer to Page 4 of this report)** and Detail Engineering Assessment required.

| Item No. | Observation | Recommended Action Plan | Recommended Timeline |
|---|---|---|---|
| 2 | Columns in Building 2 appear to be stressed to a high level and require review including immediate action as detailed on page 4 of this report and preparation of a Detail Engineering Assessment | Engage a Building Engineer to review design, loads and column stresses in all columns in Building 2. | <b>Immediate - Now</b> |
| 3 | Columns in Building 2 appear to be stressed to a high level and require review including immediate action as detailed on page 4 of this report and preparation of a Detail Engineering Assessment | Building Engineer to verify insitu concrete stresses either by 100mm diameter cores or existing cylinder strength data for cores from 4 columns, and to verify steel reinforcement and grade of reinforcement used. | <b>Immediate - Now</b> |

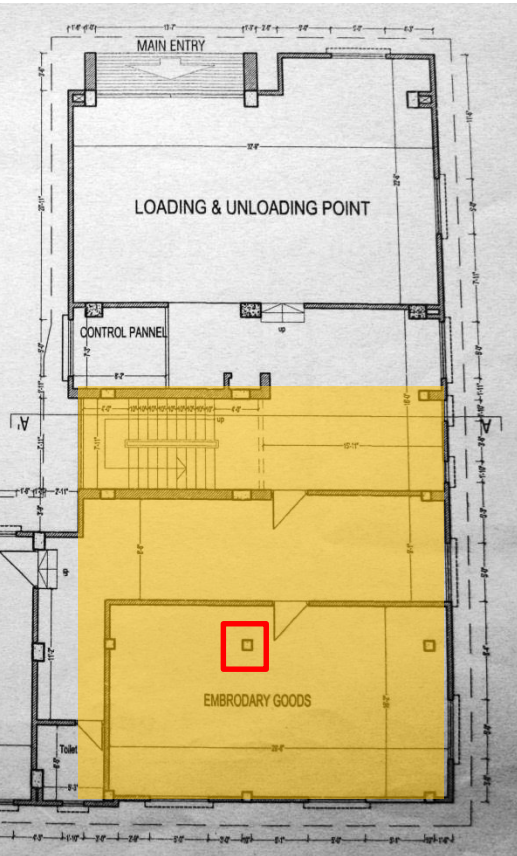
Building 2 – Ground Floor Plan

- Construction of Building 2 commenced in November 2006 and was completed in February 2009.
- Building 2 is built around and above an existing single-storey structure.
- Other than strengthening works to the four stair core columns and foundations, there is no information – structural or other – relating to the original building.
- The year of construction of the original building is not known.
- Brick aggregate was noted in the Ground Floor columns.
- Four steel reinforcement bars (two per face) were observed at ground floor level using the ferros scanner.
- There is a discrepancy between the structural drawings and the constructed building in relation to the footprint of the building above the original building.

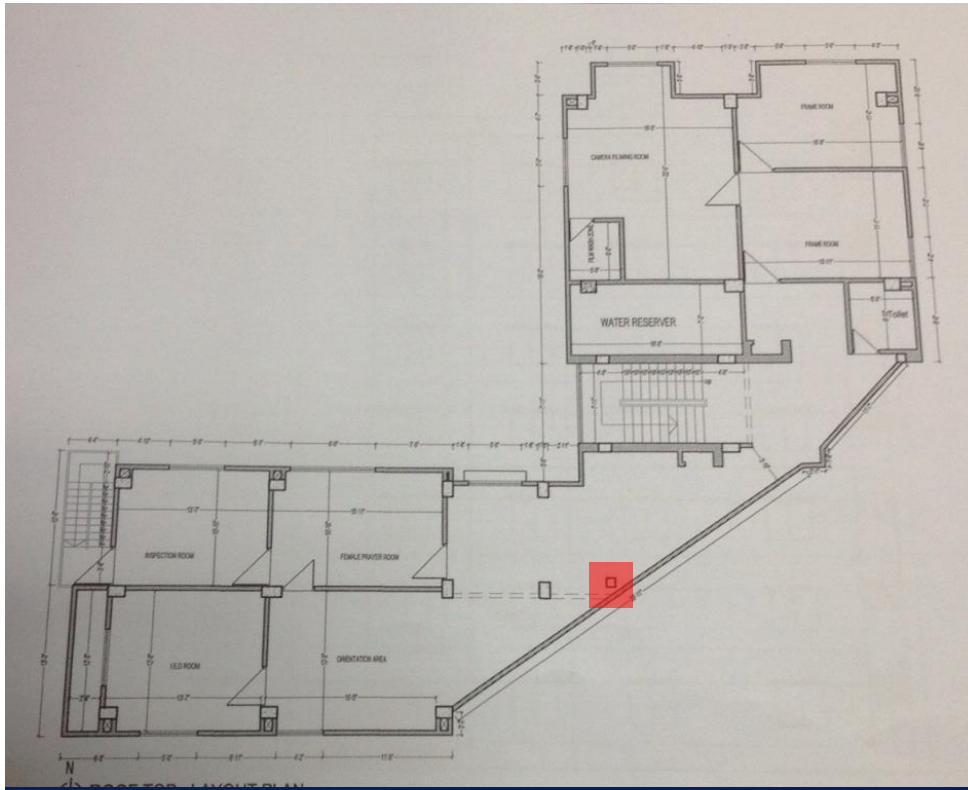
Building 2 – 6<sup>th</sup> Floor Plan

There are concerns over the structural adequacy of the columns in Building 2, particularly at the upper floor levels. Detail Engineering Assessment required.

| Item No. | Observation | Recommended Action Plan | Recommended Timeline |
|---|---|---|---|
| 12 | Concerns over the structural adequacy of the columns in Building 2, particularly at 5th and 6th Floor levels – due to possible use of brick at upper column level | Building Engineer to review all columns, including an inspection of the completed construction, as part of the Detail Engineering Assessment (refer to Item 1) and to prepare a schedule of remedial works, as required. | <b>Immediate - Now</b> |

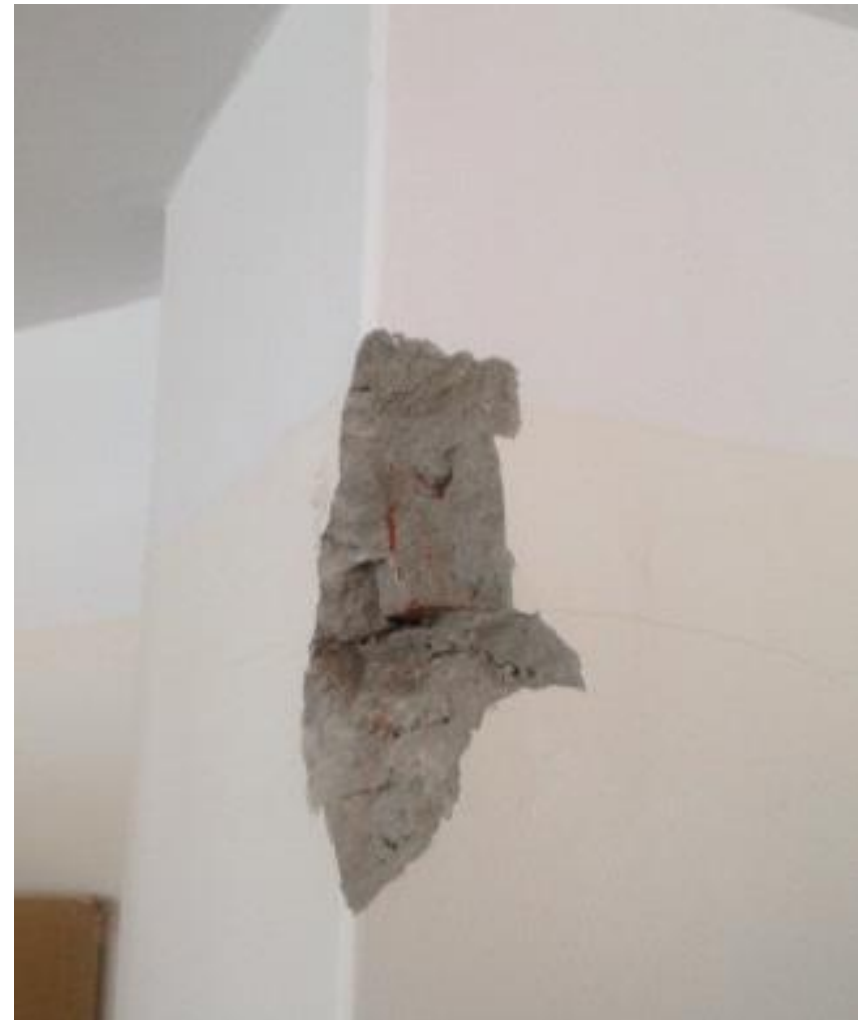
Exposed Column G.L. E / 2

Hairline cracks were noted to column head. This prompted the removal of plaster, which appeared to reveal the concrete column finishing approximately 500mm short of the slab and bricks used thereafter.

| Item No. | Observation | Recommended Action Plan | Recommended Timeline |
|---|---|---|---|
| 13 | Concerns over the structural adequacy of the columns in Building 2, particularly at 5th and 6th Floor levels – due to possible use of brick at upper column level | Detailed Engineering Assessment to be completed. | <b>6-weeks</b> |
| 14 | Concerns over the structural adequacy of the columns in Building 2, particularly at 5th and 6th Floor levels – due to possible use of brick at upper column level | Building Engineer to implement any actions / supervise any remedial works as identified following the review. | <b>6-weeks</b> |

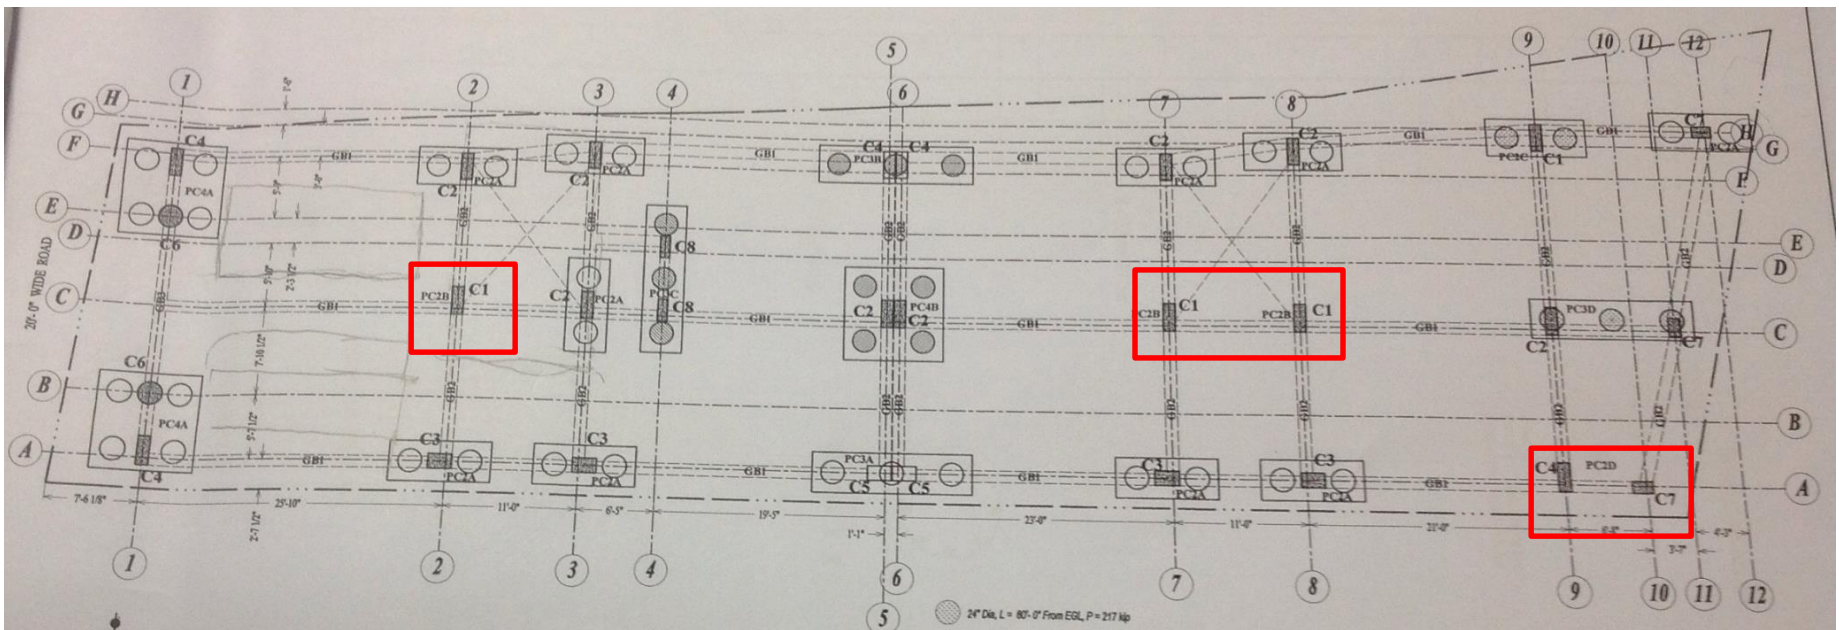
Building 1 – Piled Foundation Layout Plan

Foundations missing at key column locations. Supporting documentation for a transfer structure below Ground level which spans between adjacent foundations, as suggested by Engr. Md. Ali Hossain Majumder, was not provided.

| Item No. | Observation | Recommended Action Plan | Recommended Timeline |
|---|---|---|---|
| 15 | Detail Engineering Assessment required due to missing or incorrect design documentation for Buildings 1 and 2 | A Detail Engineering Assessment (DEA) of the as-constructed Building 1 and Building 2 (refer to Item 1) is to be commenced, see attached Scope. The DEA's should address all areas where drawings provided differ to the as constructed buildings. | <b>Immediate - Now</b> |

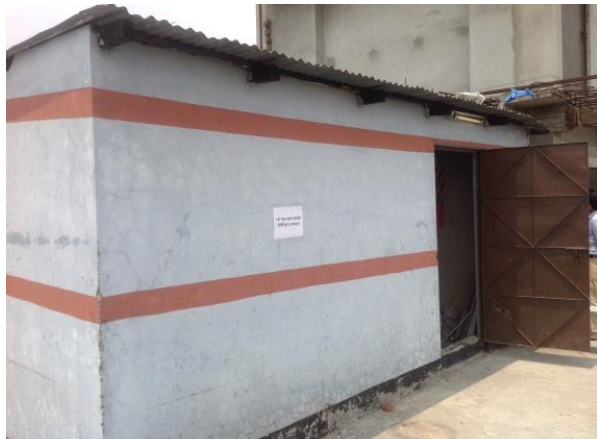
- Two maintenance rooms, which occupy approximately 25% of the Roof area of Building 1, are not shown on the structural drawings;
- There are no structural drawings for the Mezzanine floor above Ground Floor level, which occupies approximately 70% of the footprint of Building 1 – it is not clear how the load is transferred to foundations;

Maintenance Room to West of Building 1 at Roof level

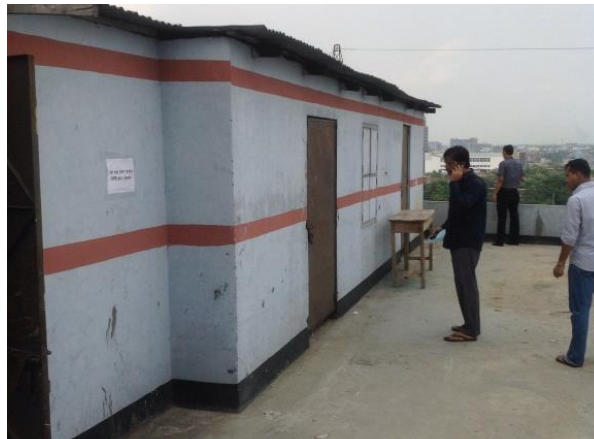
Maintenance Room to East of Building 1 at Roof level

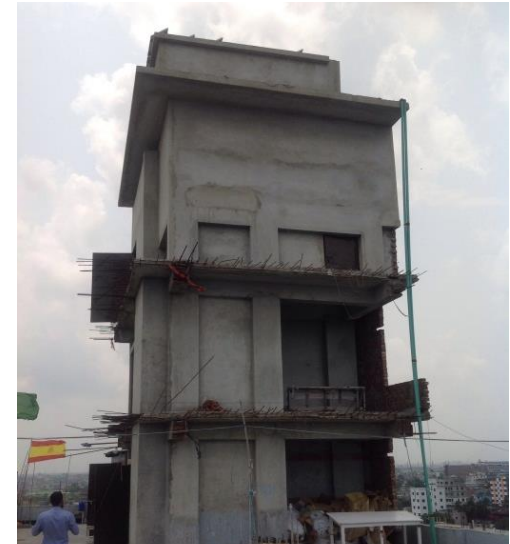
- The stair / lift core to the western-half of Building 1 extends three storeys above the existing Roof level – this is not shown on the structural drawings;

Two additional floors to stair core to West of Building 1

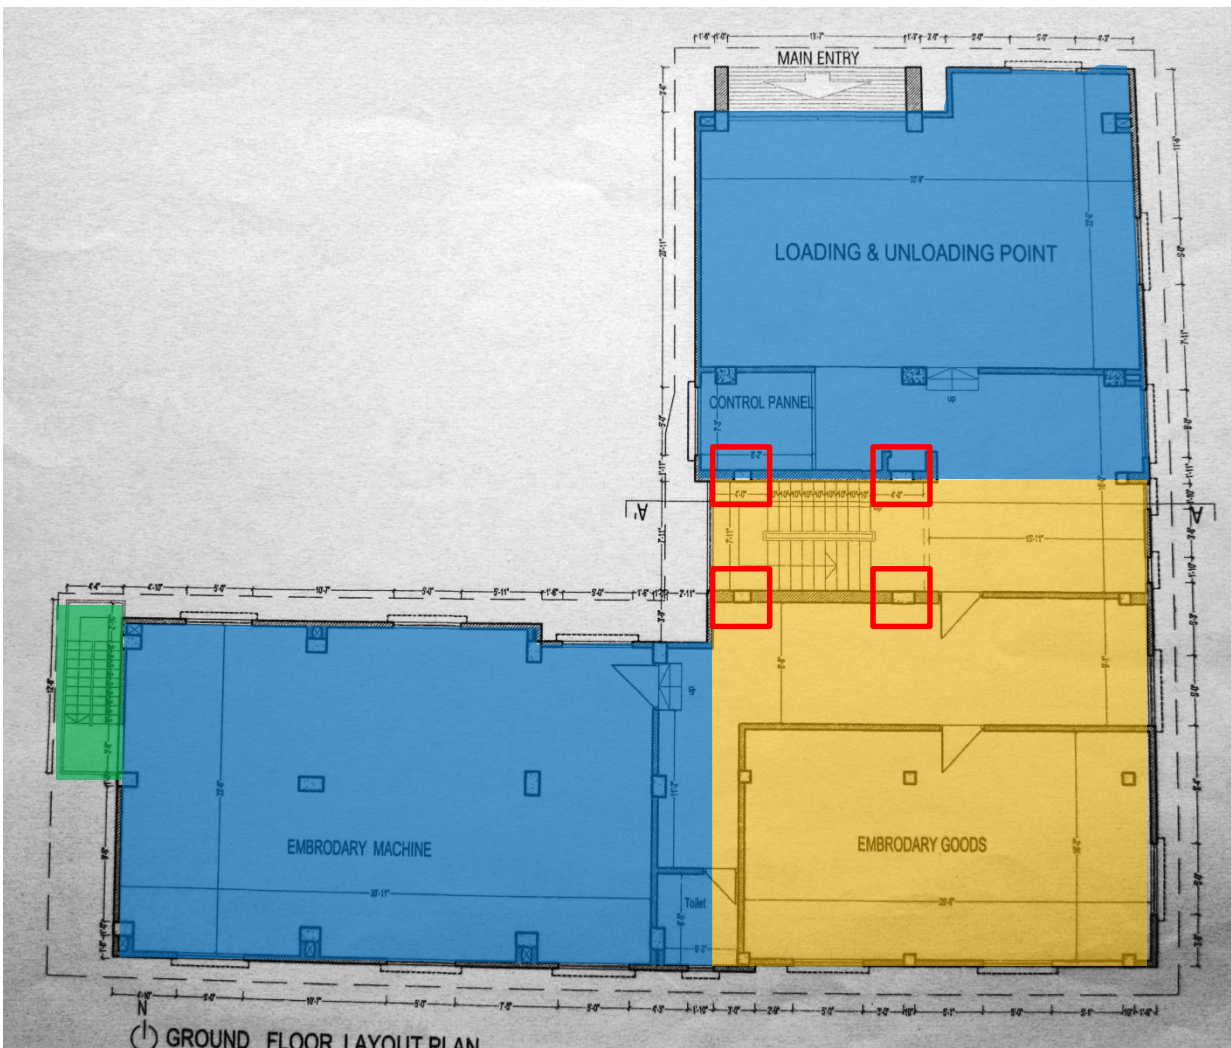
Building 2 – Typical Floor Plan

- Original single-storey building on and around which Building 2 is built
- New sections to the North and West of the original building which now comprise Building 2
- Columns and foundations to original stair core which have undergone strengthening works – shown on drawings
- Non-constructed escape stair

There is no information on the structural drawings about the single-storey original building, highlighted above, around and above which Building 2 is built, other than strengthening works to the four stair core columns and foundations. It is not clear why all columns and foundations in the existing single storey building were not strengthened.

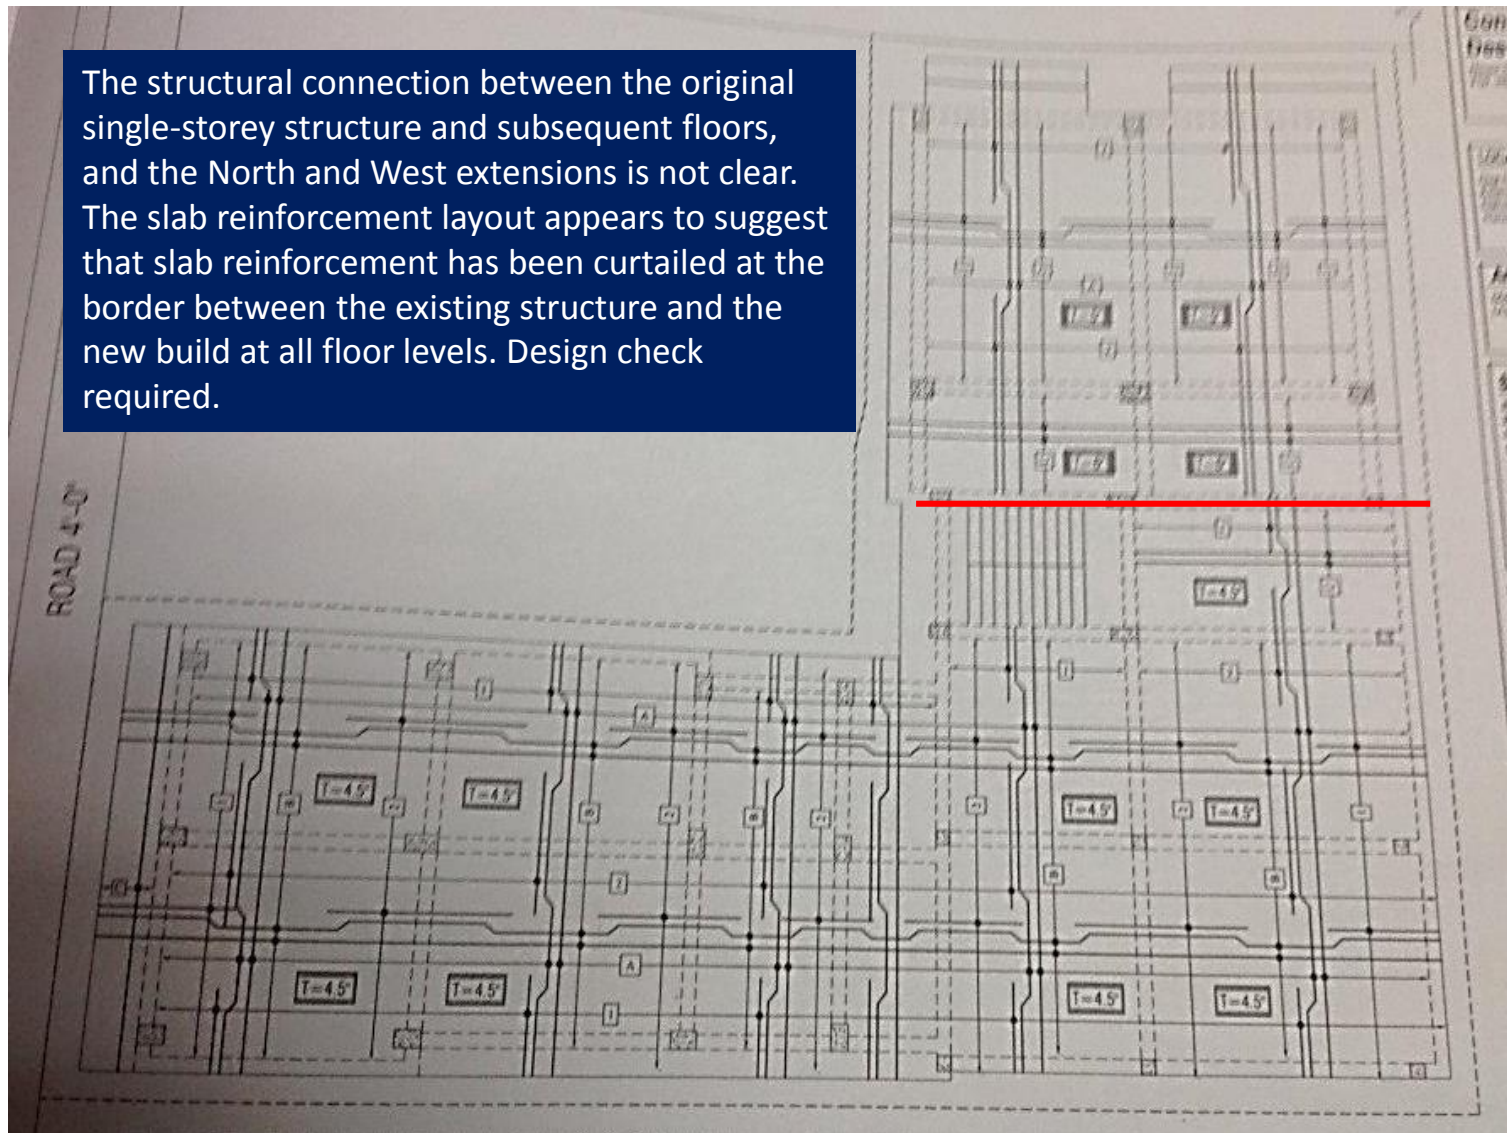
Building 2 – Slab reinforcement layout for 1<sup>st</sup>, 2<sup>nd</sup> & 3<sup>rd</sup> Floor levels

The structural connection between the original single-storey structure and subsequent floors, and the North and West extensions is not clear. The slab reinforcement layout appears to suggest that slab reinforcement has been curtailed at the border between the existing structure and the new build at all floor levels. Design check required.

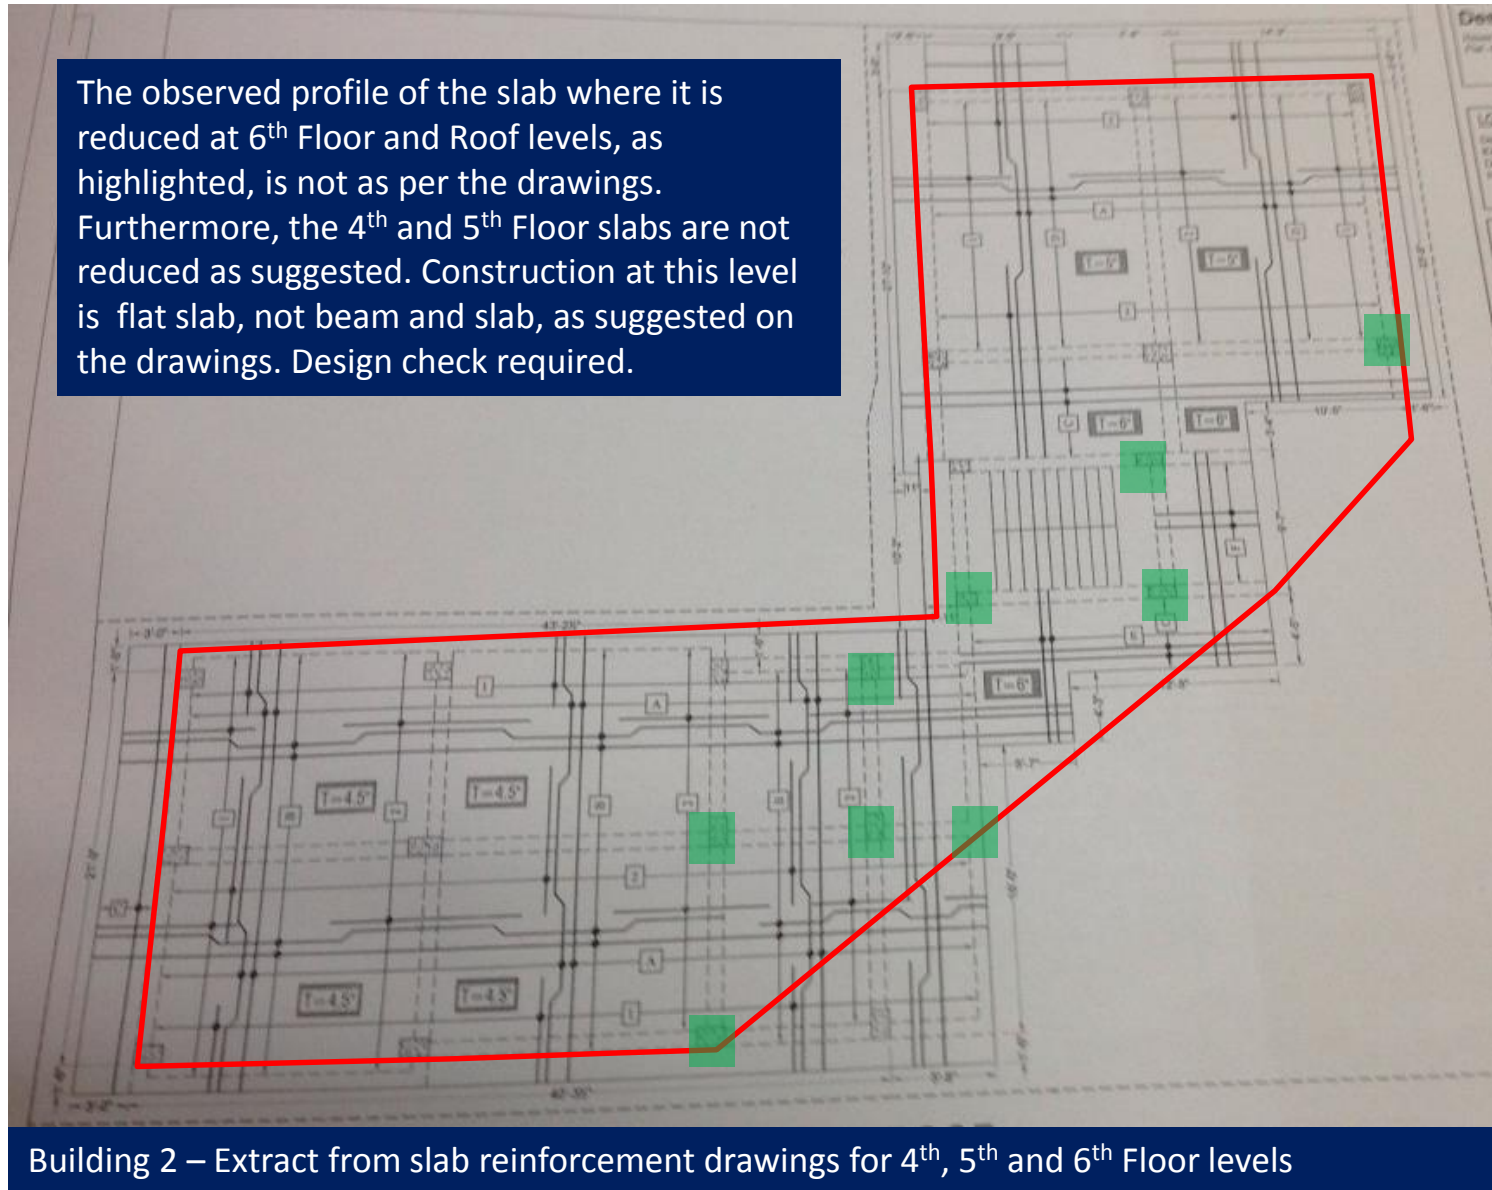
Actual slab footprint at 6<sup>th</sup> Floor & Roof

The observed profile of the slab where it is reduced at 6<sup>th</sup> Floor and Roof levels, as highlighted, is not as per the drawings. Furthermore, the 4<sup>th</sup> and 5<sup>th</sup> Floor slabs are not reduced as suggested. Construction at this level is flat slab, not beam and slab, as suggested on the drawings. Design check required.

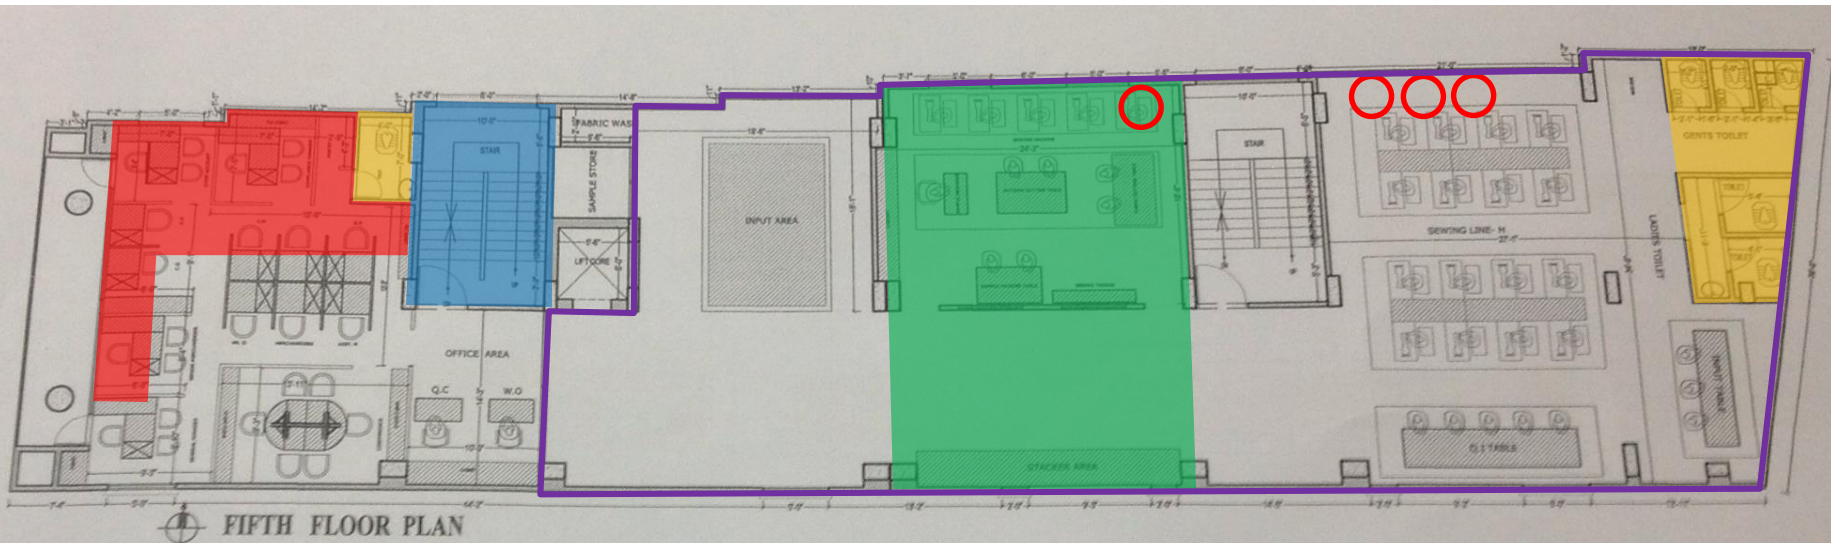
Building 1 – Typical Floor Plan

Heavy loading was observed in the fabric storage area at 1<sup>st</sup> Floor level of Building 2. Further areas of high loading were noted at the water tanks at roof level and 6<sup>th</sup> floor level of Buildings 1 and 2, respectively, and at the storage areas to Mezzanine and 7<sup>th</sup> floor levels of Building 1 and to 5<sup>th</sup> and 6<sup>th</sup> Floor levels of Building 2.

| Item No. | Observation | Recommended Action Plan | Recommended Timeline |
|---|---|---|---|
| 20 | Heavy floor loading and lack of loading plans for Buildings 1 and 2.<br>Refer to Items 1 & 4 which require preparation of Detail Engineering Assessments for Buildings 1 and 2 | Building Engineer to review loading in the yarn store, temporary storage areas, water tanks and toilet floor build-up, and to check that the different floor constructions have been adequately designed to accommodate these loadings. Note; this design check to be carried out as part of the Detail Engineering Assessments. | 6-weeks |

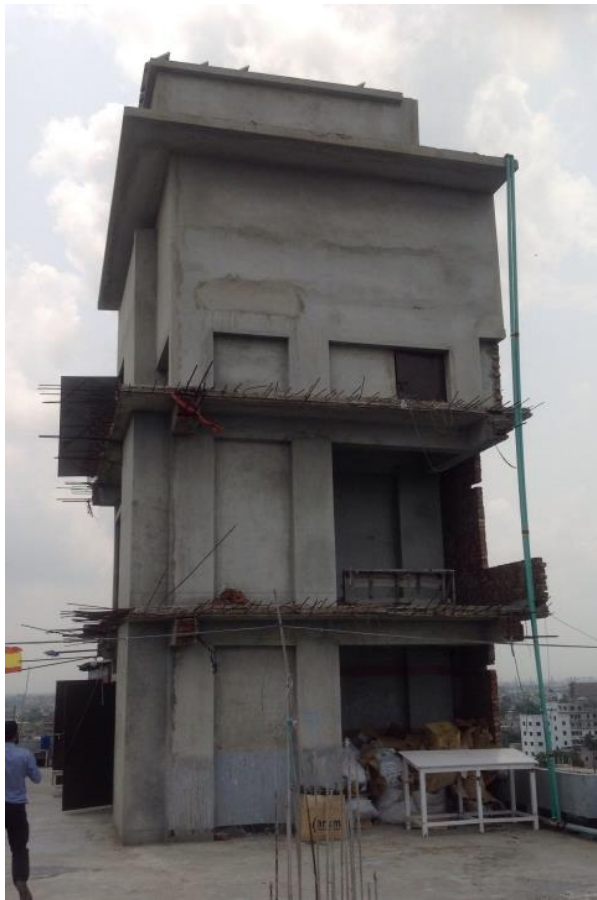
Water tank above stair core of Building 1

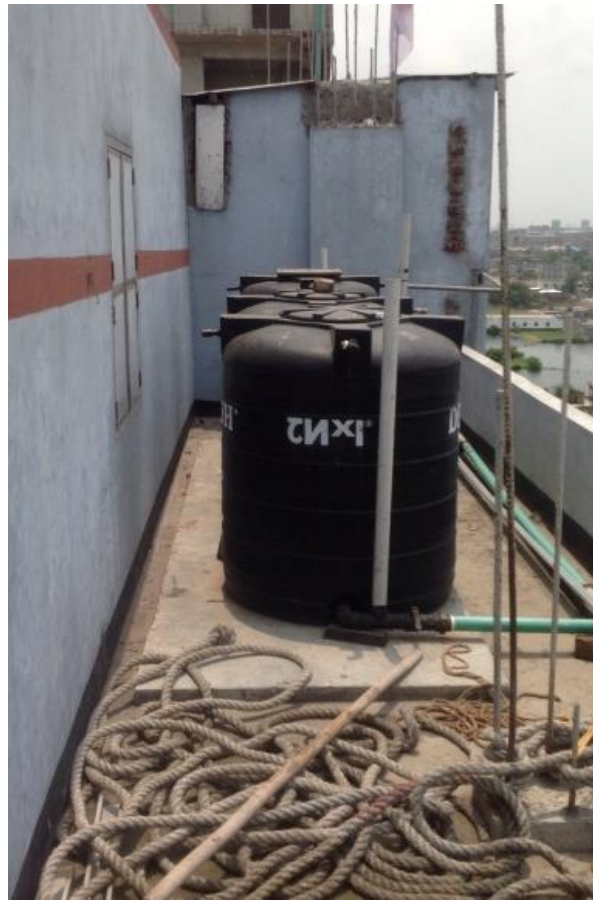
1000L capacity Gazi water tanks to Roof of Building 1

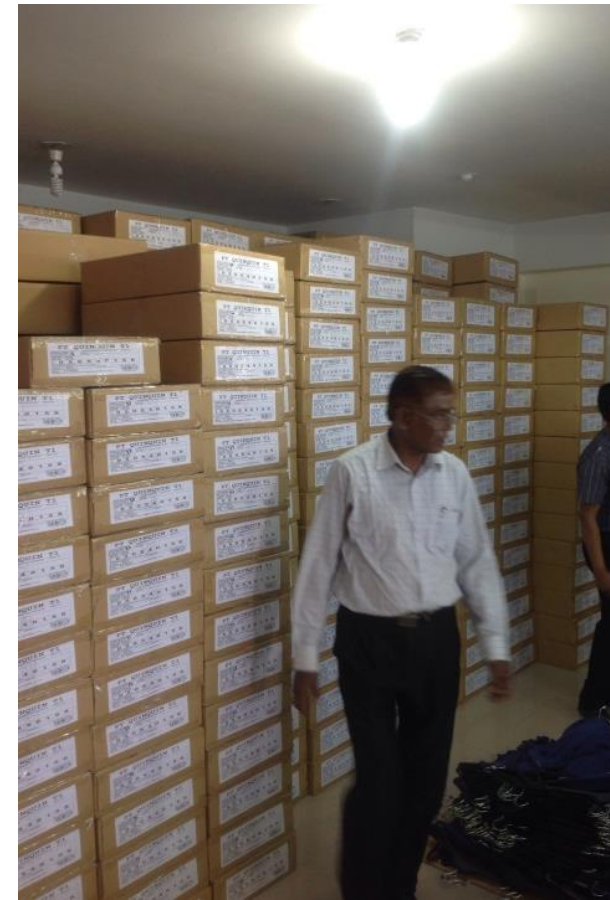
Finished Goods Store to 7<sup>th</sup> Floor of Building 1

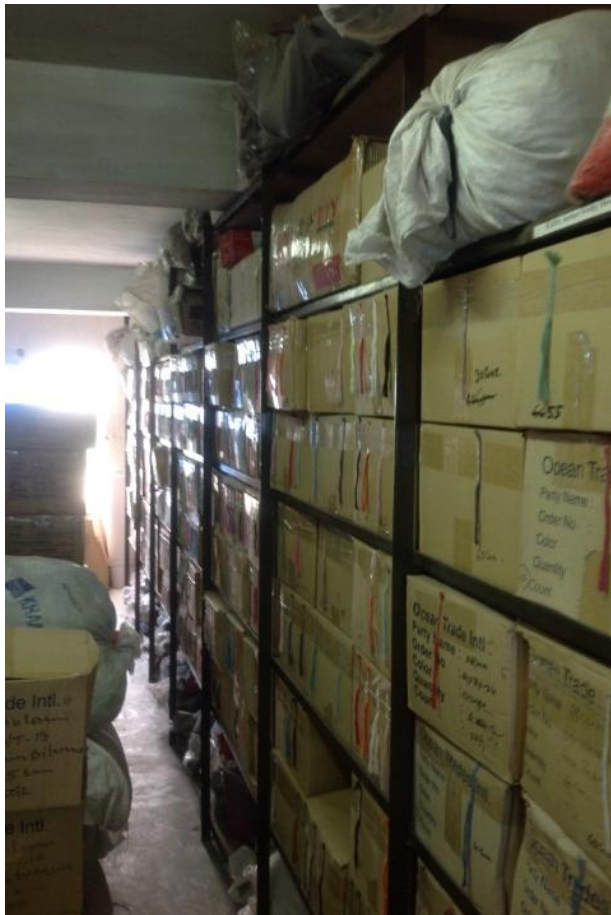
Accessories Store to 7<sup>th</sup> Floor of Building 1

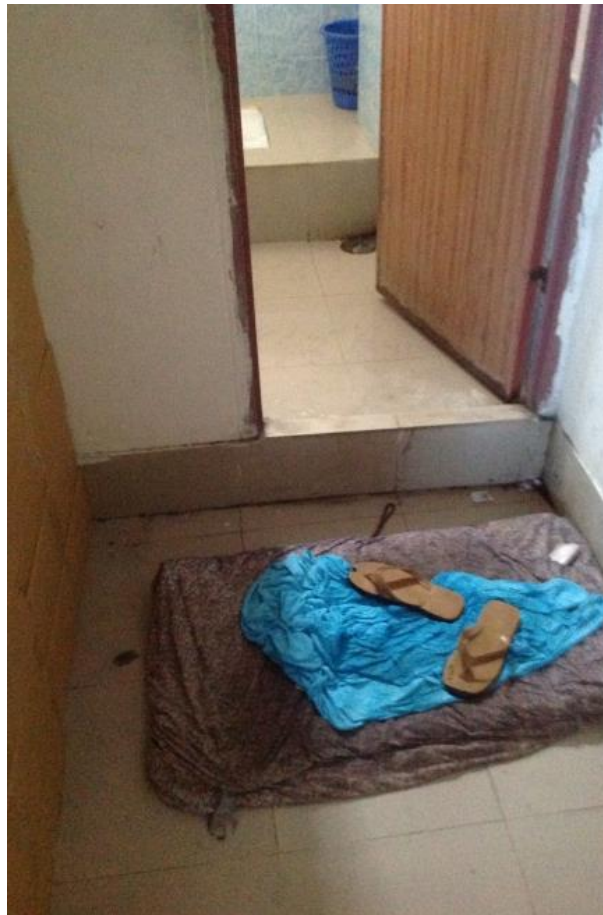
Toilet floor build-up to all floors of Building 1

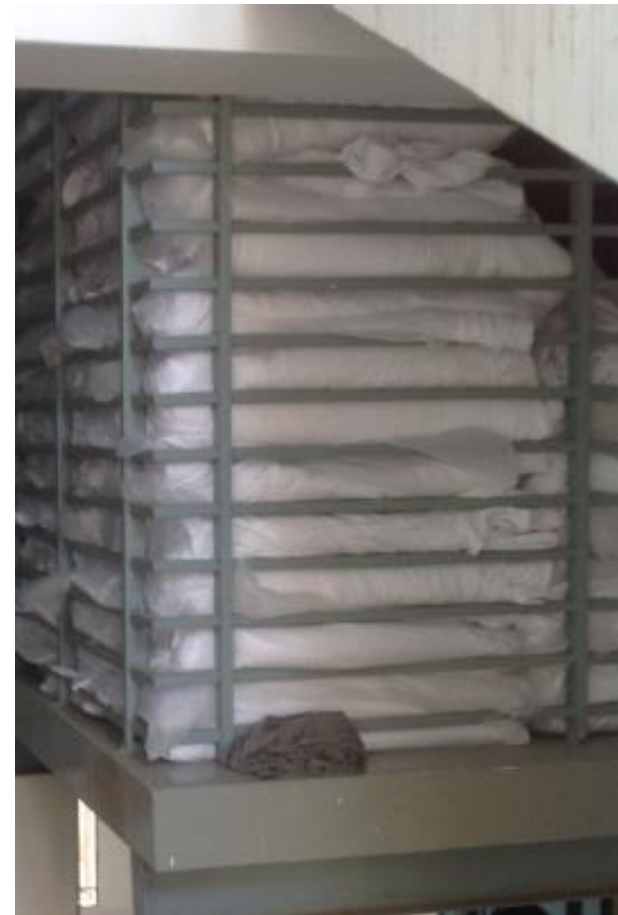
Fabric Storage to Mezzanine Floor of Building 1

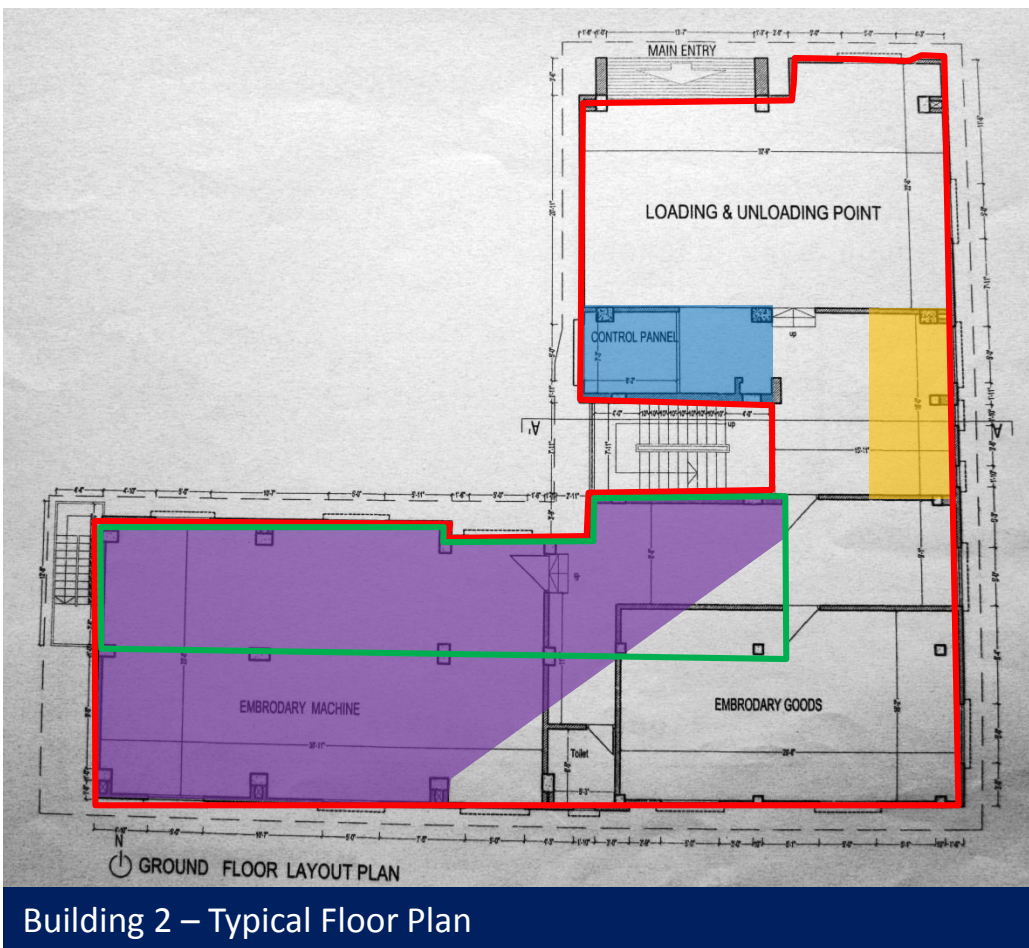
Building 2 – Typical Floor Plan

- 2m high RC water tank adjacent to stair core of Building 2
- Storage area at 6<sup>th</sup> Floor of Building 2
- Storage area at 5<sup>th</sup> Floor of Building 2
- 315mm average toilet floor build-up at 2<sup>nd</sup>, 3<sup>rd</sup>, 4<sup>th</sup> and 5<sup>th</sup> floor levels of Building 2
- Outline of Yarn Storage at 1<sup>st</sup> Floor of Building 2

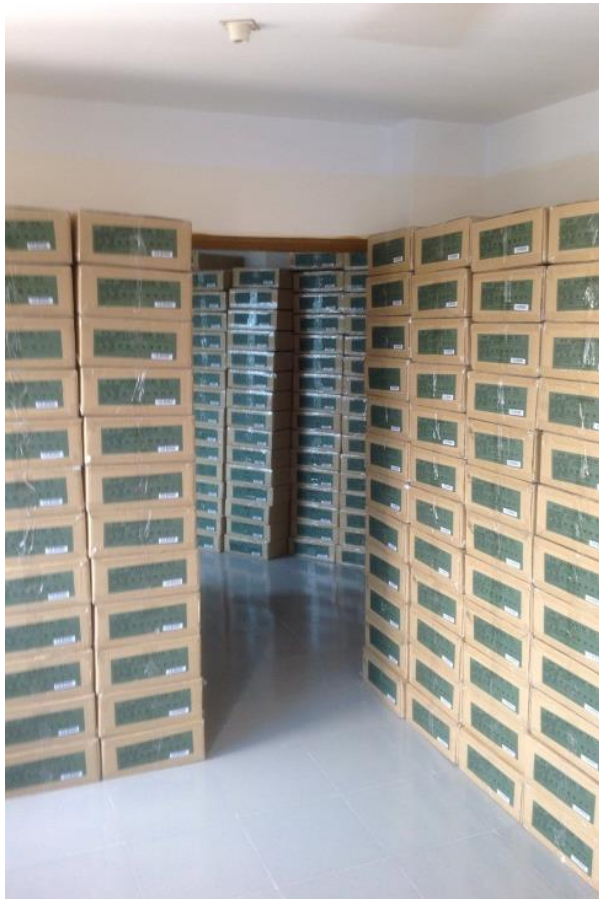
Storage area at 6<sup>th</sup> Floor of Building 2

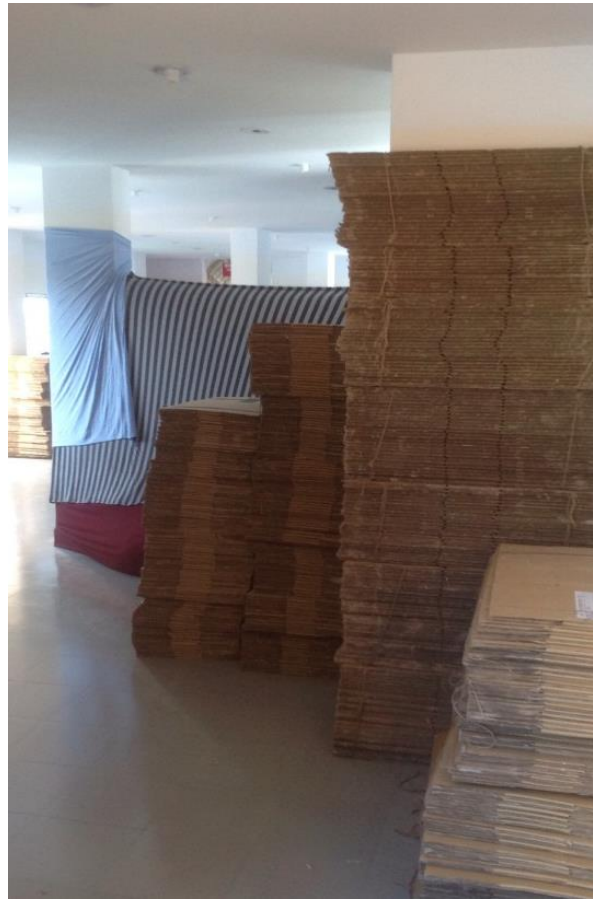
Storage area at 5<sup>th</sup> Floor of Building 2

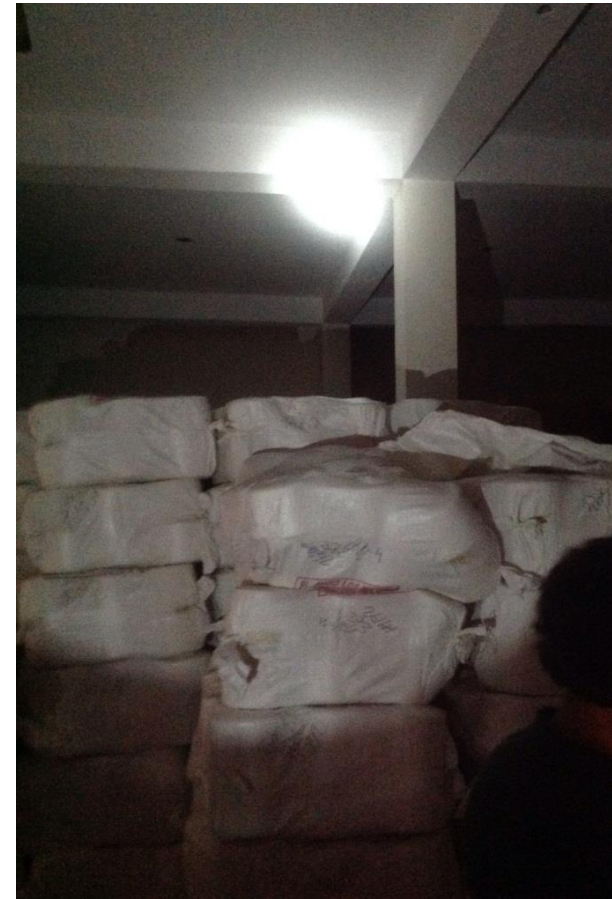
Yarn Store at 1<sup>st</sup> Floor of Building 2

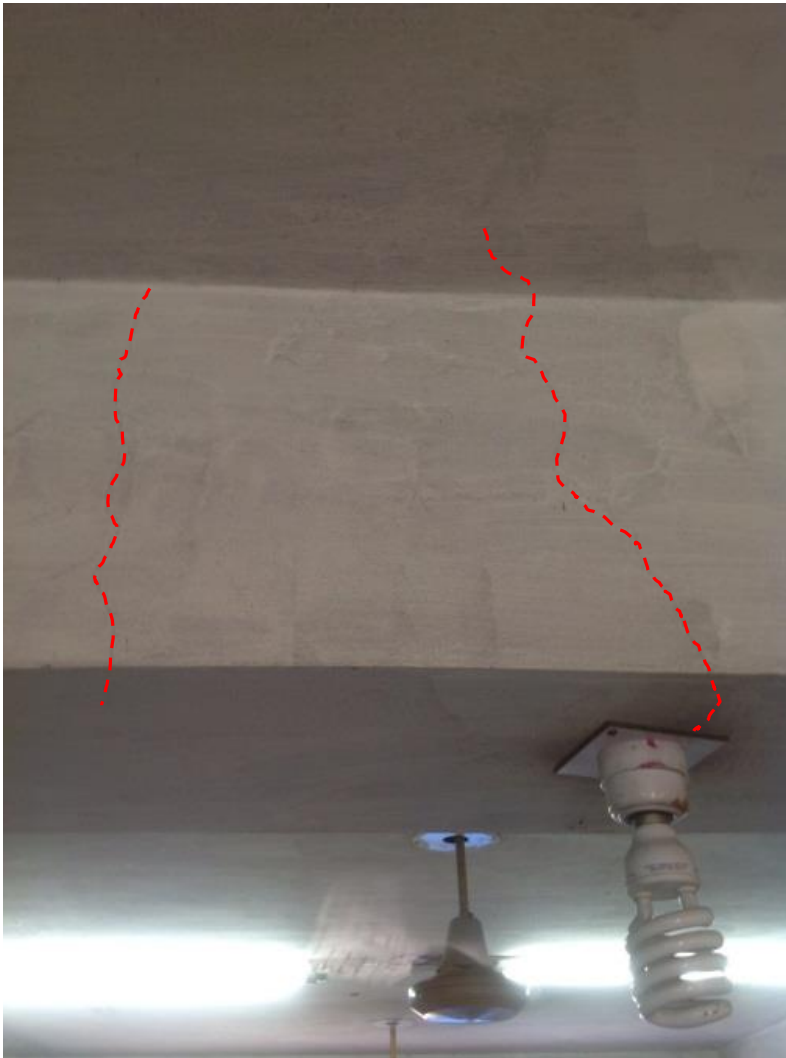
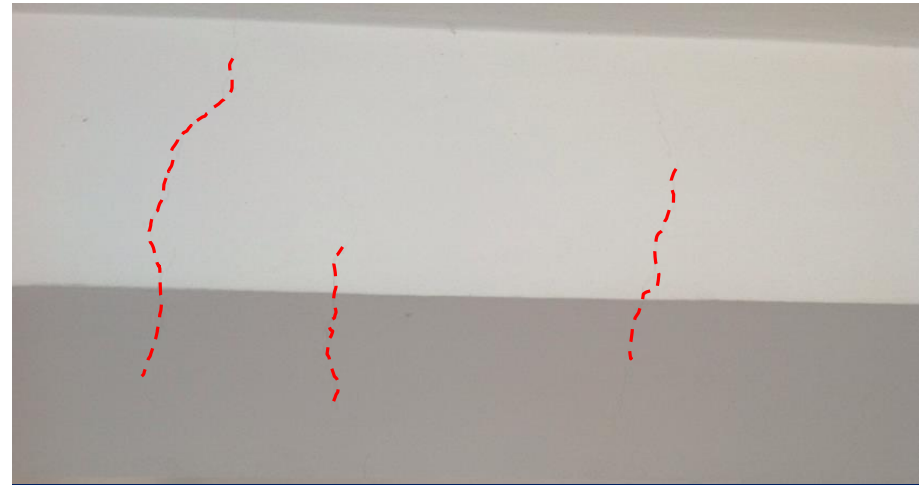
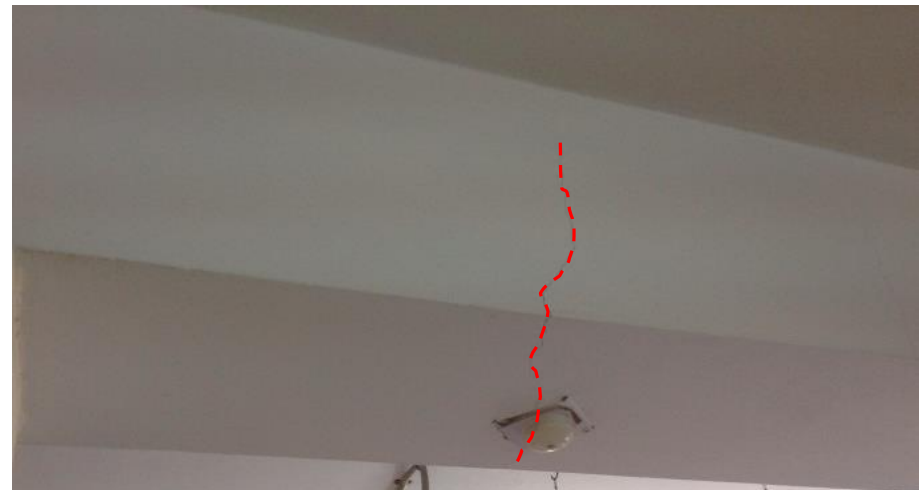
Hairline cracking was observed to a number of beam edges and soffits at most floor levels of Building 1. It is not clear whether the cracking extends to the concrete.

Hairline cracking to beam edges and soffits

| Item No. | Observation | Recommended Action Plan | Recommended Timeline |
|---|---|---|---|
| 22 | Hairline cracking to soffit of beams in Building 1 | Building Engineer to investigate if cracks are only in the plastering. | 6-weeks |
| 23 | Hairline cracking to soffit of beams in Building 1 | Design check of beams to be carried out as part of the Detail Engineering Assessment. | 6-weeks |
| 24 | Hairline cracking to soffit of beams in Building 1 | Building Engineer to advise on load reduction and repair and strengthening of the beams if required. Cracks to be monitored on an on-going basis. | 6-months |

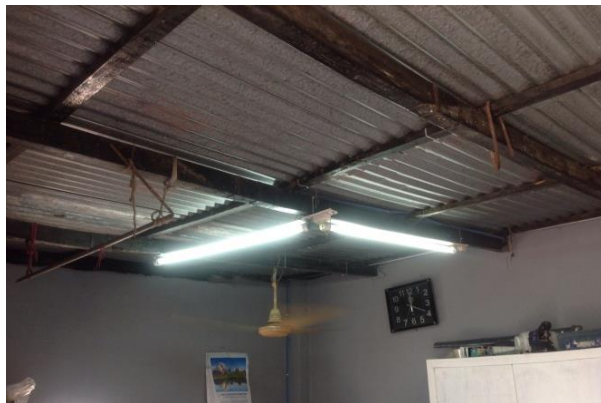
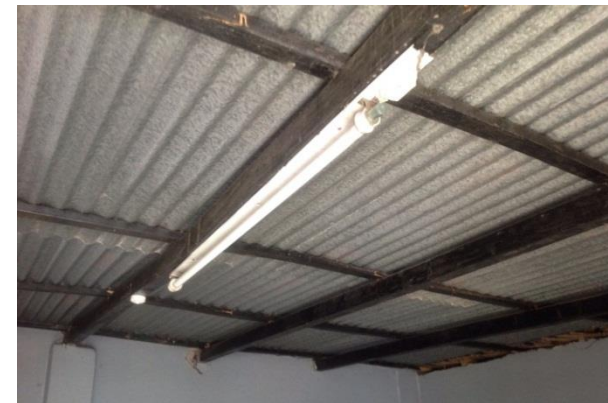
There are a number of lightweight roof structures, located at the Maintenance Rooms and the eastern stair core of Building 1. These appear to be non-engineered and may not be adequate to resist design uplift forces and lateral loads.

Roof to Maintenance Room

| Item No. | Observation | Recommended Action Plan | Recommended Timeline |
|---|---|---|---|
| 25 | Apparently non-engineered roof structures on roof of Building 1 | Engage a Building Engineer to review the design of the lightweight roof structures noted above, and confirm adequacy to withstand wind loading pressure, suctions and uplift forces, including connections and bracing. | 6-weeks |
| 26 | Apparently non-engineered roof structures on roof of Building 1 | Building Engineer to implement any actions / supervise any remedial works as identified following the review. | 6-months |

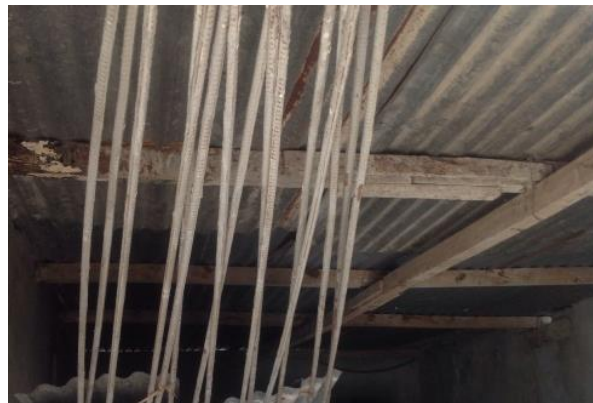
Lightweight roof to stair core
