# **Radiance Fashion Ltd. Radiance Jeans Ltd. Pearls and Pouce Ltd.**

Khajur Bagan, Ashulia, Savar, Dhaka

15<sup>th</sup> March 2014

# Observations

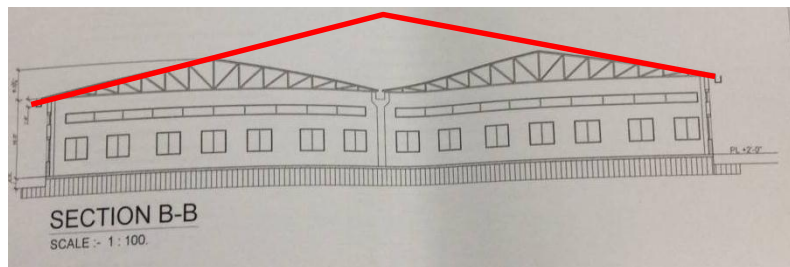
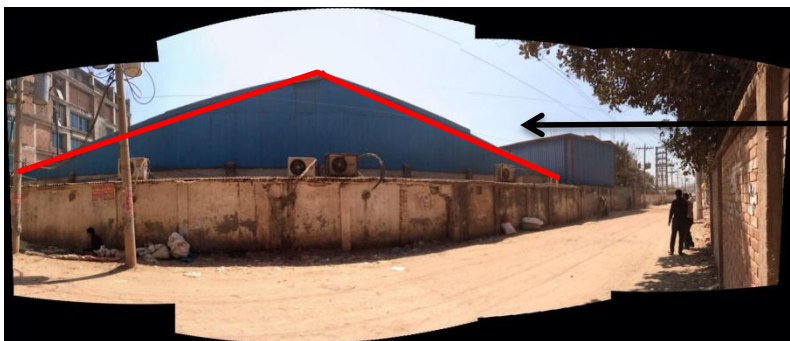
**Drawings do not match as-built: steel roof**

Lack of in-plane roof bracing

Different shape of roof to that shown on drawings

The drawings do not match the as built structure most notably for the roof structure. The roof structure as built has twice the height of the roof shown in the drawings. We were unable to see an obvious bracing system or adequate tying down details.

| Item No. | Observation | Recommended Action Plan | Recommended Timeline |
|---|---|---|---|
| 1 | BUILDING 1<br>Structural Steelwork Detailing on the main roof | Building engineer to check the structures and propose additional reinforcements and stability system, if required | 6-months |

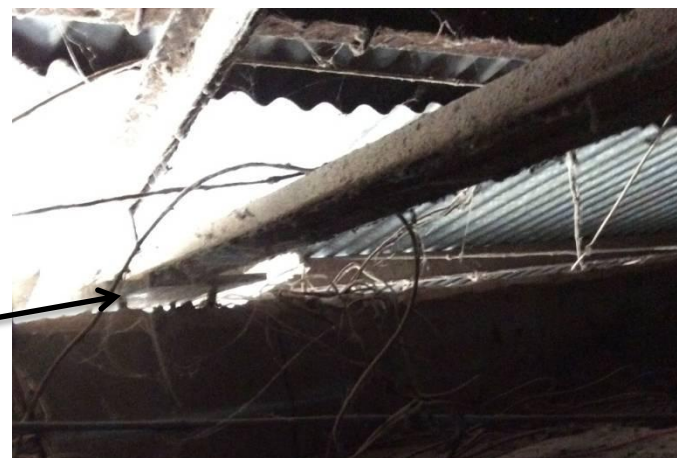
Lack of adequate tying down detail

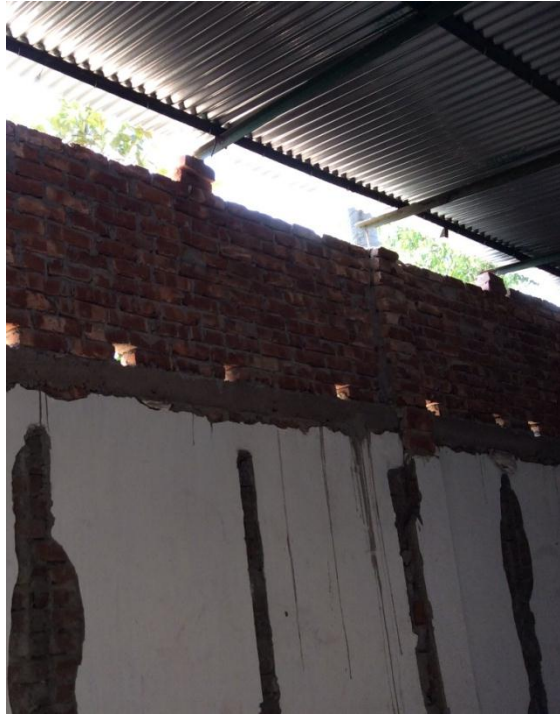
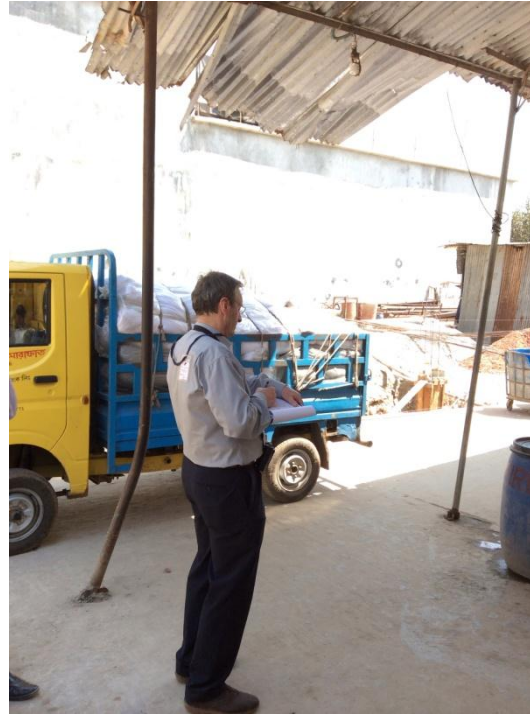
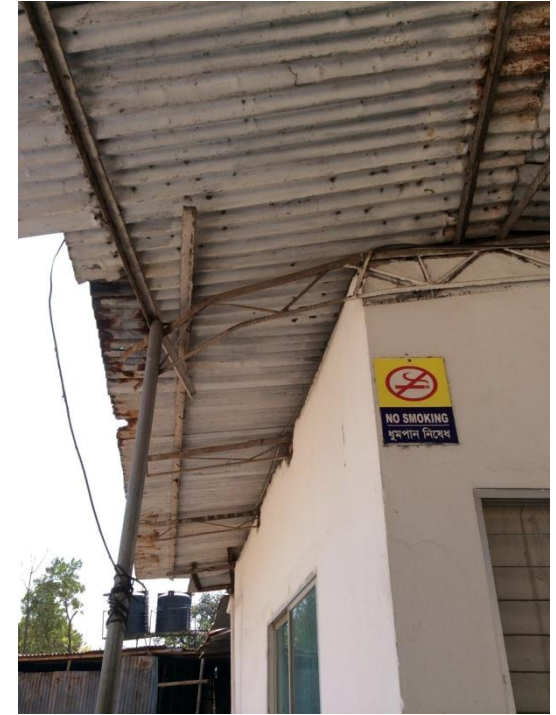
Various structures appear non-engineered and possibly unstable including tall unrestrained masonry walls, slender makeshift columns near to trafficked areas etc

| Item No. | Observation | Recommended Action Plan | Recommended Timeline |
|---|---|---|---|
| 2 | BUILDING 1<br>Non Engineered Steelwork to ancillary buildings | Building engineer to check the structures and propose additional reinforcements and stability system, if required | 6-months |

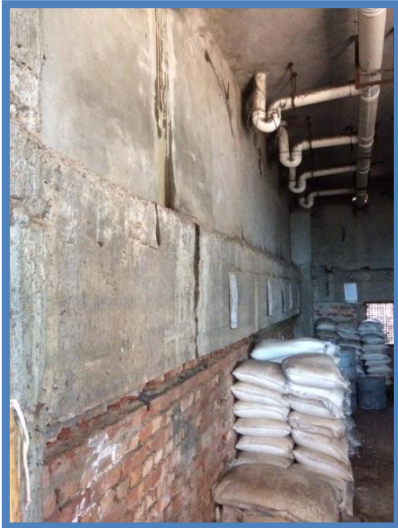
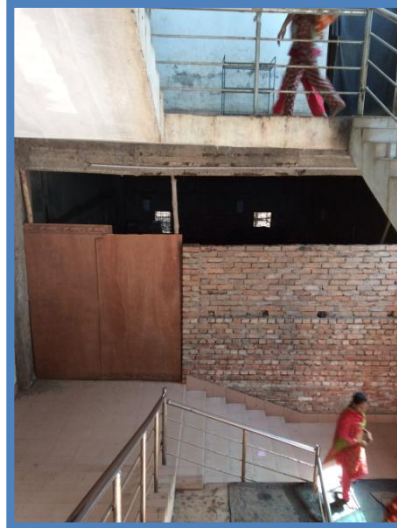
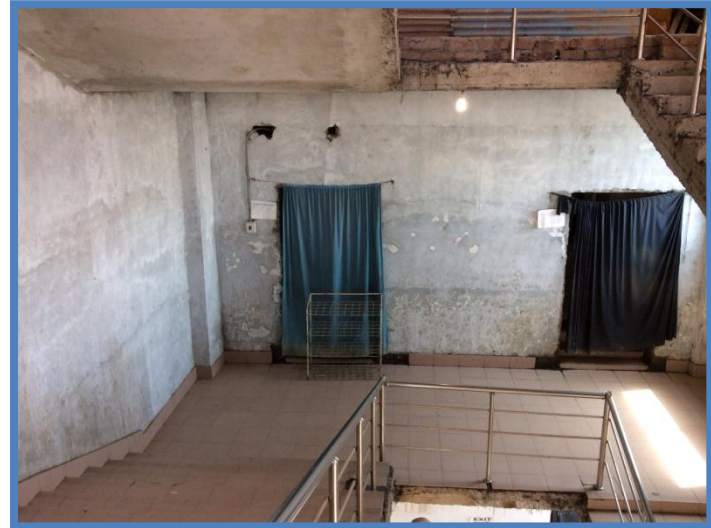
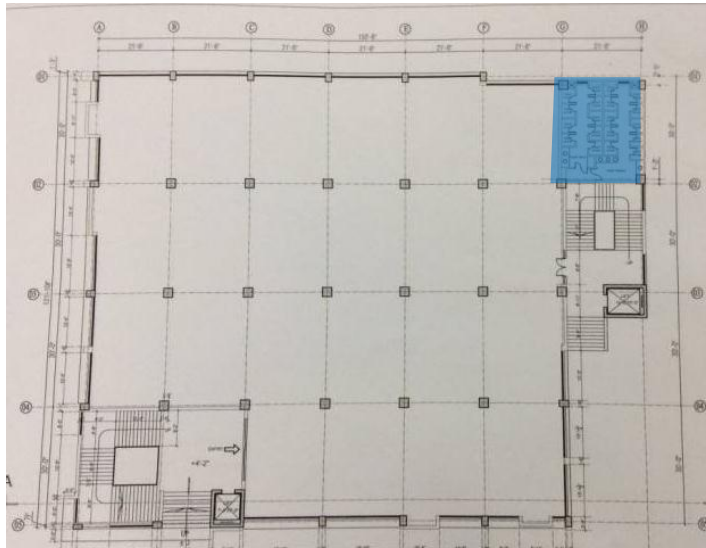
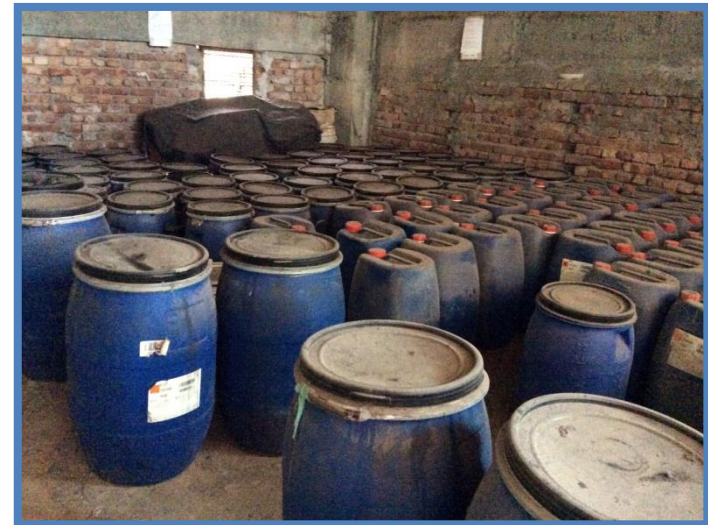
**High loading from storage and toilets on half landing structure**

Heavy toilet build-up or storage in this half-landing location on most floors

| Item No. | Observation | Recommended Action Plan | Recommended Timeline |
|---|---|---|---|
| 3 | BUILDING 2<br>Storage and Toilet Loading at Intermediate Levels between Floors | Produce and actively manage a loading plan for all floor plates within the factory and Roof, giving consideration to floor capacity and column capacity. | 6-months |

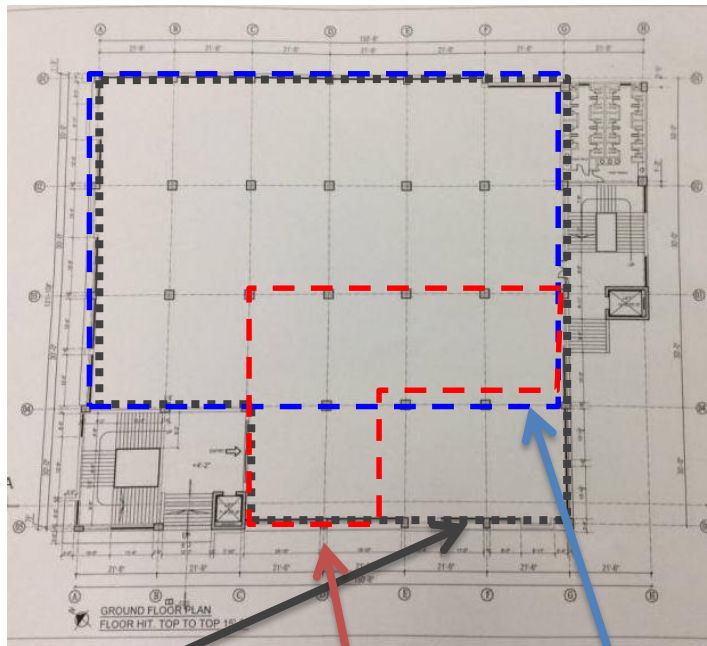
L1  
storage

High live loads arising from apparently uncontrolled storage loads. Selected examples shown below. Loading plans (i.e. plan and height restrictions) to be introduced to prevent future overloading – to be developed by building engineer

Storage areas occur throughout the floor plate on L1 and L4 and in localised areas on L3

| Item No. | Observation | Recommended Action Plan | Recommended Timeline |
|---|---|---|---|
| 4 | BUILDING 2<br>Storage Loading at L1, L3 and L4 | Produce and actively manage a loading plan for all floor plates within the factory, giving consideration to floor capacity and column capacity. | 6-months |

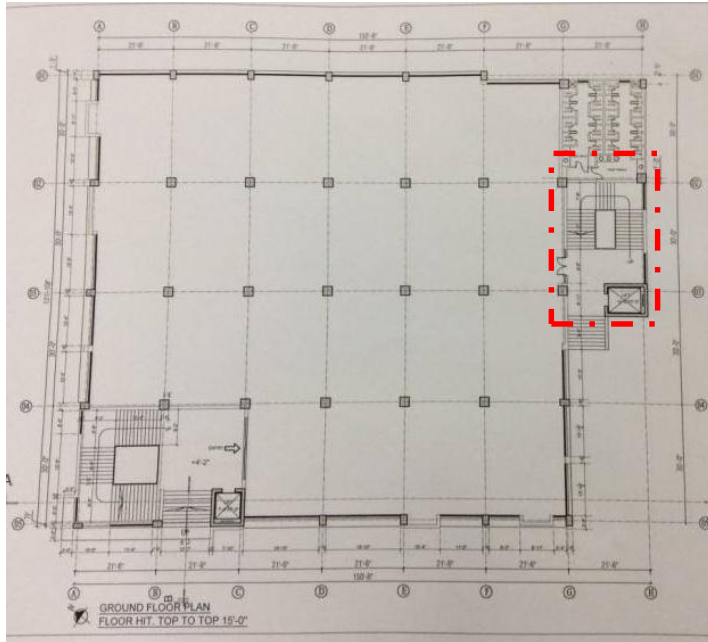
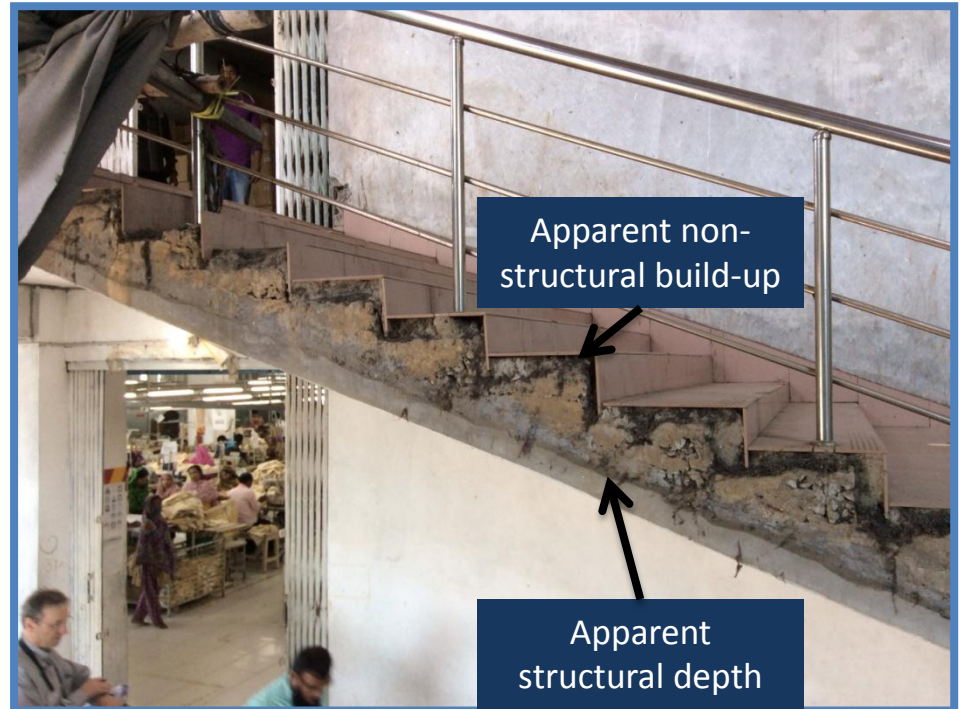
High dead loads arising from thick non-structural build-up on stairs.  
Level of non-structural dead loading and actual structural depth of stair waists to be checked by building engineer

| Item No. | Observation | Recommended Action Plan | Recommended Timeline |
|---|---|---|---|
| 5 | BUILDING 2<br>Non Structural Build up on Stairs. | Building engineer to check the structures and propose additional reinforcements, if required | 6-months |

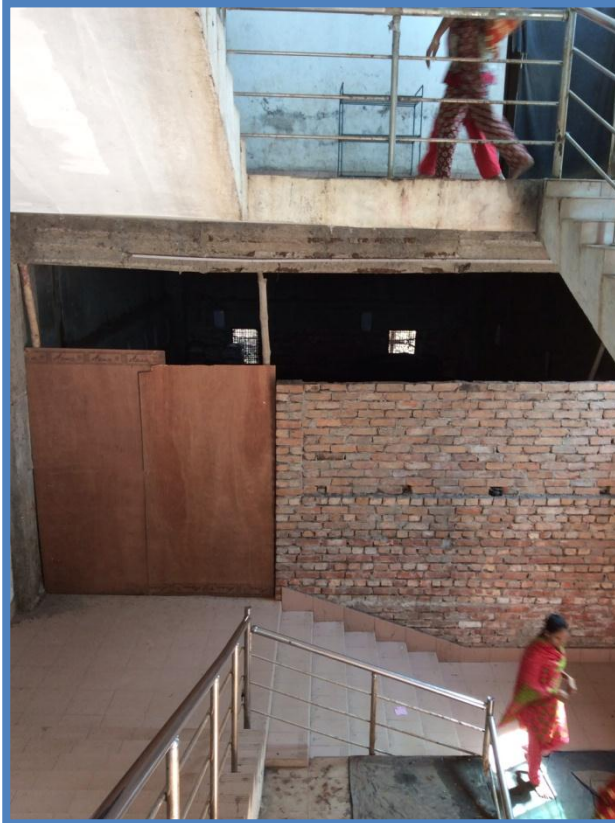
Internal masonry walls lacking top restraint

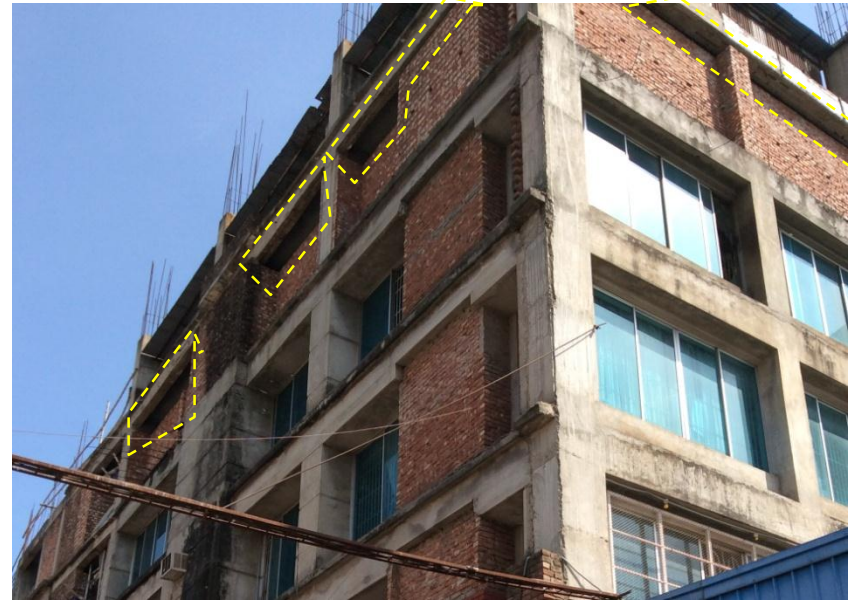
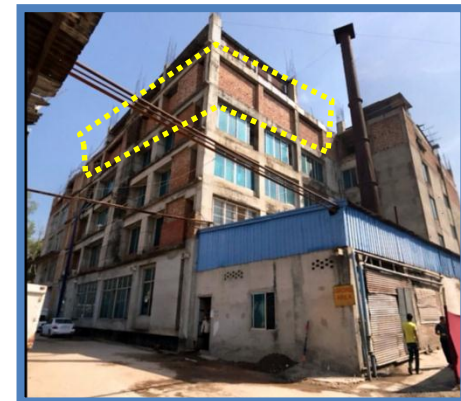
External masonry walls lacking top restraint

| Item No. | Observation | Recommended Action Plan | Recommended Timeline |
|---|---|---|---|
| 6 | BUILDING 2<br>Unrestrained Brickwork External Walls | Building engineer to check the external wall elements and propose additional lateral posts or the completion of the walls to floor level. | 6-months |

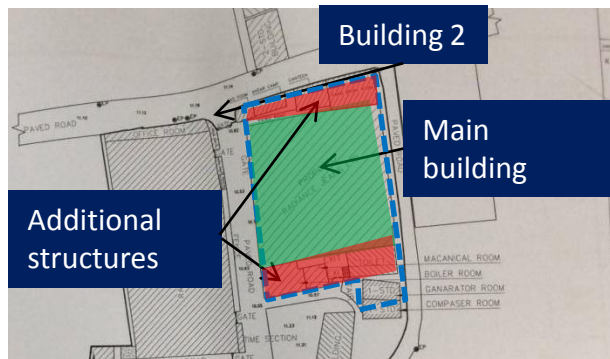
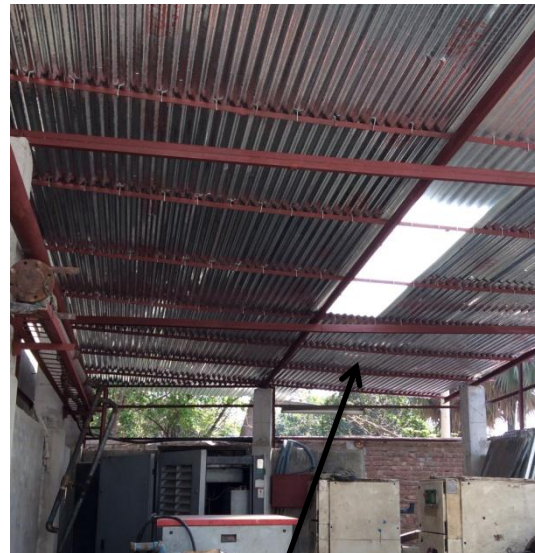
Non-engineered additional structures

Various structures appear un-engineered and possibly unstable including slender makeshift columns, a non-engineered roof structure on the top level of the main building and some possibly temporary bamboo structures

| Item No. | Observation | Recommended Action Plan | Recommended Timeline |
|---|---|---|---|
| 7 | BUILDING 2<br>Non Engineered Steelwork to ancillary buildings | Building engineer to check the structures and propose additional reinforcements and stability system | 6-months |

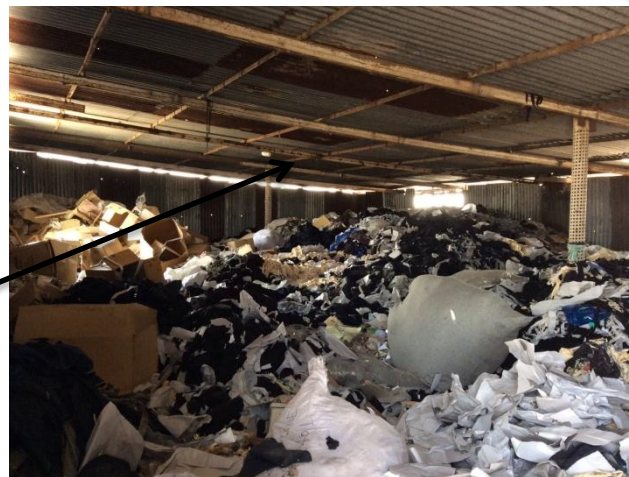
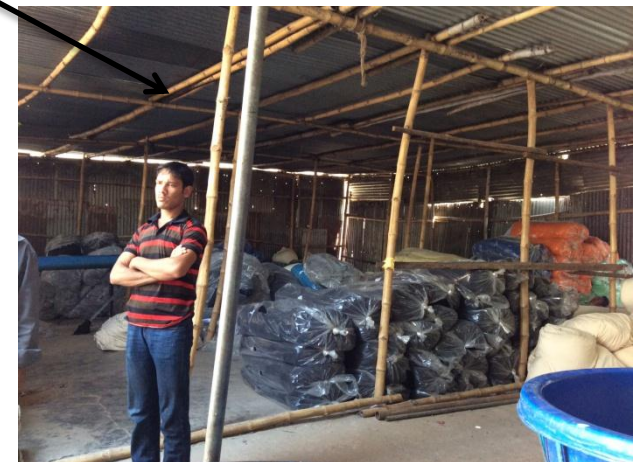
Non-engineered roof structure (roof level of main building), apparently lacking bracing, tying down details and other standard engineering details

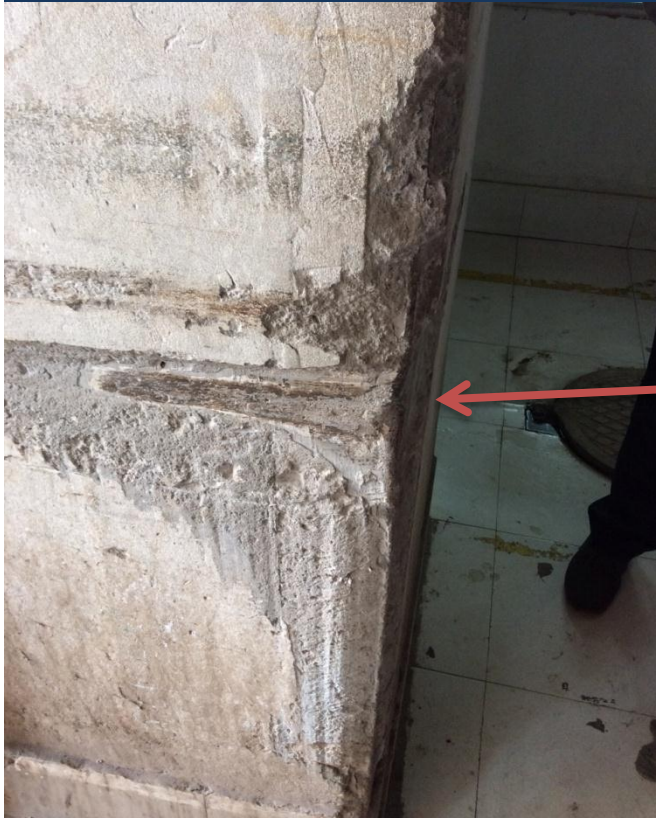
## Building column damaged by vehicles

Column near entrance has sustained damage from passing vehicles, removing render.

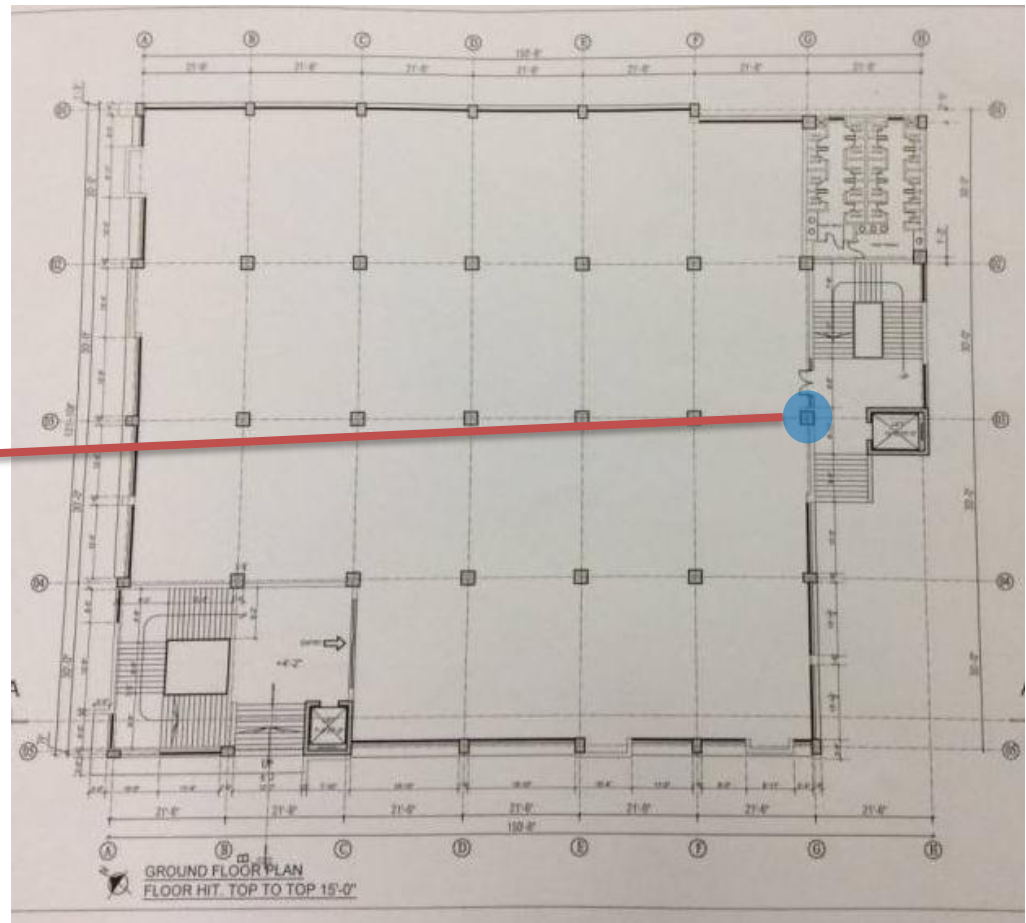
Column location tested

Design drawings are in good agreement with as-built structure. Opening up confirms aggregate type is stone throughout, and scanning on several columns indicates levels of reinforcement in agreement with drawings.

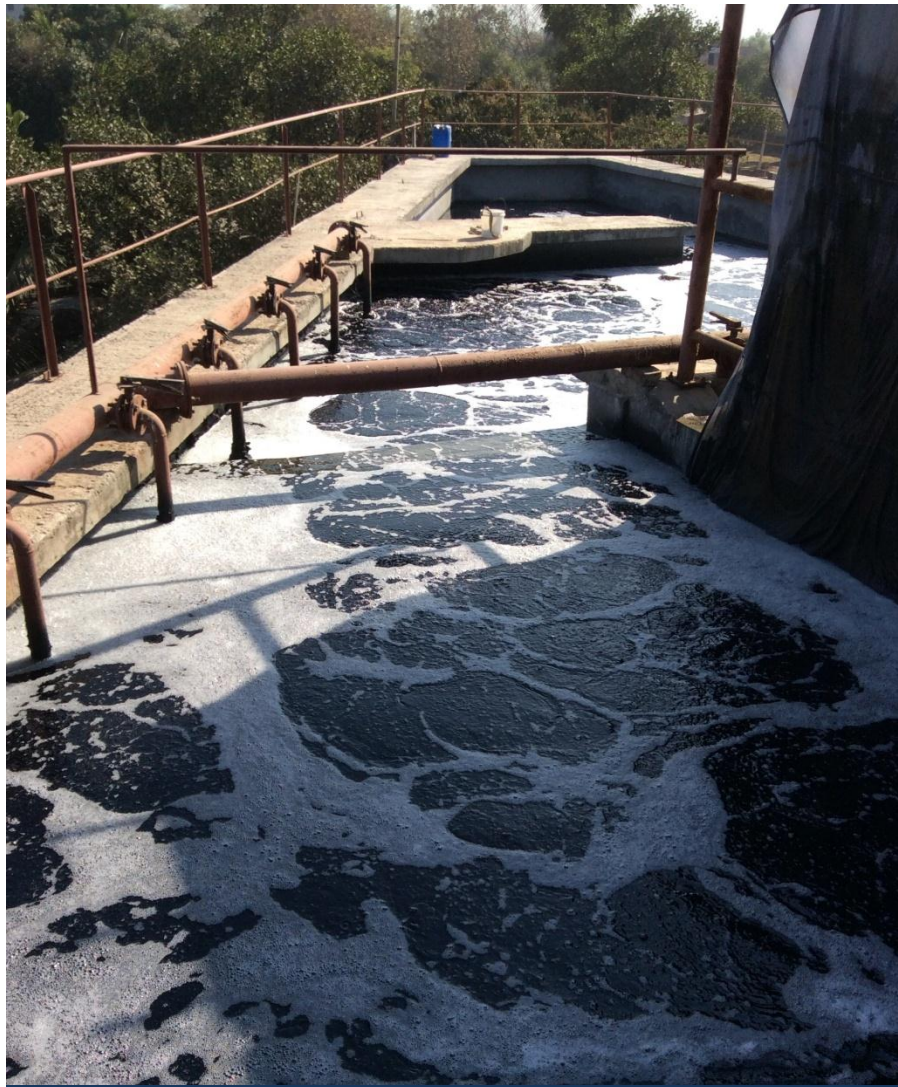
Edge protection only in place to prevent falls off of the tanks but not into tanks

| Item No. | Observation | Recommended Action Plan | Recommended Timeline |
|---|---|---|---|
| 8 | BUILDING 3<br>Inadequate protection along Tank perimeter. | Provide protection (guard rail) along the walkway at the top of the tanks to prevent possible falls into the tanks. | 6-months |

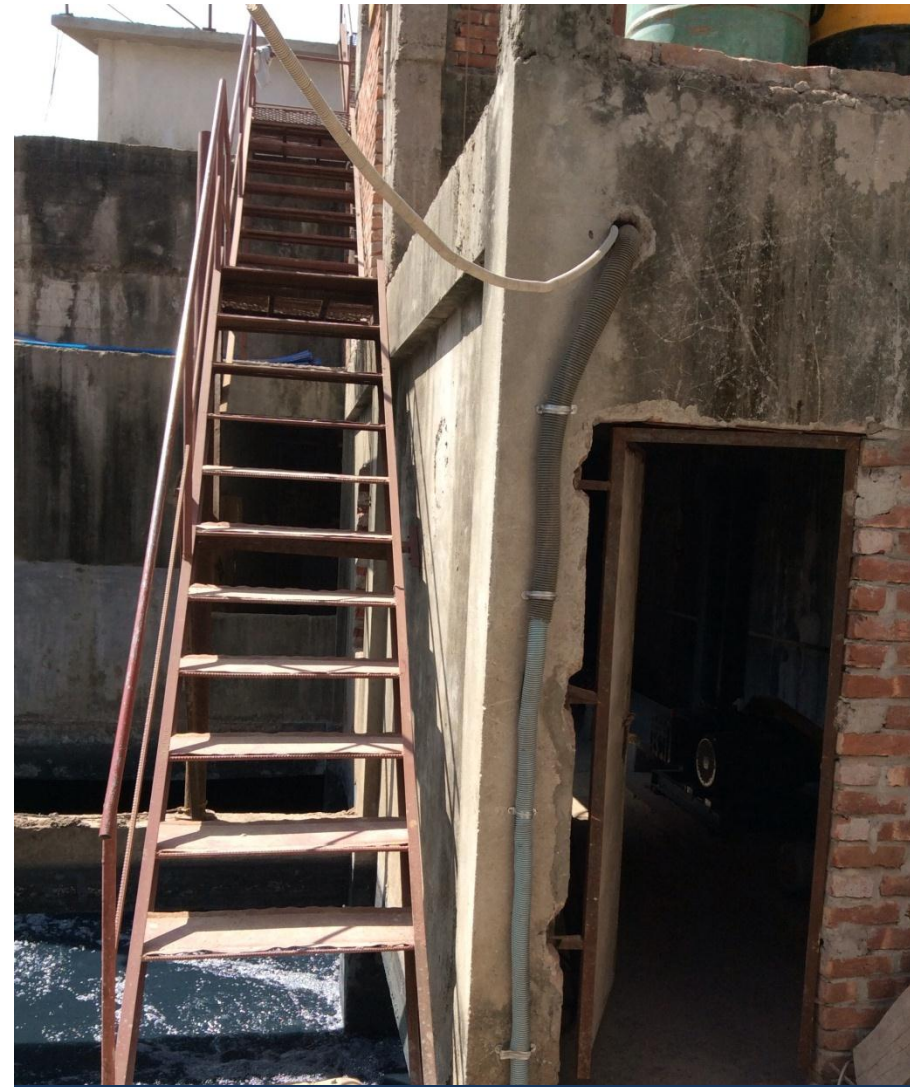
Apparently non-engineered stairs mainly fixed in place with welded reinforcement

| Item No. | Observation | Recommended Action Plan | Recommended Timeline |
|---|---|---|---|
| 9 | BUILDING 3<br>Non Engineered Stairs (external access stairs) | Building engineer to check the structure of the stairs and propose additional reinforcements. | 6-months |
