Dip Knitwear Ltd.

Hamid Plaza-2, Degarchala Road, National University,
Gazipur Sadar-1704, Gazipur, Dhaka, Bangladesh.

15 May 2014

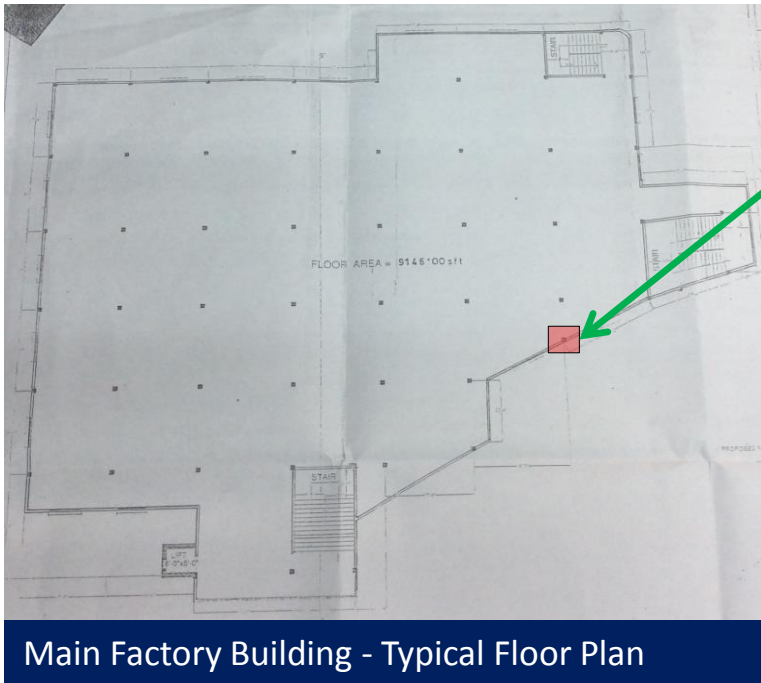
**Column Indicated on Structural Drawings
Not Provided Introducing a 3.0m Cantilever**

Column indicated on structural drawings not provided introducing a 3.0m Cantilever.

Item No.	Observation	Recommended Action Plan	Recommended Timeline
1	Column Indicated on Structural Drawings Not Provided Introducing a 3.0m Cantilever	A Detail Engineering Assessment (D.E.A.) of Factory to be commenced, see attached Scope	Immediate - Now
2	Column Indicated on Structural Drawings Not Provided Introducing a 3.0m Cantilever	Factory Engineer to review design, loads and cantilever stresses in area identified above.	Immediate - Now
3	Column Indicated on Structural Drawings Not Provided Introducing a 3.0m Cantilever	Verify insitu concrete strength either by 100mm diameter cores or existing cylinder strength data for cantilever identified above.	Immediate - Now
4	Column Indicated on Structural Drawings Not Provided Introducing a 3.0m Cantilever	All loading in excess of 1kN/m ² on cantilever to be removed immediately.	Immediate - Now
5	Column Indicated on Structural Drawings Not Provided Introducing a 3.0m Cantilever	Detail Engineering Assessment to be completed	6-weeks

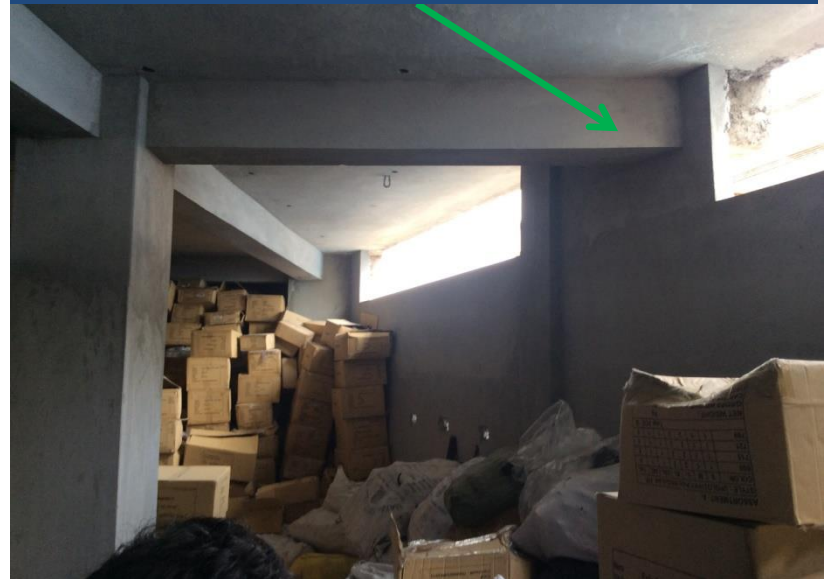
Cursory Calculations indicate cantilever beams to be stressed in excess of design limits

Item No.	Observation	Recommended Action Plan	Recommended Timeline
7	Preliminary calculations indicate cantilever beams to be stressed in excess of normal design limits	A Detail Engineering Assessment (D.E.A.) of Factory to be commenced, see attached Scope	Immediate - Now
8	Preliminary calculations indicate cantilever beams to be stressed in excess of normal design limits	Factory Engineer to review design, loads and cantilever stresses in areas identified above.	Immediate - Now
9	Preliminary calculations indicate cantilever beams to be stressed in excess of normal design limits	Verify insitu concrete stresses either by 100mm diameter cores or existing cylinder strength data for cantilevers identified above	Immediate - Now
10	Preliminary calculations indicate cantilever beams to be stressed in excess of normal design limits	Detailed Engineering Assessment to be completed	6-weeks
11	Preliminary calculations indicate cantilever beams to be stressed in excess of normal design limits	Continue to implement load management plan (See Item 4)	6-months

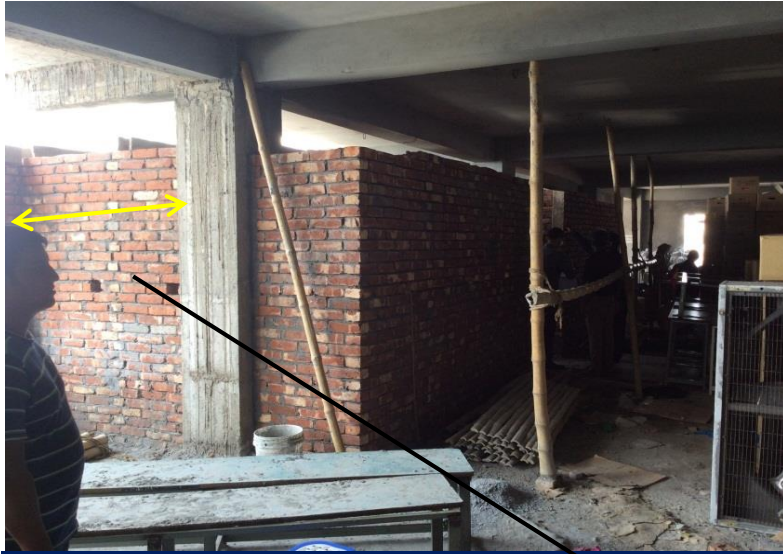
Toilet Build-up and Brick Partitions on Cantilever

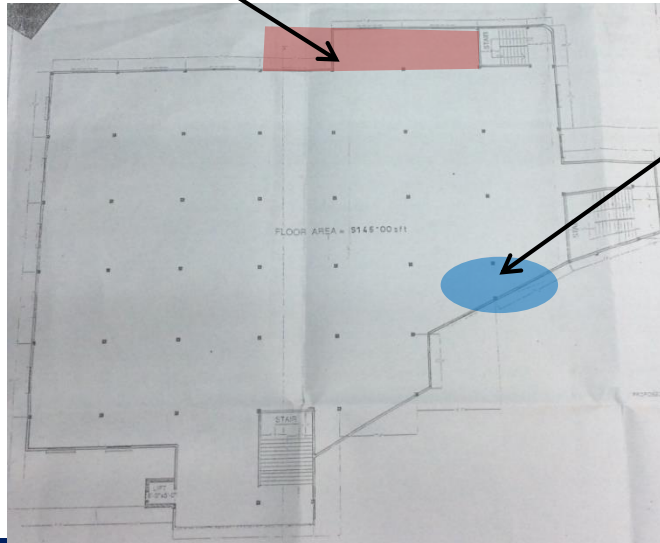
Main Factory Building - Typical Floor Plan

Cursory Calculations indicate columns to be stressed in excess of design loads for the proposed 5 Storey Building

Item No.	Observation	Recommended Action Plan	Recommended Timeline
12	Cursory Calculations indicate column stresses in excess of normal design limits	A Detail Engineering Assessment (D.E.A.) of Factory to be commenced, see attached Scope	Immediate - Now
13	Cursory Calculations indicate column stresses in excess of normal design limits	Factory Engineer to review design, loads and columns stresses in area identified above.	Immediate - Now
14	Cursory Calculations indicate column stresses in excess of normal design limits	Verify insitu concrete stresses either by 100mm diameter cores or existing cylinder strength data for cores from 4 columns.	Immediate - Now
15	Cursory Calculations indicate column stresses in excess of normal design limits	Detailed Engineering Assessment to be completed	6-weeks
16	Cursory Calculations indicate column stresses in excess of normal design limits	Produce and actively manage a loading plan for all floor plates within the factory giving consideration to floor capacity and column capacity. This should include a safe level to which any water tanks can be filled.	6-weeks

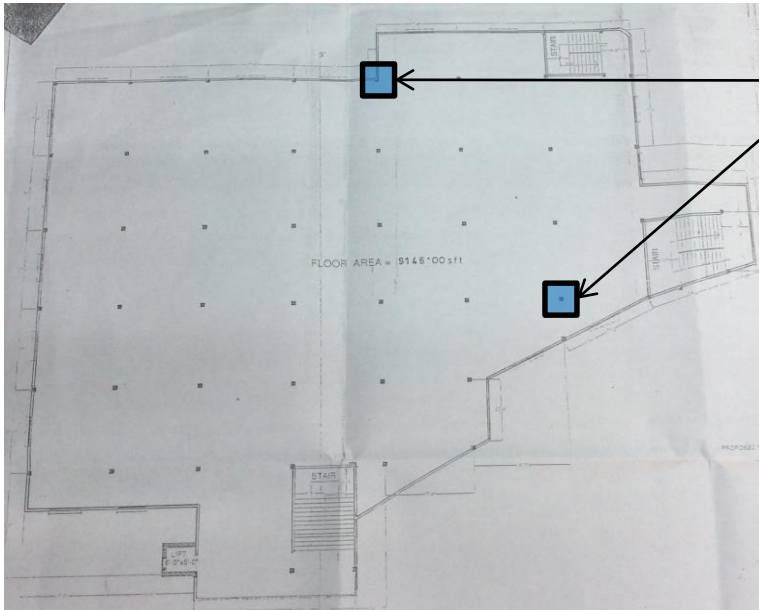
Main Factory Building - Typical Floor Plan

Testing Conformed Brick Aggregate in ground floor columns. Cursory calculations indicate column stress is in excess of design limits.

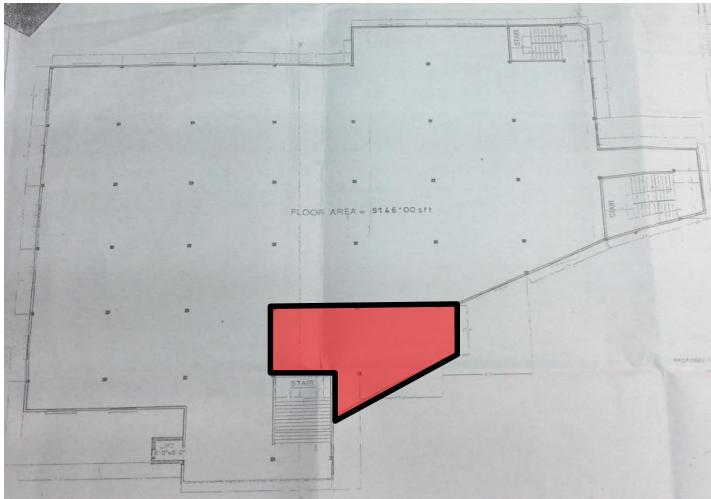
Main Factory Building – 1st Floor Plan

Localised areas of high loading

Item No.	Observation	Recommended Action Plan	Recommended Timeline
18	Localised areas of high loading	Produce and actively manage a loading plan for all floor plates within the factory giving consideration to floor capacity and column capacity. This should include a safe level to which any water tanks can be filled.	6-weeks
19	Localised areas of high loading	Continue to implement load management plan	6-months
20	Inconsistencies noted between drawings and as built construction	Building Engineer to survey as constructed building and update drawings as required.	6-weeks

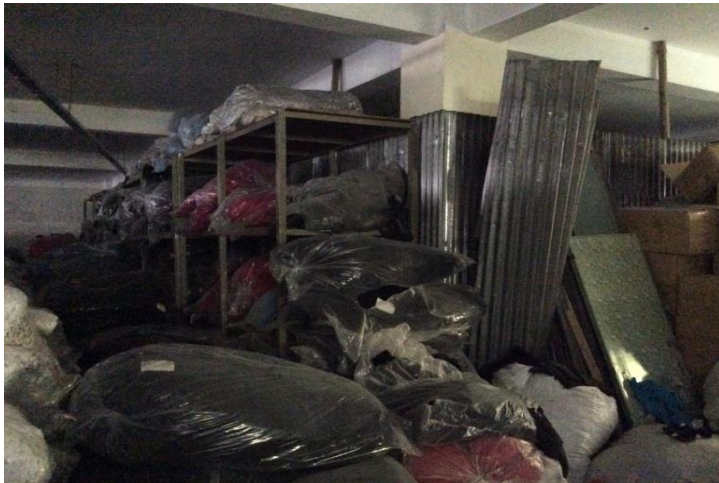
High loading area on 1st floor

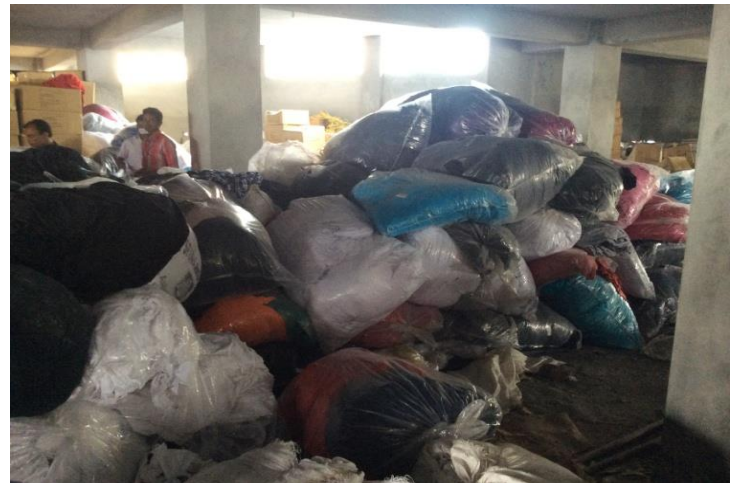
High loading area on 3rd floor

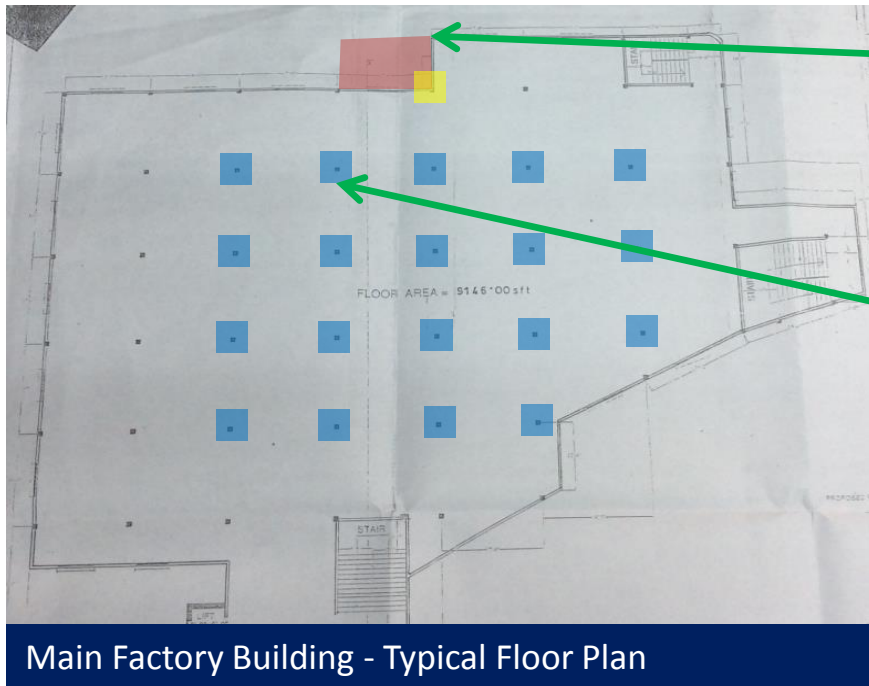
Inconsistencies noted between drawing & as built construction

Increased floor area on every floor

Column size on the drawing 500mm x 500mm
Observed column size 3rd and 4th floor - 510mm x 515mm (Without Plaster)
Ground to 2nd floor – 450mm x 450mm (Without Plaster)

Drawing column size 400mm x 400mm. As built column at ground floor 510mm x 515mm
