FIRE SAFETY INSPECTION REPORT

Factory Name: Designer Fashion Ltd

Date: 29th March, 2017

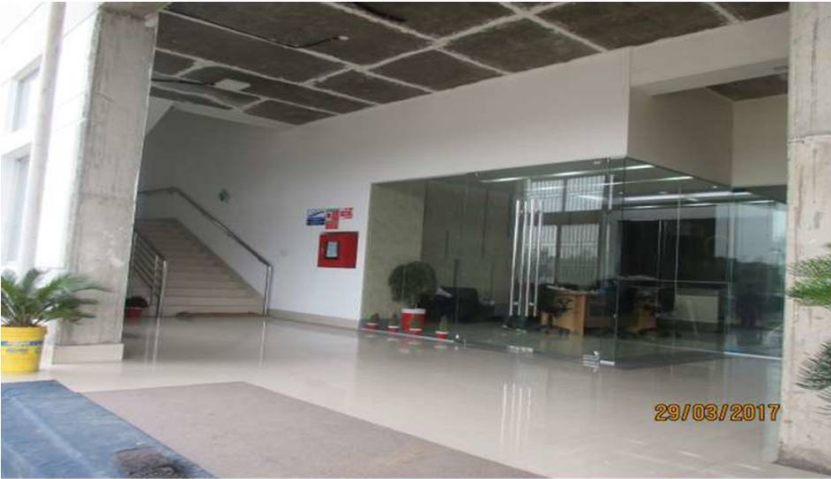
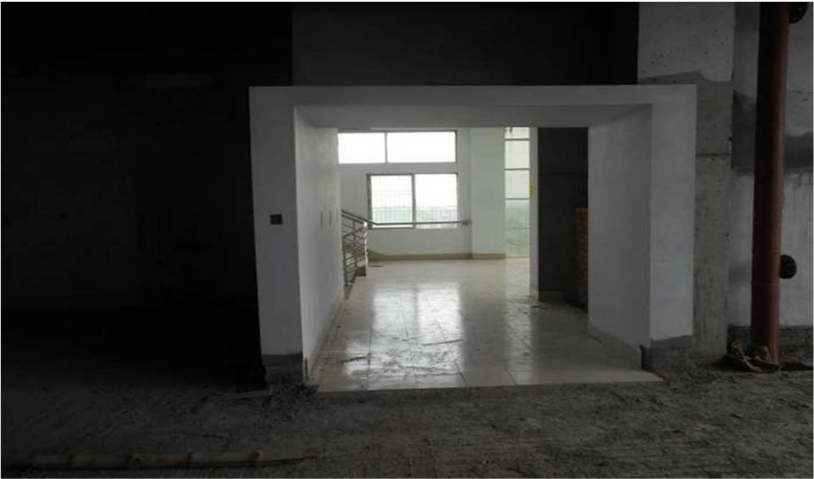
SI No.	Category	Findings	Required Action	Remediation Time Frame
1	Fire Rated Construction	Exit stairs are not completely separated from other occupancy by fire rated assemblies. Fire door has not been installed in all the floors.	Complete installation of fire doors in the remaining required floors And Inspect, test and maintain the fire door's functionality and If fire doors are required to be held open for functional reasons, provide automatic-closing devices tied to the fire alarm system.	Within 3 months

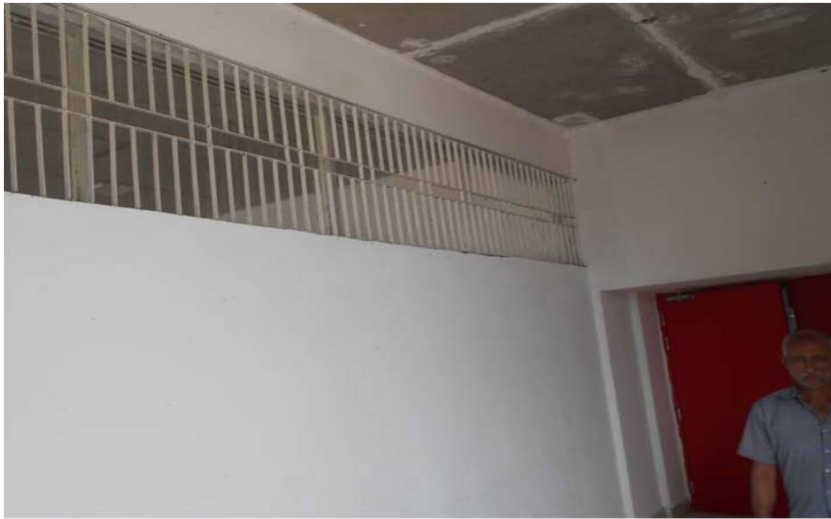
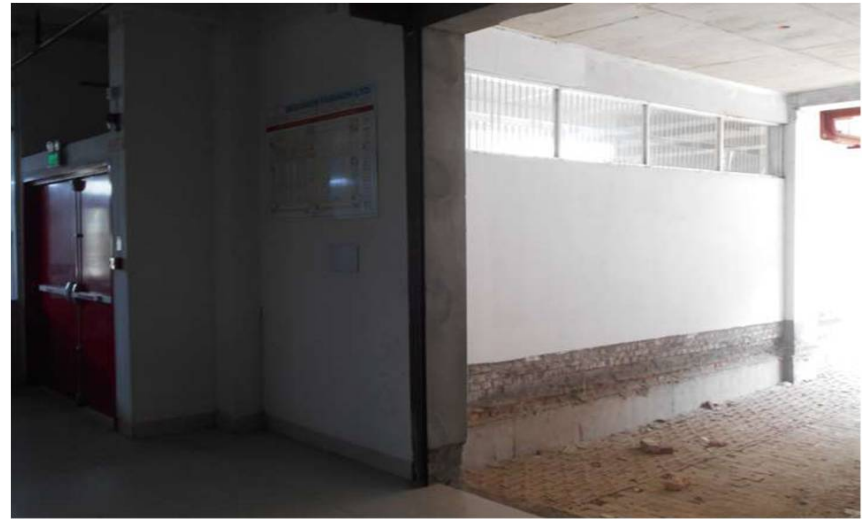
SI No.	Category	Findings	Required Action	Remediation Time Frame
2	Fire Rated Construction	Unsealed penetrations and openings are located in exit stair enclosures.	Seal all penetrations and openings in the wall of exit enclosure walls (full thickness of the wall) by fire rated materials to maintain the fire resistance rating.	Within 3 months

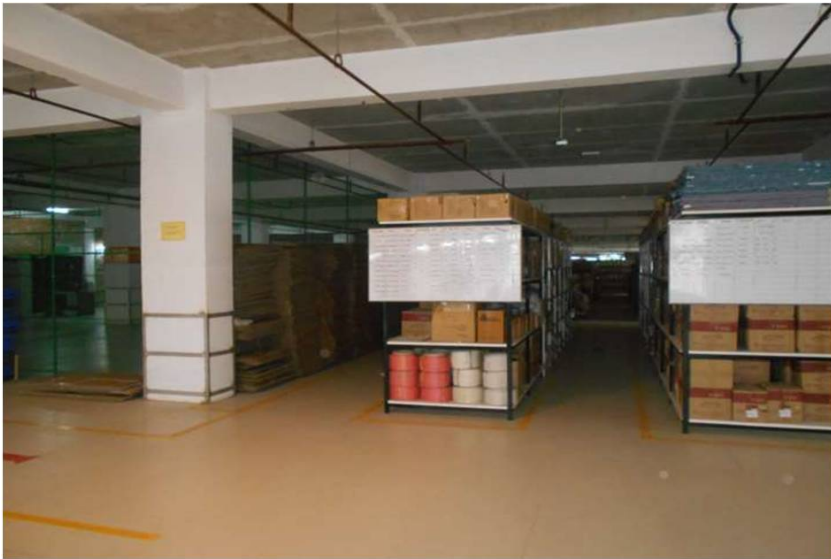
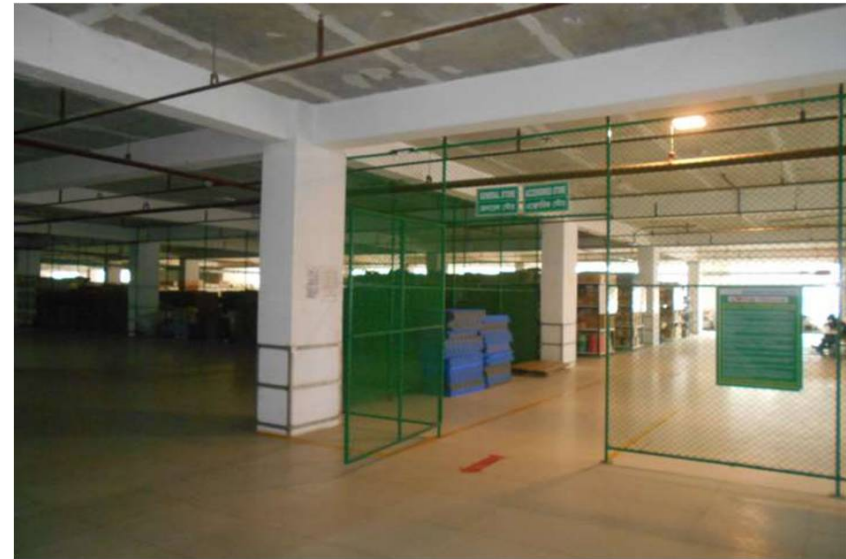
SI No.	Category	Findings	Required Action	Remediation Time Frame
3	Fire Rated Construction	<p>Rooms used for storage of combustible materials are not separated from other occupancies.</p> <p>Location: General and Accessories store at Ground floor.</p>	<p>Rooms used for storage of combustible materials shall be separated from the surrounding occupancy with a minimum 1 hour construction.</p>	Within 3 months

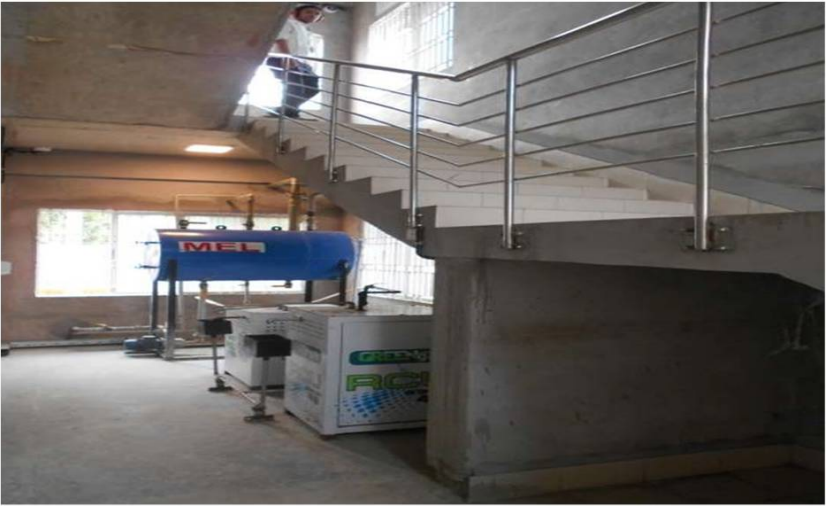
SI No.	Category	Findings	Required Action	Remediation Time Frame
4	Fire Rated Construction	Compressor was located underneath the exit stair. Location: Utility Building	Remove all storage from exit stairs.	Within 3 months

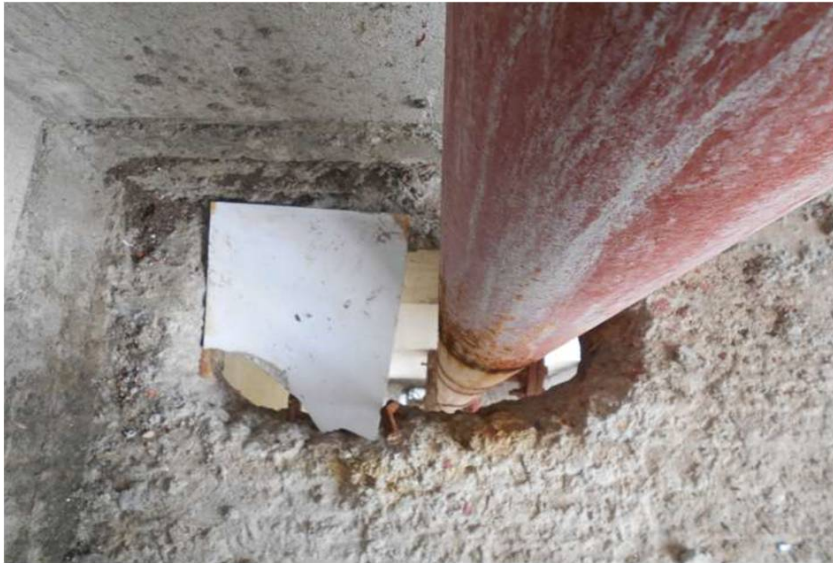
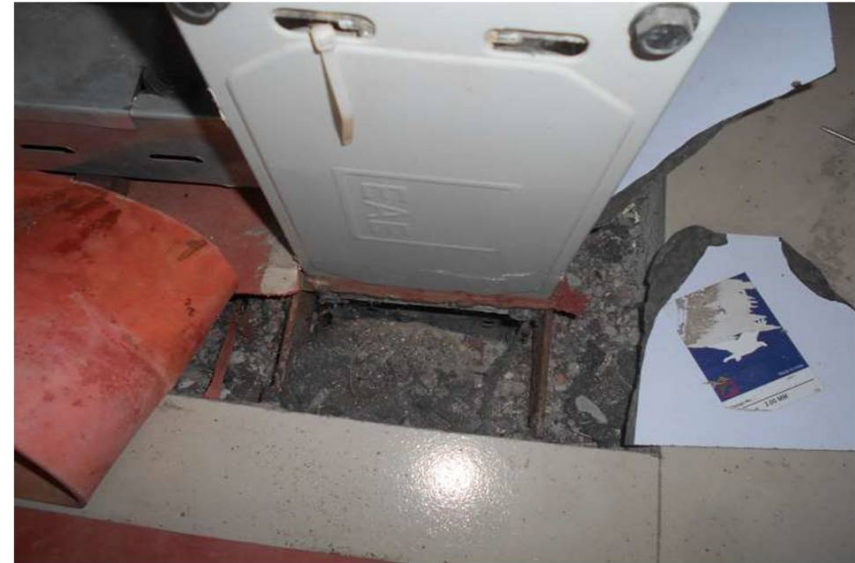
SI No.	Category	Findings	Required Action	Remediation Time Frame
5	Fire Rated Construction	Penetrations through floor/ceiling assemblies are found unsealed. Location: Different places at all level.	Seal all penetrations and openings in the wall of exit enclosure walls (full thickness of the wall) by fire rated materials to maintain the fire resistance rating.	Within 3 months

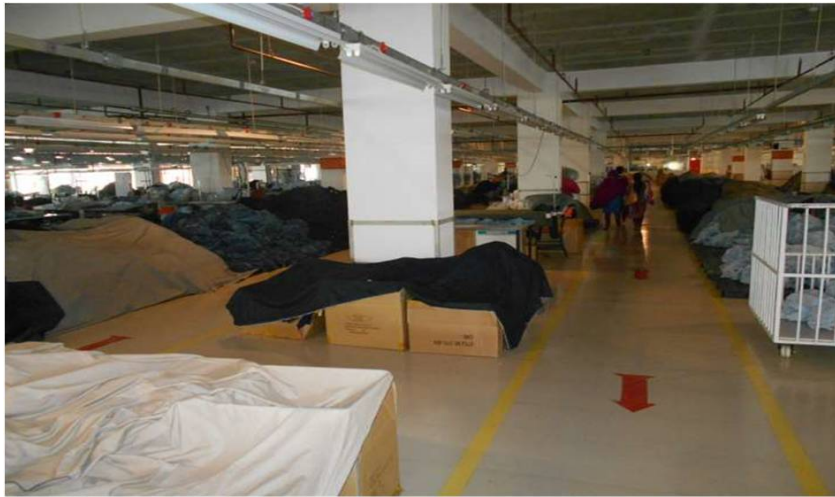
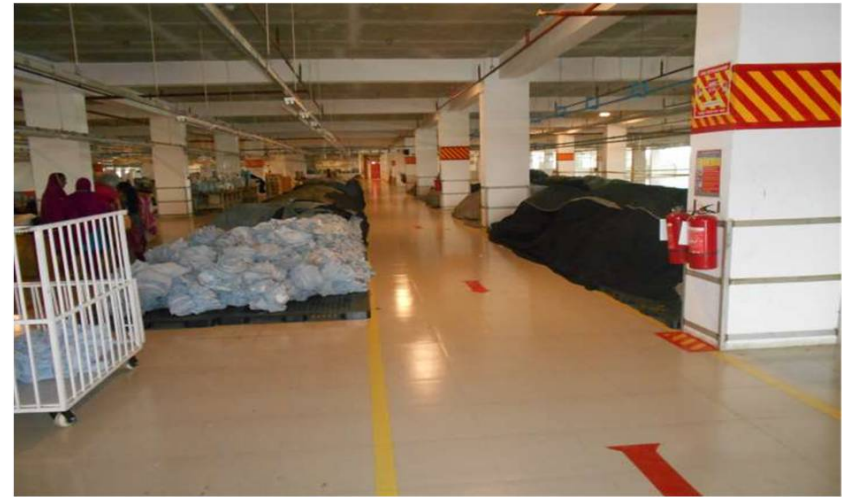
SI No.	Category	Findings	Required Action	Remediation Time Frame
6	Fire Rated Construction	Areas used for in-process storage of combustible materials are open to the surrounding occupancy. Location: First floor	Provide defined storage areas and limit the storage arrangement as follows:- 1. General Condition: Maximum height of 2.4m and maximum area of 23m ² . Separate areas of unenclosed combustible storage by a minimum clear distance of 3m. 2. If sprinkler protected: maximum height of 3.66m and maximum area of 93m ² . Separate areas of unenclosed combustible storage by a minimum clear distance of 3m. or 3. Enclose the storage area from the surrounding occupancy with a minimum 1 hour construction.	Within 3 months

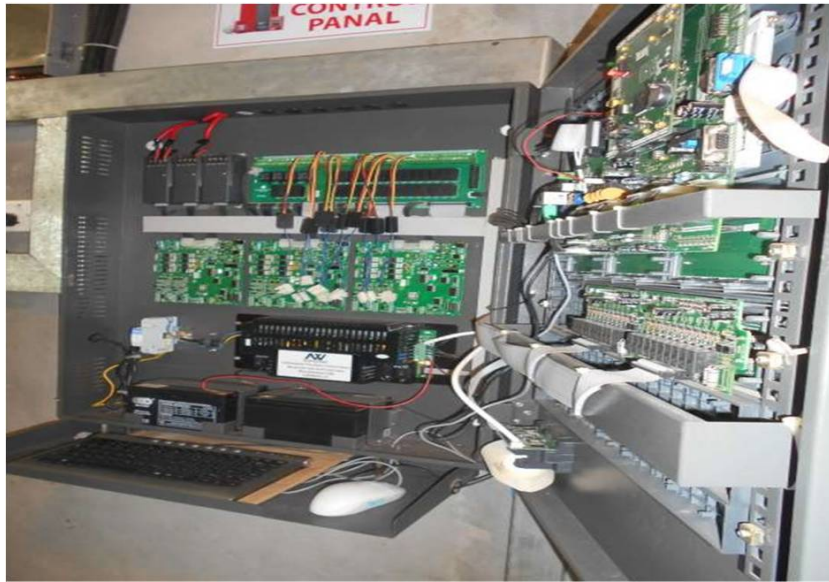
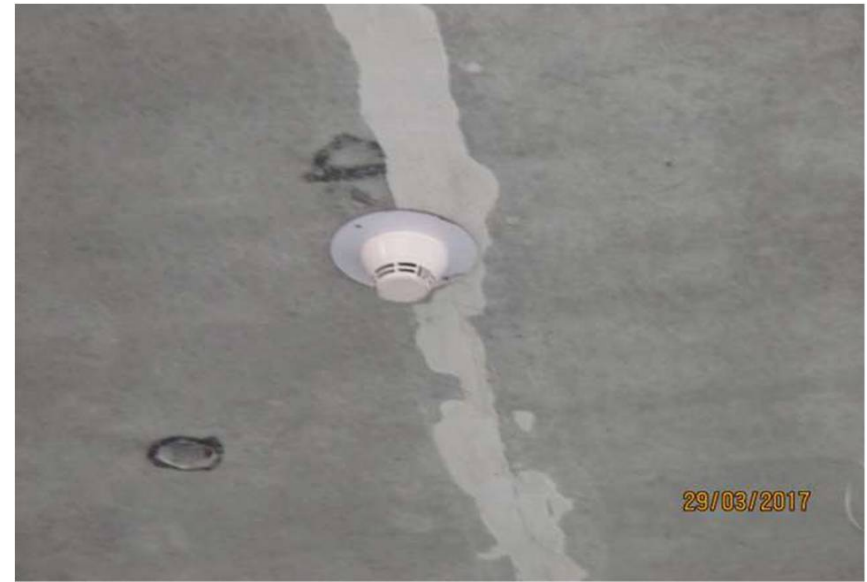
SI No.	Category	Findings	Required Action	Remediation Time Frame
9	Fire Protection	Fire detection and alarm system installation is on-going. However drawing is not reviewed and the system is not confirmed to be as per NFPA-72.	Submit the drawing for ACCORD review And Complete installation/modification as per NFPA-72	Within 6 months

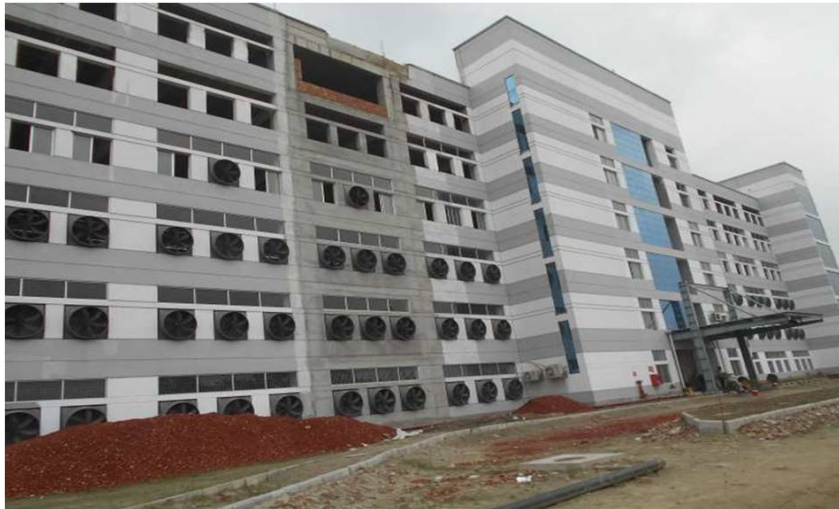
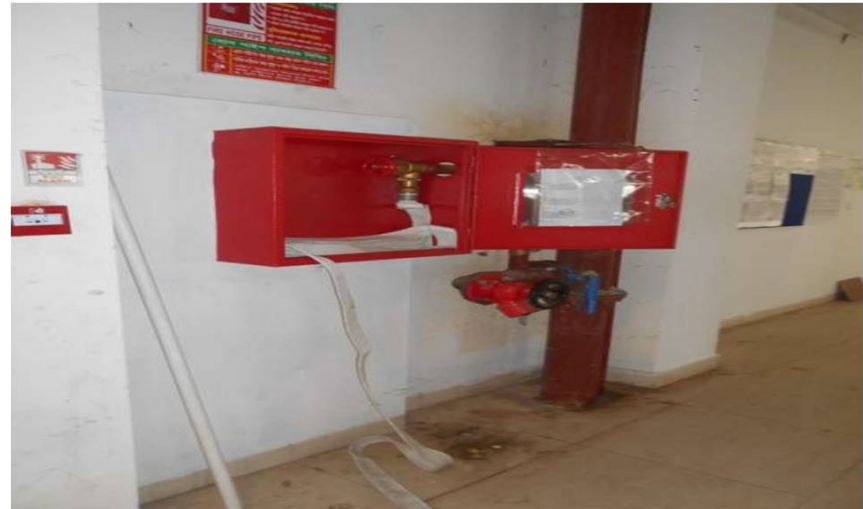
SI No.	Category	Findings	Required Action	Remediation Time Frame
10	Fire Protection	The building has an occupied floor greater than 10 meter (33 feet) and its not provided with standpipe system as per NFPA 14 & 20.	Provide standpipe and hose system as per NFPA 14 & 20.	Within 6 months

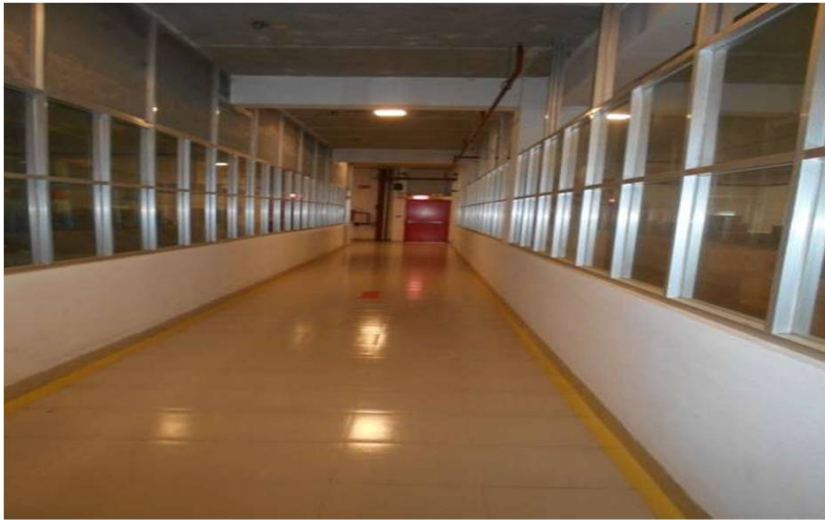
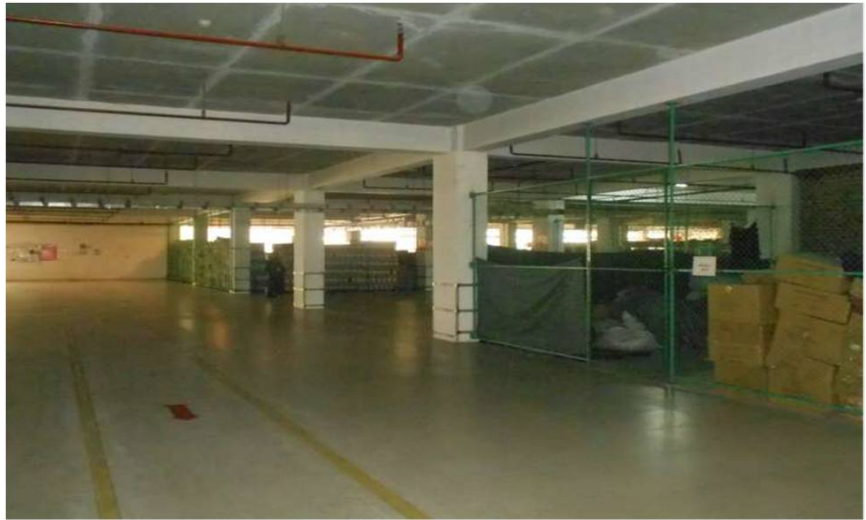
SI No.	Category	Findings	Required Action	Remediation Time Frame
11	Egress Lighting	Based on the number and location of emergency lights observed, adequate illumination levels are not anticipated along egress routes.	Test the emergency lighting system on each floor and provide additional emergency fixtures to provide adequate illumination along the means of egress. Provide a minimum illumination of 10 lux at the floor level within exit stairs and exit discharge paths and minimum 2.5 lux along exit access aisles.	Within 3 months

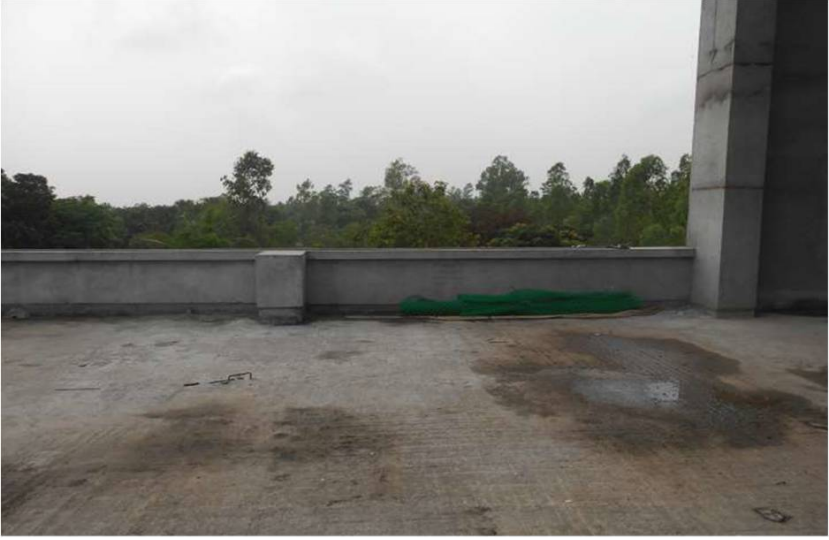
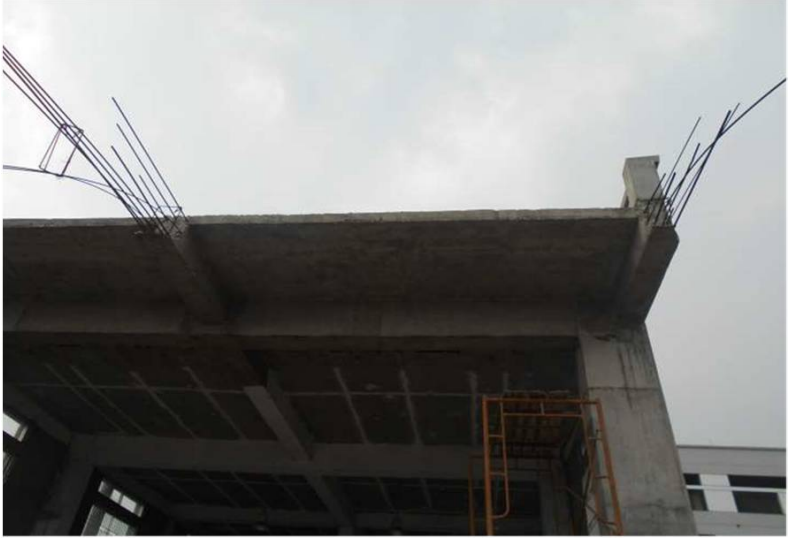
SI No.	Category	Findings	Required Action	Remediation Time Frame
12	Egress	Parapets or guards are not provide in Occupiable roof as per Accord standard.	Provide parapets or guards with a minimum height of 1067mm (42 inch.).	Within 3 months

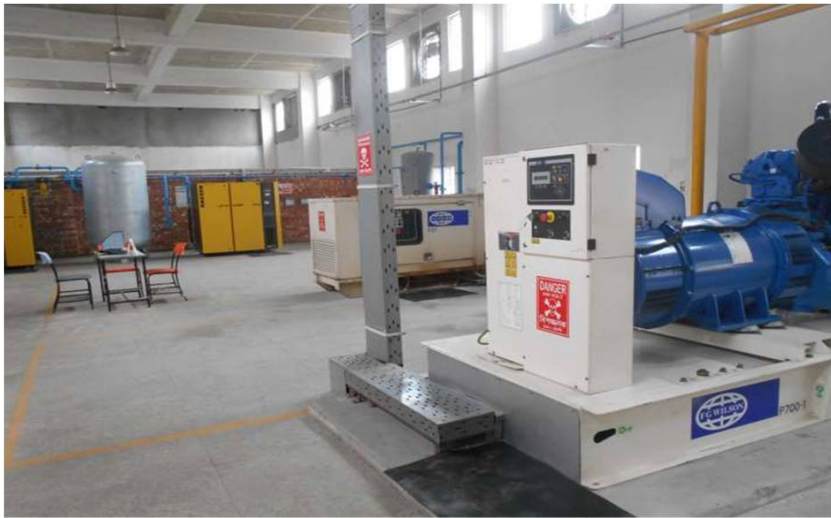
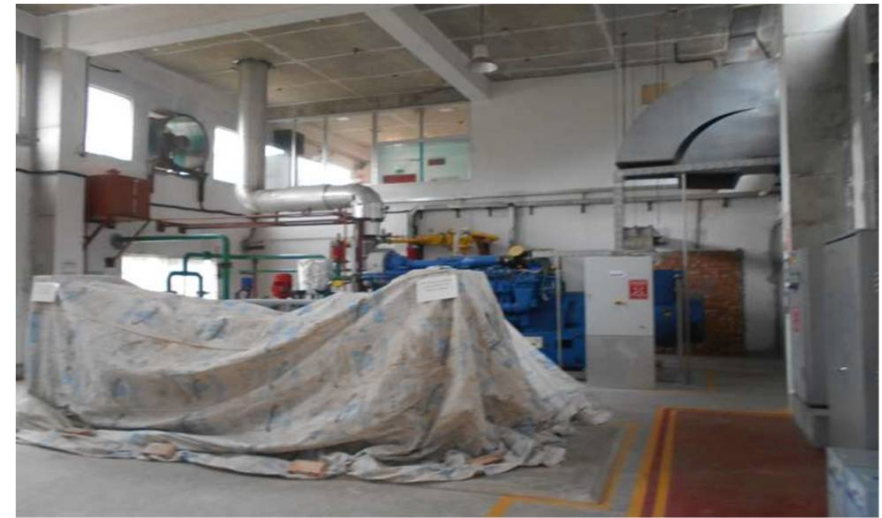
SI No.	Category	Findings	Required Action	Remediation Time Frame
13	Fire Rated Construction	Workshop, Generators and Compressors are not separated from each other by fire rated construction. Location: Utility Building	Generator, workshop, compressors shall be separated from other occupancies & from each other by a minimum 2-hr fire rated construction (wall, floor, slab etc.). Seal all penetrations and openings (door, window etc.) shall be protected by 1.5-hr fire rated materials to maintain the fire separation if required. All exhaust systems shall discharge to the exterior of the building in a safe location.	Within 3 months
