INTERFAB SHIRT MFG CO. (10041)

302/547, Gasa Union Road, Gazipur
(+23.933525N, 90.387314E)
25 March 2014

Site Observations

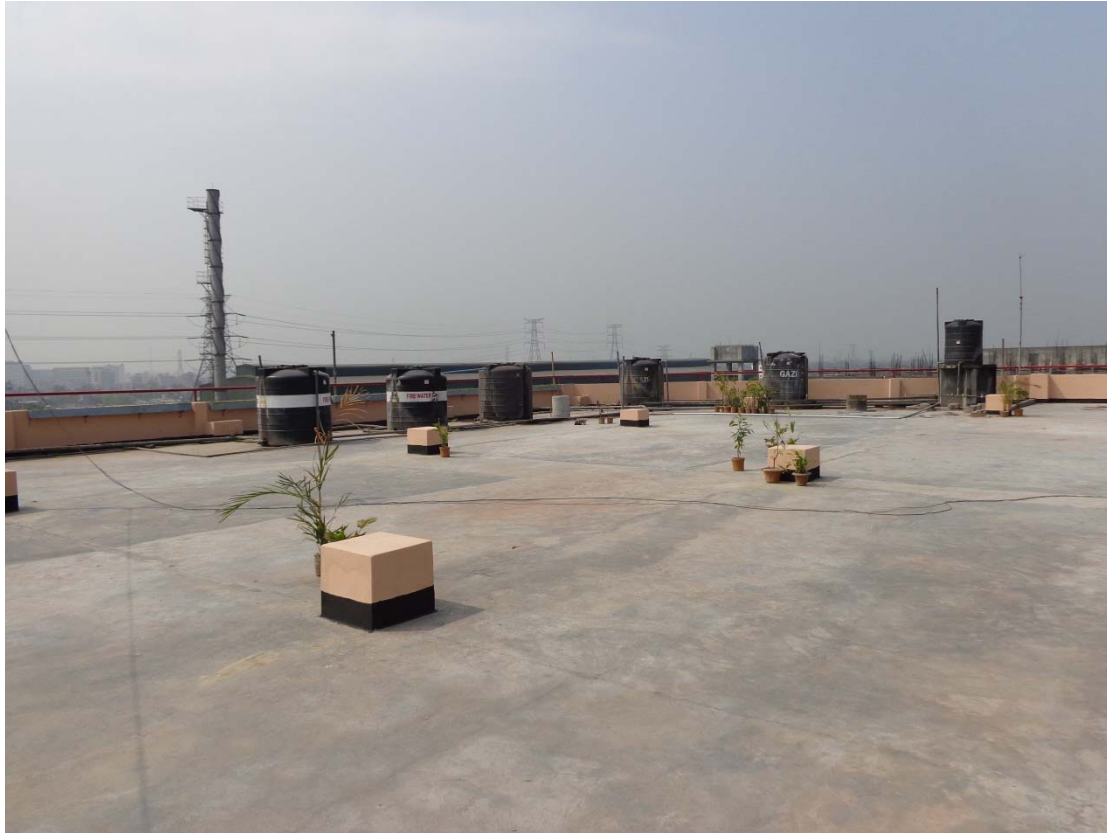
No apparent water proofing on roof

Priority 3 Concern

No waterproofing membrane was visible on the roof of the building. This means that any cracks in the surface finishes on the roof will allow water to seep into the concrete slab beneath the finishes, and cause long-term soaking of the slab.

Roof Floor does not appear to have any waterproof membrane to protect lower floor from water damage

Roof appears not to have any waterproofing system applied.

- Consider applying a new waterproofing membrane.
