Oxford Shirts Ltd.

Pretty Square, South Salna, Salna, Gazipur
(24.035049N,90.388135E)
2nd March 2017

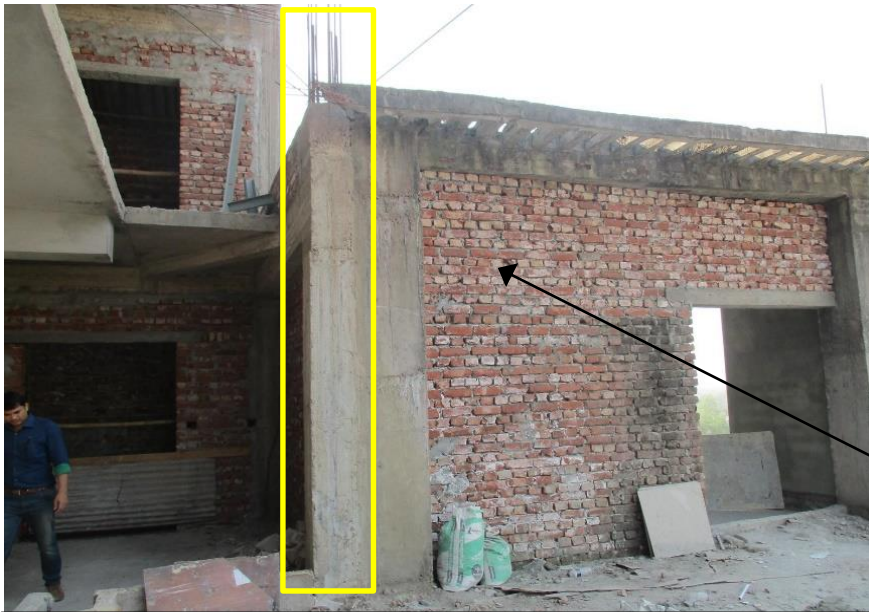
Additional RC column with 12 number of rebar

Additional 300 x 525 mm RC column with 12 number of rebar was observed adjacent to the column C1 near west side stair zone of the main (part-1) building

As-built architectural drawings for the internal partition wall does not match with as-built conditions. Building engineer to survey the structure and update the as-built (architectural & structural) drawings for all buildings based on actual scenario.

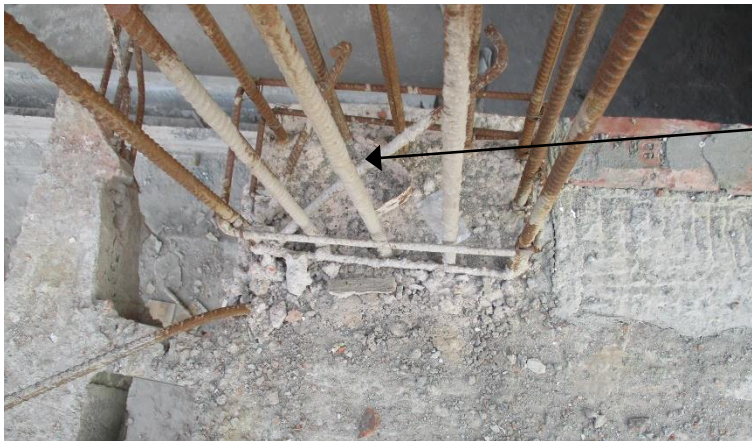
Exposed rebar of the Additional column

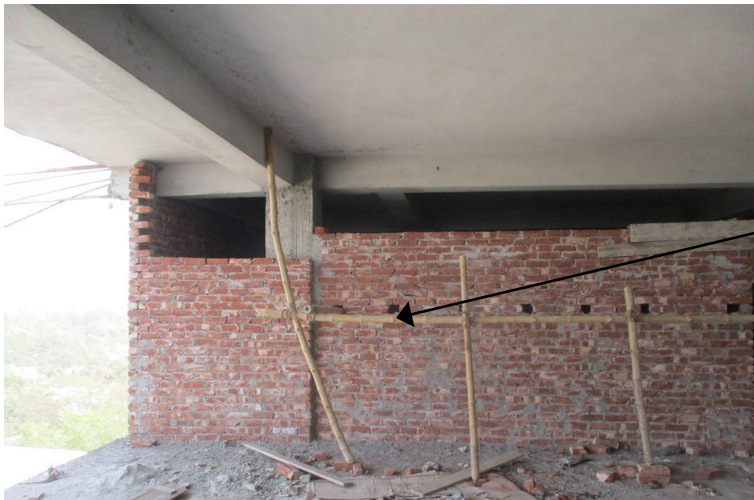
Internal 5" brick walls not shown in as-built drawings

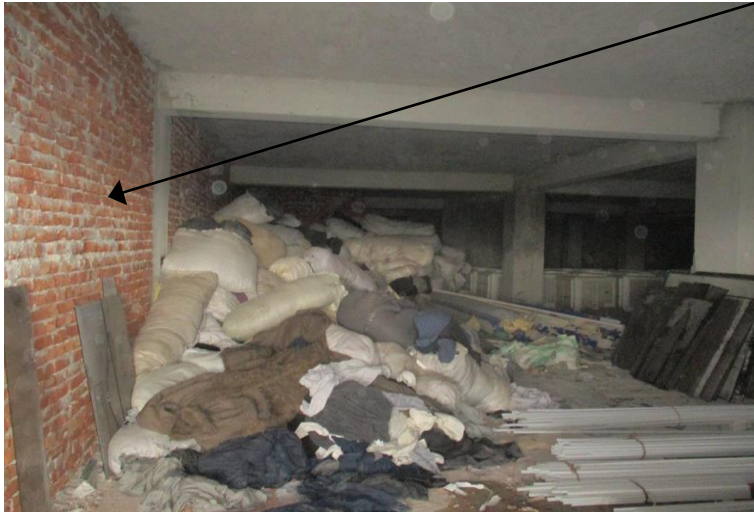
Internal 10" full height brick walls not shown in as-built drawings.

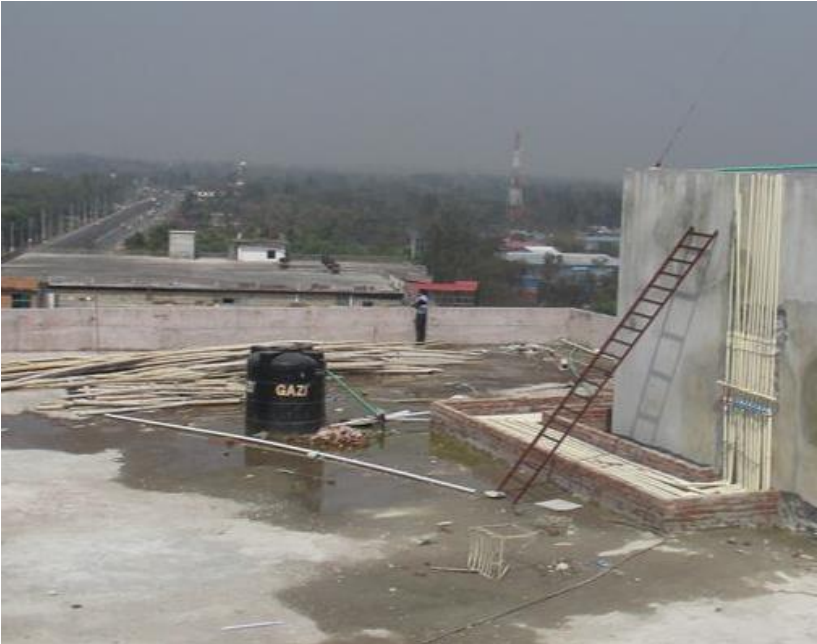
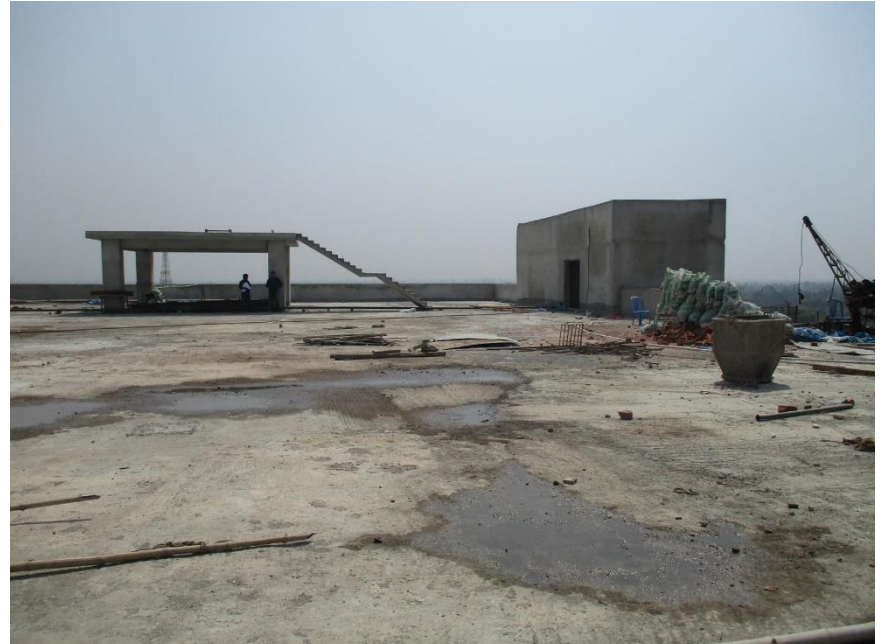
Absence of water proofing membrane on roof

Water ponding observed on roof and there was no water proofing layer to resist the water ingress into the slab.

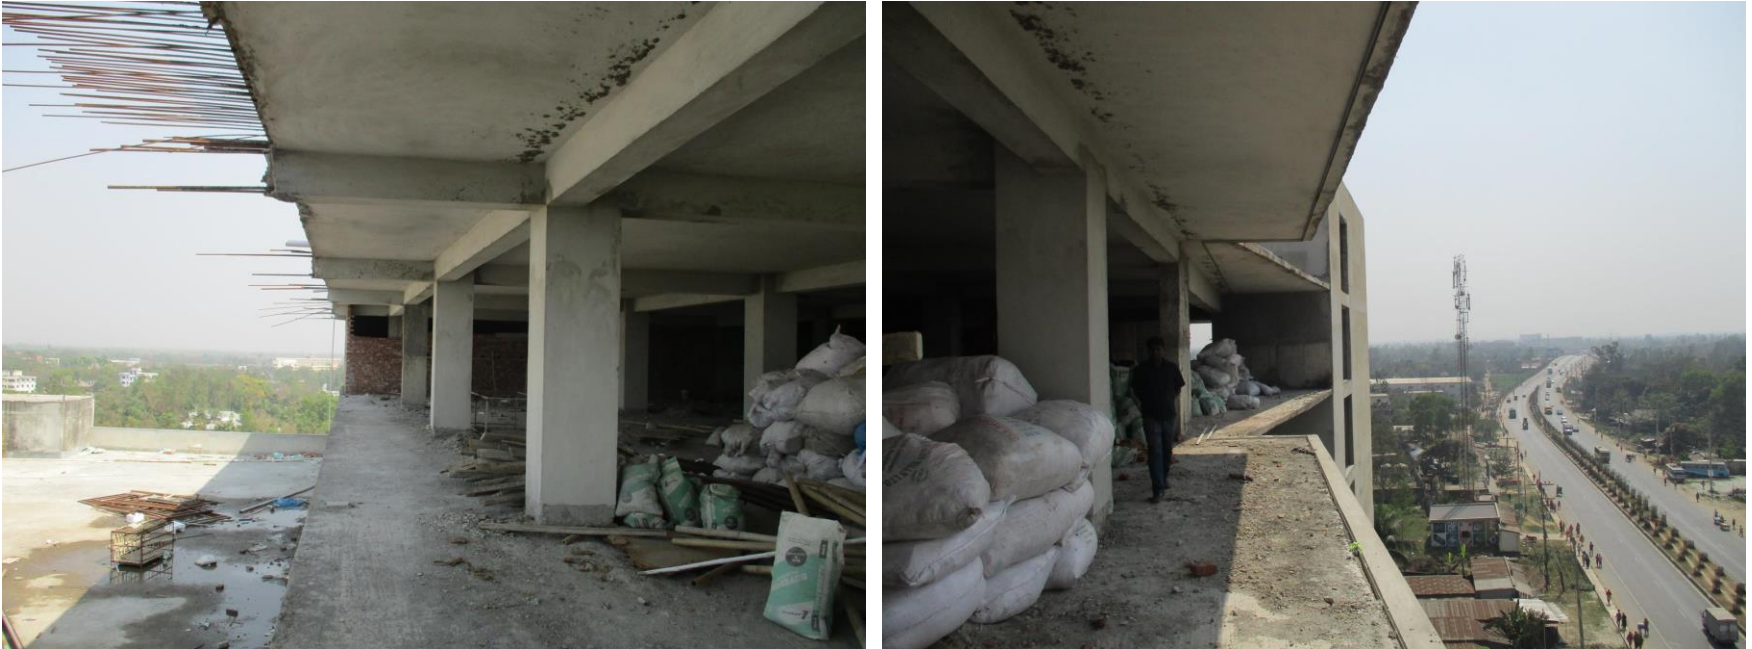
Falling hazard

There are no edge protection around the floors which may causes falling hazard.

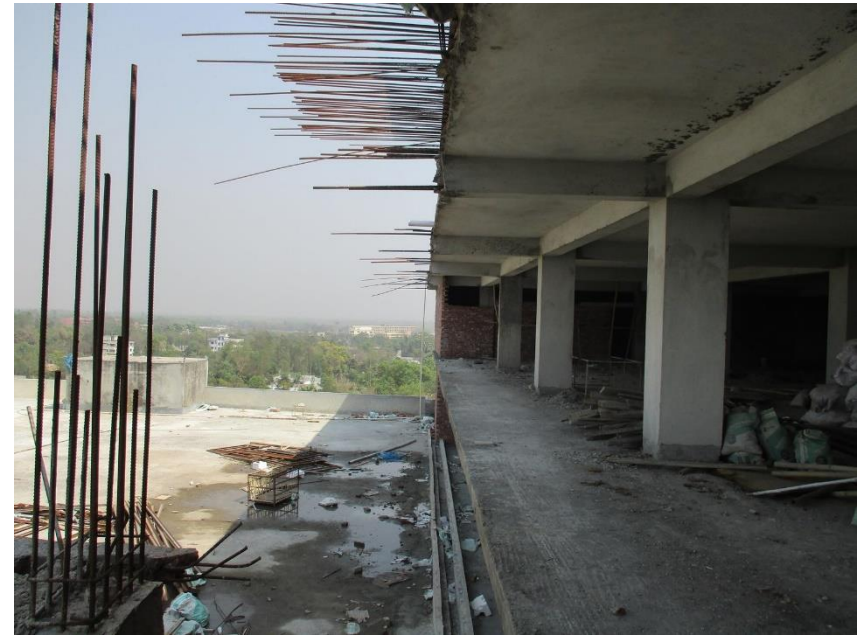
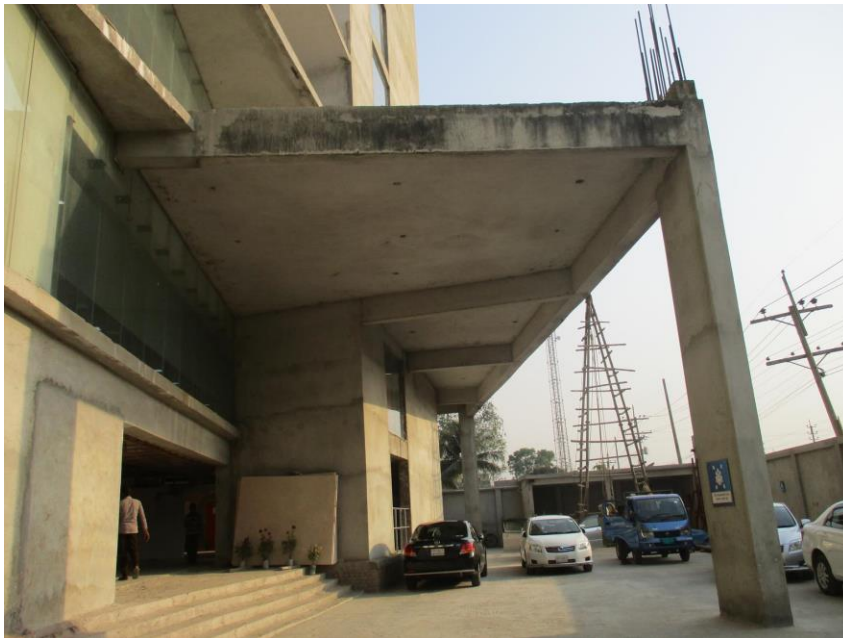
Possibility of future extension

The exposed rebar indicate that the factory have an intension for future extension. Incase of any type of horizontal and vertical extension Detail Engineering Assessment (DEA) to be carried out following BNBC provision.
