# Flamingo Fashions Ltd.(Unit-2)

Mariali, Joydebpur, Gazipur  
(24.009385N, 90.415008E)  
23<sup>rd</sup> February 2017

# **Discrepancies between drawing provided and the as-constructed building**

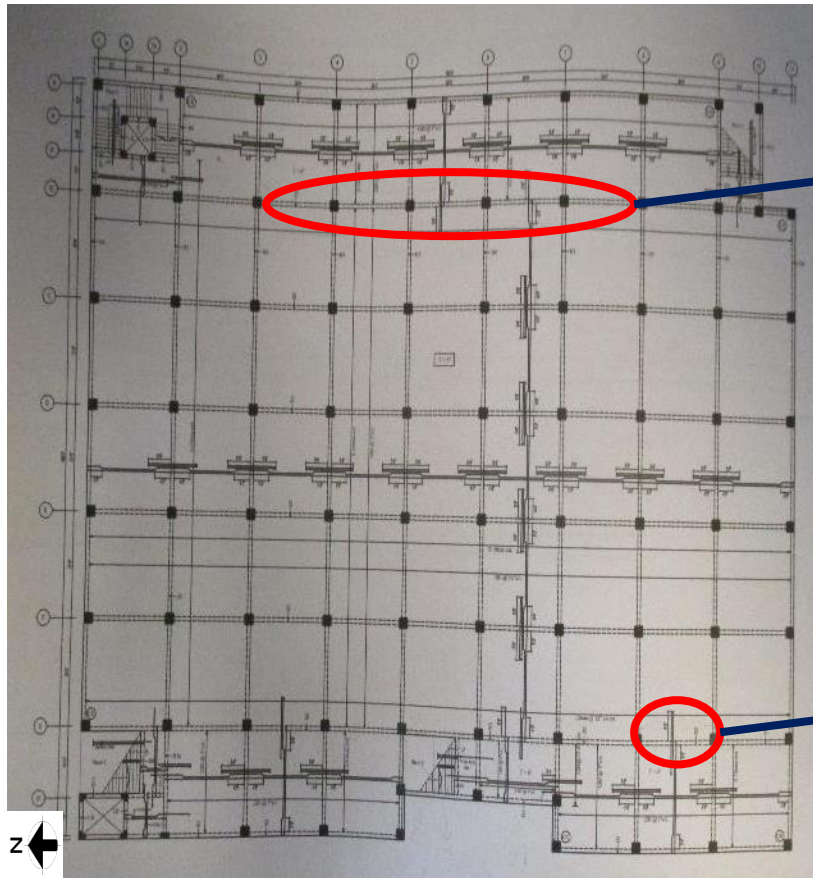
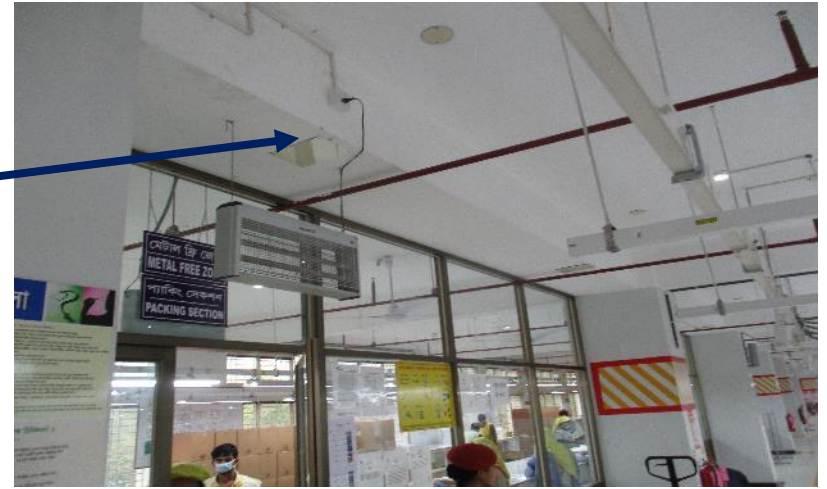
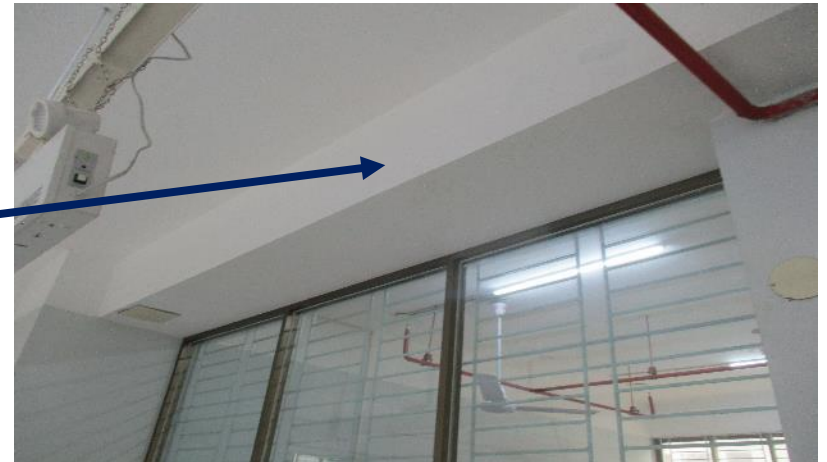
Typical Floor Beam layout Plan

During inspection, Beam of the highlighted area found over sized. Beam width found 24 inch instead of 12 inch on almost every floor.

**Observation: Discrepancies between drawing provided and the as-constructed building**

| Item No. | Observation | Recommended Action Plan | Recommended Timeline |
|---|---|---|---|
| 1 | Discrepancies between drawing provided and the as-constructed building | Building Engineer required to prepare As –Built drawings reflecting the actual condition. | 6-weeks |

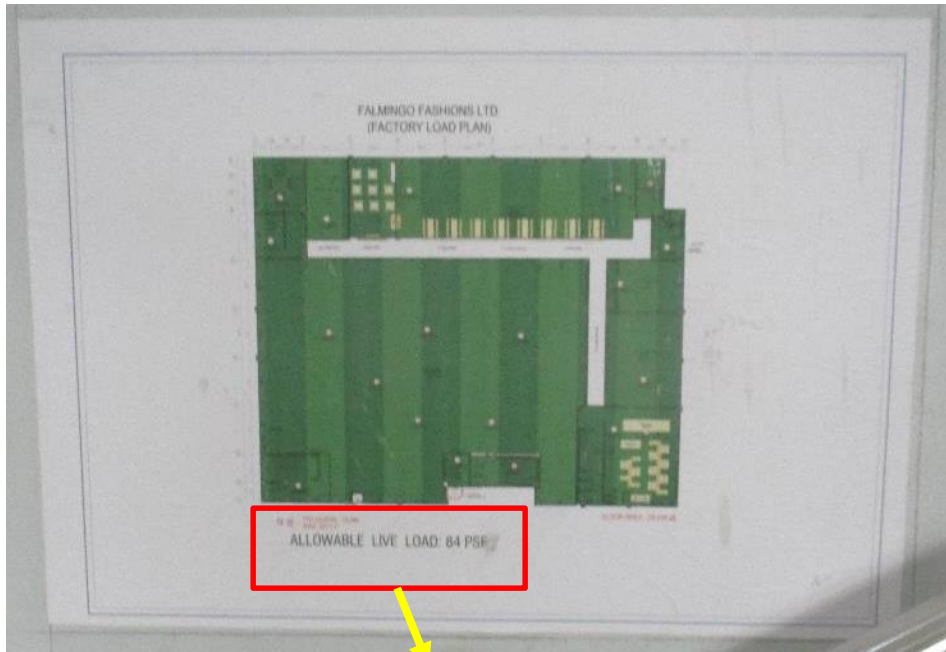
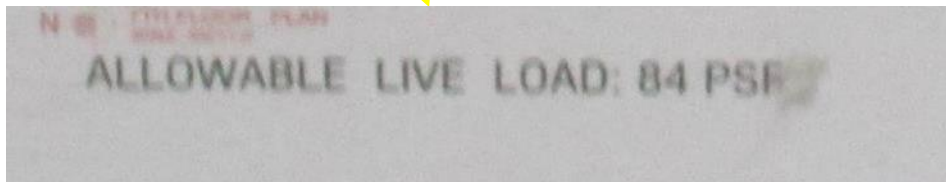
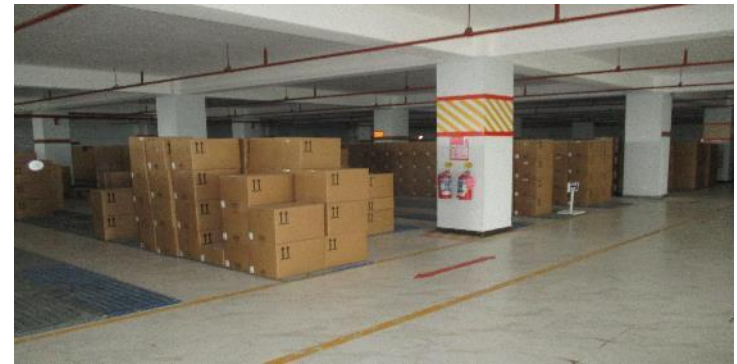
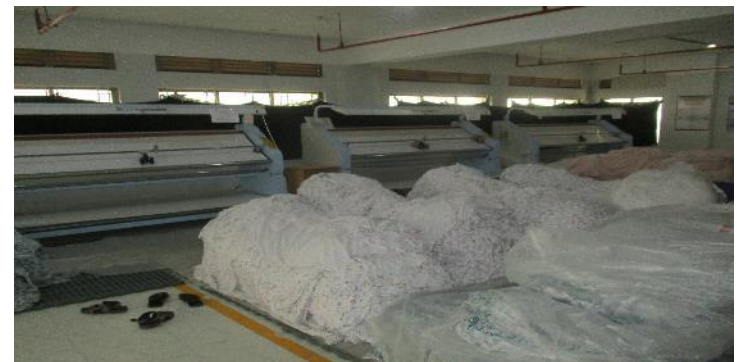
Factory Engineer prepared a load plan considering 4 Kpa (84 psf) allowable floor loading for production building. Design review required if the factory management wants to implement that load plan

Factory is required to maintain floor live load 3Kpa until further verification by design engineer. During inspection, no overloading was observed and FOS calculation for internal column was found satisfactory considering 3Kpa allowable live loading.

**Observation: Prepared Load Plan required to be verified**

| Item No. | Observation | Recommended Action Plan | Recommended Timeline |
|---|---|---|---|
| 2 | Prepared Load Plan required to be verified | Maintain 3 Kpa loads on all floors. | 6-weeks |
| 3 | Prepared Load Plan required to be verified | Produce and actively manage a load plan for all floor plates within the factory giving consideration to floor capacity and column capacity if loading above 3Kpa is considered. | 6-weeks |
| 4 | Prepared Load Plan required to be verified | Continue to implement load plan | 6-months |
