# Jerat Shirt Limited

Plot - 188/189, Nasirabad I/A, Baizid, Chittagong.  
(22.387914N, 91.812415E)  
9<sup>th</sup> March 2017

# Observations

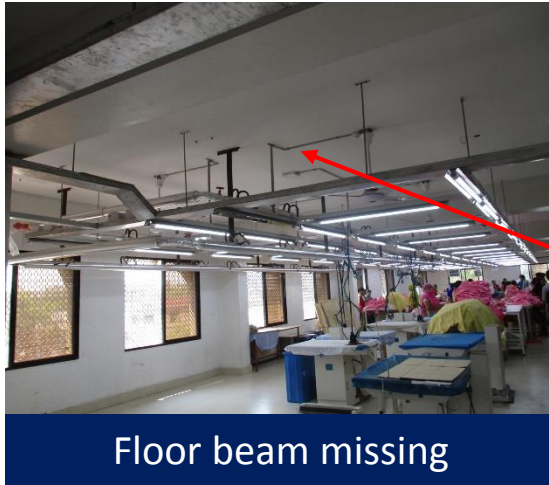
Floor beam missing

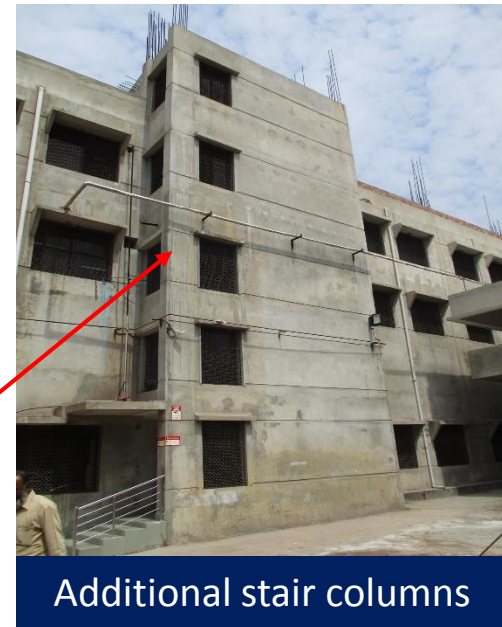
Additional stair columns

Two number of columns with beam at south side stair were not shown in drawing. Again, two additional columns with a beam were shown in drawings but not found on site. factory engineer to survey the structure and update the as-built drawings.

| Item No. | Observation | Recommended Action Plan | Recommended Timeline |
|---|---|---|---|
| 1 | Mismatch in as-built drawings of production building | Building Engineer is required to survey the structure and update the as-built architectural and structural drawings to the “as-constructed” status. | 6-weeks |

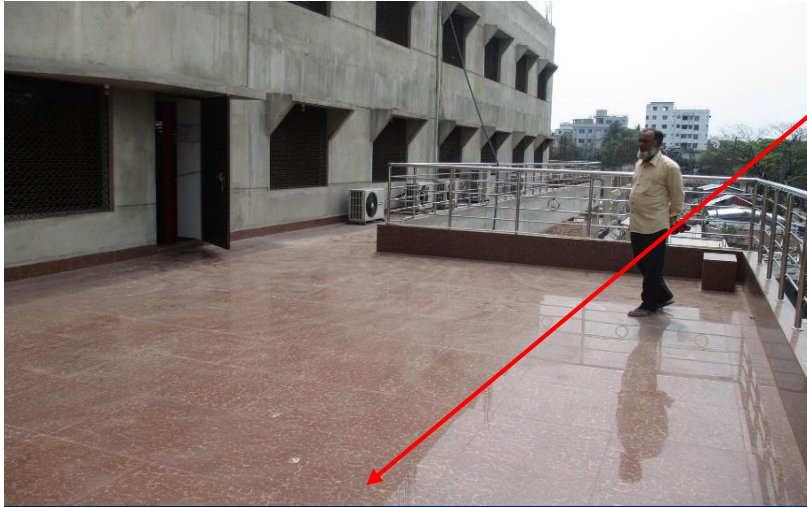
The porch and the cantilever beam and slab not shown in as-built drawings.

Provided as-built drawing does not matched with as-built conditions. Floor built-up, roof top water tanks, cantilever slab, porch and some internal partition walls were not mentioned in as-built drawings. Factory engineer to update the as-built drawings as per actual scenario.

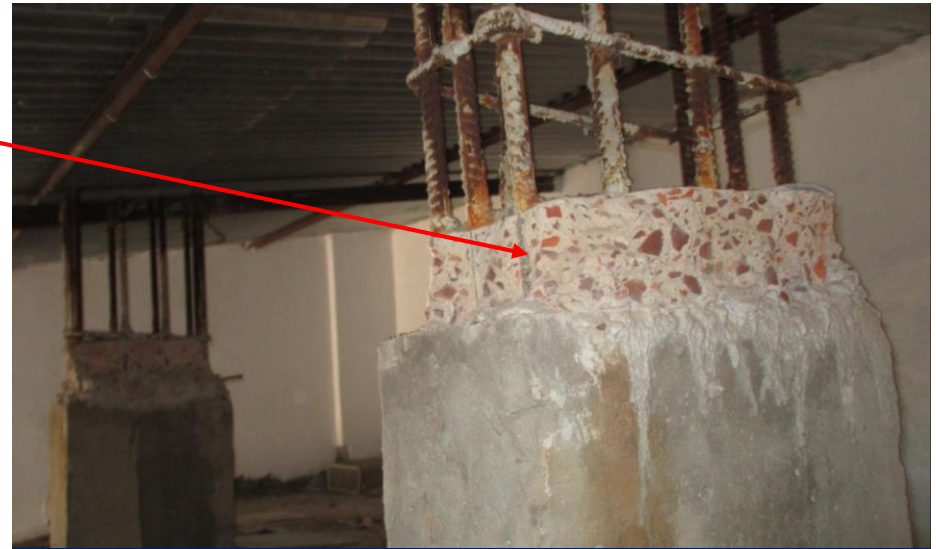
10 numbers of rebar found on column C5

10 numbers of rebar were found inside for the column C5 where drawing shows 12 numbers.

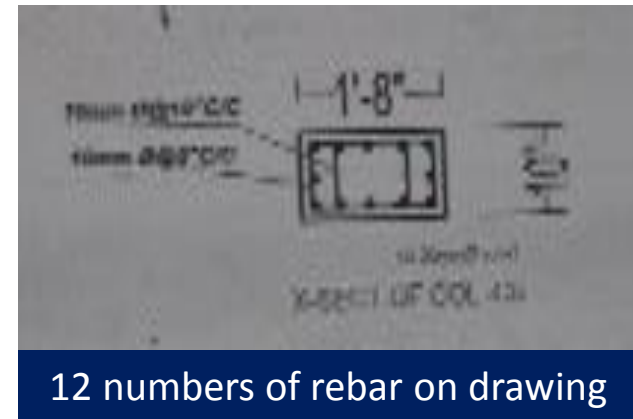
12 numbers of rebar on drawing

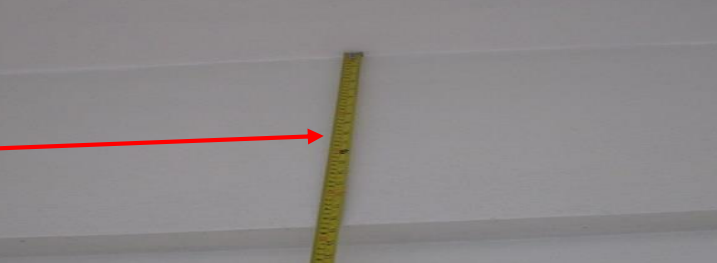
LONG SECT. OF R.BEAM-RB4

The dimension of floor beams for RB2, RB3 and RB4 does not matched with as-built conditions.

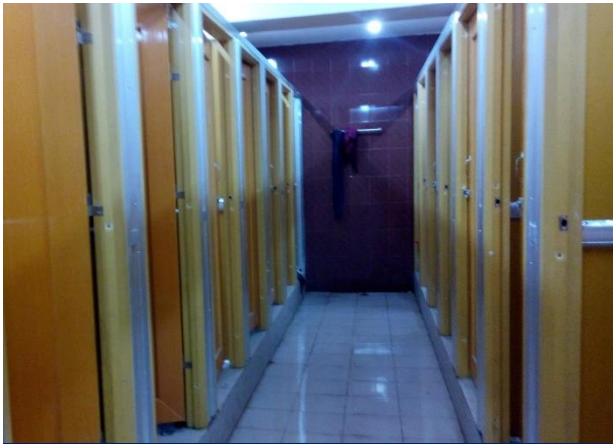
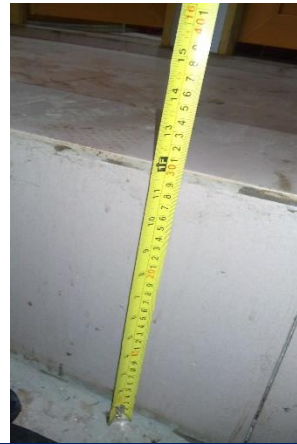
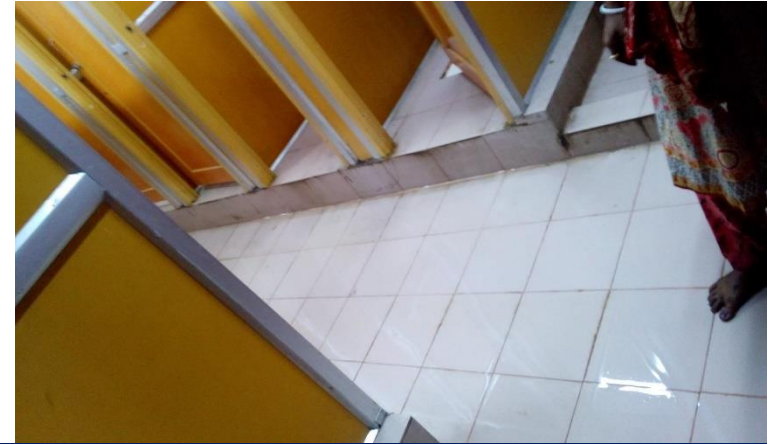
The floor built up on toilet zone not shown in as-built drawings.

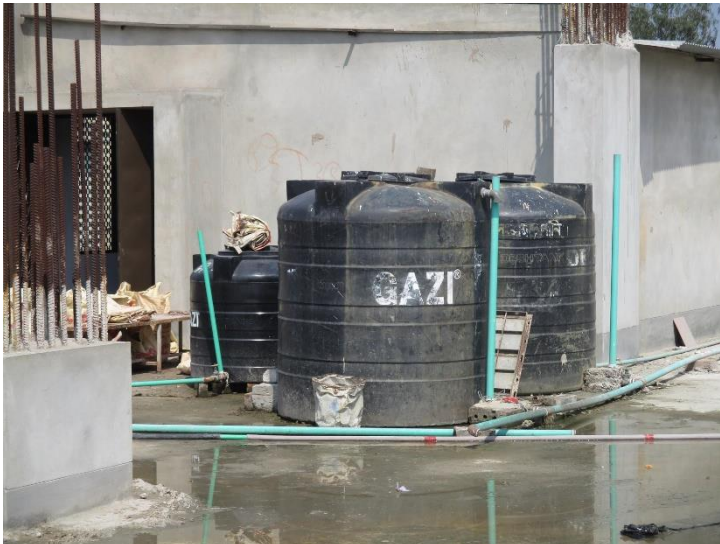
Roof top water tanks were not shown in as-built drawings.

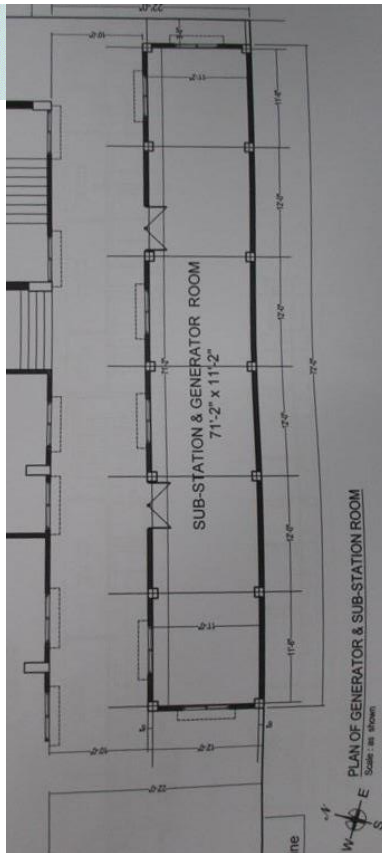
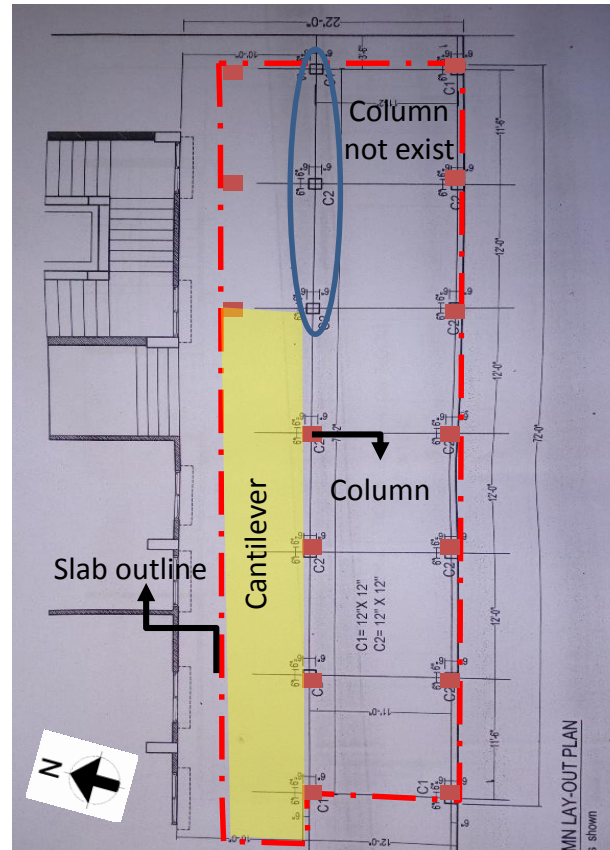
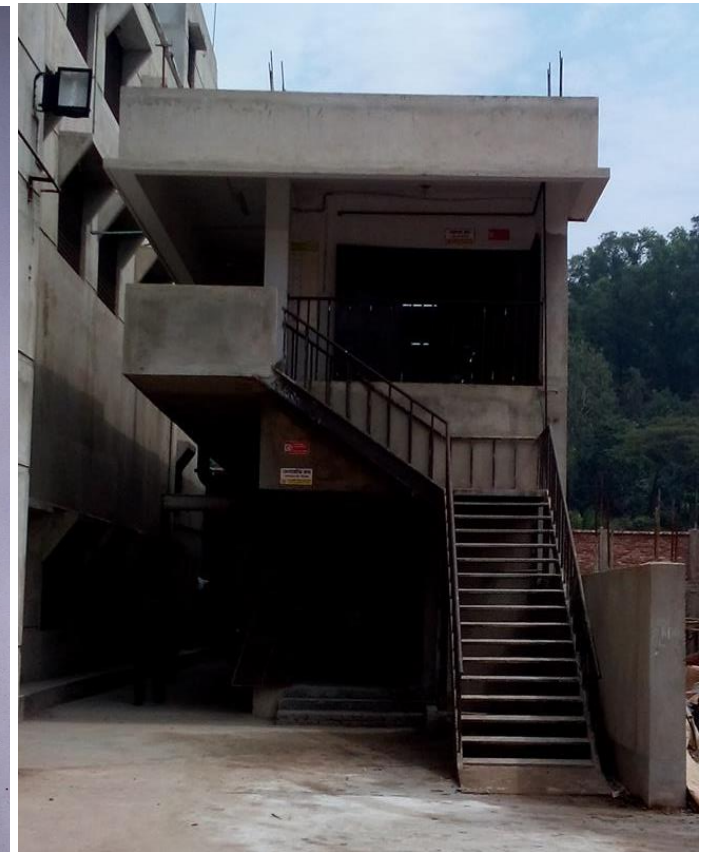
Floor & Column Layout Plan

As-built drawing of Utility Building does not match with as-built conditions.  
The column dimension and the grid spacing not match's with drawings.  
Factory engineer to update the as-built drawings to the as-constructed status.

| Item No. | Observation | Recommended Action Plan | Recommended Timeline |
|---|---|---|---|
| 2 | Lack of as-built drawing for the utility building | Building Engineer is required to prepare the as-built architectural and structural drawings for the utility building. | 6-weeks |

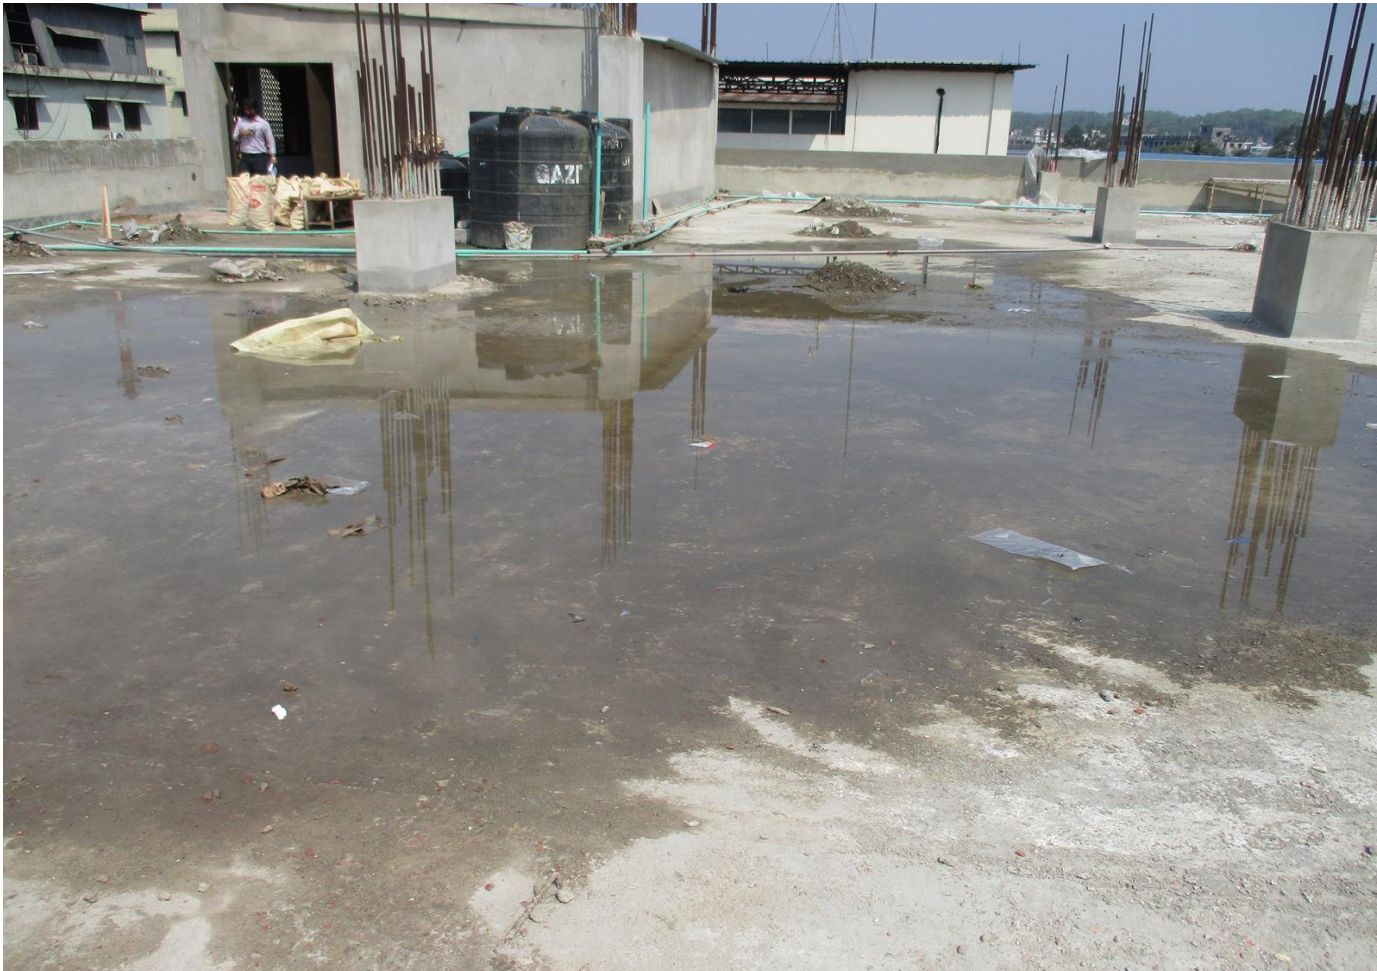
Water ponding was observed on the roof of production building. Proper drainage system and water proofing membrane need to be apply on roof to resist water ingress into the slab.

| Item No. | Observation | Recommended Action Plan | Recommended Timeline |
|---|---|---|---|
| 3 | Lack of water proofing membrane on the roof of production building | Building engineer to develop drainage system and apply water proofing membrane on the roof | 6-months |

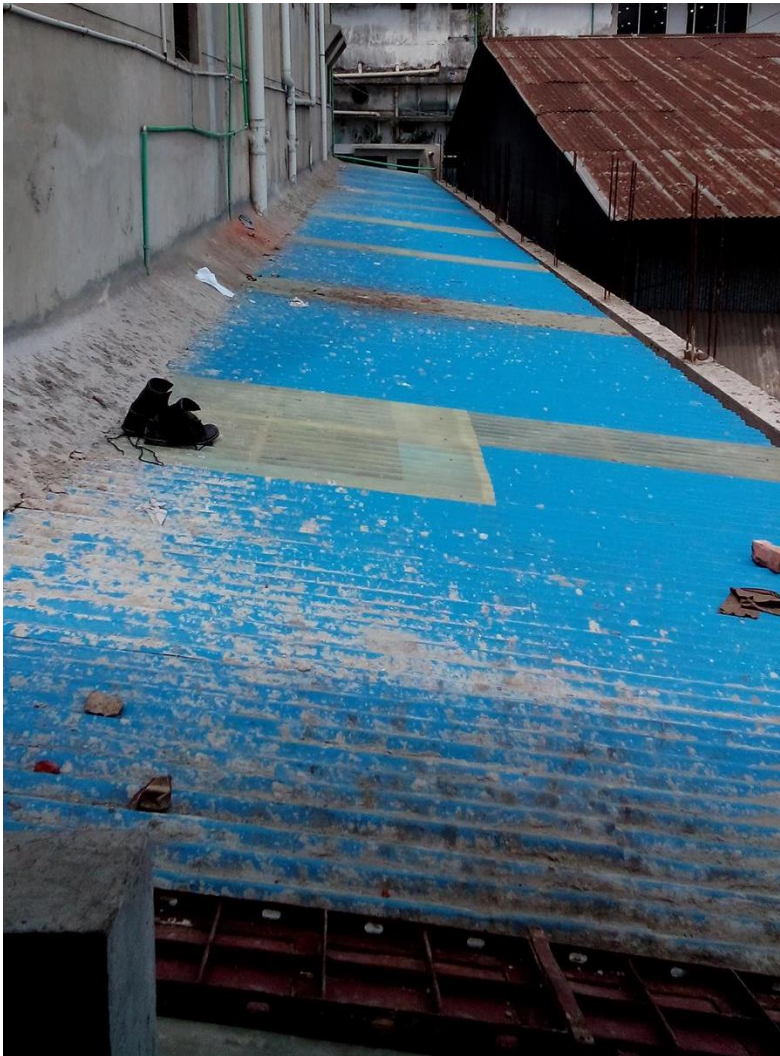
Mono-pitched roof lean to the production building

The support between steel frame and production is not clear for the light weight steel roof in the premises of the factory. The drawing of the roof system were not available on site. Factory engineer to prepare as-built drawing including support details and check the adequacy of supports.

| Item No. | Observation | Recommended Action Plan | Recommended Timeline |
|---|---|---|---|
| 4 | Non engineered steel roof lean to production building | Factory engineer to be checked the connections and adequacy of the steel roofing against wind loading. | 6-weeks |
| 5 | Non engineered steel roof lean to production building | Carry out repair works if required | 6-months |

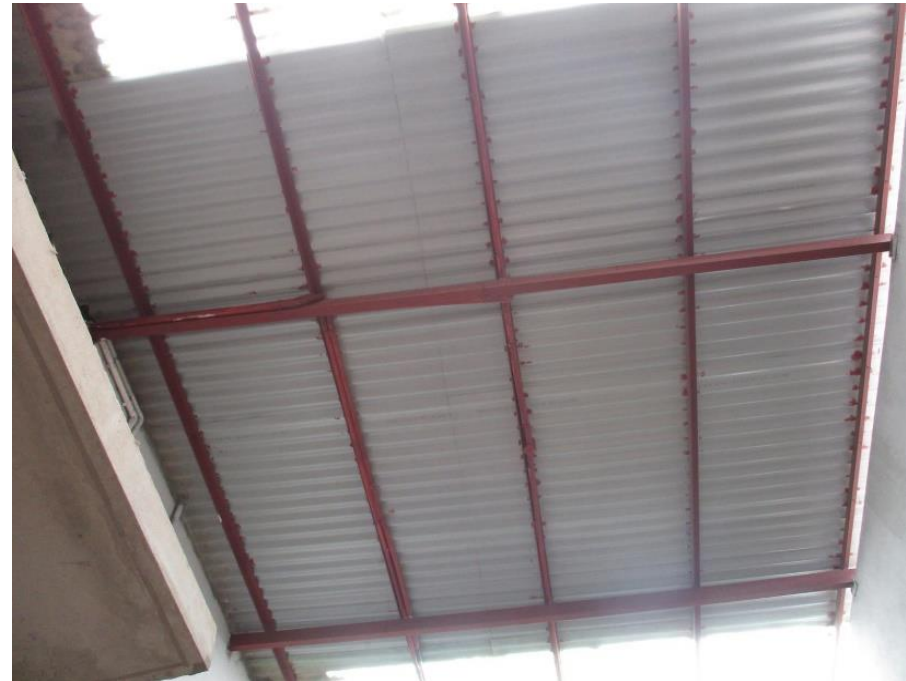
Steel framing

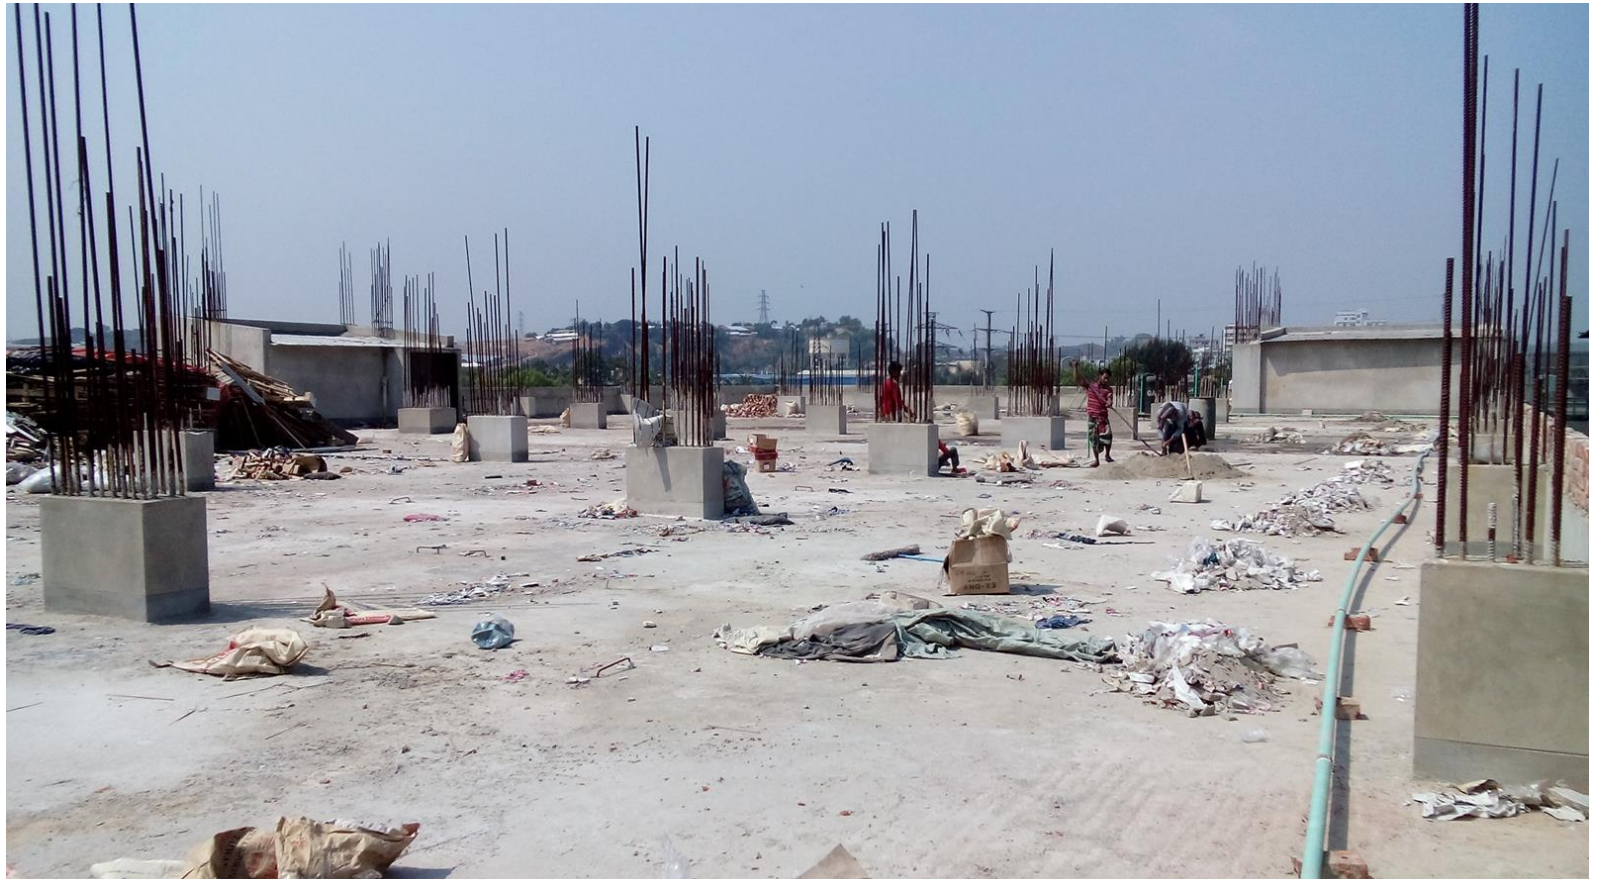
Factory has permit of 8 storey factory building from local authority (CDA). If any extension above 3-storey to be carried out, building engineer is required to carry out a Detail Engineering Assessment considering BNBC provision.

| Item No. | Observation | Recommended Action Plan | Recommended Timeline |
|---|---|---|---|
| 6 | Extension to be carried out | Factory engineer to be carried out a Detail Engineering Assessment (DEA) prior to commencement of further construction above 3 storey. | 6-months |
