# Ajax Sweaters Ltd.

Zirabo Bazar, Ashulia, EPZ Road, Savar, Dhaka,  
(23.914509N, 90.318490E)  
18<sup>th</sup> May 2014

# Observations

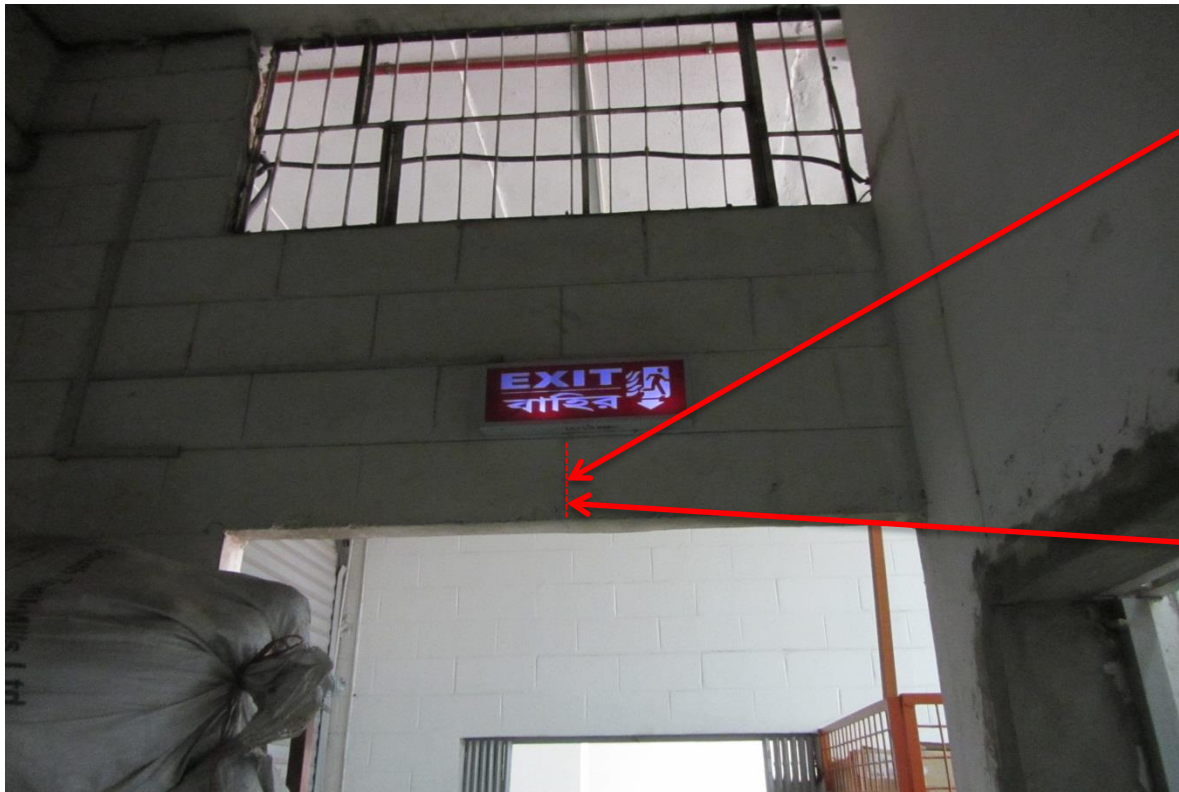
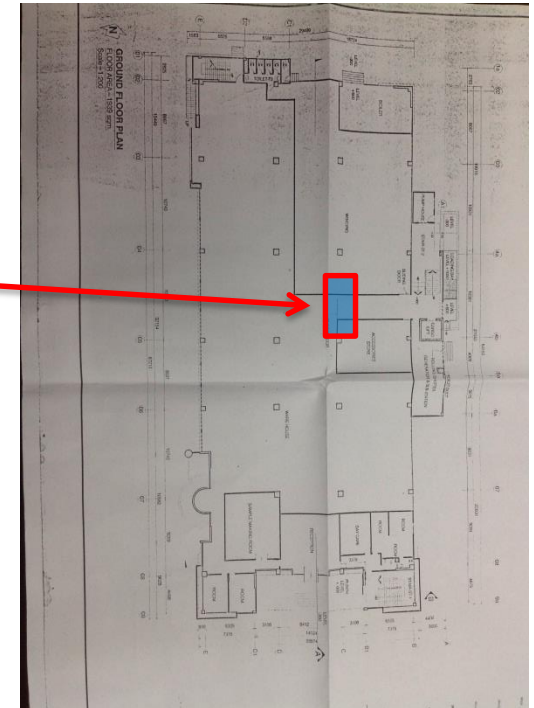
**No support to wall above opening  
at ground floor**

The opening shown has no lintel and there is a vertical crack in the mortar joint (as shown). The factory management were informed that the opening should be supported and stated that they would construct a suitable frame.

**ITEM 1:** No support to wall above opening at ground floor

Item No.	Observation	Recommended Action Plan	Recommended Timeline
1	No support to wall above opening at ground floor	Install lintel or suitable support frame. Note: This was raised during our inspection, the factory management stated that they will construct a suitable support frame	6-weeks
2	No heat protection to slab soffit evident above naked flame. Risk of heat damage to structure	Install suitable protection to slab soffit above drier to prevent damage to slab	6-weeks
3	Cracking to external façade at third floor.	Monitor cracks in wall.	6-months
4	Cracking to external façade at third floor.	If crack width increases, seek advice from suitably qualified structural engineer.	6-months

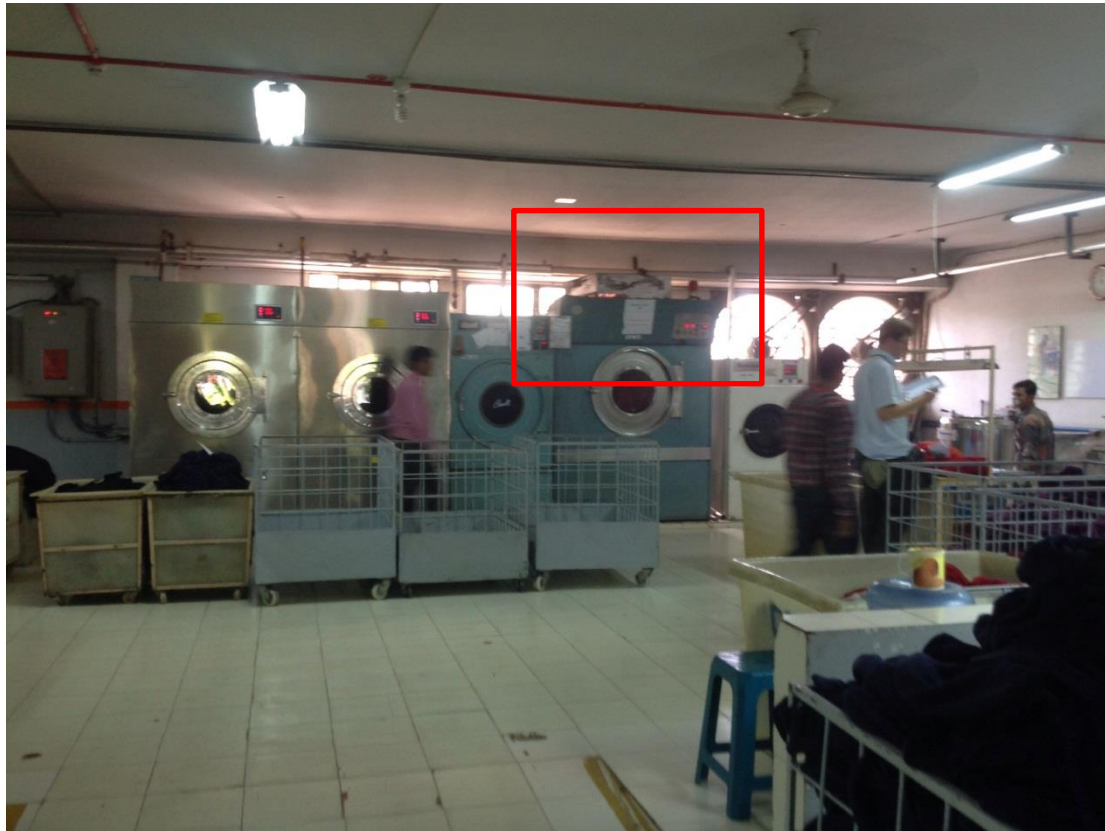
**No heat protection to slab above naked flame**

No protection to slab soffit evident above naked flame. Risk of heat damage to concrete and PT tendons. Protection to be installed to prevent damage

**No heat protection to slab above gas fired dryer**

**ITEM 2:** Heat protection to slab above drier

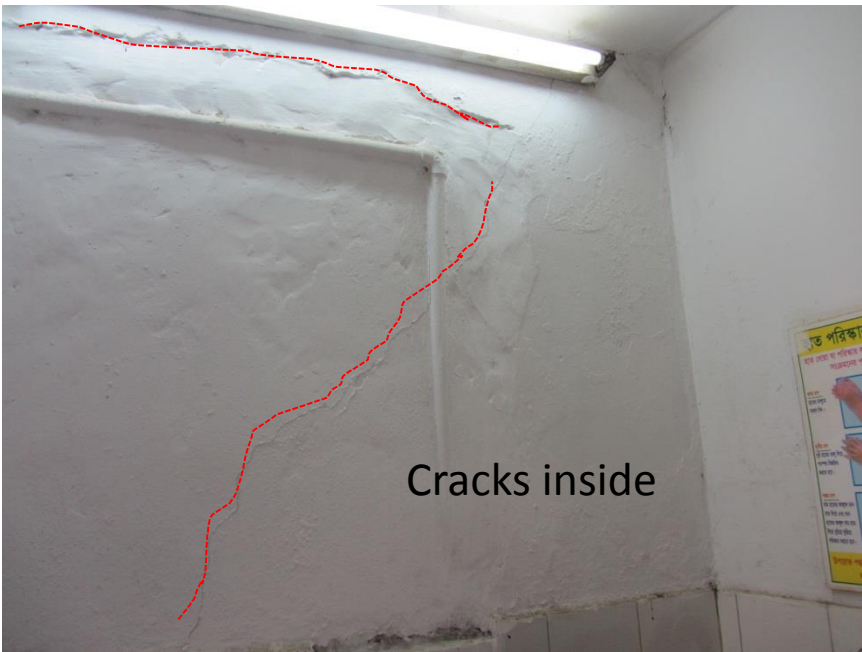
Cracks inside

Horizontal, vertical and diagonal cracks have been repaired in the area shown. These may have been caused by settlement of the foundations.

**ITEM 3:** Cracking to external façade at third floor.

Cracks should be monitored on a regular basis

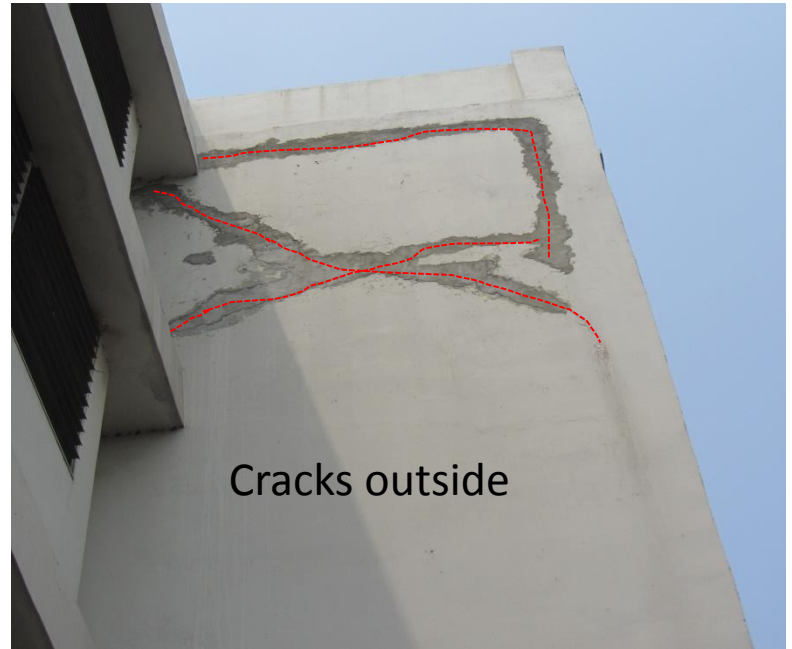
Cracks outside

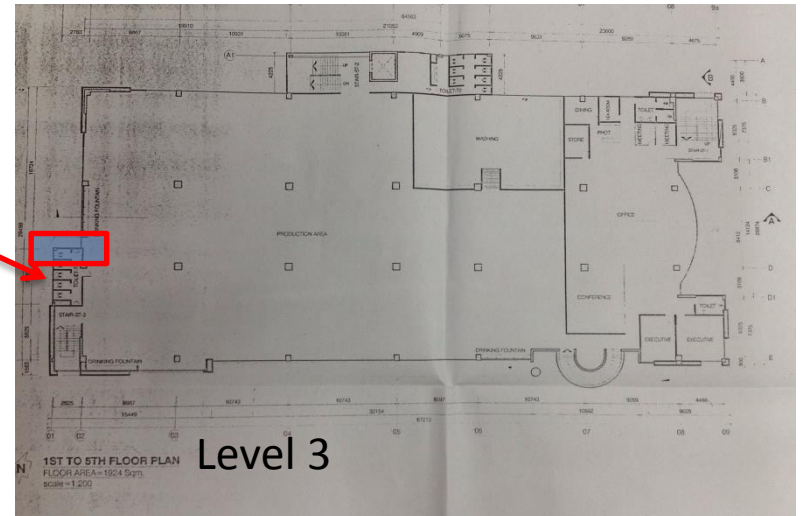
Level 3

## Cracking to external façade
