One Up Sweaters Ltd.

122-123 Choydana, National University, Bangladesh.

21st May 2014

Building Observations

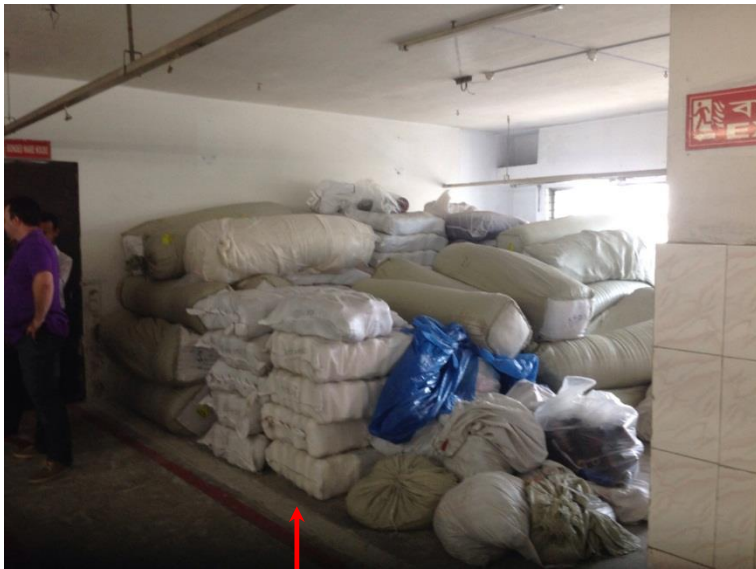
Local high stress levels in columns

Area designated to be 'Knitting Inspection' area instead used as storage. Load was applied to building edge where concrete slab cantilevers from column line.

- **No additional storeys may be constructed until the verification of column stresses is complete.**
- Building Engineer to review design, loads and column stresses at ground floor level.
- Verify in-situ concrete stresses either by 100mm diameter cores or existing cylinder strength data from min. 4 columns.

- Produce and actively manage a loading plan for all floor plates within the factory, giving consideration to floor capacity and column capacity.

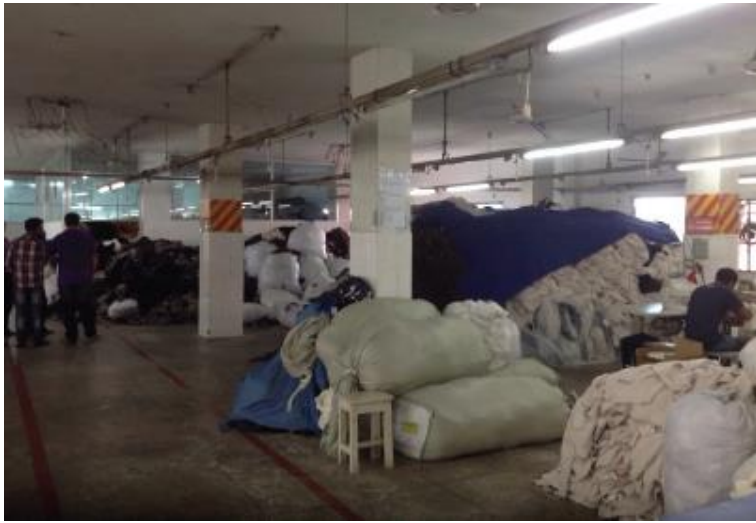
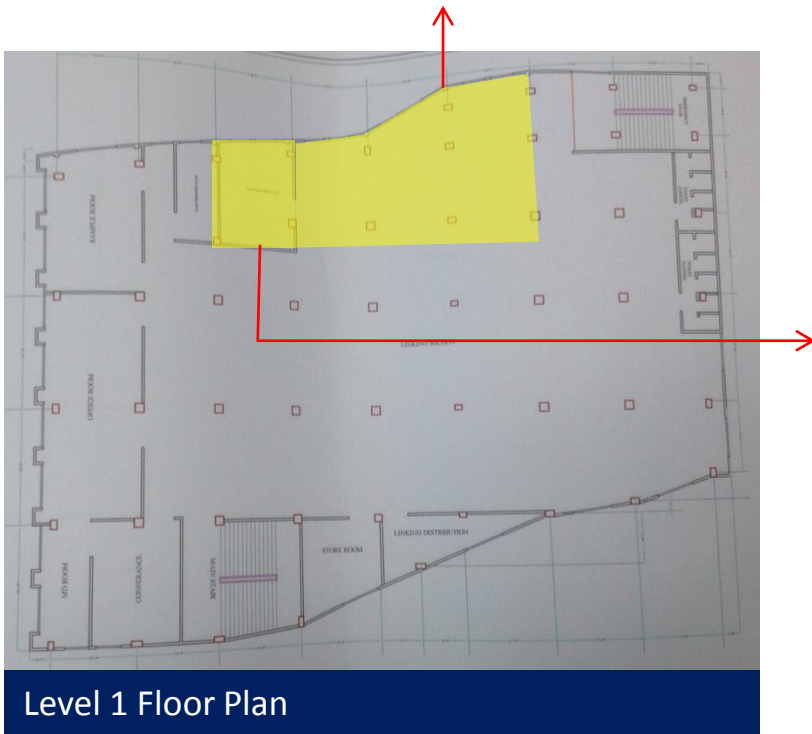
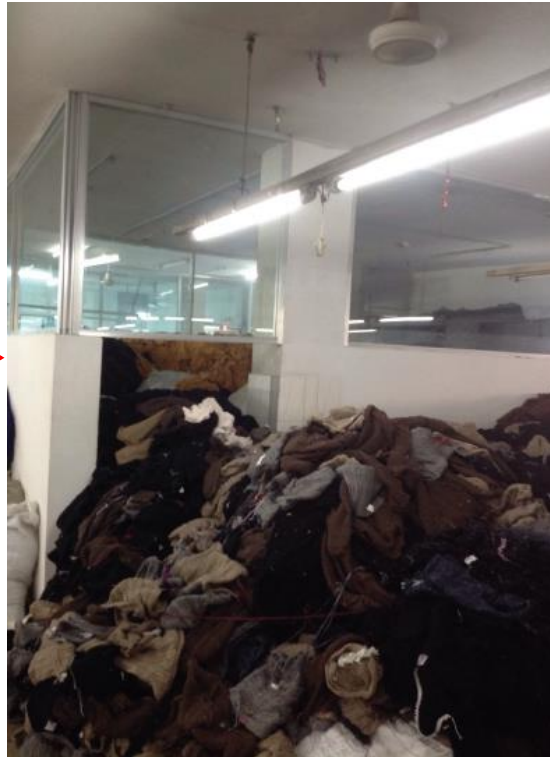
High storage loading on slabs

- Building Engineer to check the adequacy of structure against storage load.
- Building Engineer to review design, loads and stresses in RC slabs, including cantilevers. The slab check should include a punching shear check.
- Verify in-situ concrete stresses in the slabs either by 100mm diameter cores or existing cylinder strength data for cores from 4 locations remote from columns.

- Implement any strengthening / remedial works as required arising from slab checks.
- Input findings from slab checks into loading plan (see Item 1).

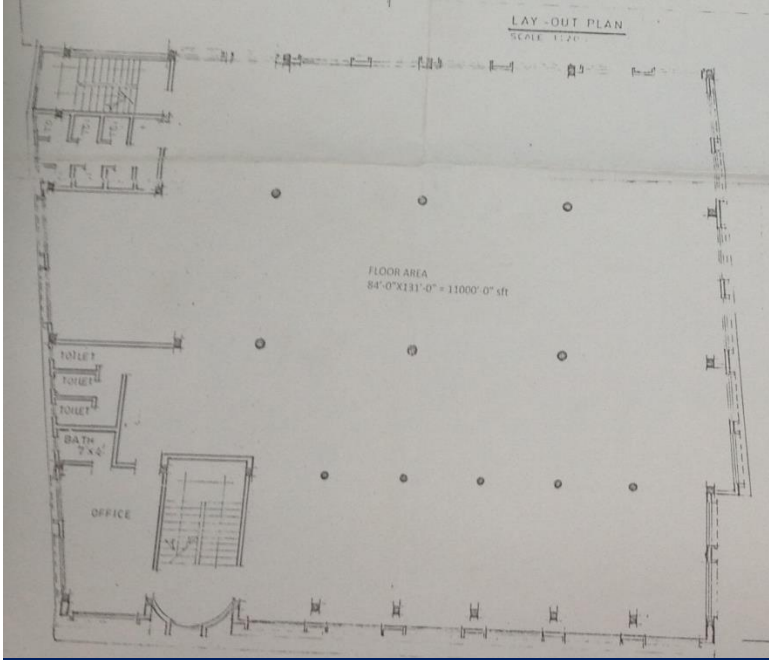
Permit Drawing – No Cantilevers shown.

- Building Engineer to survey building.

- Building Engineer to update all drawings to reflect as-built construction.

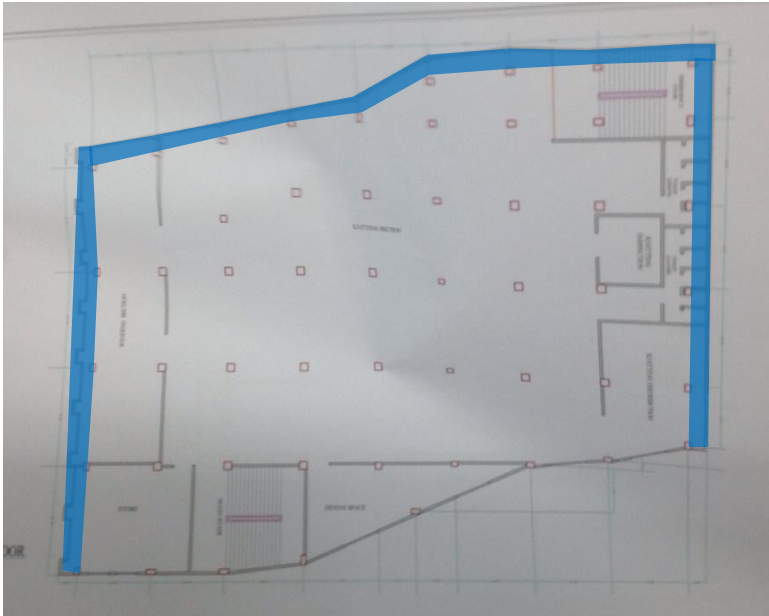
Structural Drawing – Cantilevers shown.

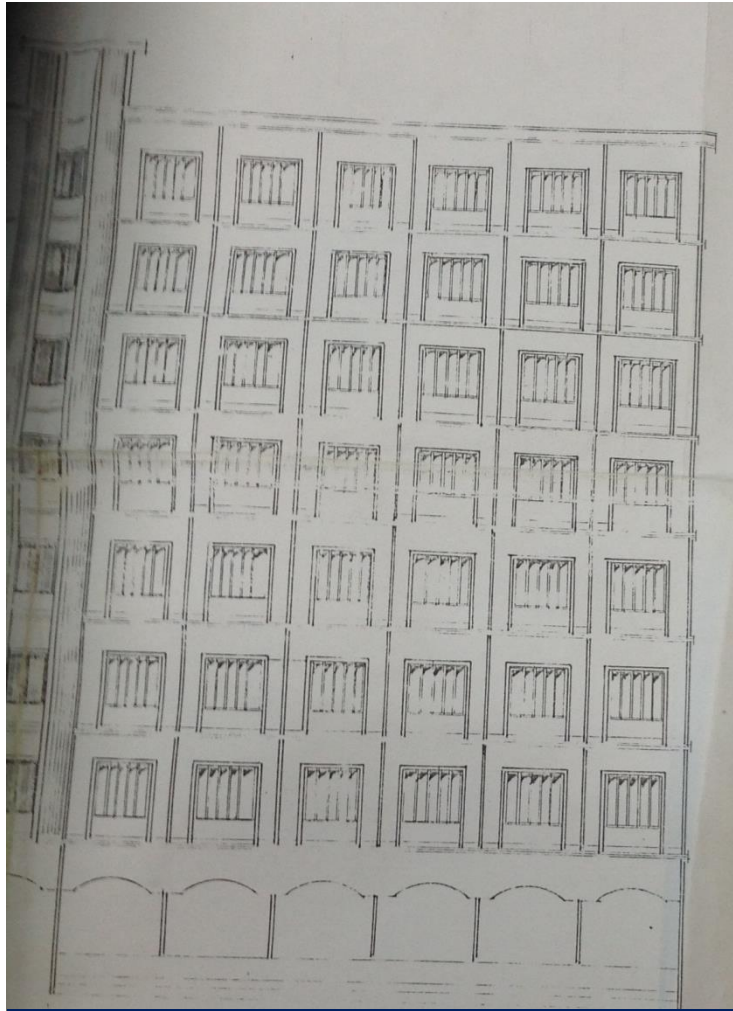
Permit Drawing – 8 Storey Building

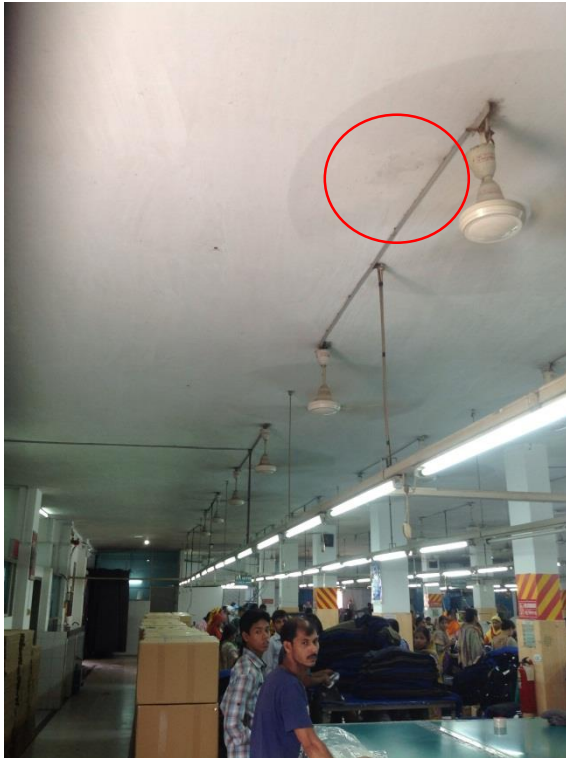
1st Floor soffit

Recent patch repairs carried out on concrete slab soffit in numerous locations

- Building Engineer to assess extent and nature of cracking.

- If cracking is of a structural nature, Building Engineer to specify required structural repairs / strengthening.
- Structural repairs / strengthening to be carried out.

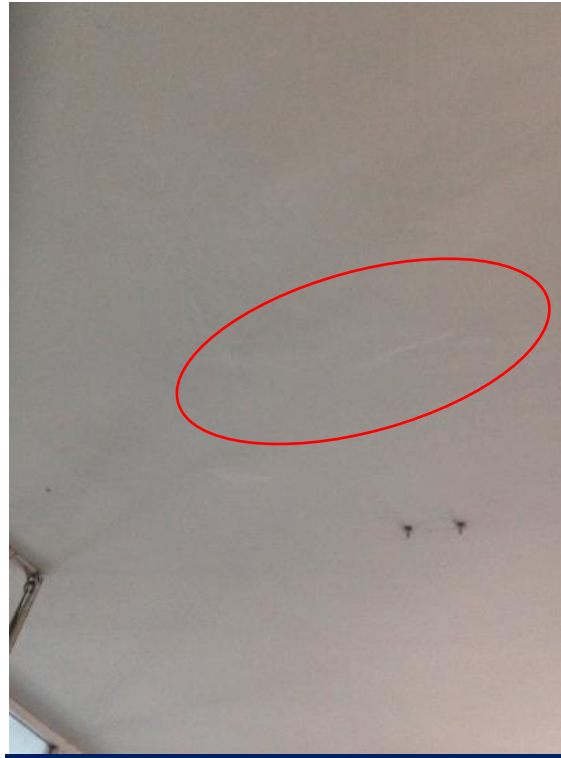
2nd Floor soffit

Recent patch repairs carried out on crack in soffit in numerous locations.

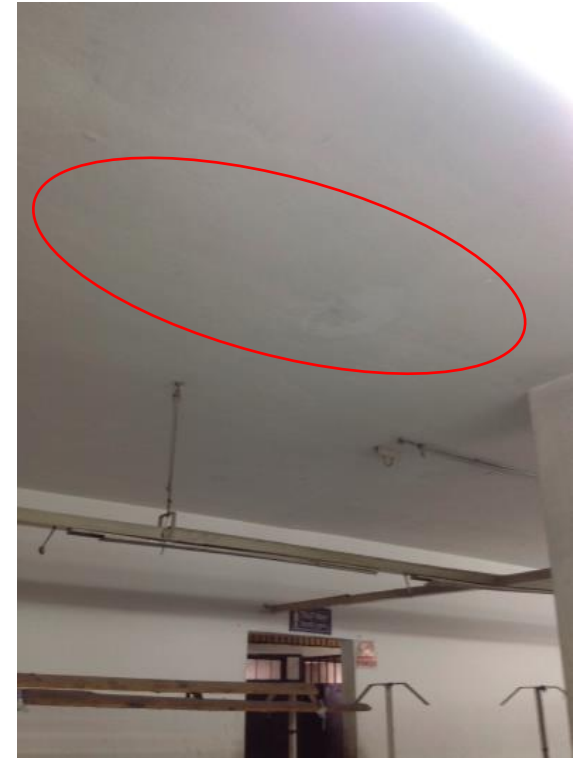
3rd Floor soffit

Crack in concrete slab soffit

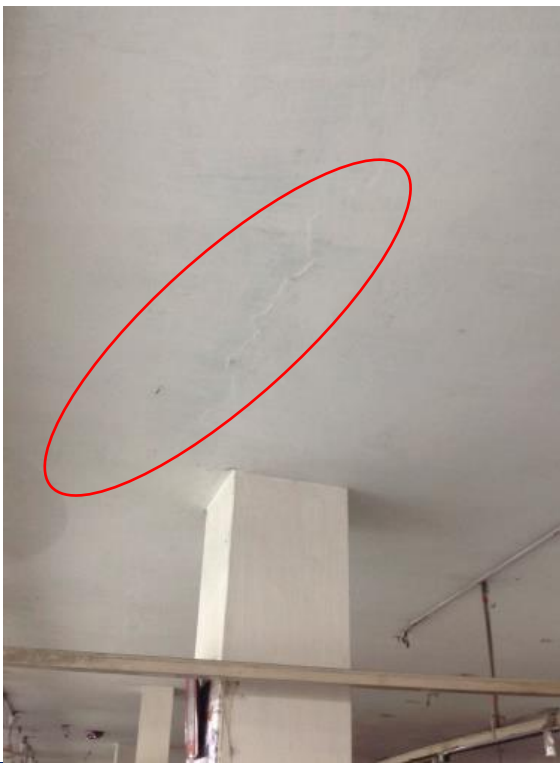
2nd Floor soffit
Crack on concrete slab soffit

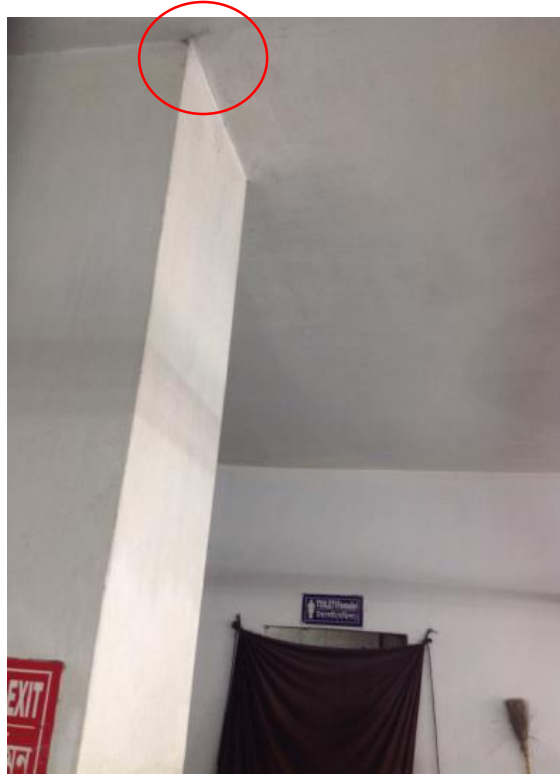
2nd Floor soffit
Crack originating from RC column

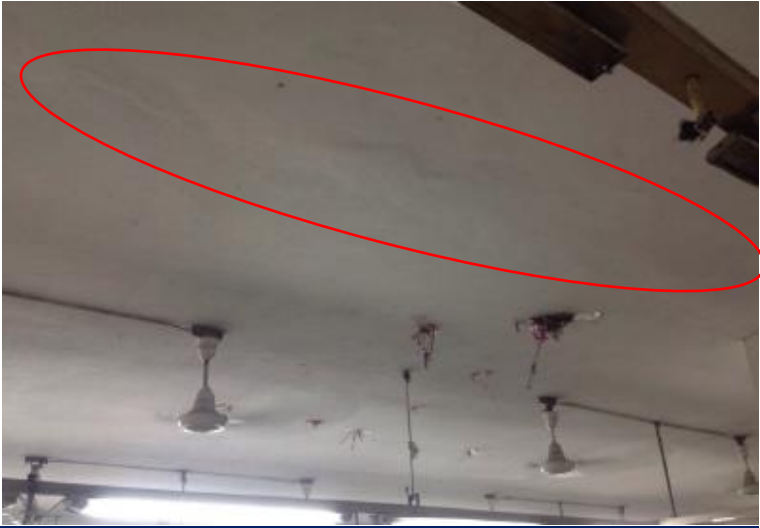
2nd Floor soffit

Crack in concrete slab soffit running along the full length of floor plan

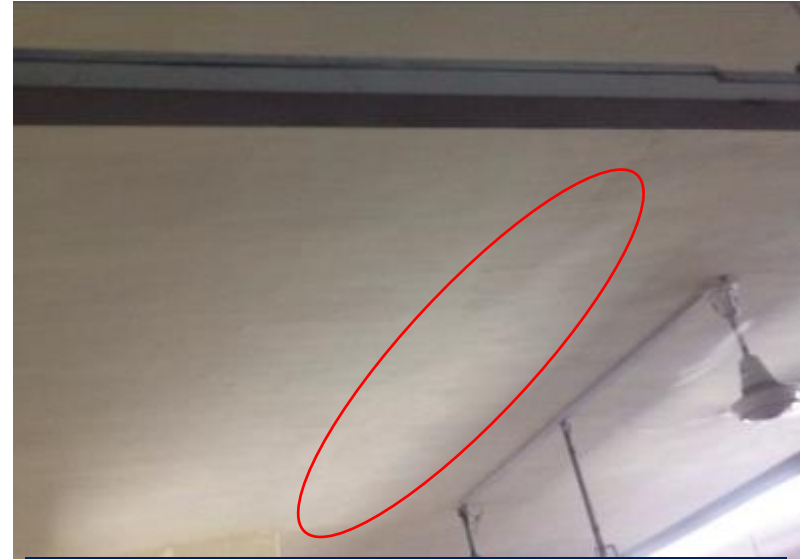
4th Floor soffit

Crack in concrete soffit

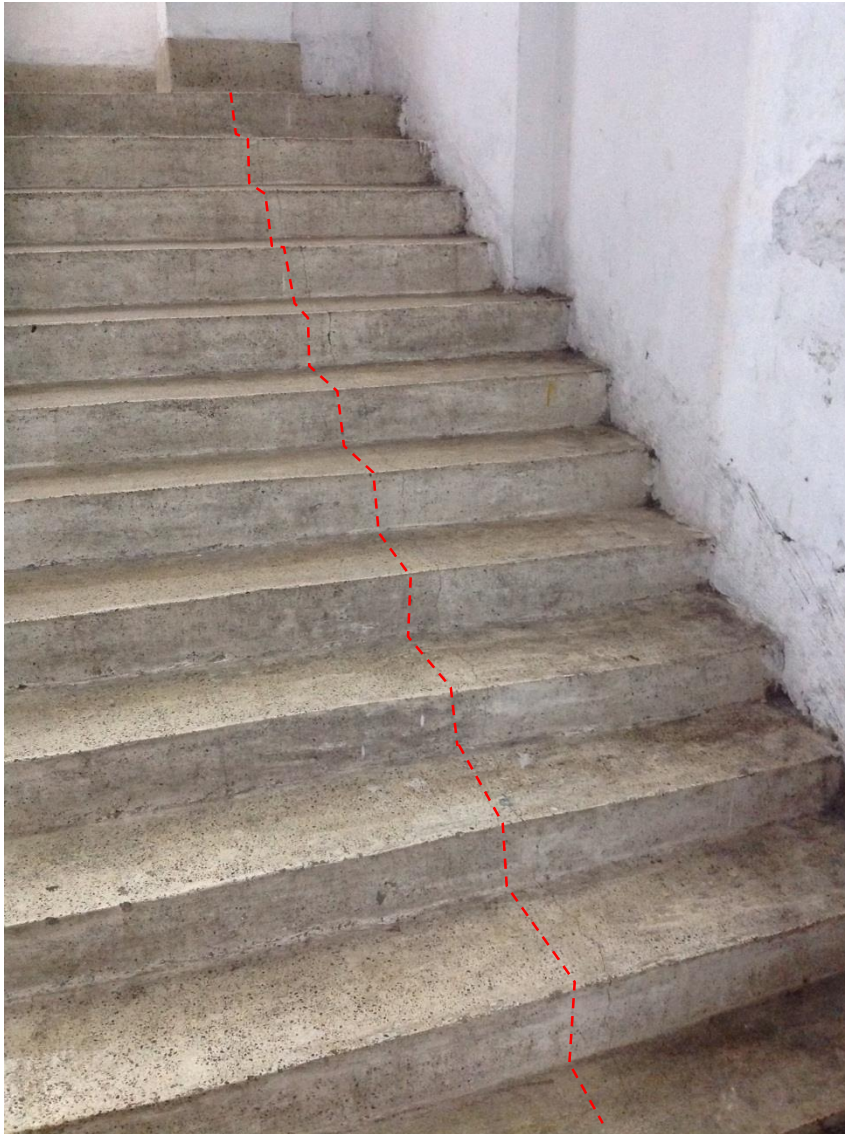
Localised crack along stairs descending onto Ground floor.
Crack is likely to be caused by poor construction.

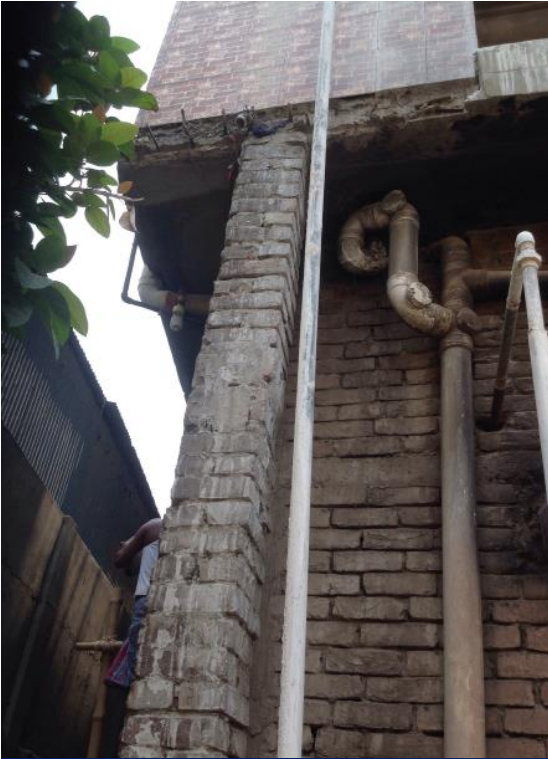
Ground Floor –
External brick column is distorted/twisting.

- Building engineer to check structural capacity of external brick pier.

- Reconstruct if required.

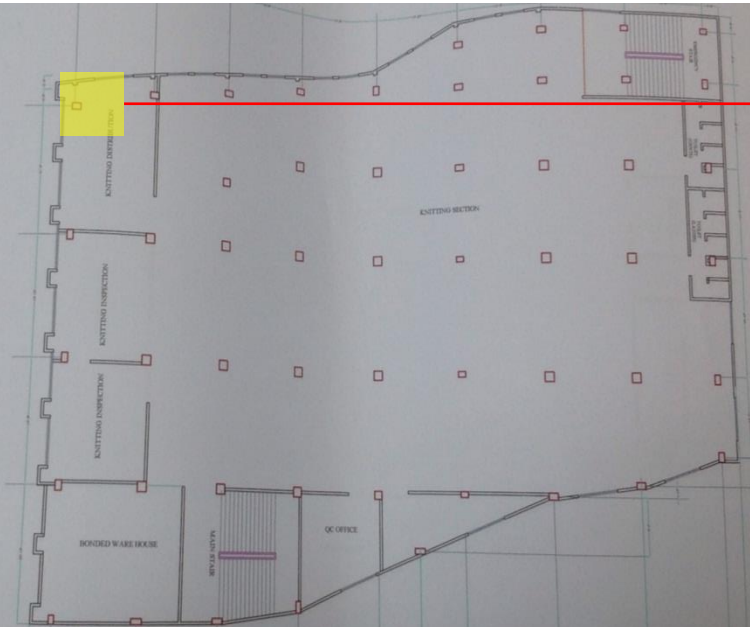
Level 2 and 3 Floor Plan

Additional concrete / steps build-up on slab

- Building engineer to check the adequacy of structure against additional load

- Implement any strengthening / remedial works as required arising from load checks.

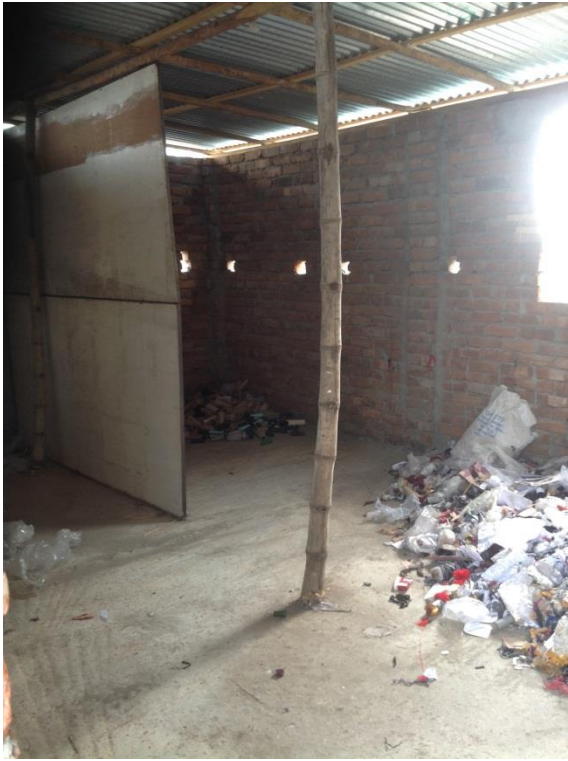
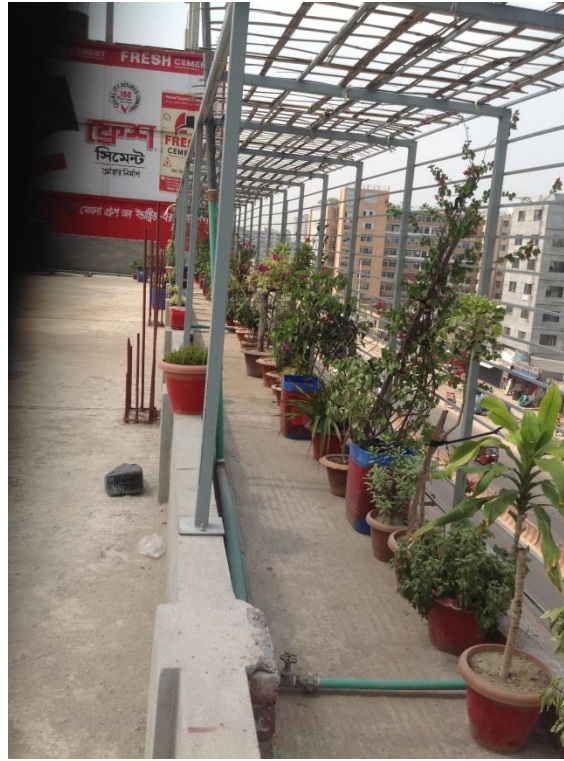
Non-engineered lightweight steel roofs

- Lightweight roof structures to be analysed by Building Engineer to ensure adequacy for code vertical and wind loads by the Building Engineer.

- Implement any remedial / strengthening works arising from analysis.
