# Disney Sweater Ltd.

Barpa, Rupshi, Rupgonj, Narayangonj  
(23.747071N, 90.536042E)

22<sup>nd</sup> February, 2017

# Observation

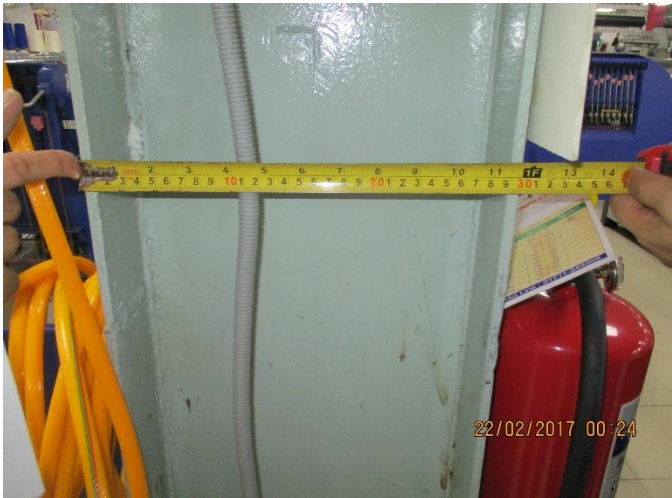
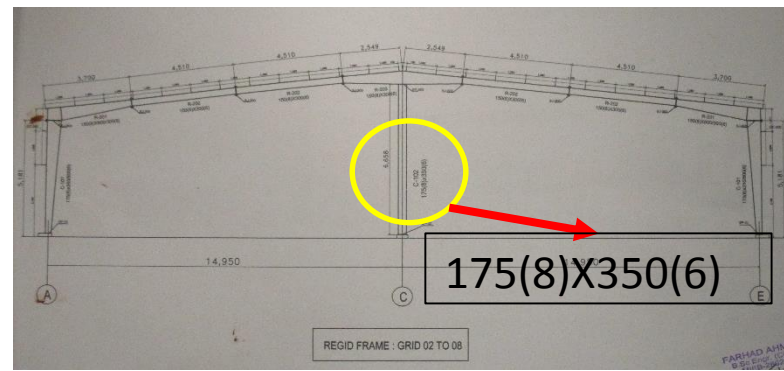
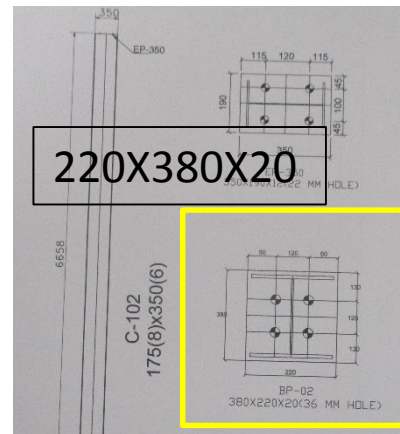
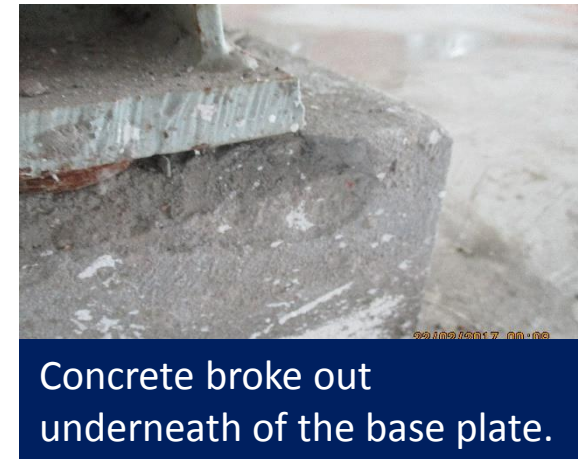
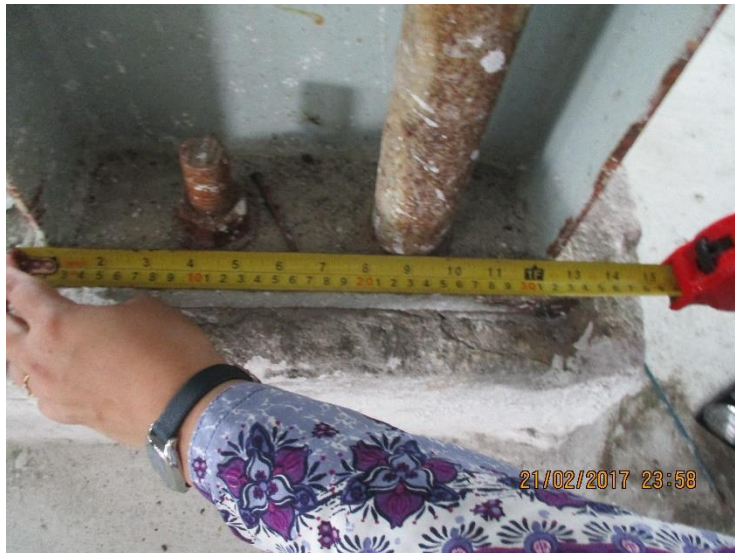
**Bracing layout, steel columns and base plate sizes doesn't match with structural drawings.**

Drawings shows columns are 175(8)X350(6) mm but on site column of 175(8)X300(6) mm was observed. Base plate was observed 220X330X20 instead of 220X380X20. Building Engineer is required to check the as built condition and prepare as built drawings. Also required to check the structural adequacy for the reduced size of section.

| Item No. | Observation | Recommended Action Plan | Recommended Timeline |
|---|---|---|---|
| 1 | Bracing layout, steel columns and base plate sizes doesn't match with structural drawings | Building Engineer is required to carry out the Engineering Assessment to ensure structural adequacy. Also check the lateral stability against lateral loading. | 6-weeks |
| 2 | Bracing layout, steel columns and base plate sizes doesn't match with structural drawings | Produce the update as built drawing as part of Engineering Assessment. | 6-weeks |
| 3 | Bracing layout, steel columns and base plate sizes doesn't match with structural drawings | Check the base plate adequacy against uplift force | 6-weeks |
| 4 | Bracing layout, steel columns and base plate sizes doesn't match with structural drawings | Carryout remedial works where necessary. | 6-months |

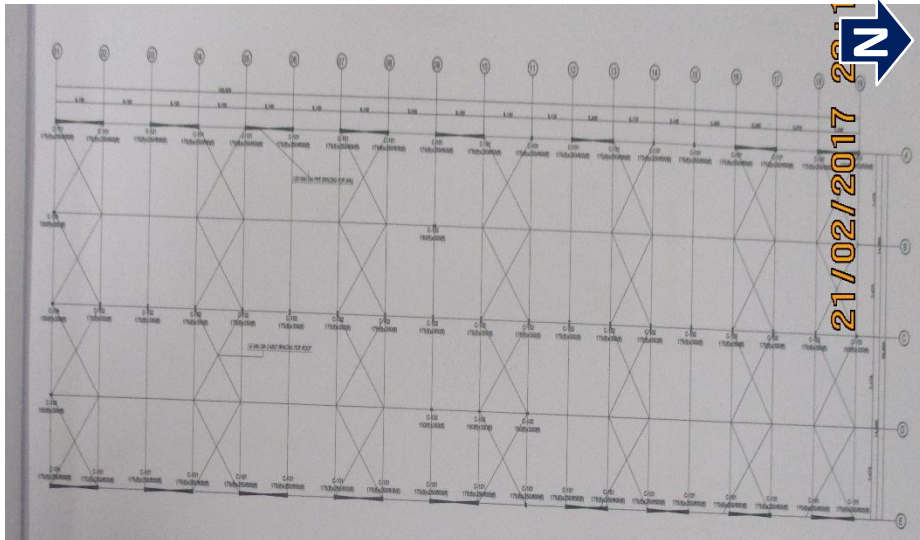
Bracing layout

Roof bracings were not installed as per drawings. It may effect the stability of the shed against lateral loading. Building engineer is required to check the lateral stability of the shed against lateral loading.

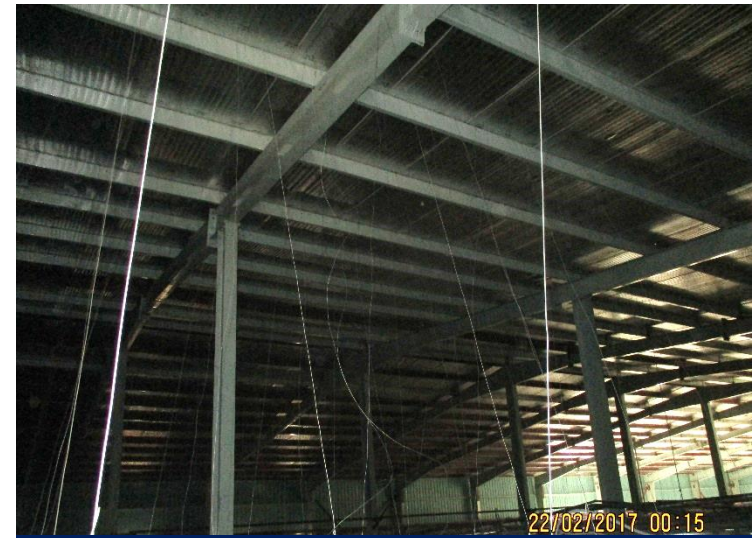
Missing bracing

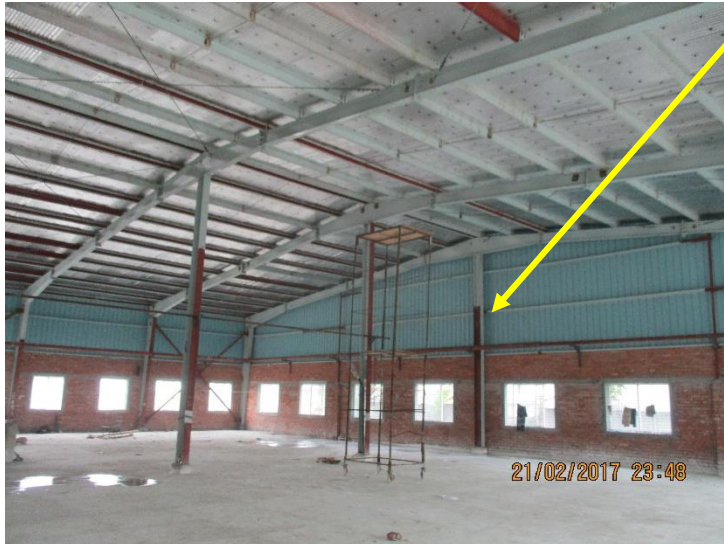
This frame  
suppose to  
be gable  
frame.

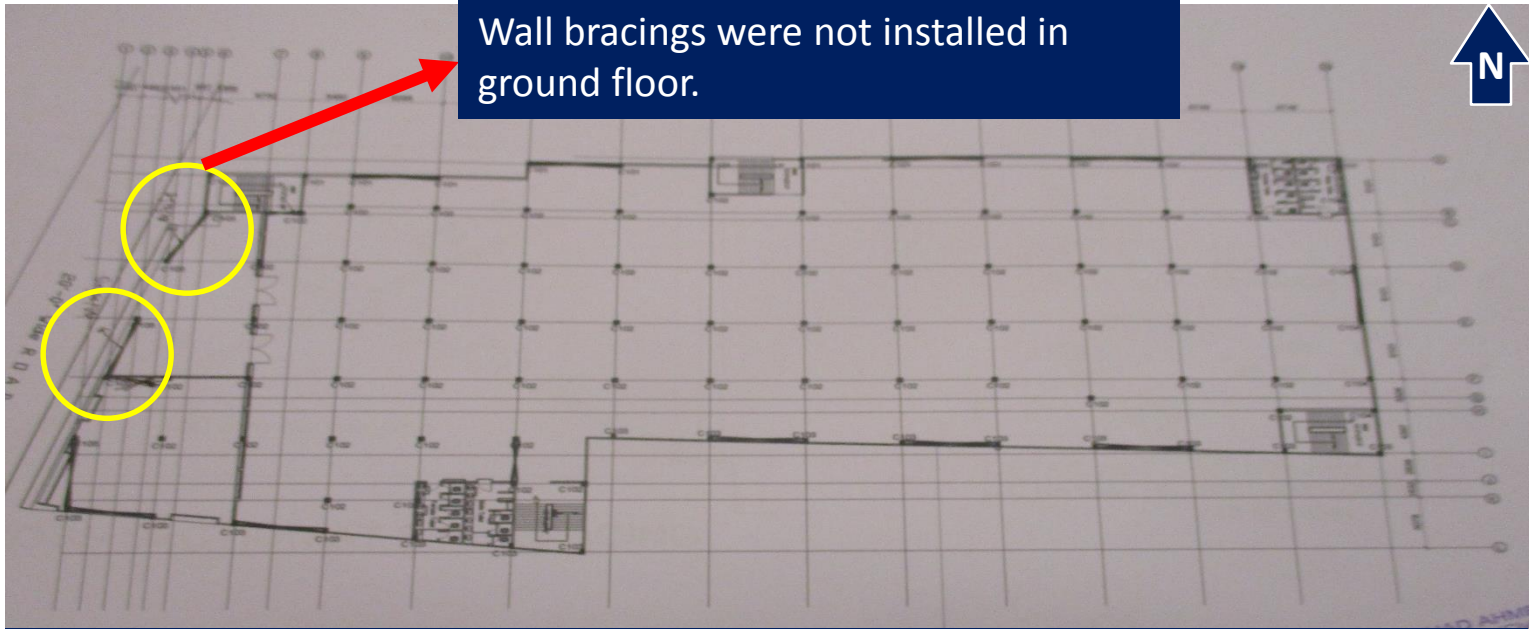
Wall bracing layout

**Wall bracings were found missing**

Wall bracings were not installed in ground floor.

| Item No. | Observation | Recommended Action Plan | Recommended Timeline |
|---|---|---|---|
| 5 | Wall bracings were found missing | Install the missing bracing to ensure stability. | 6-weeks |
| 6 | Wall bracings were found missing | Carryout remedial works where necessary | 6-months |

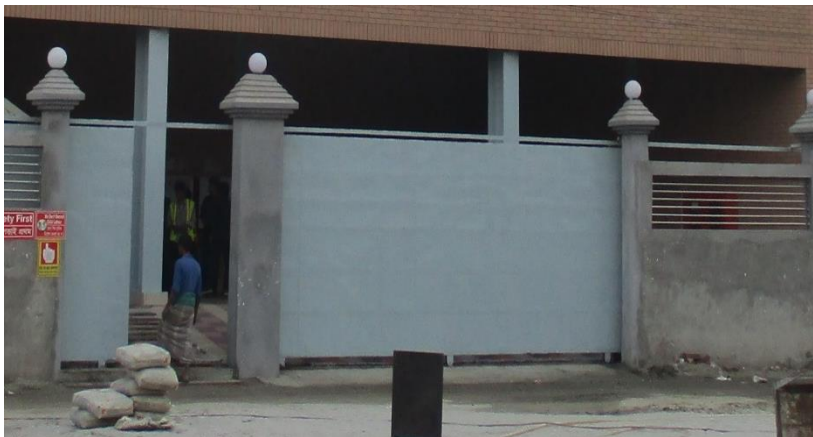
Wall bracing missing area in ground floor

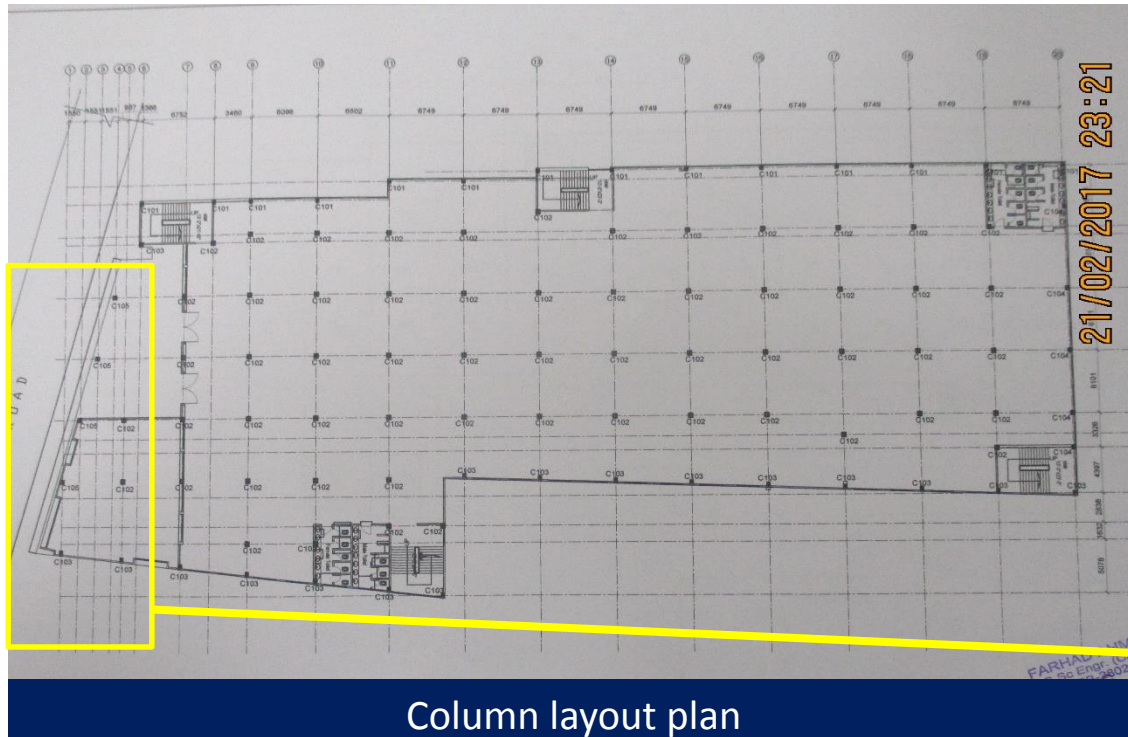
Column layout plan

**Column layout and size doesn't match with drawings.**

| Item No. | Observation | Recommended Action Plan | Recommended Timeline |
|---|---|---|---|
| 7 | Column layout and size doesn't match with drawings | Building engineer is required to check the on site condition and update the as built drawings. Structural members integrity is required to check for revised condition. | 6-weeks |
| 8 | Column layout and size doesn't match with drawings | Carryout remedial works where necessary | 6-months |

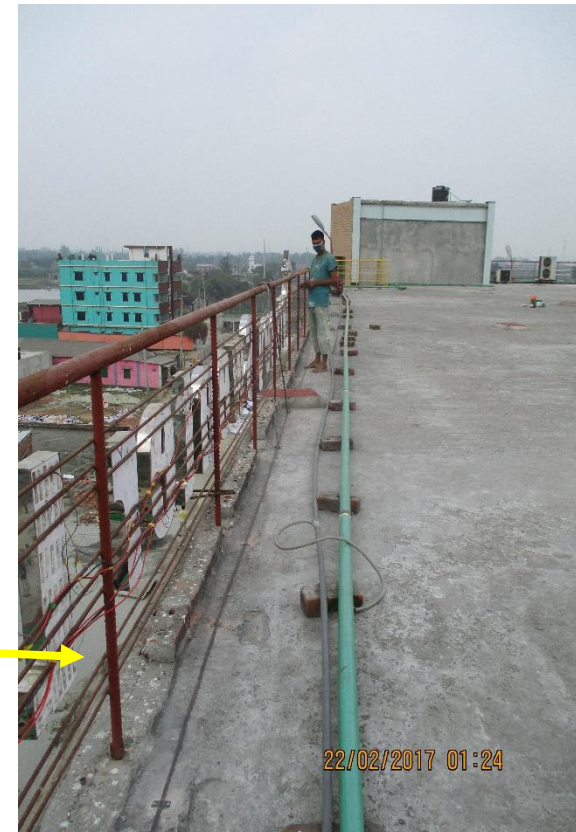
Column layout of this portion doesn't match with drawings.

Building engineer is required to check the site condition and update the as built drawings.

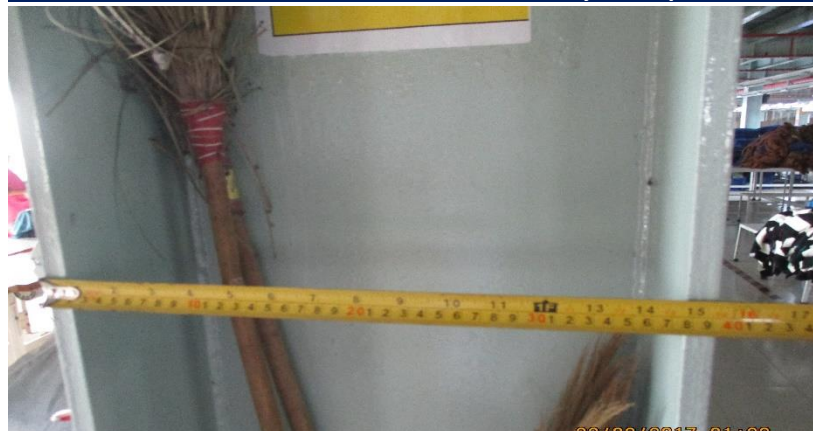
Several columns were found short of 10mm as per drawing

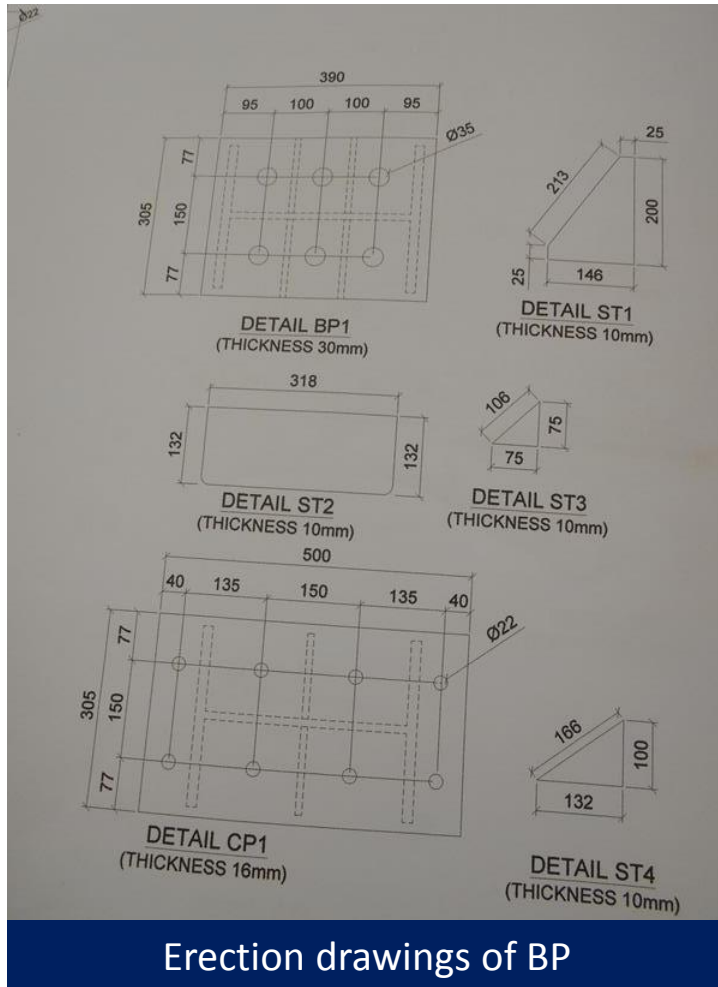
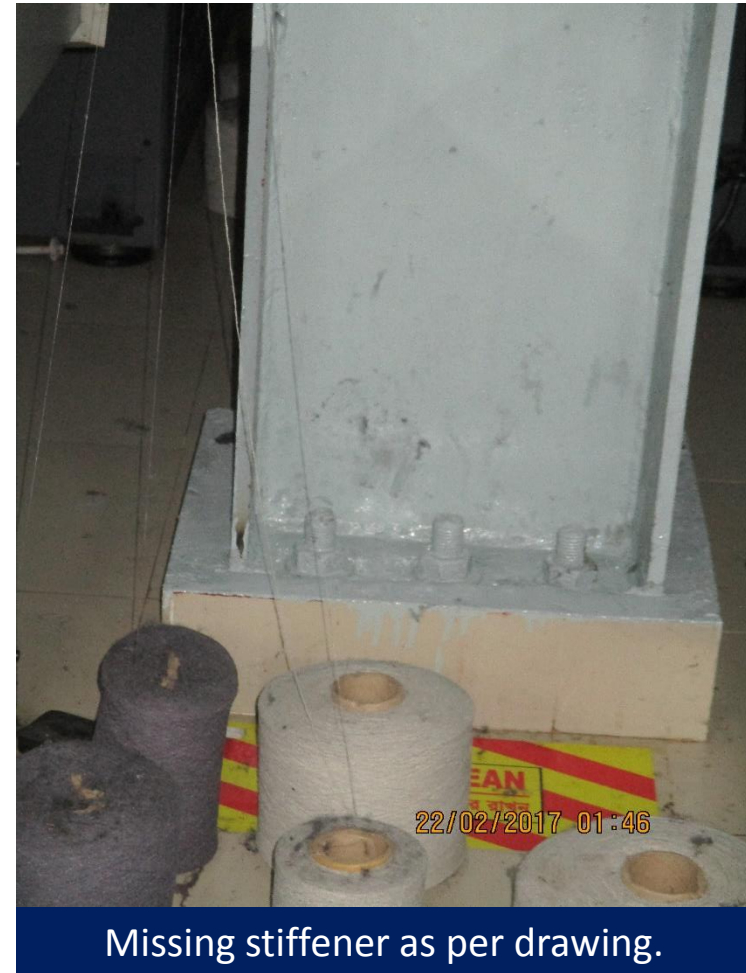
**Carryout steel fabrication & erection works as per drawing.**

Building engineer is required to check the steel erection and fabrication drawings and carry out the erection works where not installed yet

| Item No. | Observation | Recommended Action Plan | Recommended Timeline |
|---|---|---|---|
| 9 | Carryout steel fabrication & erection works as per drawing | Carry out erection and fabrication works as per drawings to supplement the design parameters. | 6-weeks |

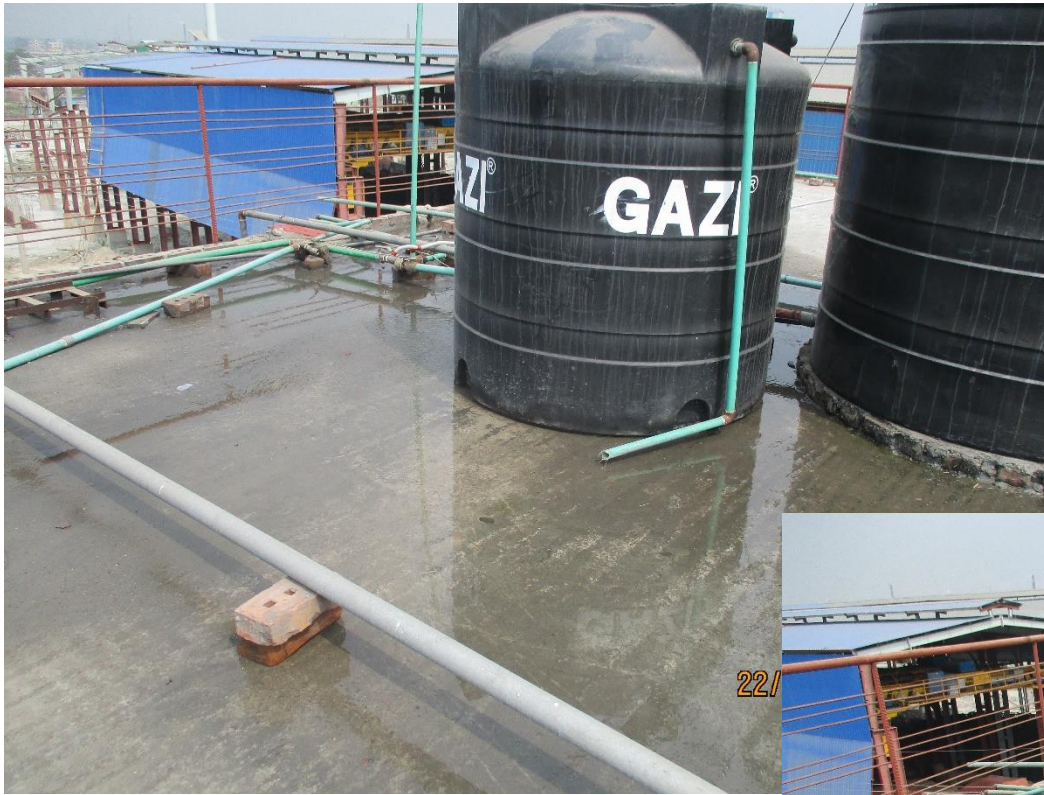
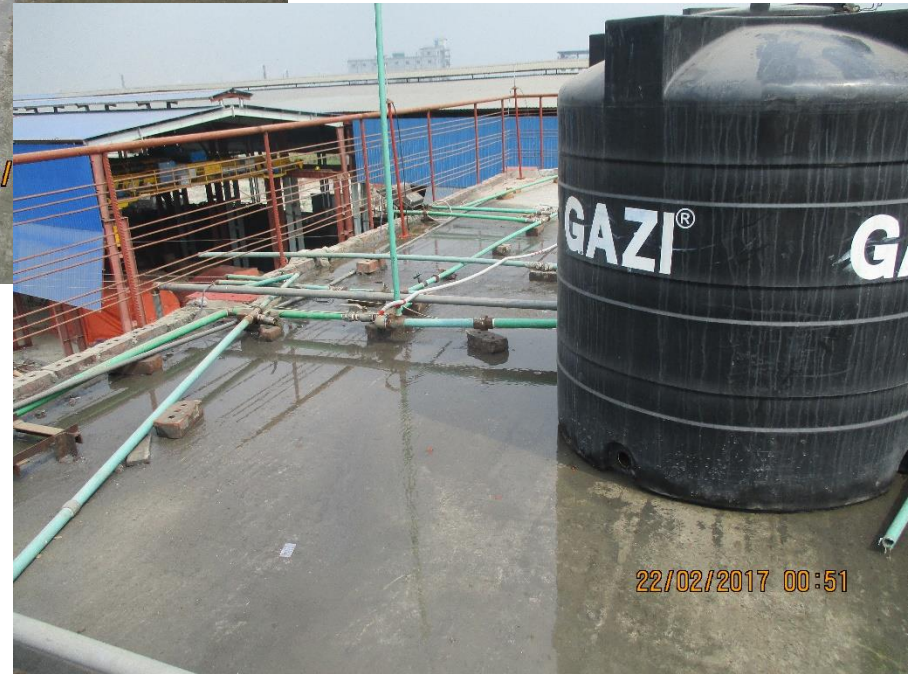
**Water logging at roof.**

Water logging was observed on roof. It may effect the steel section for long term effect. Building engineer is required to provide water proofing layer and drainage system to be improved.

| Item No. | Observation | Recommended Action Plan | Recommended Timeline |
|---|---|---|---|
| 10 | Water logging at roof | Improve the drainage system to prevent long term effect of water logging. | 6-months |

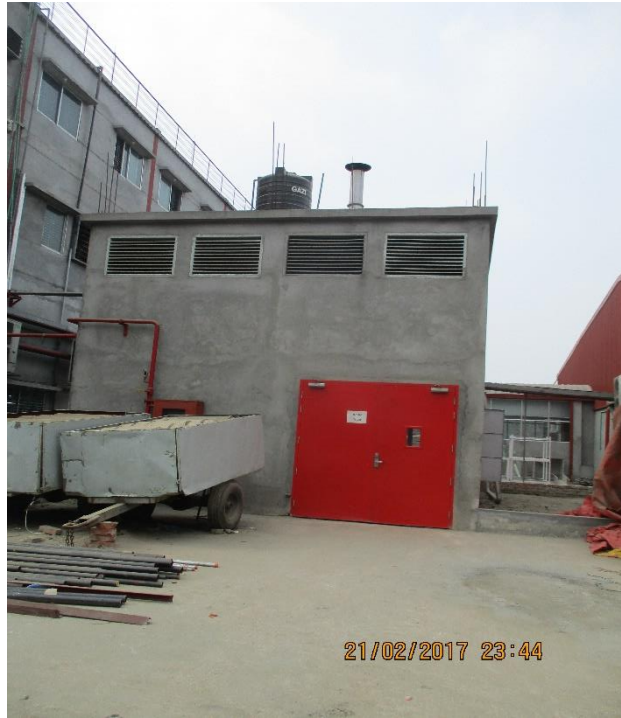
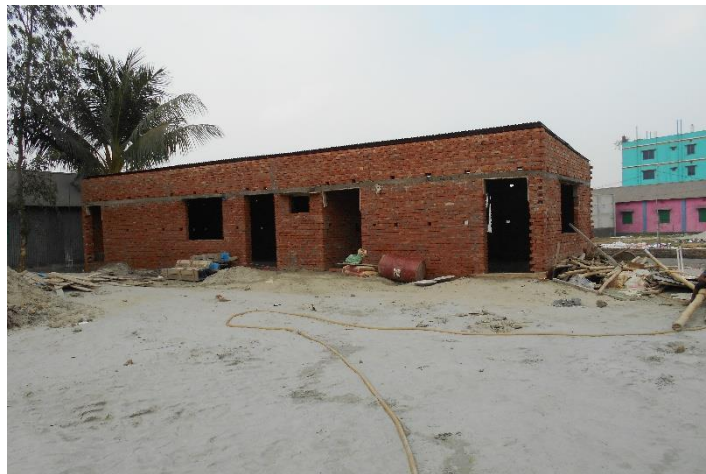
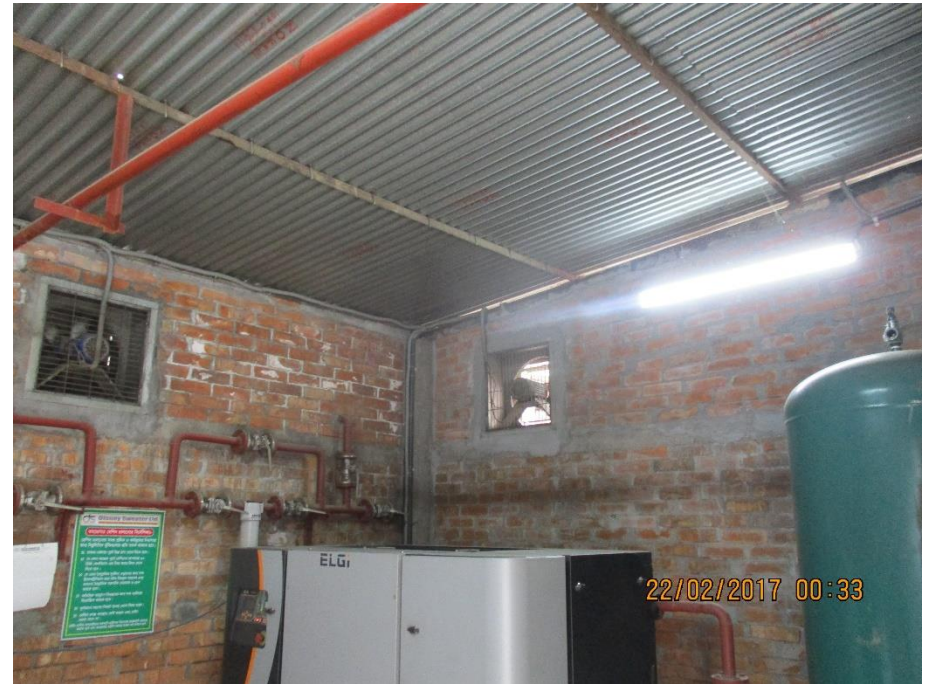
**Produce as-built drawings of all ancillary structures.**

No drawings were available for ancillary structures. Building engineer is required to produce drawings for ancillaries.

| Item No. | Observation | Recommended Action Plan | Recommended Timeline |
|---|---|---|---|
| 11 | Produce as-built drawings for all ancillary structures | Building engineer is required to produce as built drawings for all ancillary structures. | 6-weeks |
