# INITIAL ELECTRICAL ASSESSMENT REPORT (EAR)

Factory Name: **SAN Apparel Limited**

Assessor: **Emkay Enterprises LTD**

Date: **03 Apr 2016**

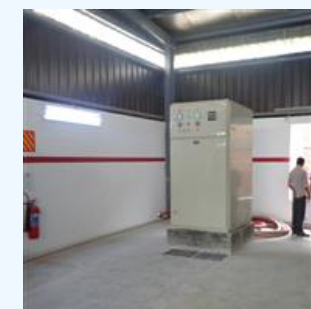
| Description: | MCCBs in LT Panel were not provided with phase separators. |
| Source of Findings: | Photograph: No phase separators in MCCBs of LT Panel. |

| Suggested Plan of Action: | Install phase separators between terminal connections. Verify phase separators are installed at all remaining locations. |
