# Newtex Knit Fashion Ltd.

Gorai, Industrial Area, Mirzapur

24<sup>th</sup> May 2014

# Building Observations

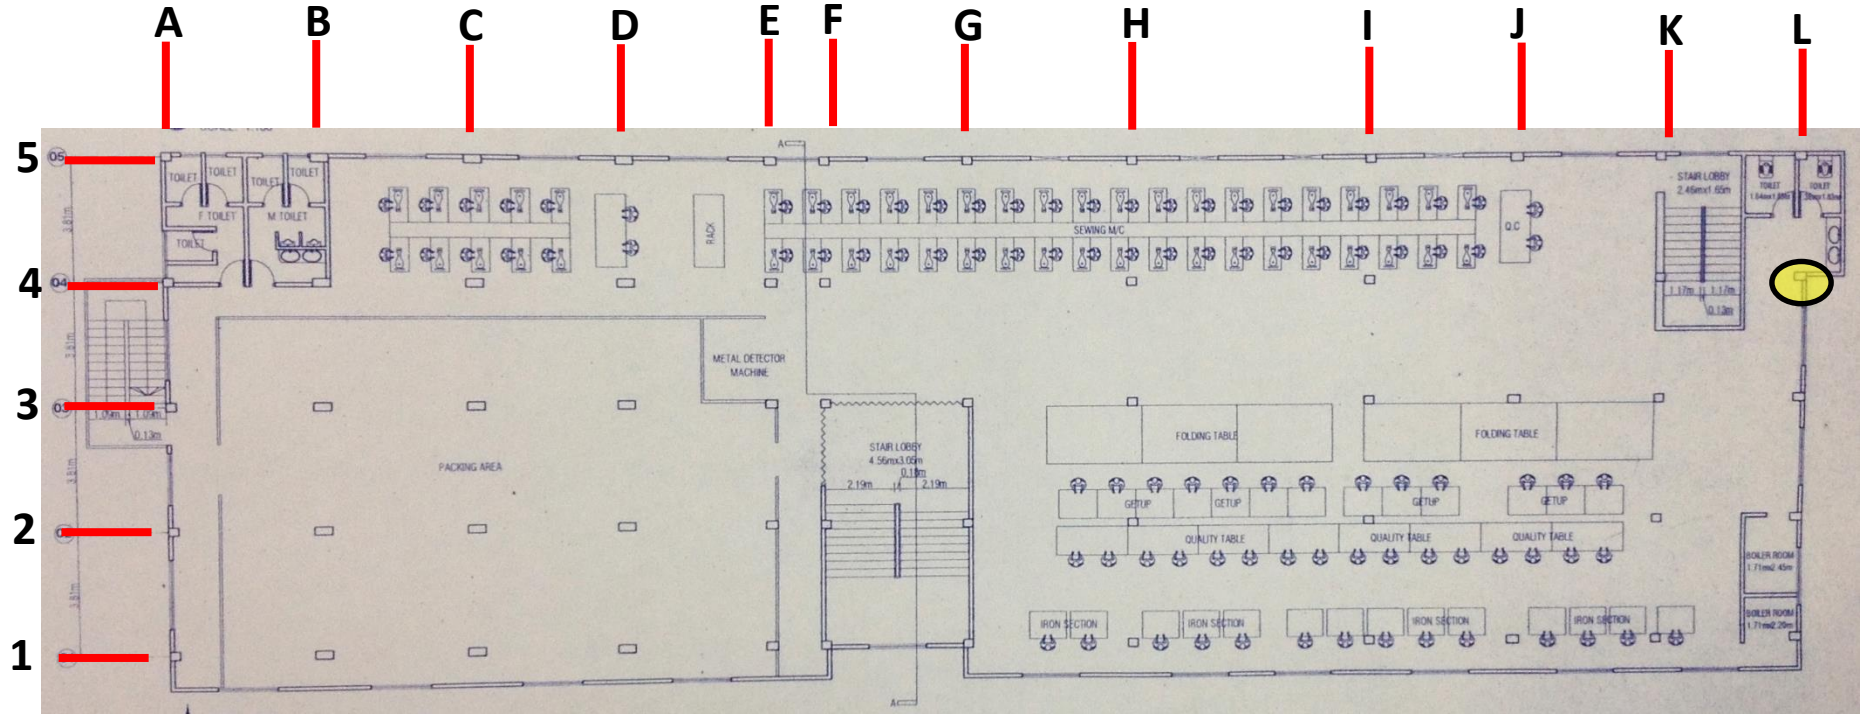
**High stress levels in columns/cantilevered  
concrete slabs.**

**Cantilever**  
↔

| Item No. | Observation | Recommended Action Plan | Recommended Timeline |
|---|---|---|---|
| 1 | High stress levels in cantilevered concrete slab/perimeter columns | Building Engineer to confirm by calculation the adequacy of the perimeter columns to carry the loading from the cantilevered elements in the building | 6-weeks |

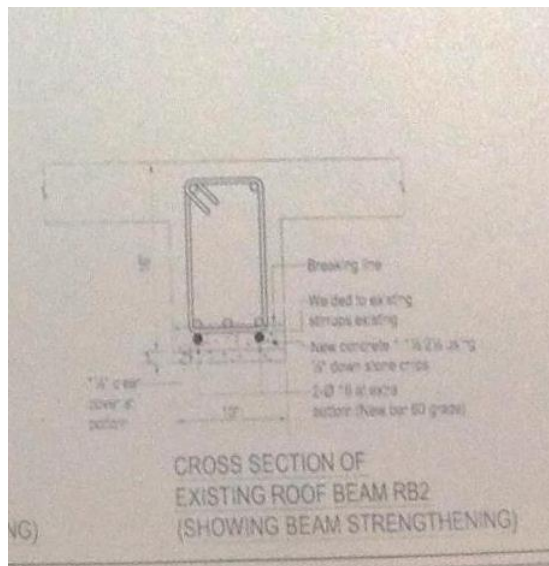
## Beam Strengthening (has cover to top reinforcement been compromised?)

| Item No. | Observation | Recommended Action Plan | Recommended Timeline |
|---|---|---|---|
| 3 | Strengthening of Columns/Beams | Building Engineer to confirm that the reinforcement cover to the top of the beam strengthening is adequate and that the welding of the new bars to the underside of the link is structurally adequate. | 6-months |

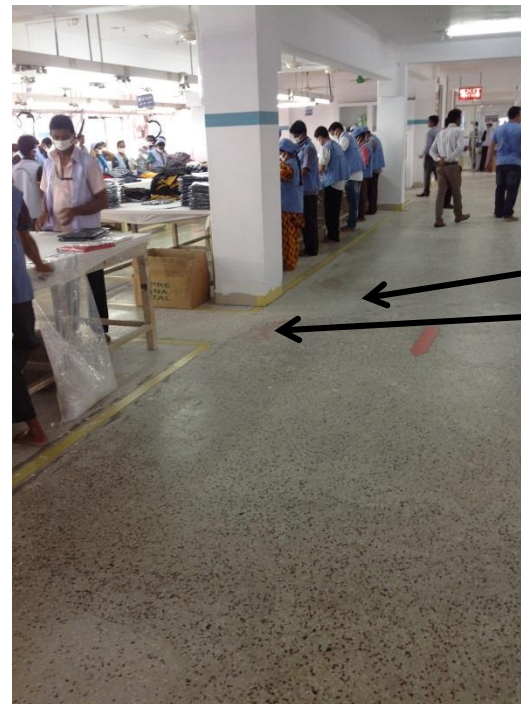
## Beam Strengthening (new bar welded to link, is weld adequate?)

Lighter floor colouring  
Is where beam  
strengthening has  
occurred.

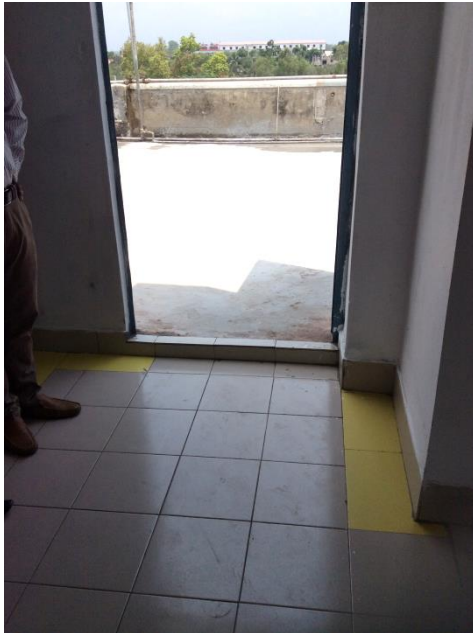
65mm Build Up at roof Level

| Item No. | Observation | Recommended Action Plan | Recommended Timeline |
|---|---|---|---|
| 2 | Additional floor build ups and wall loadings at roof level | Building Engineer to confirm the adequacy of the structure to support the additional screeds, walls etc. at roof level. | 6-months |

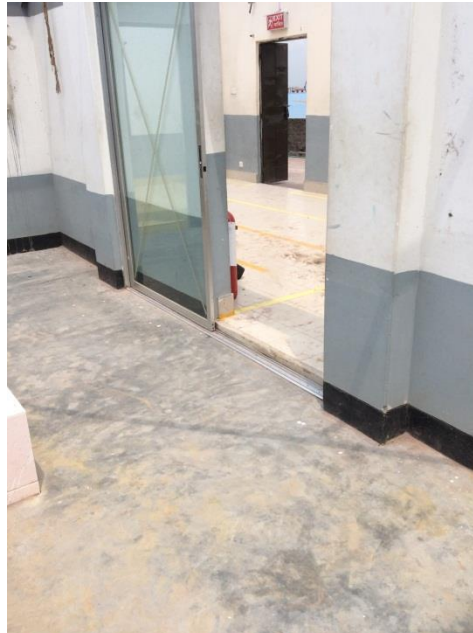
Additional 60mm Build Up at roof Level

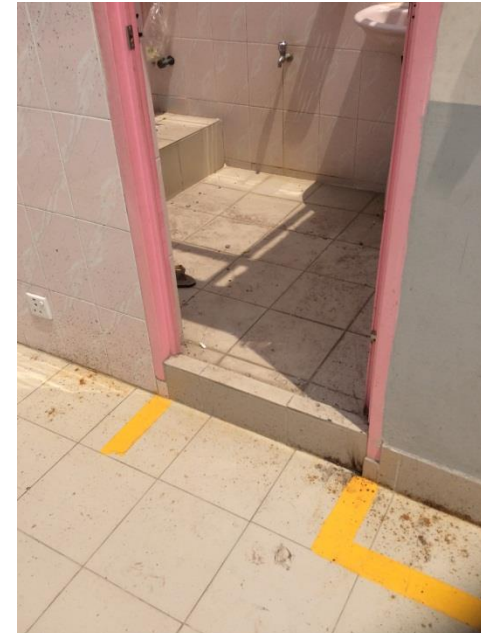
Additional 90mm Build Up In toilet area at roof level.

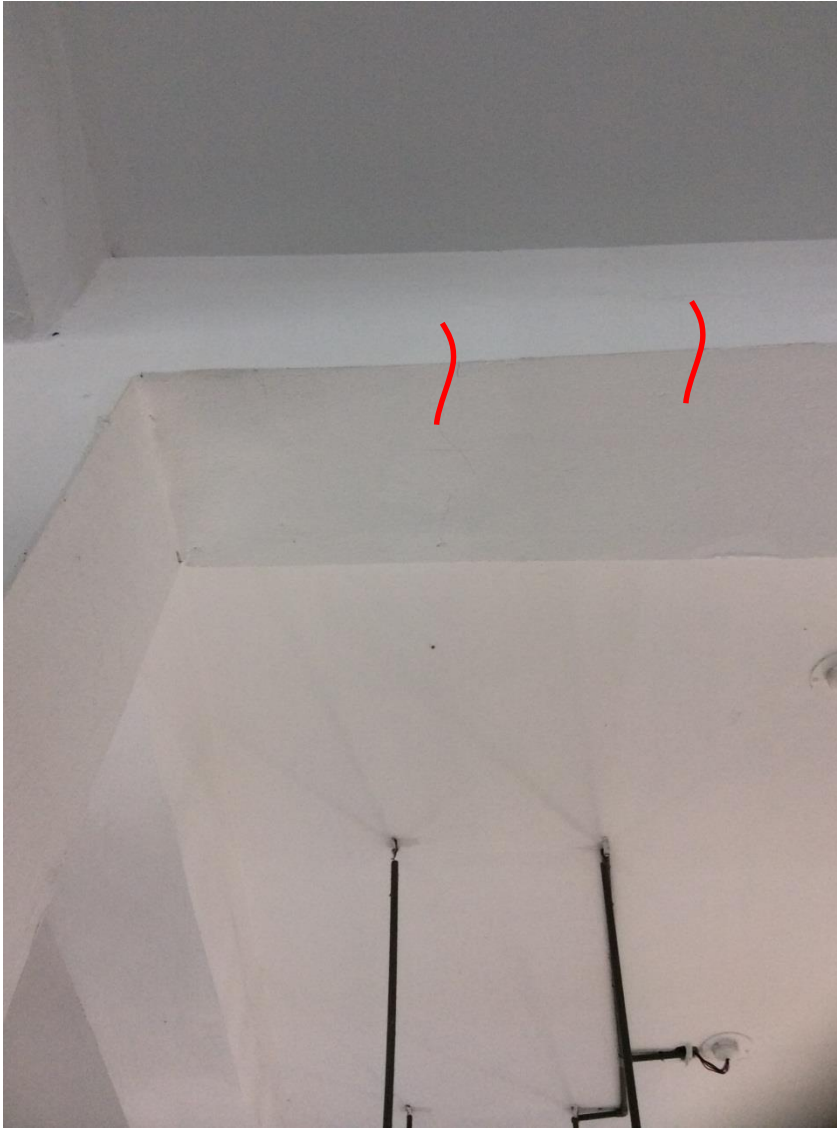
**Cracking in Beams, most have recently been repaired and repainted, some have re-opened.**

| Item No. | Observation | Recommended Action Plan | Recommended Timeline |
|---|---|---|---|
| 4 | Cracking in Beams | Building Engineer to confirm that the cracking in beam elements is non-structural. | 6-weeks |
| 5 | Cracking in Beams | Building Engineer to monitor cracking on an on-going basis. | 6-months |

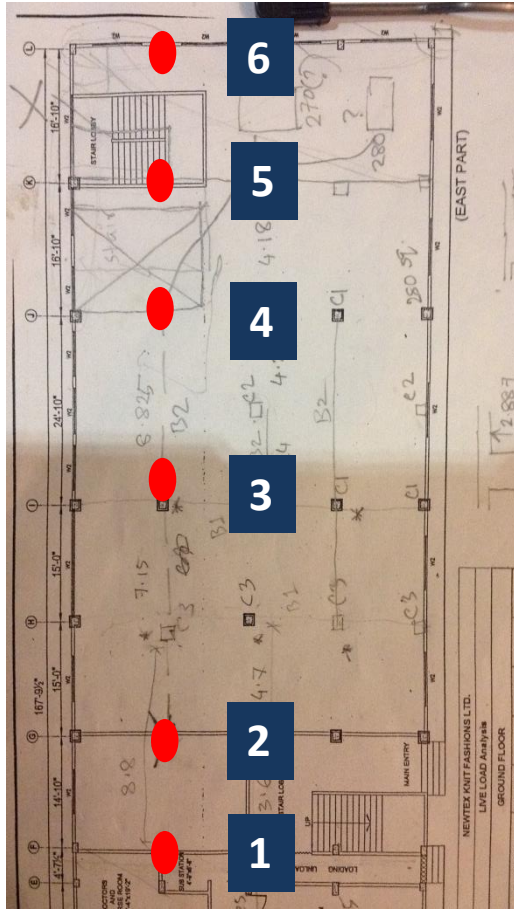
Loading Plan

There is an additional grid/column line in the loading plan compared to structural Layout and actual observations

| Item No. | Observation | Recommended Action Plan | Recommended Timeline |
|---|---|---|---|
| 6 | Discrepancies between loading plan and as built structure | Building engineer to check the adequacy of the existing structure to take the loading from the as built structure. | 6-months |
| 7 | Discrepancies between loading plan and as built structure | Building engineer to implement load management plan. | 6-months |

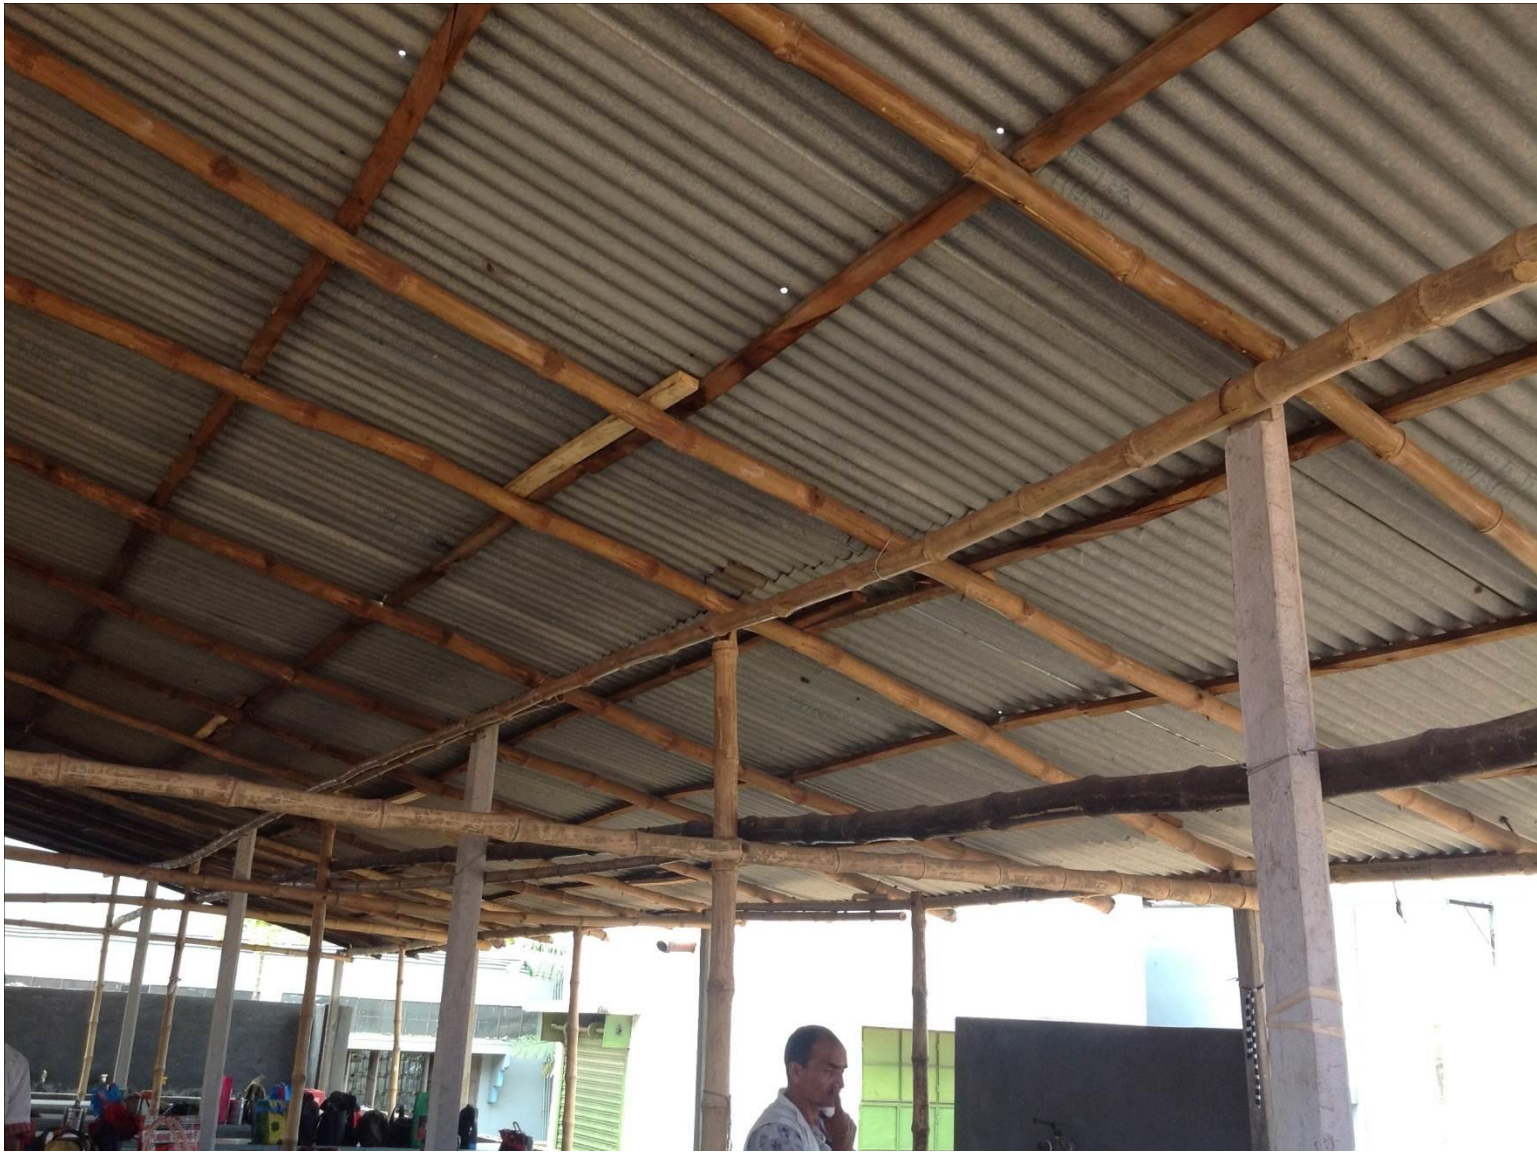
# Un-engineered Steel/Bamboo Shed

| Item No. | Observation | Recommended Action Plan | Recommended Timeline |
|---|---|---|---|
| 9 | Non-engineered steel/Bamboo Dining area | Lightweight structure to be reconstructed/upgraded to ensure adequacy for code vertical and wind loads by the Building Engineer. | 6-months |
