# INITIAL STRUCTURAL INTEGRITY ASSESSMENT REPORT (SIAR)

Factory Name: **SAN Apparel Limited**

Assessor: **Emkay Enterprises LTD**

Date: **03 Apr 2016**

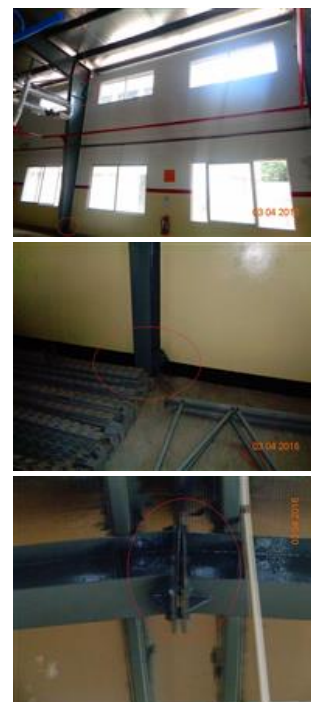
| Description: | Corrosion found to be formed in some shades column bottom face during visual assessment. |
| Source of Findings: | Photograph: corrosion picture-1 corrosion picture-2, Visual Assessment: Corrosion found to be formed in some shades column bottom face during visual assessment. |

| Suggested Plan of Action: | Complete further testing on areas of deterioration and have a qualified structural engineer develop a remediation plan. |
