# Hannan Knit & Textiles Ltd.

505, Kalmeshor, Board Bazar, National University, Gazipur-1704, Dhaka  
(23.94233E, 90.38211N)  
27 April 2014

# Building Observations

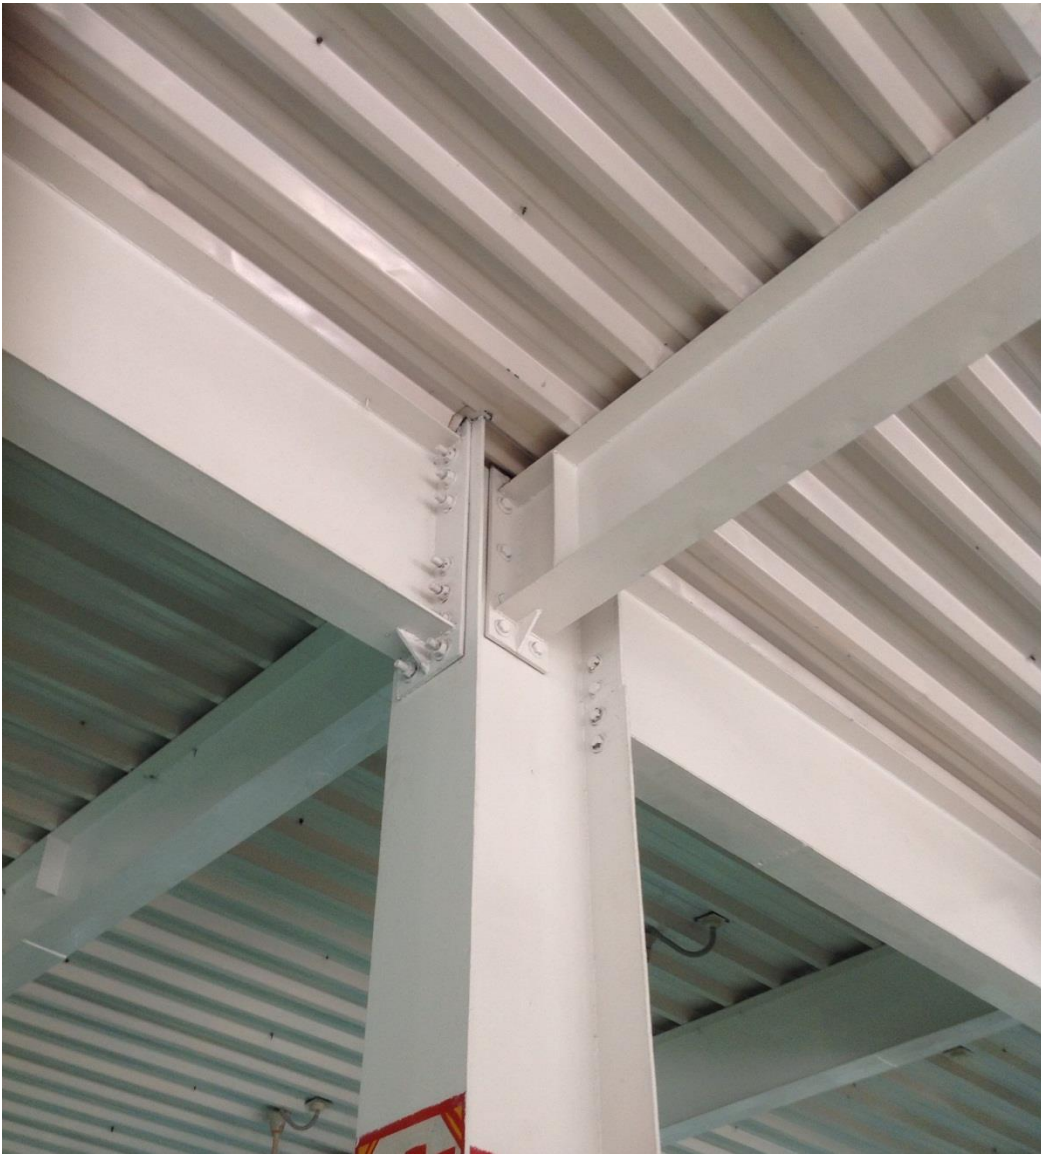
## **Fire protection to steelwork**

**It was not possible to determine if there was fire protection applied to the steelwork.**

| Item No. | Observation | Recommended Action Plan | Recommended Timeline |
|---|---|---|---|
| 1 | Fire protection to steelwork | Building engineer to review adequacy of fire protection to steelwork | 6-weeks |
| 2 | Fire protection to steelwork | Any required remediation work to be completed | 6-months |

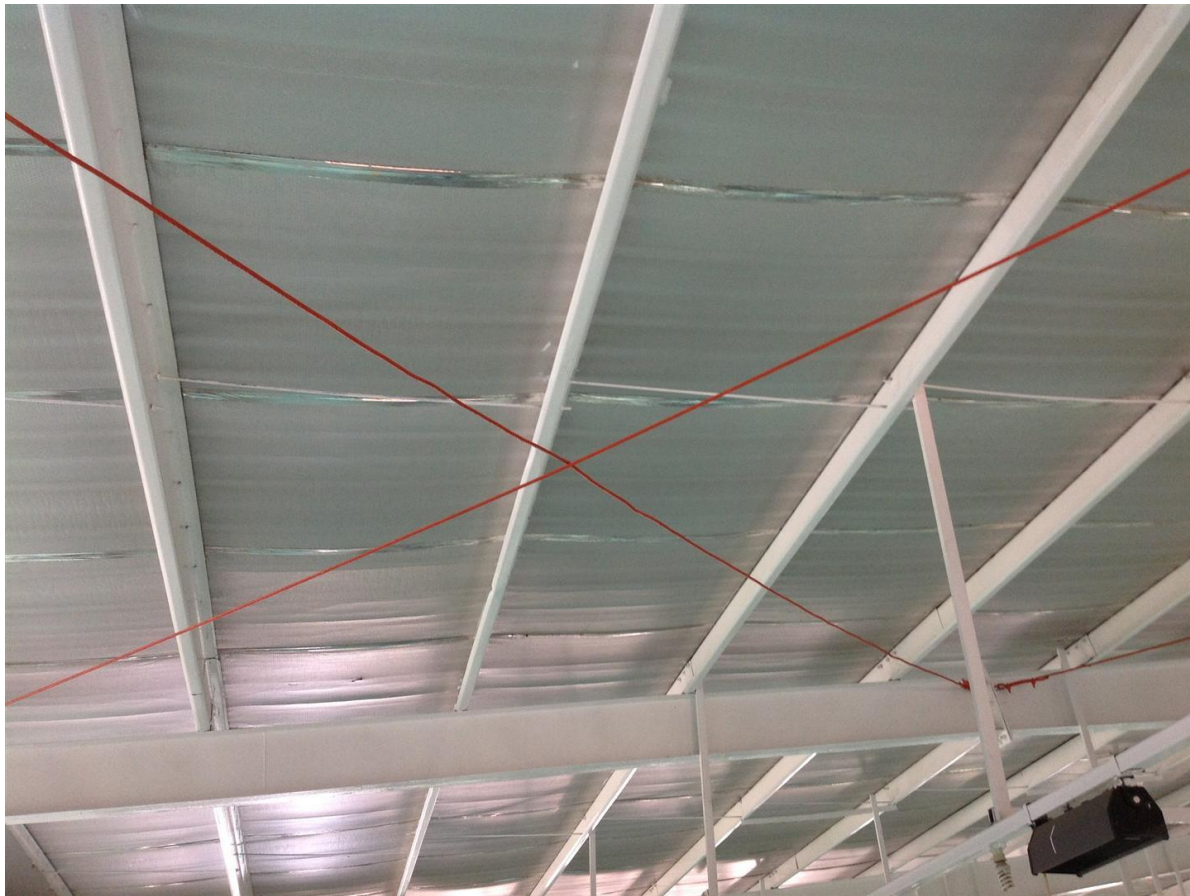
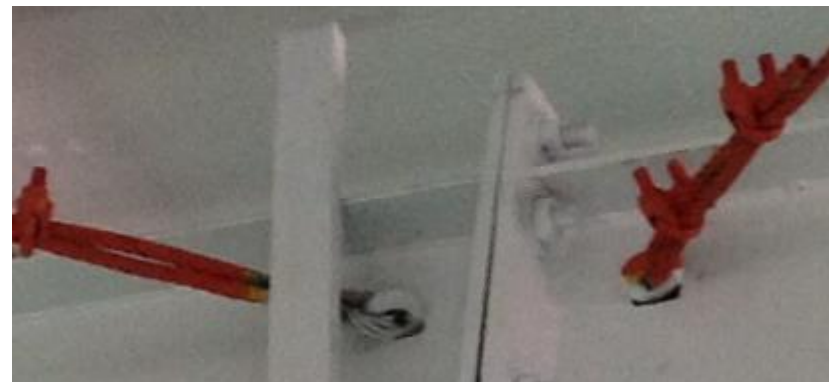
## **Roof stability system**

**Roof bracing, which appears to be coated steel cable, was found to be slack at some locations, with purlins acting as compression struts.**

| Item No. | Observation | Recommended Action Plan | Recommended Timeline |
|---|---|---|---|
| 3 | Roof stability system | Building engineer to review adequacy of roof stability system including cable bracing and compression struts | 6-weeks |
| 4 | Roof stability system | Any required remediation work to be completed | 6-months |
