# Shangutex Limited

Dusaid, Ashulia, Savar, Dhaka.  
(23.884852N, 90.30434E)  
1<sup>st</sup> March 2017

# Observations

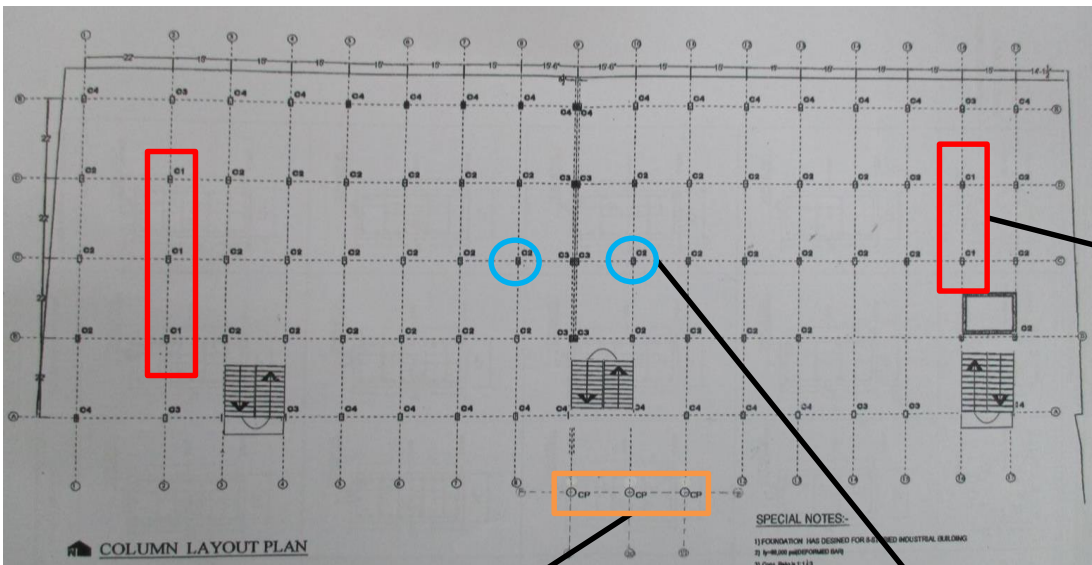
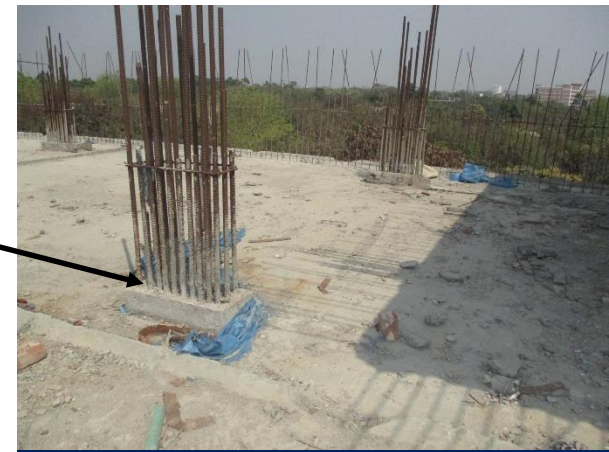
Column schedule shows size of column C1 is 12"x28". On site 12"x26" column was observed.

Factory engineer to be surveyed the structure and update the drawings to as-built conditions.

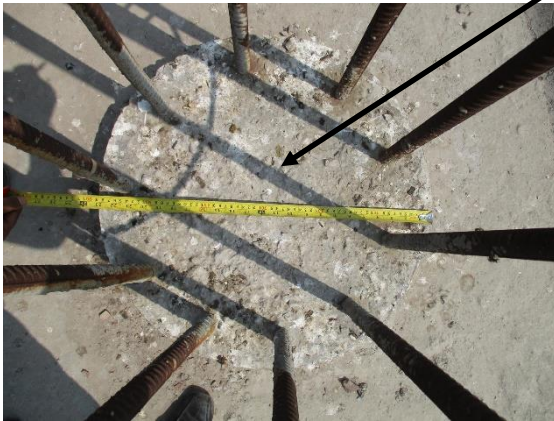
Column schedule shows 26" diameter circular column but 23" diameter column was observed on site.

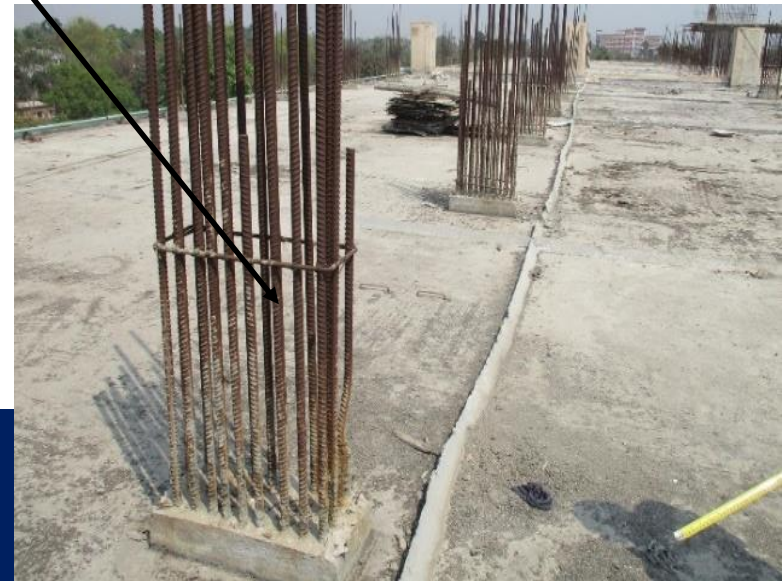
For the column C2, rebar number of east part does not match with west part. 22 nos. of rebar were found on east part where 20 nos. on west part.

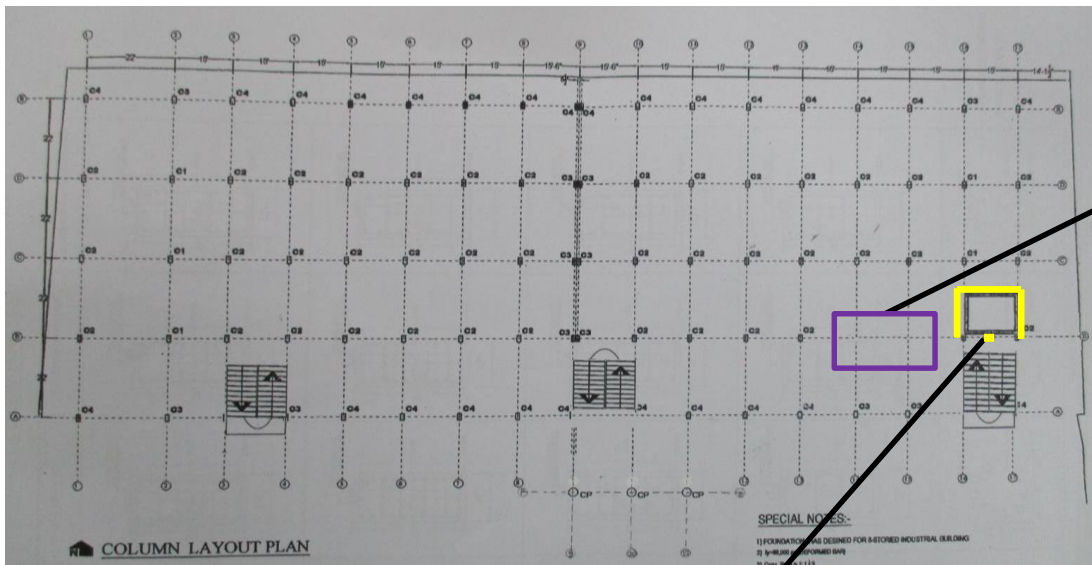
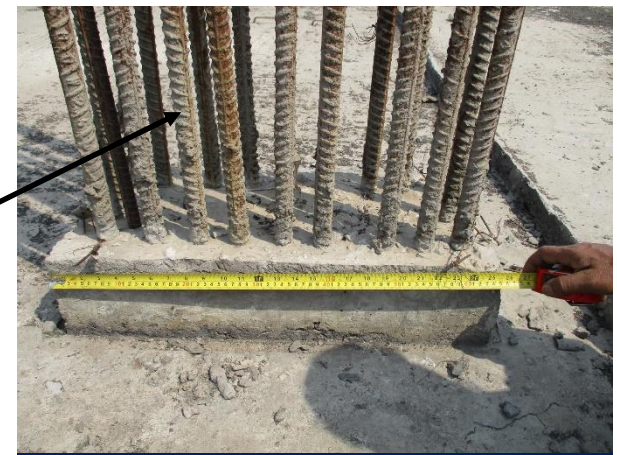
Column C2 was observed on grid D-14&15 where no columns were shown in drawing

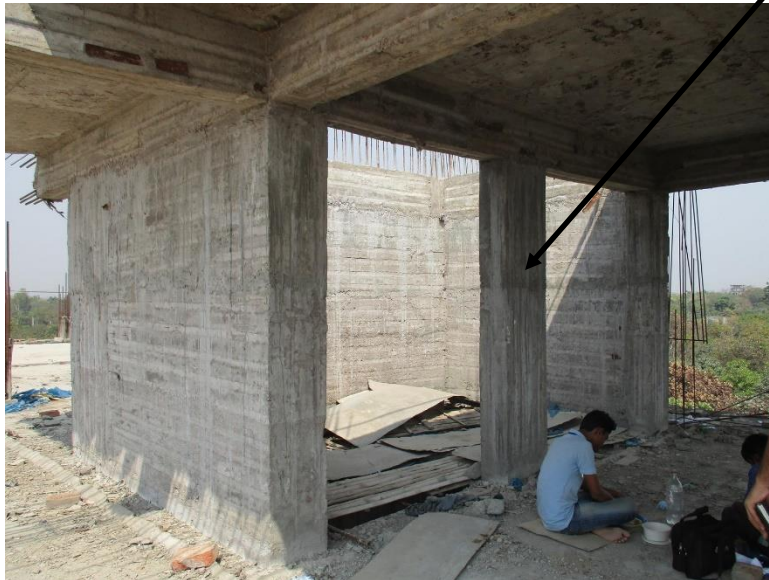
Drawing shows rectangular shaped shear wall but U-shaped shear wall was observed on site. Additional column in front of shear wall opening was also observed.

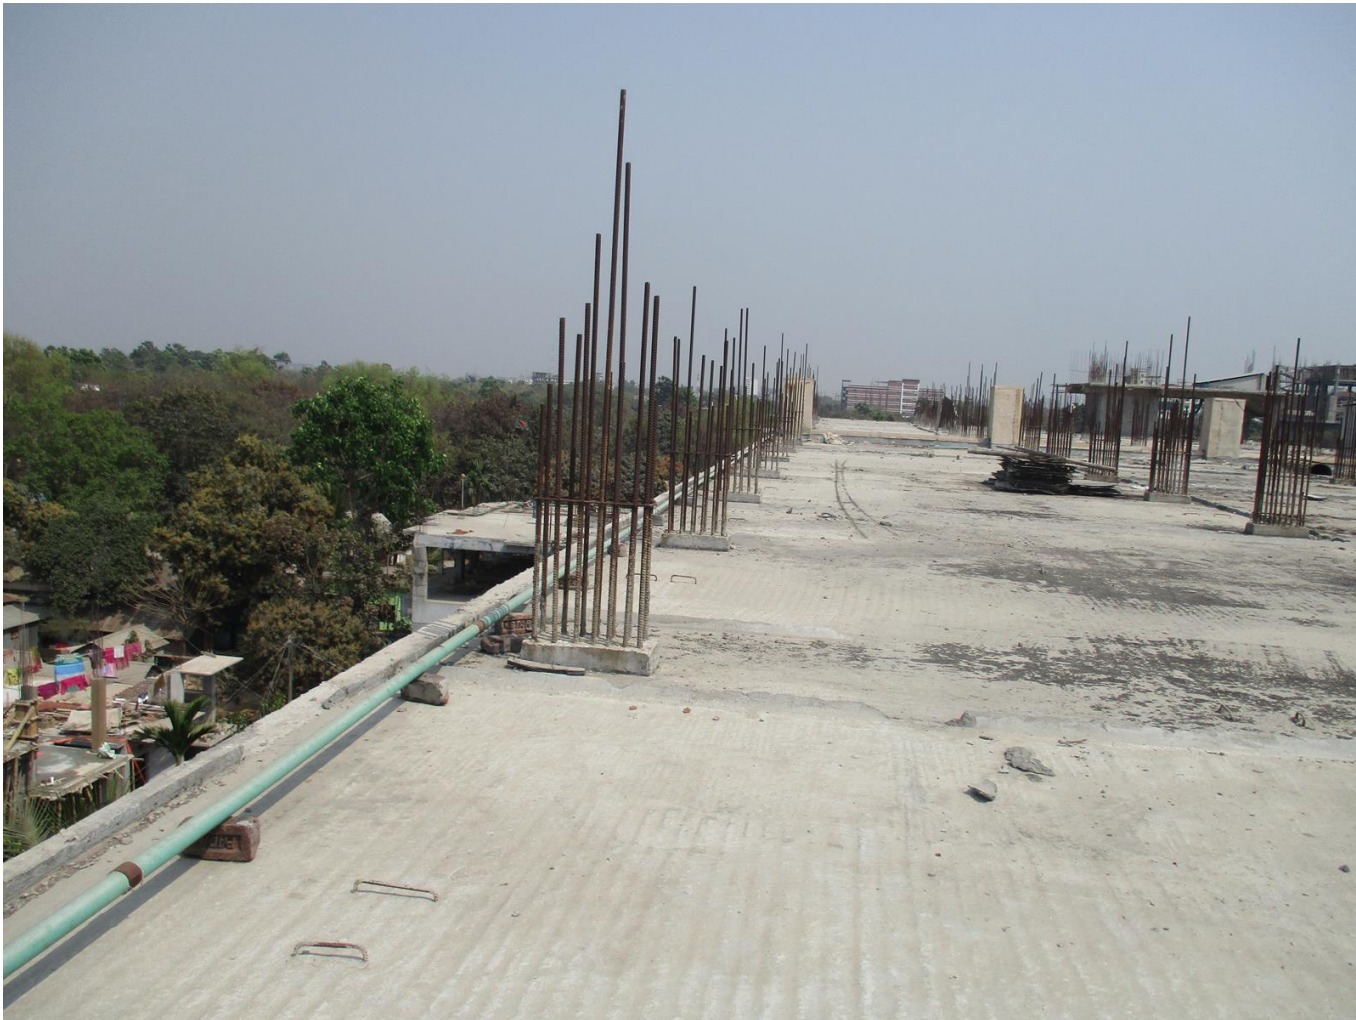
# Falling hazard on roof

There is no parapet or edge protection on roof

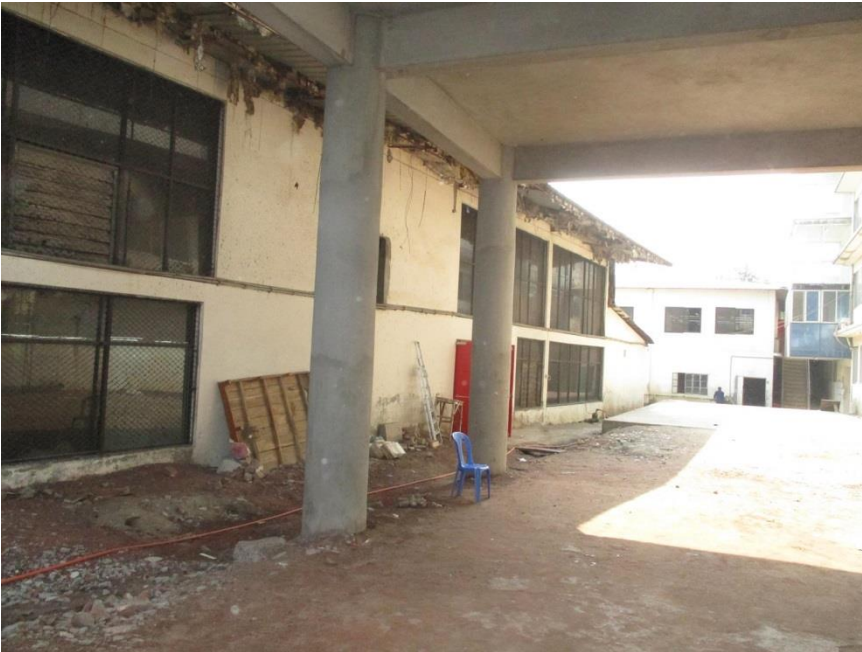
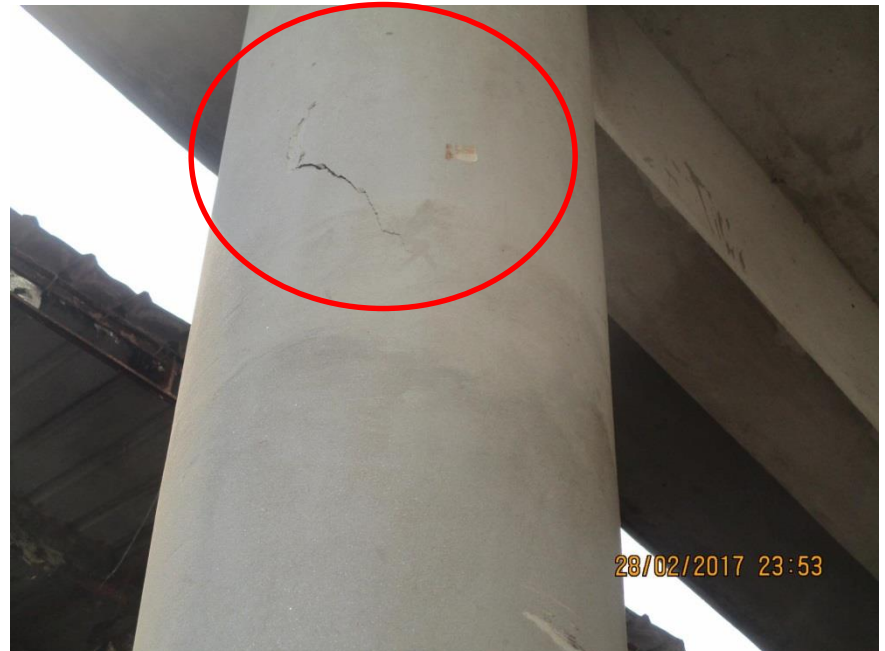
# Columns susceptible to vehicle impact

Columns were suspected to vehicle impact loading. Damaged due to vehicle impact was observed on an exterior porch column.

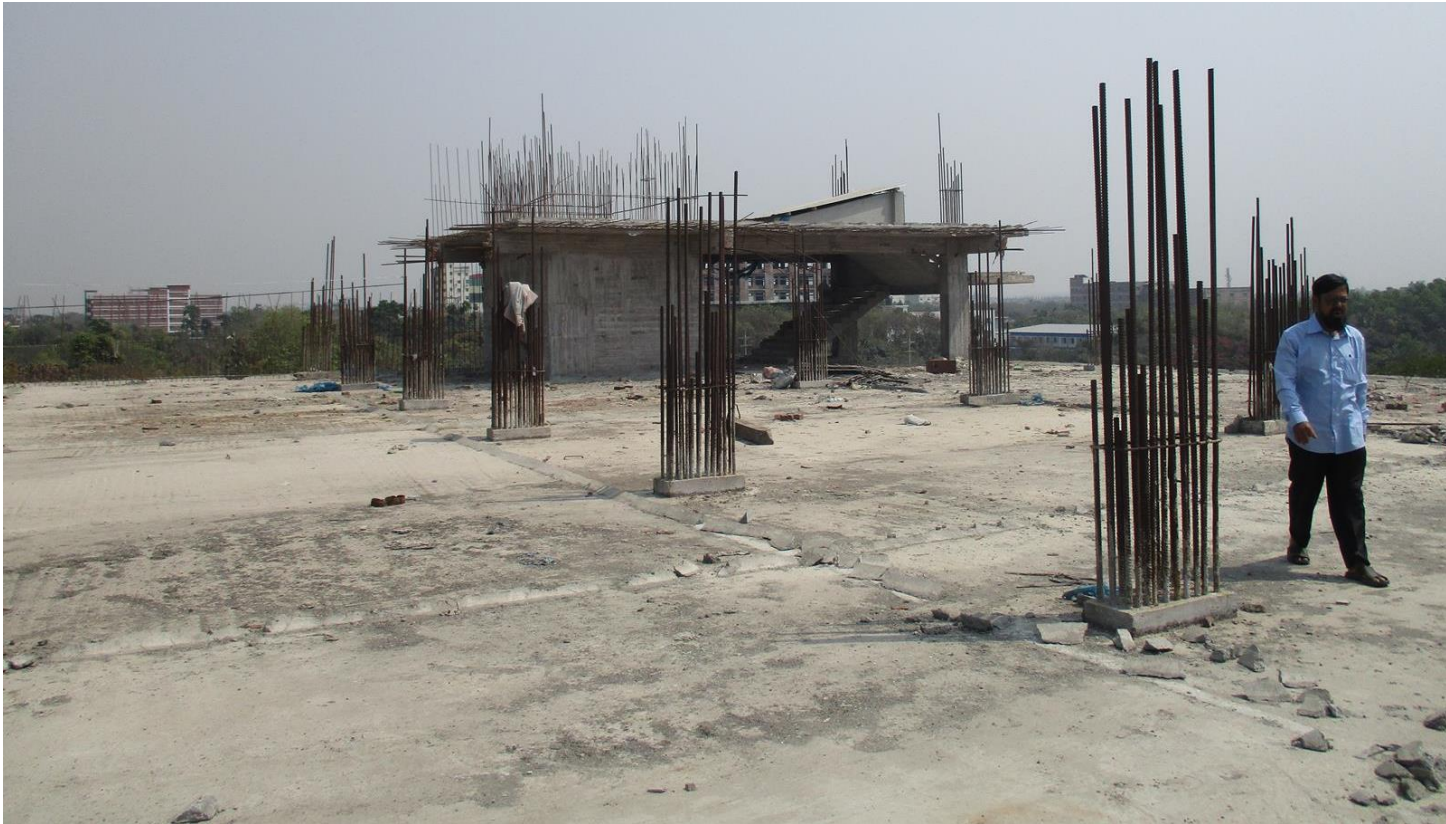
# Corrosion on rebar's and absence of water proofing membrane on roof

Corrosion was observed on exposed rebars and no water proofing membrane was observed on roof of the building.

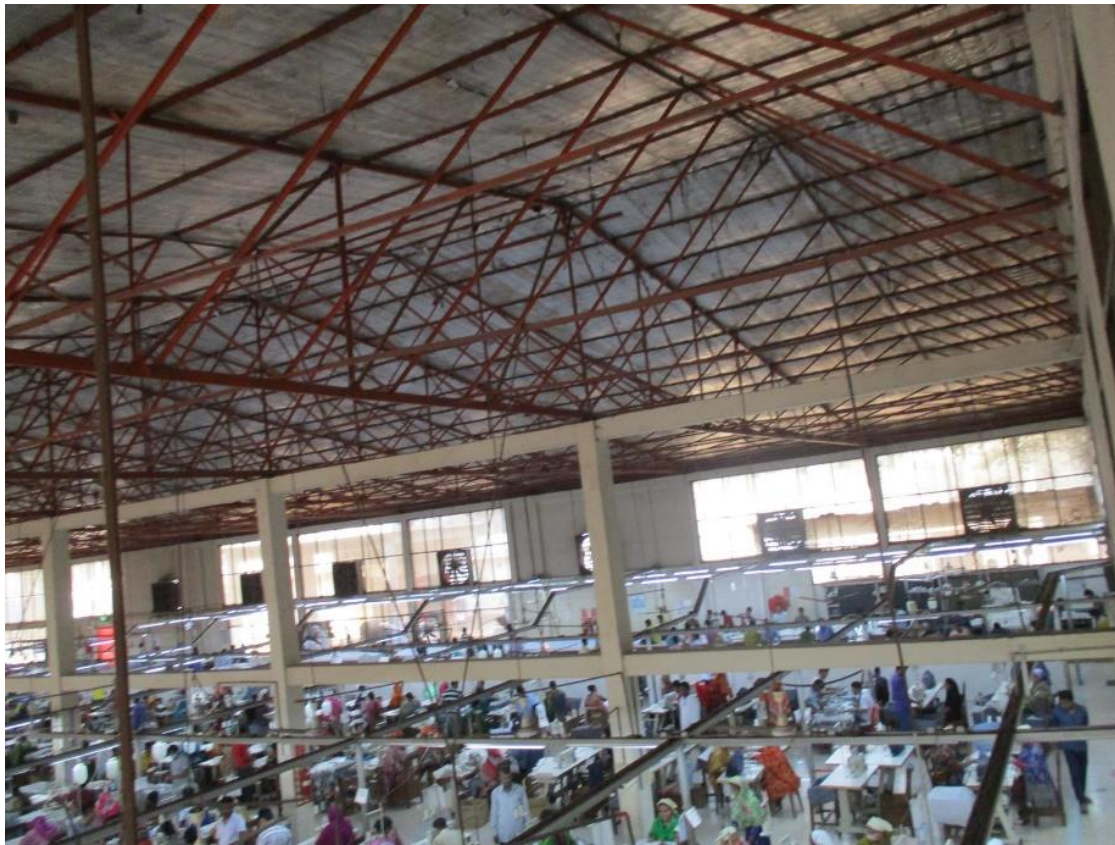
# Lack of as-built drawings

As-built structural drawing was not available during inspection. Factory engineer to be prepared as-built structural drawing.

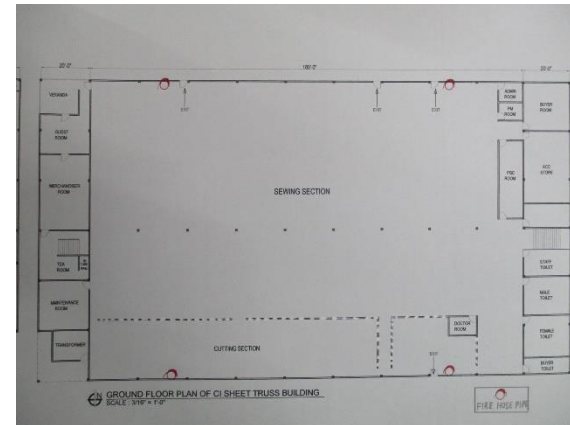
Factory have as-built architectural drawings only.

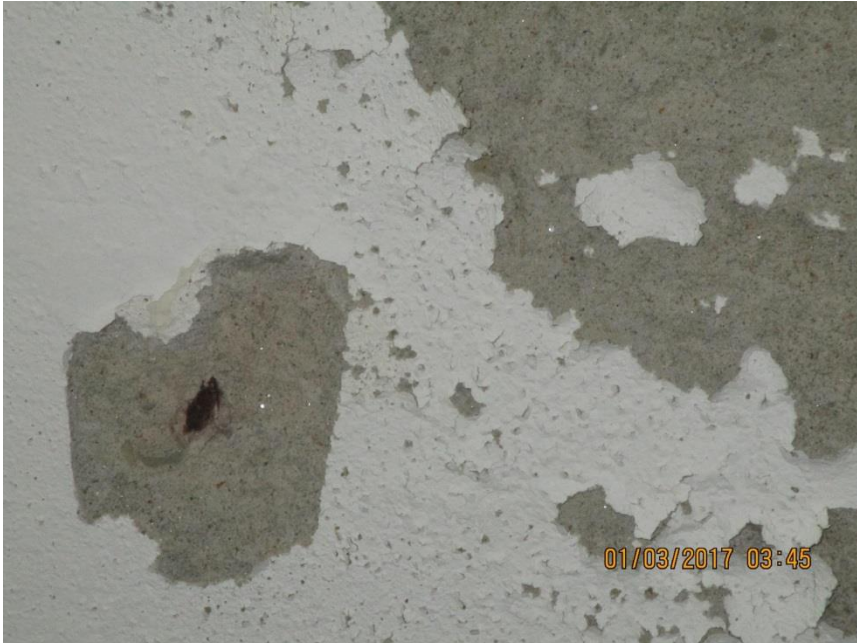
Corrosion on rebar due to dampness on roof slab was observed

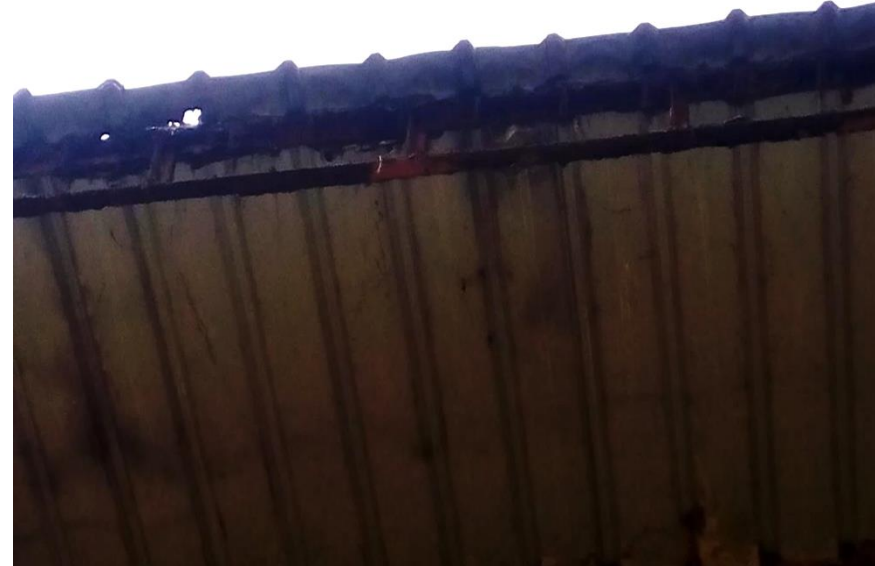
Corrosion on MS angle of truss member was observed

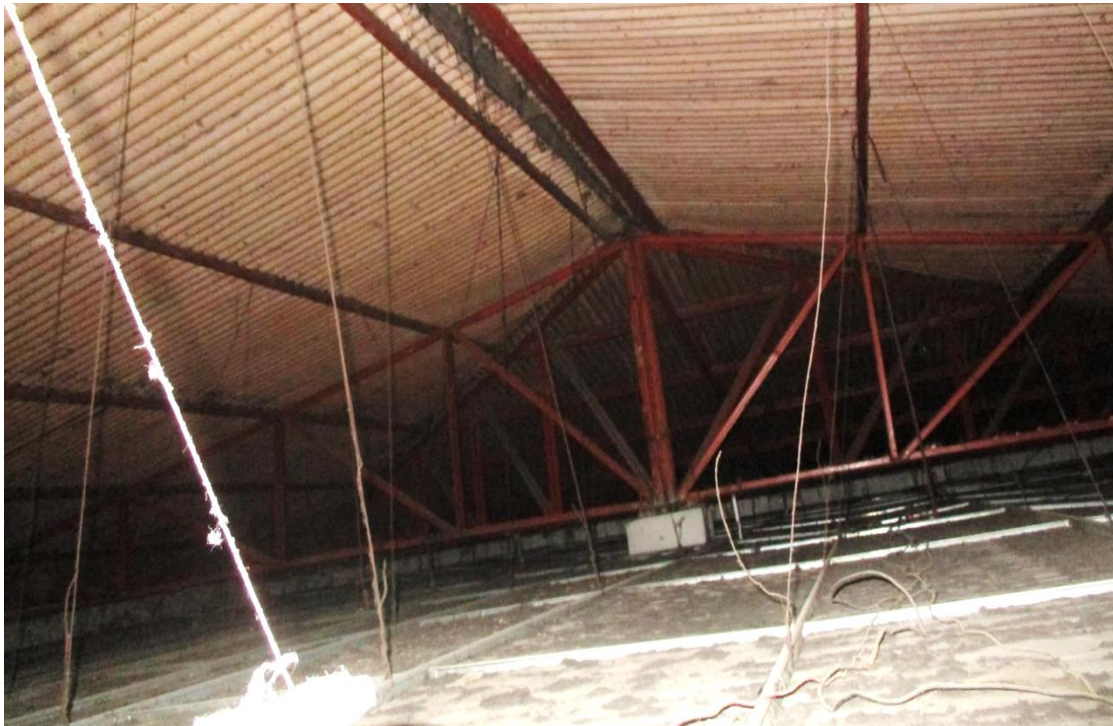
# Insufficient as-built drawings

As-built structural drawing was not available during inspection. Factory engineer to be prepared as-built structural drawing.

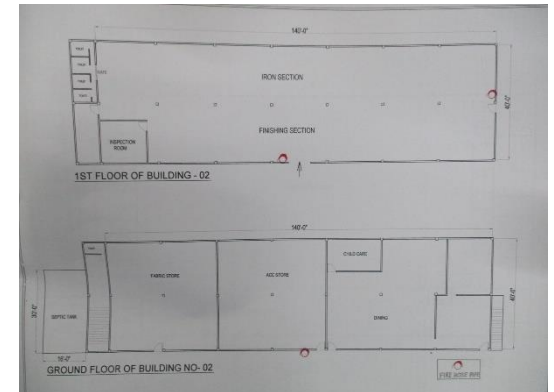
Factory have as-built architectural drawings only.

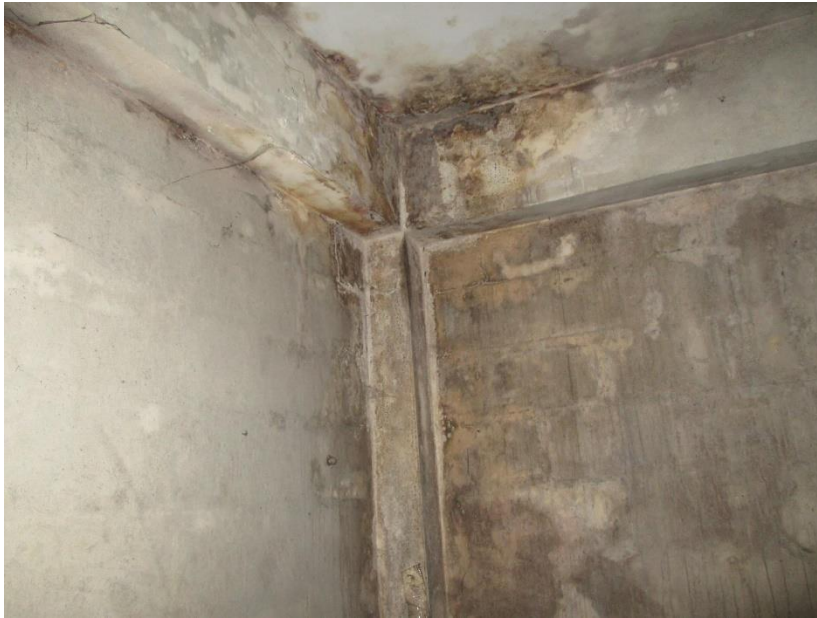
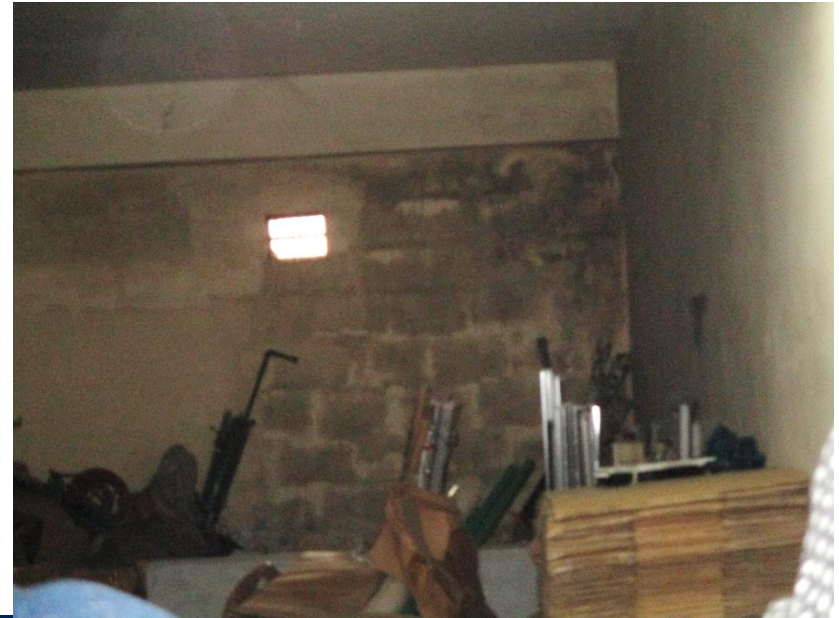
# Dampness on façade walls

Dampness was observed on the exterior walls.

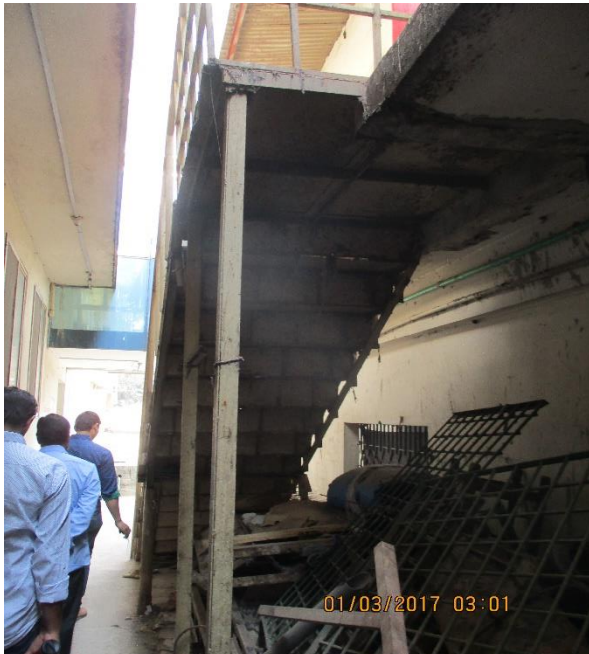
Apparently inadequate member sizes and thickness.

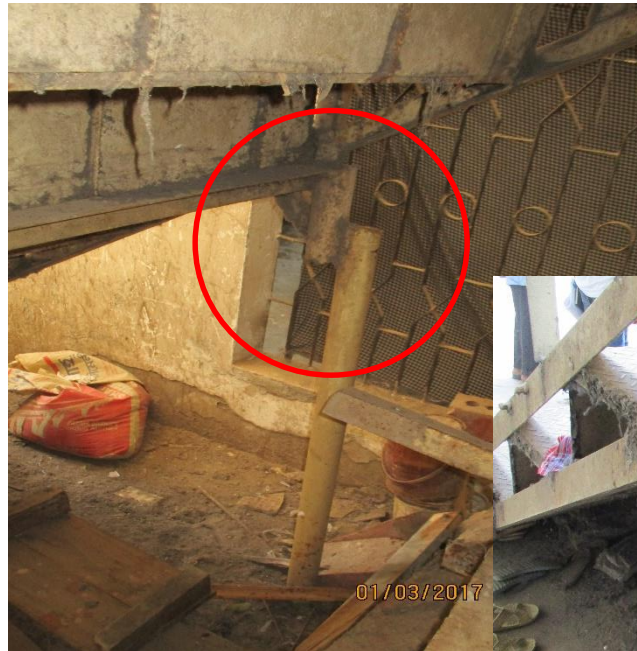
Poor connection.

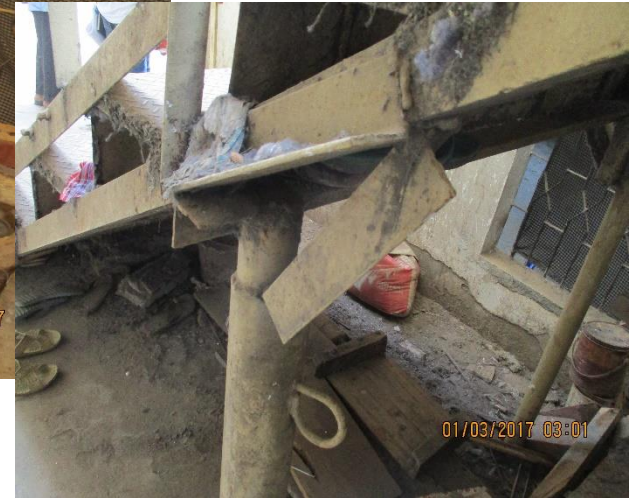
Non engineered emergency steel stair observed at north part of the Building-2. Building engineer is required to check the adequacy of the non-engineered emergency stair .

Item No.	Observation	Recommended Action Plan	Recommended Timeline
7	Corrosion on slab rebar and truss member	Factory engineer need to be check the ingress of corrosion and suggest proper remedial action accordingly.	6-weeks
8	Corrosion on slab rebar and truss member	Implement repair works suggested by the engineer	6-months
9	Insufficient as-built drawings	Building Engineer is required to check the structure and update as-built drawings	6-weeks
10	Dampness on facade walls	Implement repair works suggested by the factory engineer	6-months
11	Non engineered emergency steel stair	Factory engineer is required to check the adequacy of the emergency steel stair.	6-weeks
12	Non engineered emergency steel stair	Carry out the remedial works as per adequacy check.	6-months
