FIRE SAFETY INSPECTION REPORT

FACTORY: Epyllion Style Limited (Extension Project)

ACCORD ID: 12768

Date: 23/04/2017

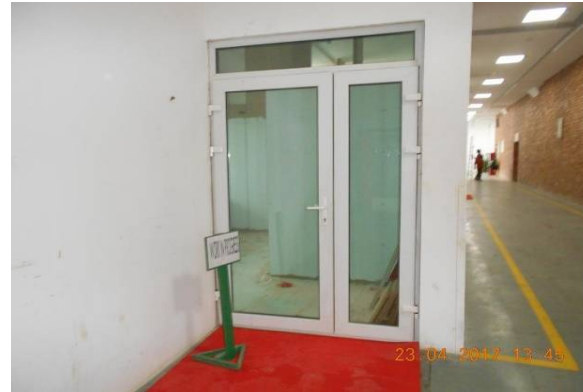
Child-care Room (Under Construction)

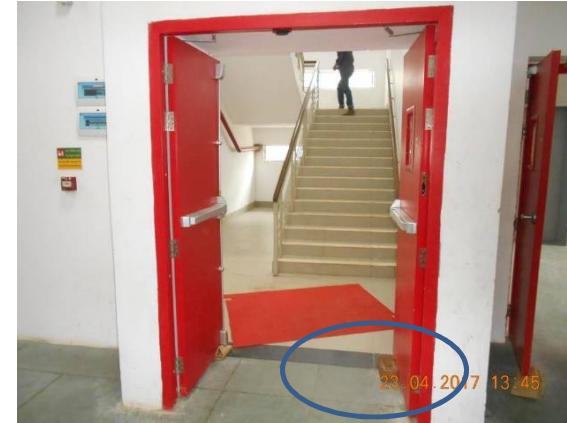
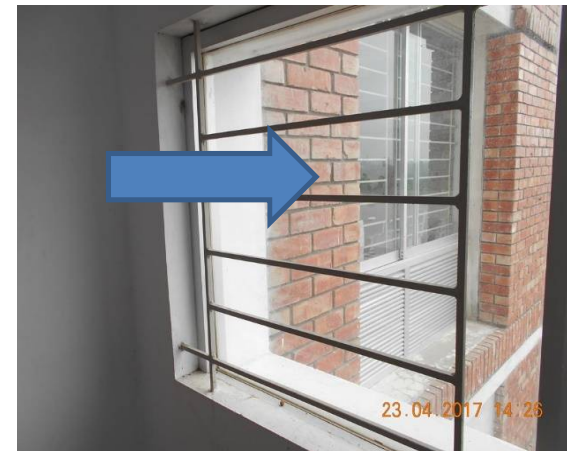
1 Fire Rated Construction

The exit stairs are not separated from [work areas, other spaces] on each floor by fire-rated construction.
 Fire doors were found open by non-mechanical means during working hour but those are not tied with fire alarm system by automatic closing devices.

Stair shall be enclosed with a minimum 2-hr fire-rated construction. Seal all unprotected openings and provide minimum 1.5-hr fire rated doors to separate the exit stairs from work areas and other building spaces on all floor levels. Ensure that the fire doors are self-closing, positive latching and that they are provided with fire exit (panic) hardware where serving production floors.
 If fire doors are required to be held open for functional reasons, provide automatic-closing devices tied to the fire alarm system.

Within 3 Months

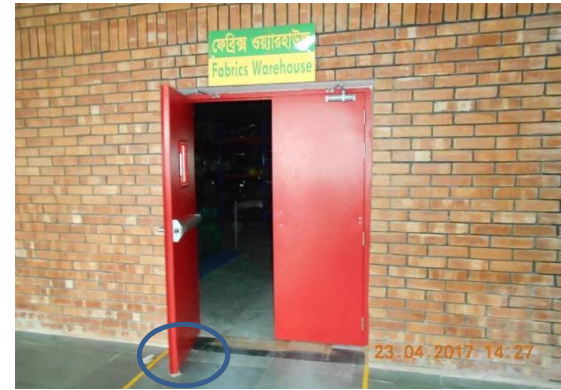
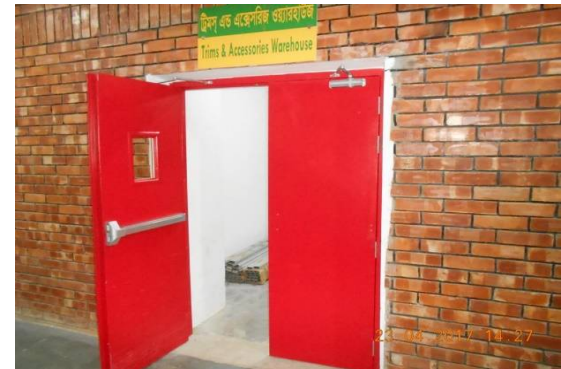
2	Fire Rated Construction	Rooms used for storage of combustible materials are not separated from the surrounding occupancy/areas.	Rooms used for storage of combustible materials shall be separated from the surrounding occupancy with a minimum 1 hour construction.	Within 3 Months	
---	-------------------------	---	---	-----------------	--

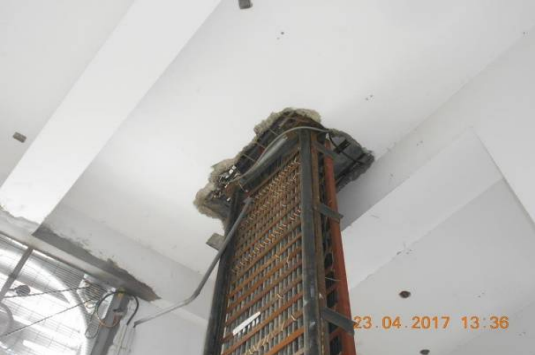
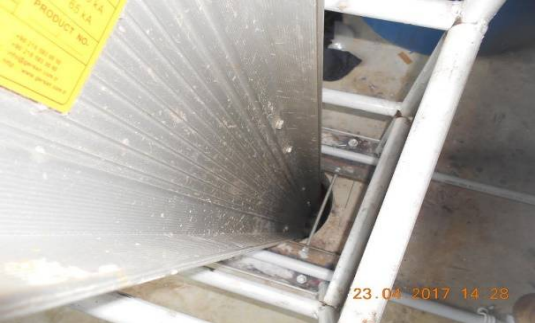
SI No.	Category	Findings	Required Action	Remediation Time Frame	Pictorial Evidence
3	Fire Rated Construction	Penetrations through floor/ceiling assemblies are found unsealed.	<p>Seal all penetrations and openings in floor/ceiling (full thickness of the floor/ceiling) assemblies by fire rated materials to maintain the fire resistance rating.</p> <p>Or</p> <p>Provide a minimum 2-hr fire rated shaft to separate the utility risers from each floor if required.</p>	Within 3 Months

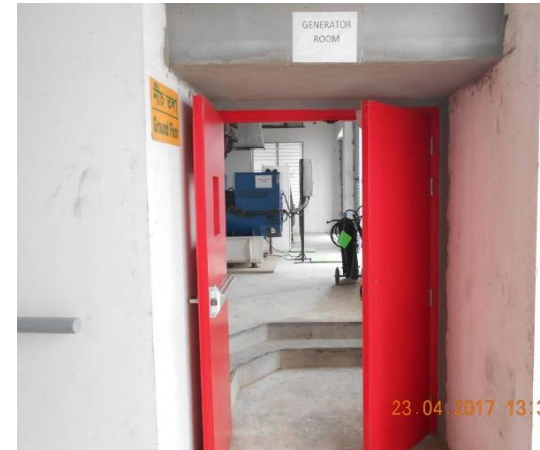
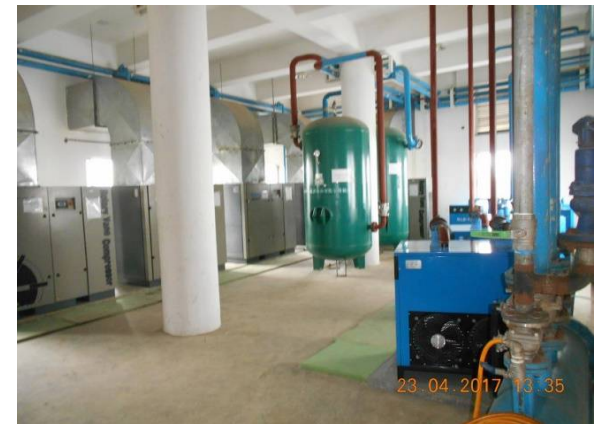
4 Fire Rated Construction

Generator and Compressor room is not properly separated by fire rated construction. Fire doors were found open during working hour but those are not tied with fire alarm system by automatic closing devices.

Generator, Compressor or other heat producing equipment shall be separated from other occupancies by a minimum 2-hr fire rated construction (wall, floor, slab etc). Seal all penetrations and openings (door, window etc.) should be protected by 1.5 hr fire rated materials to maintain the fire separation if required. All exhaust systems shall discharge to the exterior of the building in a safe location.
Or
Relocate it to exterior of the building and maintain a minimum 3m (10 ft.) spatial separation distance from the building.

Within 3 Months

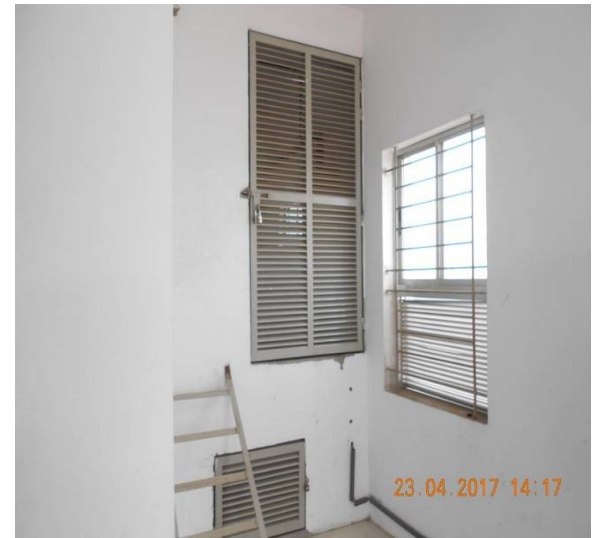
5	Fire Rated Construction	All elevator machine rooms were not separated by fire rated construction. The elevator machine rooms in Building were not provided with fire rated doors .	Separate the elevator machine rooms. by a minimum 2-hr firerated construction. Seal and/or protected all openings to maintain the required fire separations	Within 3 Months	
---	-------------------------	--	---	-----------------	--

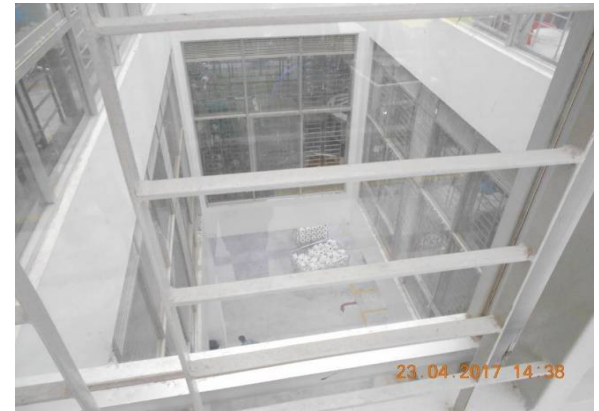
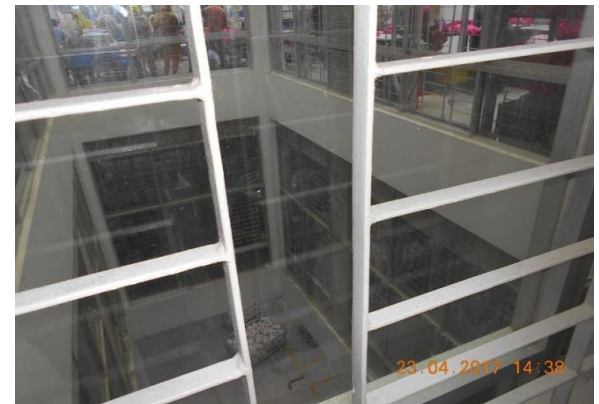
6	Fire Rated Construction	An atrium creates a vertical opening between floors.	Completely separate the atrium from adjacent areas of the building with 2-hr fire rated construction such that egress paths do not pass through the atrium and emergency workers are not required to access the atrium. Alternatively, design atrium in accordance with Accord Building Standard Section 3.7	Within 3 Months	
---	-------------------------	--	--	-----------------	--

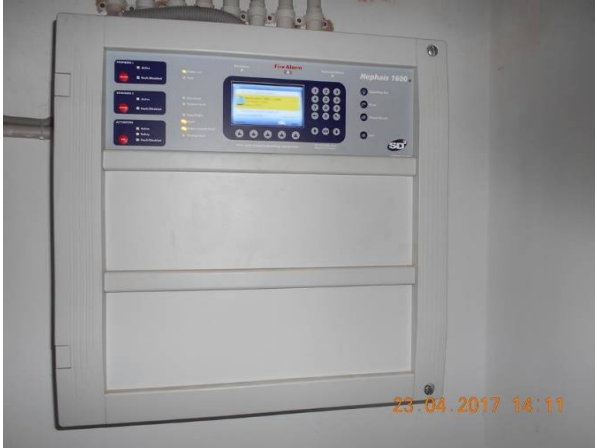
SI No.	Category	Findings	Required Action	Remediation Time Frame	Pictorial Evidence
8	Fire Alarm & Detection System	The addressable fire alarm system installation is going on without design approval from AHJ.	Submit As-Built drawing to AHJ for approval and replace or modify the fire alarm system in accordance with NFPA 72.	Within 2 months (Design submission) & 6 months (Installation)

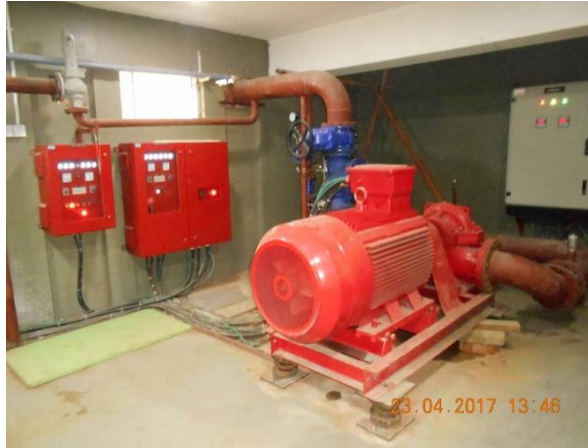
SI No.	Category	Findings	Required Action	Remediation Time Frame	Pictorial Evidence
10	Water Based Fire Protection System	The standpipe system installation is going on without design approval from AHJ.	Submit As-Built drawing to AHJ for approval and replace or modify the standpipe system in accordance with NFPA 14.	Within 2 months (Design submission) & 6 months (Installation)

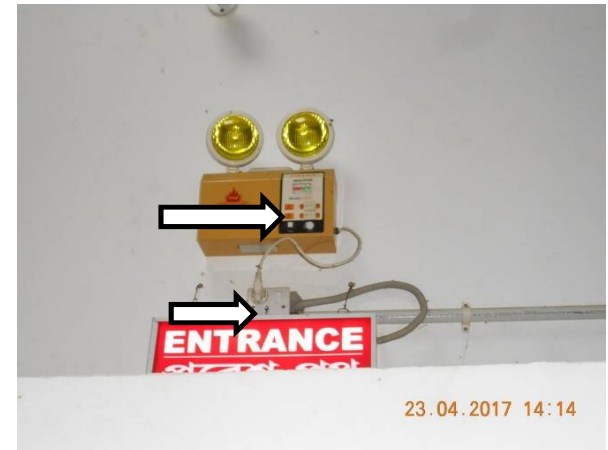
14	Egress Lighting	Manual on-off switch is provided for emergency lighting / exit signage units.	Remove manual on/off switches from emergency lighting / exit signage units to prevent them from being switched off.	Within 1 month	
----	-----------------	---	---	----------------	--

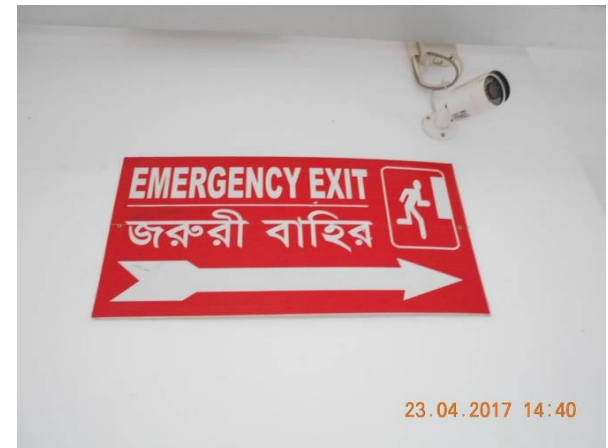
15	Egress Lighting	Exit signage not illuminated.	Regularly inspect all exit signage as per Accord standard and replace/install lights as needed to illuminate signs.	Within 1 month	
----	-----------------	-------------------------------	---	----------------	--
