# **FIRE SAFETY INSPECTION REPORT**

**SEACOTEX FABRICS LTD**  
**SANARPAR, SIDDIRGANJ, NARAYANGONG,1430**

August 5, 2014

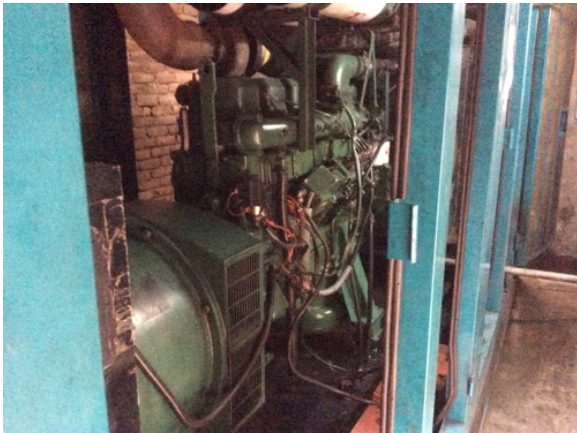
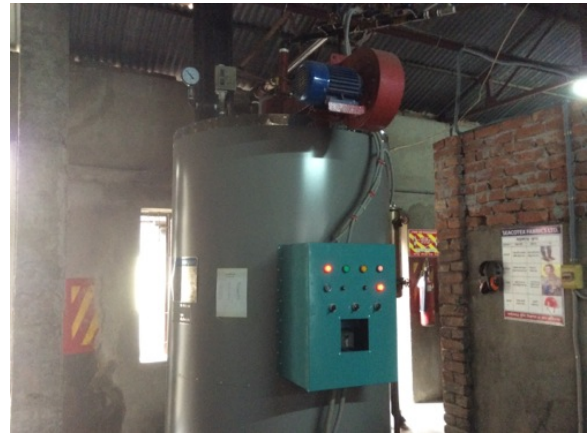
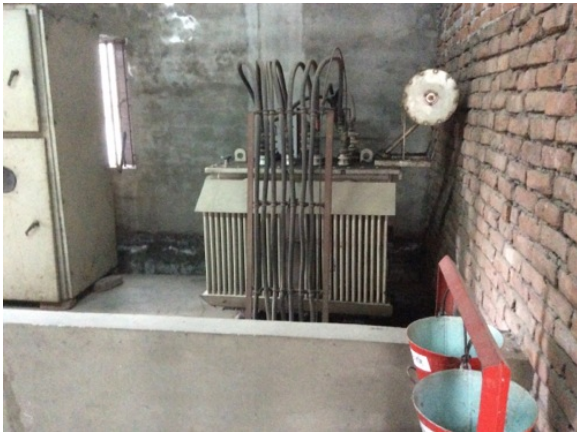
No.	Category	Finding	Recommendation	Remediation Timeframe
F-1	Fire Rated Construction	The boiler, generator, and transformer room located on the ground floor, is not separated by fire-rated construction, openings, non-rated doors, and penetrations.	Separate the boiler, generator, and transformer room by a minimum 2-hr fire-rated construction. Seal and/or protected all openings to maintain the required fire separations	Within 3 months

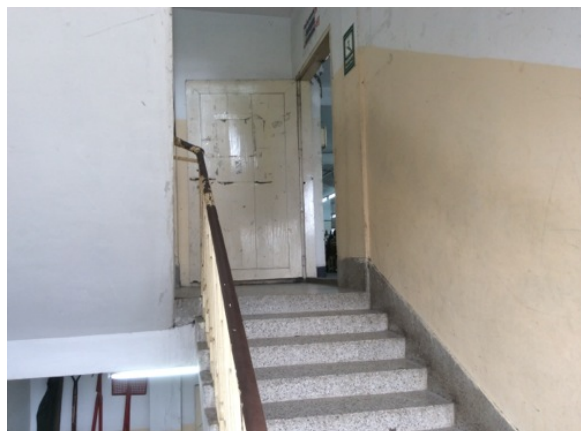
F-2	Fire Rated Construction	The exit stairs are not separated from work areas, and other spaces on each floor by fire-rated construction. This was reflected throughout the building on all floors.	Provide minimum 1.5-hr fire rated doors and seal all unprotected openings to separate the exit stairs from work areas and other building spaces on all floor levels. Ensure that the fire doors are self-closing and positive latching and that they are provided with fire exit (panic) hardware where serving production floors.	Within 3 months
			If fire doors are required to be held open for functional reasons, provide automatic-closing devices tied to the fire alarm system.

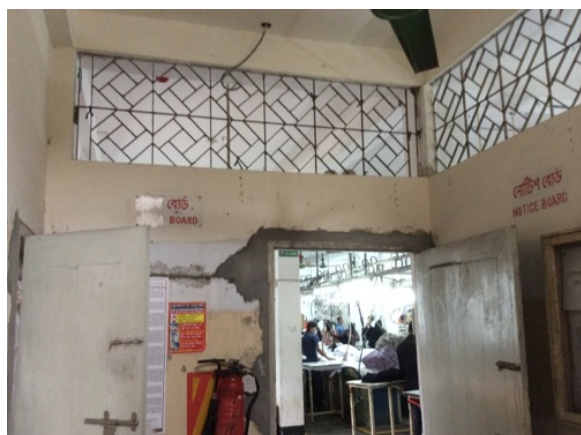
F-3	Fire Rated Construction	Unsealed penetrations and openings on the ground floor are located in the north and south exit stair enclosures.	Seal all penetrations and openings in exit stair enclosure walls to maintain the fire separation.	Within 3 months
-----	-------------------------	--	---	-----------------

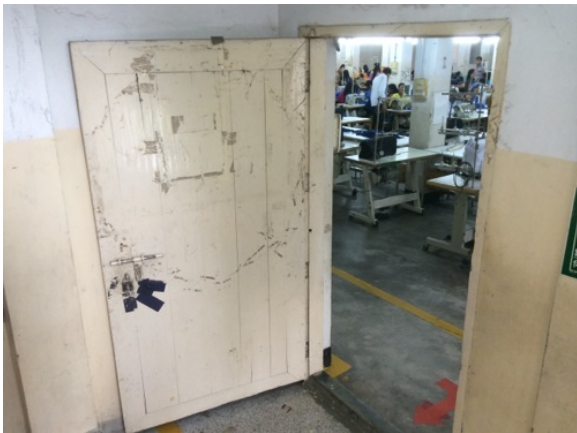
F-4	Egress	Egress doors / gates with locking features are provided at building exits, exit stairs, along egress routes, and exit discharge. This was reflected throughout the building on all floors.	Remove locking features from all egress doors / gates.  If locks are required for security reasons, utilize special door locking features complying with NFPA 101.	Immediate
-----	--------	--	--	-----------

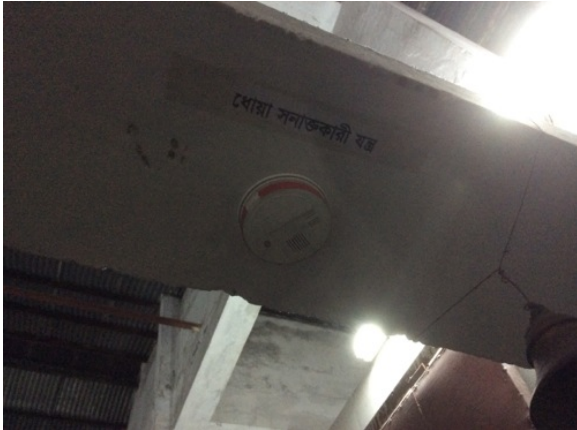
F-6	Fire Protection	In addition to having photoelectric smoke detectors, the building is equipped with single-station smoke alarms. Smoke alarm activation sounds only a local alarm and does not provide automatic fire alarm notification of occupants.	Remove single-station smoke alarms.	Within 6 months
-----	-----------------	---	-------------------------------------	-----------------

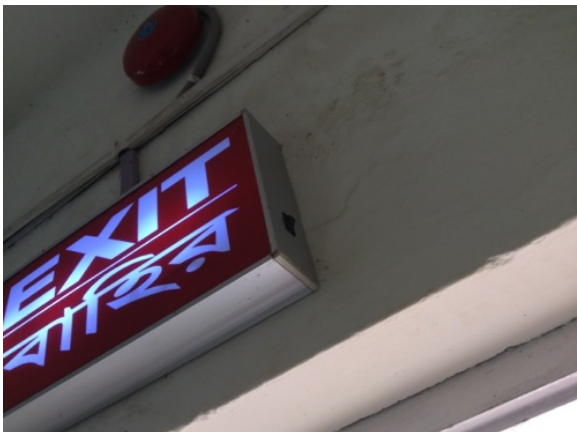
F-7	Egress Lighting	Manual on-off switch is provided for emergency lighting units. This was reflected throughout the building in various locations.	Remove manual on/off switches from emergency lighting units to prevent them from being switched off.	Within 1 month
-----	-----------------	---	--	----------------
