# **FIRE SAFETY INSPECTION REPORT**

**BOTTOM GALLERY PVT. LTD**  
**BULBUL TOWER,DIGIRCHALA,CHANDANA,**  
**JOYDEBPUR GAZIPUR**

**ACCORD**  
on Fire and Building Safety in Bangladesh

June 4, 2014

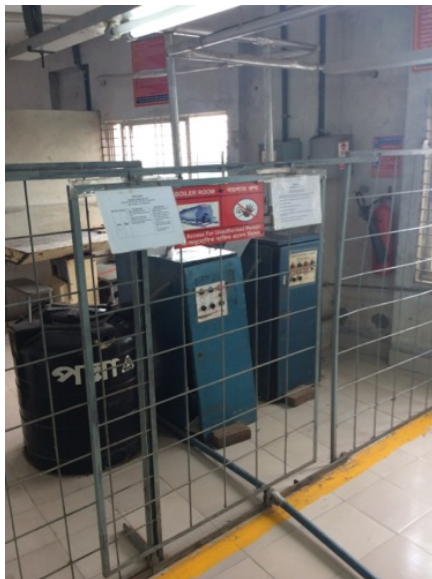
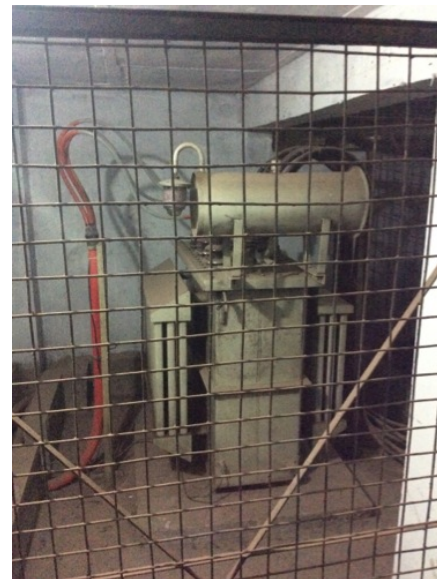
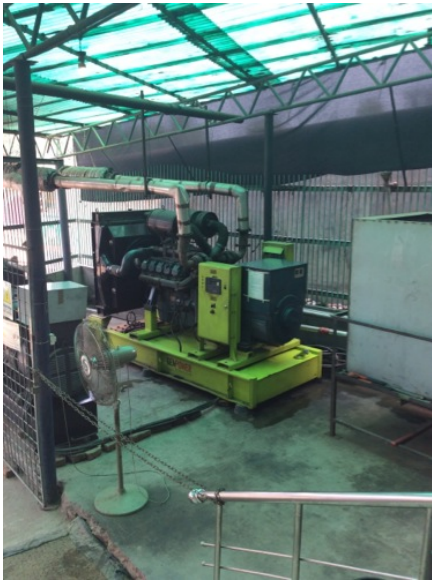
| No. | Category | Finding | Recommendation | Remediation Timeframe |
|---|---|---|---|---|
| F-1 | Fire Rated Construction | The boiler's, generator's and transformer areas are not separated by fire-rated construction. Unprotected openings, non-rated doors, and penetrations all noted present at time of inspection. | Separate the boiler's, generator's and transformer areas by a minimum 2-hr fire-rated construction. Seal and/or protected all openings to maintain the required fire separations | Within 3 months |

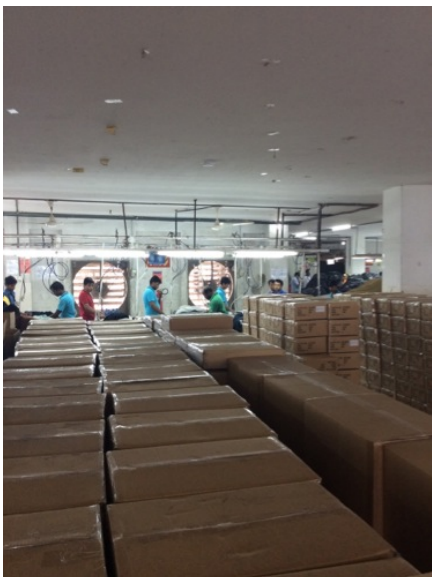
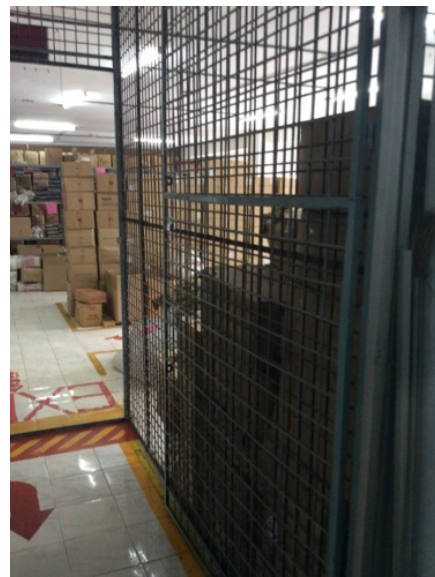
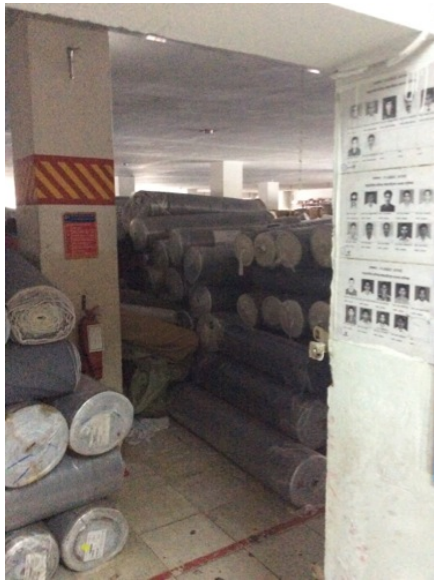
| F-2 | Fire Rated Construction | Areas used for combustible storage are not separated by fire-rated construction. The basement, ground, first, second, fourth and fifth floors have combustible storage open to production processes and exit discharge routes with no adequate fire rated separations. | Provide dedicated storage rooms separated by minimum 1-hr fire-rated construction. | Within 3 months |

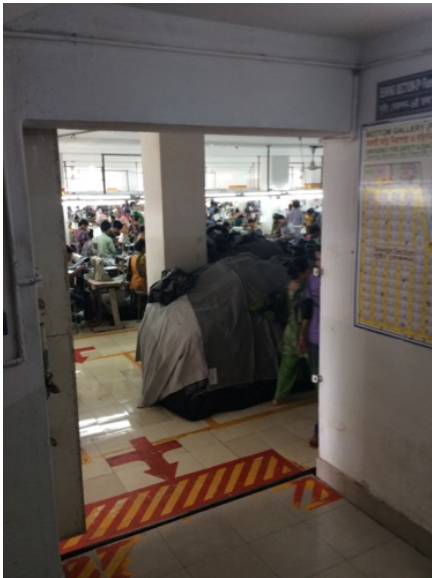
| F-3 | Fire Rated Construction | The exit stairs are not separated from work areas on each floor by fire-rated construction. | <p>Provide minimum 1.5-hr fire rated doors and seal all unprotected openings to separate the exit stairs from work areas and other building spaces on all floor levels. Ensure that the fire doors are self-closing and positive latching and that they are provided with fire exit (panic) hardware where serving production floors.</p> <p>If fire doors are required to be held open for functional reasons, provide automatic-closing devices tied to the fire alarm system.</p> | Within 3 months |

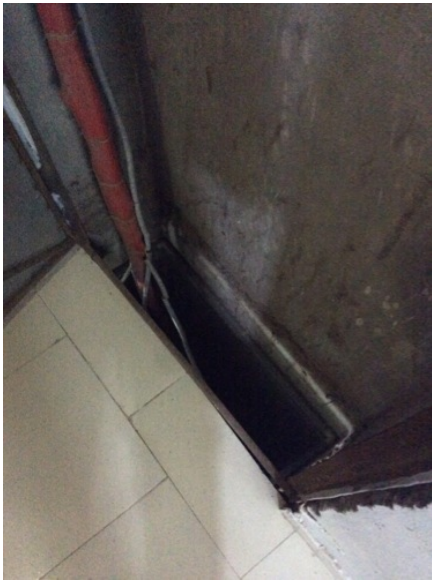
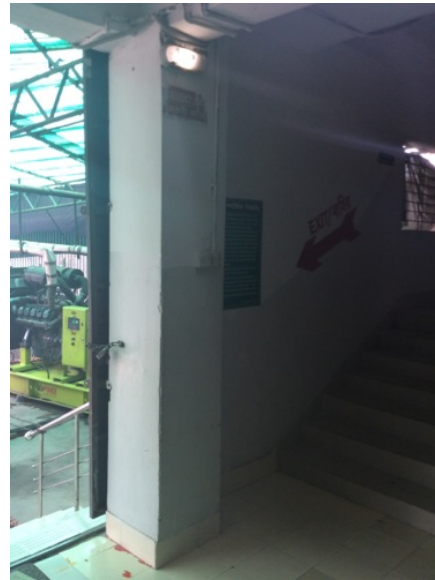
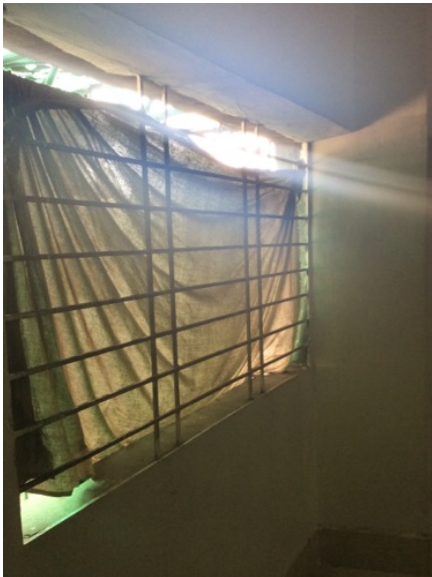
| F-4 | Fire Rated Construction | Unsealed penetrations and openings are located in East and West exit stair enclosures. The East stair has an electrical shaft penetrating each stairwell landing and factory floor. The West stair and ground/first floor level has an opening at close proximity to the generator space. | Seal all penetrations and openings in exit stair enclosure walls to maintain the fire separation. | Within 3 months |

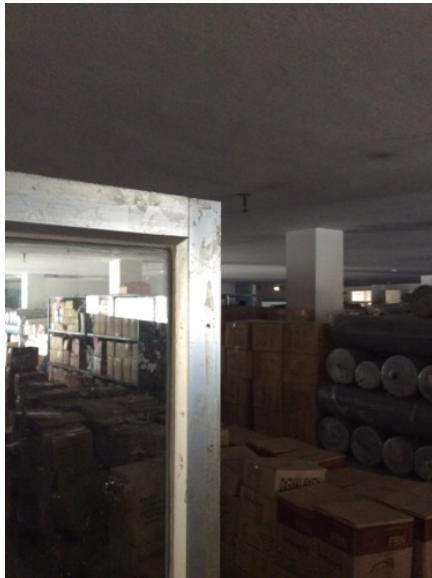
| F-5 | Fire Rated Construction | As the first floor dining space has approx 250 employees during dining times the space requires two (2) exits. This is the case however to access the west exit stair the exit route is open to large amounts of combustibile storage with no adequate separations by fire-rated construction. | Provide 2-hr fire-rated exit passageway leading directly outside (vestibules to separate any storage areas). | Within 3 months |

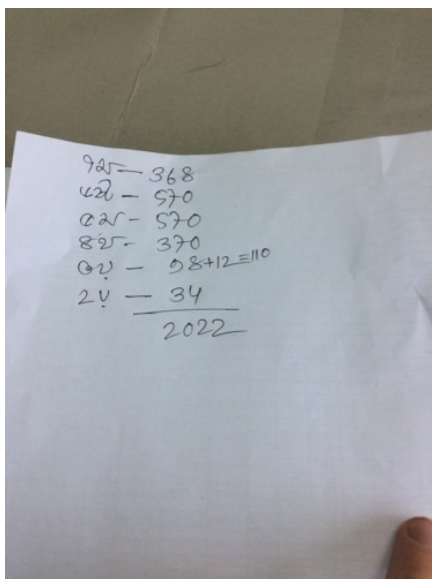
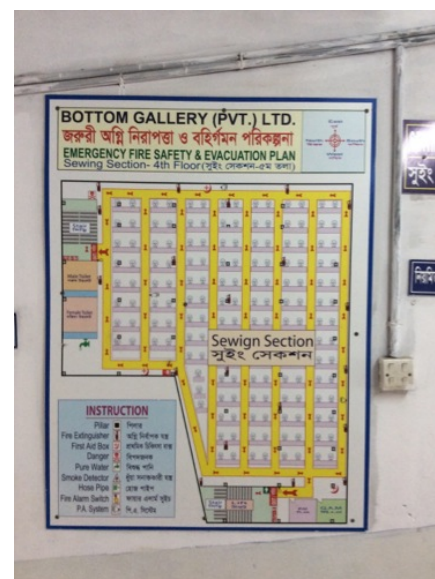
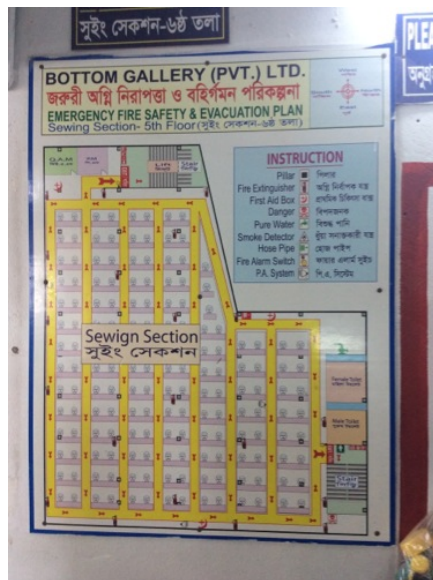
| F-6 | Egress | Exit capacity is not adequate for the occupant load on the fourth and fifth floors due to the number of employees being 570, as the building has 2 exits the maximum calculated egress capacity on these floors must be 373. | Reduce occupant load to not more than available exit capacity of 373 on the fourth and fifth floors.<br><br>In the future provide additional exits to allow for increased number of employees. | Immediate |

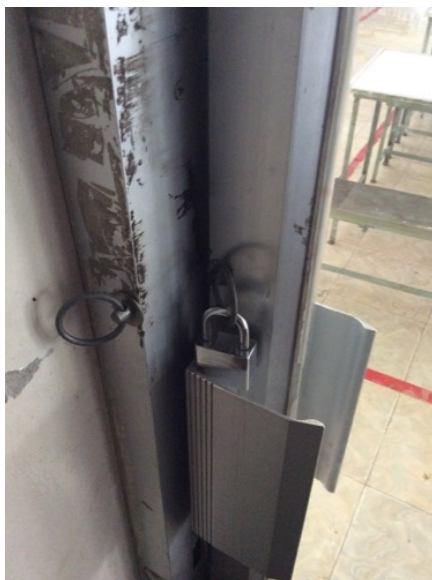
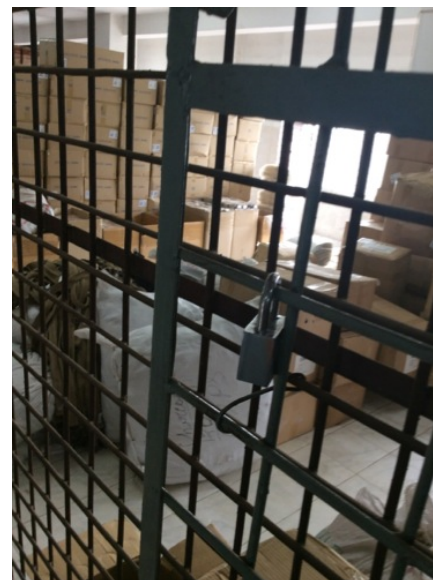
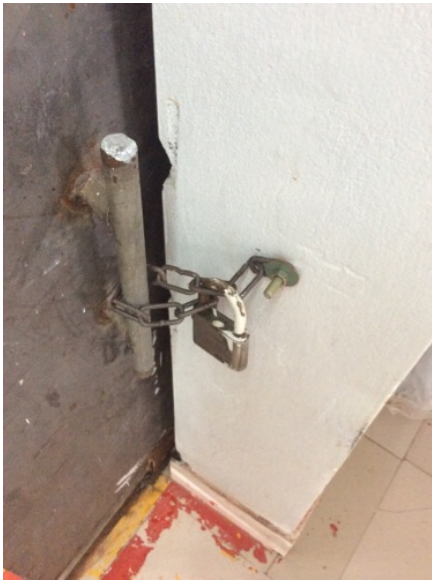
| F-7 | Egress | Egress doors and gates with locking features are provided at building exits and storage areas. All gates/doors were open and unlocked during the inspection. | Remove locking features from all egress doors / gates. If locks are required for security reasons, utilize special door locking features complying with NFPA 101. | Immediate |

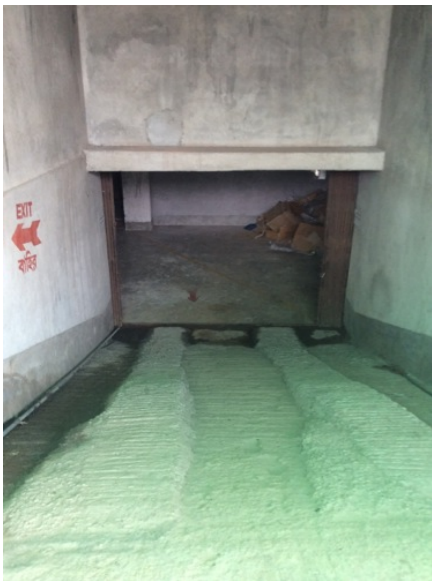
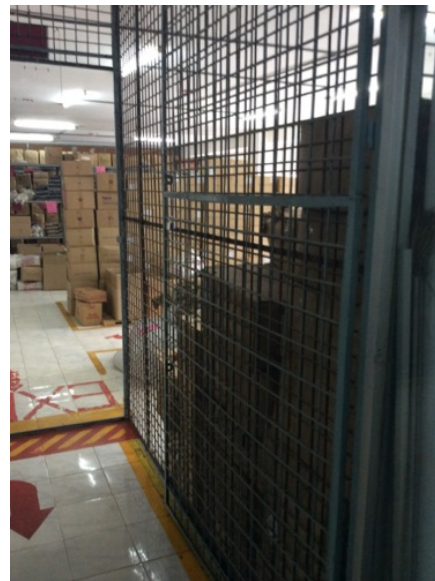
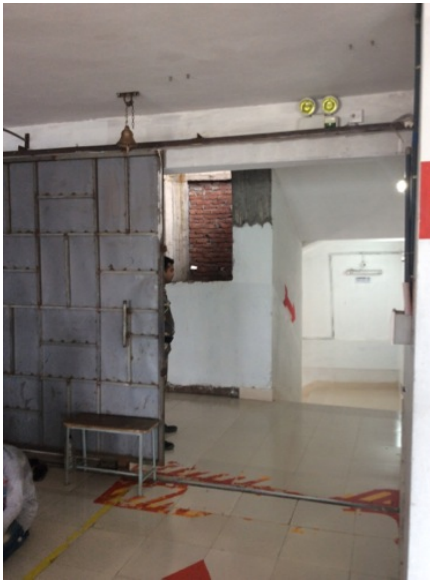
| F-8 | Egress | Collapsible gates and sliding doors are provided at building exits, exit stairs, along egress routes and main exit discharge. | Replace all gates / sliding doors along the means of egress with side-hinged, swinging egress doors.<br><br>If locks are required for security reasons, utilize special door locking features complying with NFPA 101. | Within 1 month |

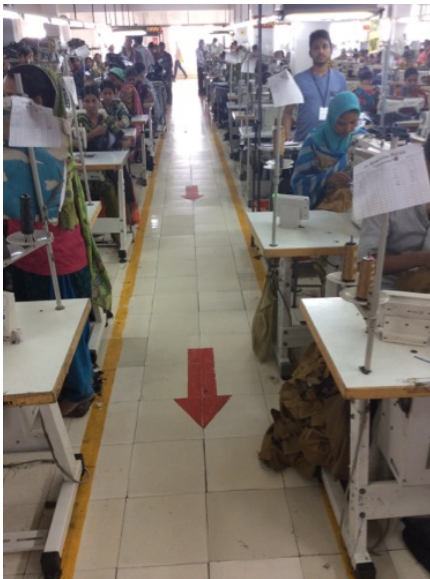
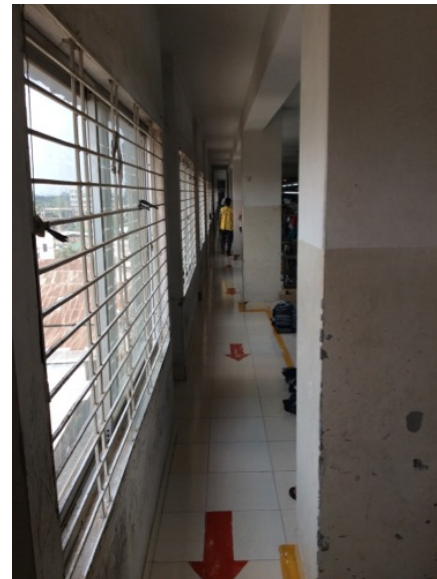
| F-9 | Egress | The width of egress aisles is less than 36-in on the third and fourth floors due to structural column and machinery layout. | Provide minimum aisle widths of 36-in. | Within 3 months |

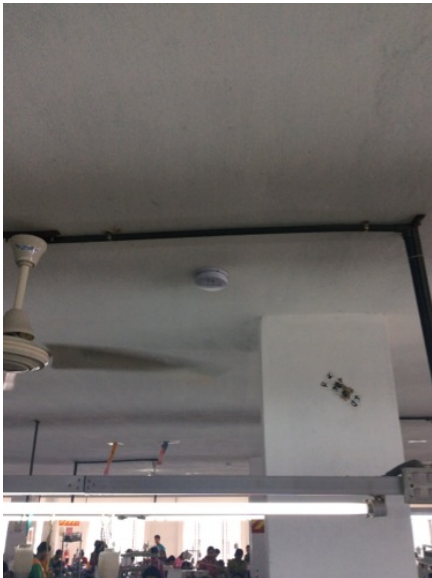
| F-12 | Fire Protection | The building is equipped with single-station smoke alarms. Smoke alarm activation sounds only a local alarm and does not provide automatic fire alarm notification of occupants. | Remove single-station smoke alarms. Provide automatic smoke detection throughout the building, tied into the fire alarm system, in accordance with NFPA 72. | Within 6 months |

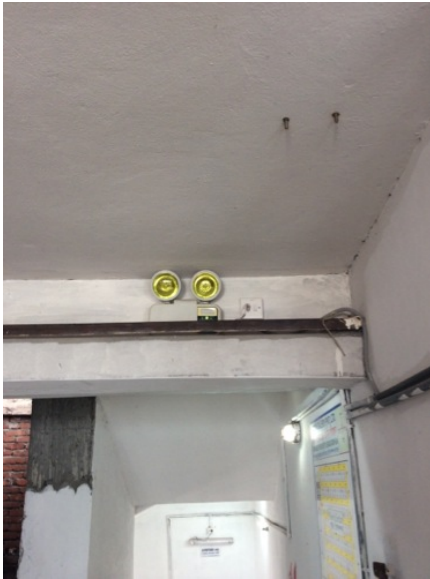
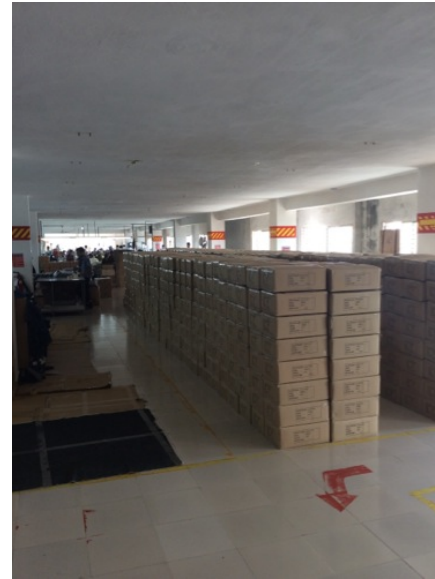
| F-13 | Egress Lighting | Manual on-off switch is provided for emergency lighting units at floor plate exits and stairwell landings. | Remove manual on/off switches from emergency lighting units to prevent them from being switched off. | Within 1 month |
