Fuji Knitwears Ltd.

Hossain Ahmed Road Opposite Police Line , Fatullah
(23.633595, 90.482869)

12th March 2017

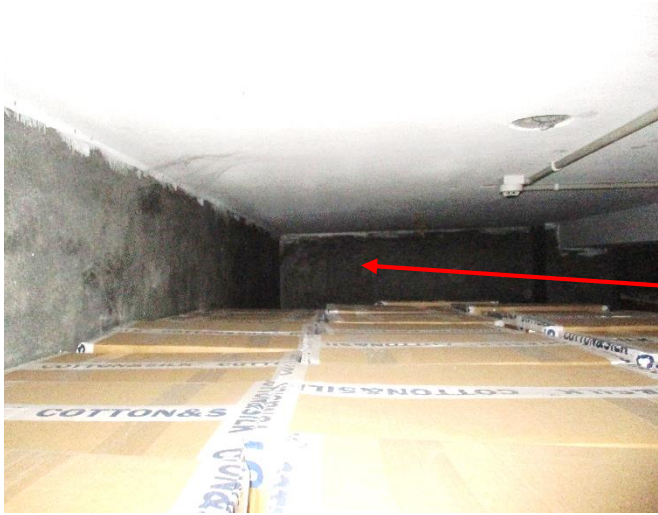
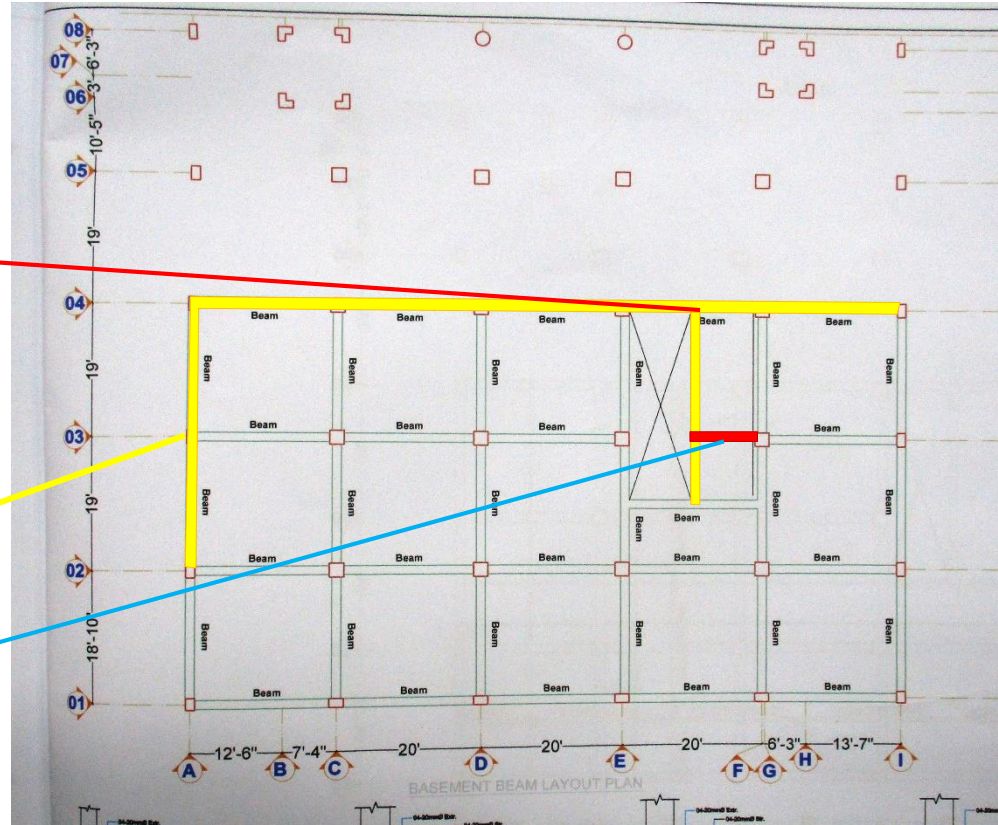
Beam Layout of Basement

Beam layout for basement wasn't matched with site condition. On grid-03 floor beam was found continuous and rest on brick wall shown as red mark on drawing. Floor beams were missing at Ground floor level marked as yellow in layout drawing.

Item No.	Observation	Recommended Action Plan	Recommended Timeline
1	Discrepancies between provided drawings and on site condition	Building Engineer is required to survey the as-built structure and prepare the accurate as-built drawings.	6-weeks
2	Falling hazards and exposed rebar at the roof	Secure constructed area from any possible falling hazard.	Immediate - Now
3	Falling hazards and exposed rebar at the roof	All exposed reinforcement is required to protect from corrosion which may cause degradation of the concrete.	6-weeks
4	Columns suspected to vehicle impact	Install a barrier to prevent vehicle impact in column.	6-weeks

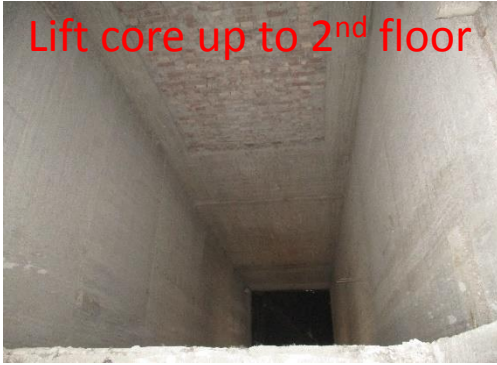
Lift core up to 2nd floor

RC walls were observed at three side up to 1st floor and two side up to 2nd floor at lift core.
No detail drawings were found for lift core walls and retaining walls.

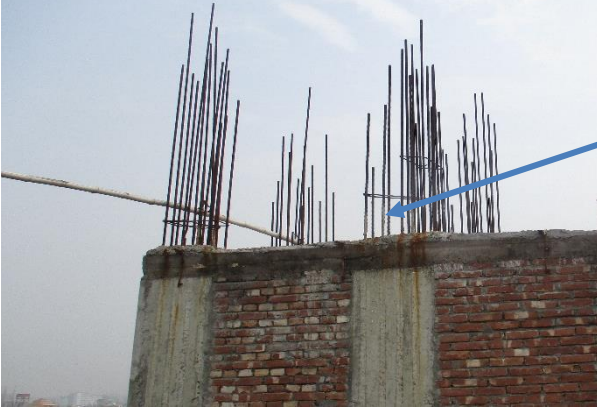
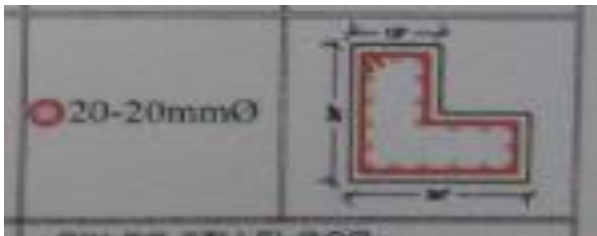
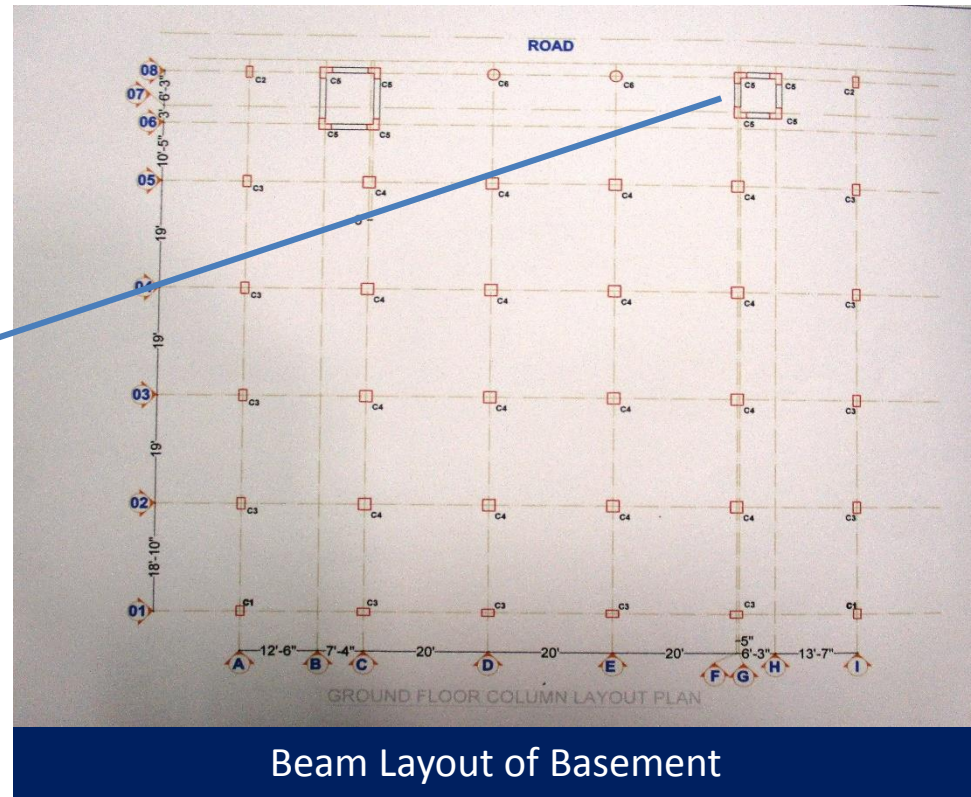
Number of rebar wasn't matched between drawings and site condition. On site 16 nos of vertical rebars were observed instead of 20 nos of vertical rebar at Lift core column (C-6 type).

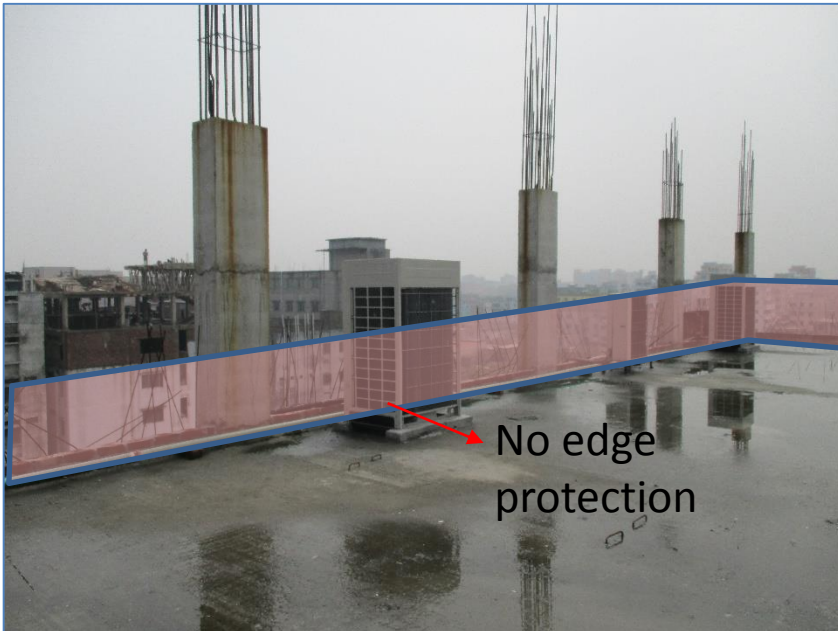
No edge protection

No parapet wall

Falling hazards due to unprotected edge of under construction building and extended rebar was exposed.

Factory engineer to provide proper edge protection system and all exposed reinforcement must have adequate protection from the corrosion.

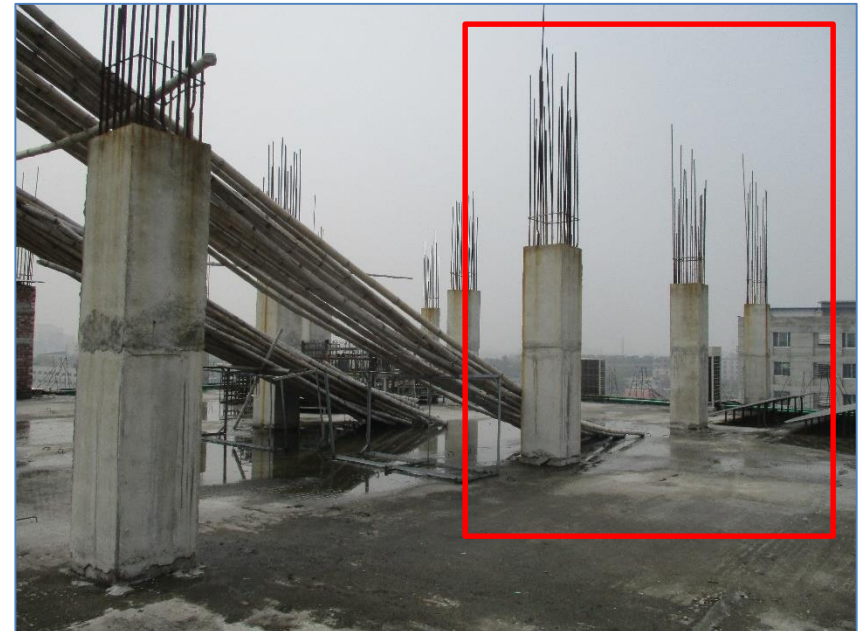
Exposed rebar on roof

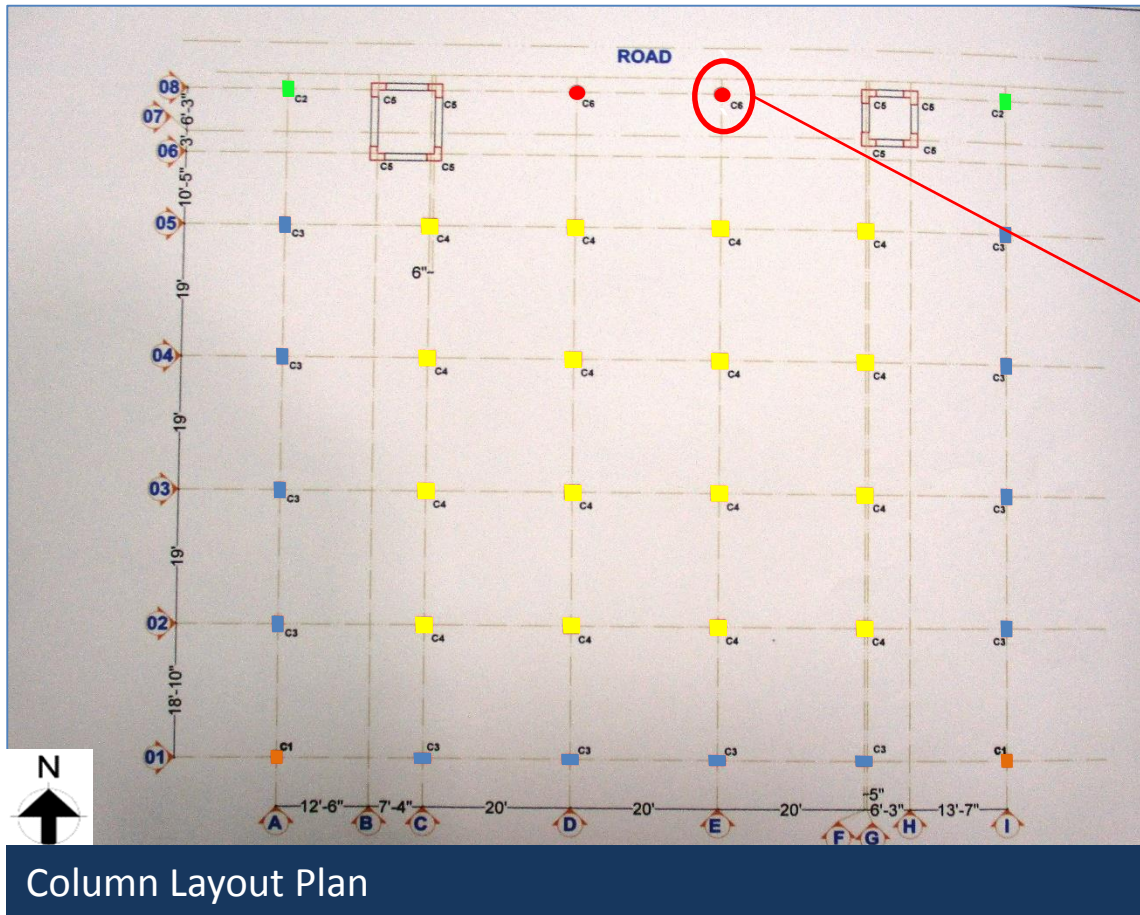
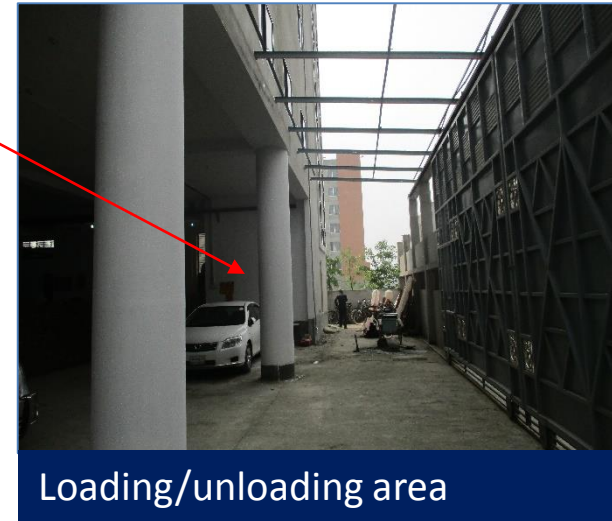
Columns suspected to vehicle impact

Impact protection not provided to columns at loading –unloading area. Columns were suspected to have impact loading from vehicles.
