# **FIRE SAFETY INSPECTION REPORT**

**MB Knit Fashion Ltd.**

**ACCORD ID: 12502**

**Inspected By: Nusrat Hossain Trisha, Md. Sabbir Ahmed Shourav  
Date: 06 September, 2016**

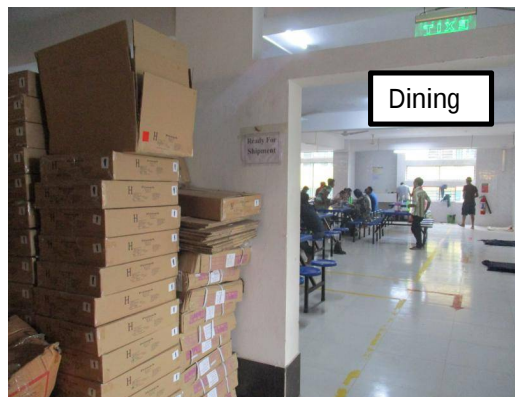
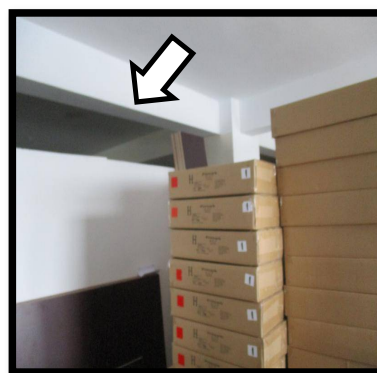
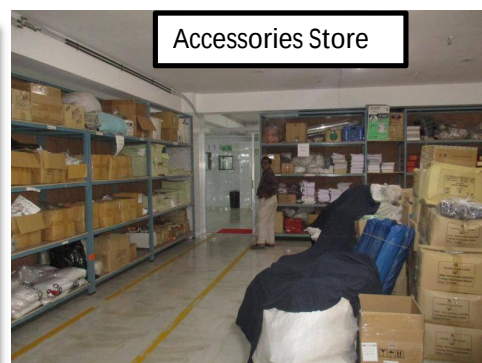
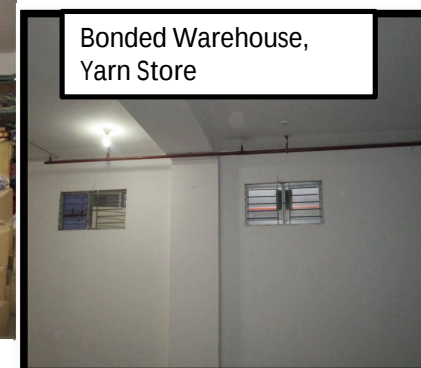
| Sl No. | Category | Findings | Required Action | Remediation Time Frame |
|---|---|---|---|---|
| F-1 | Fire Rated Construction | Rooms used for storage of combustible materials are not separated from the surrounding occupancy (Location: Ground floor warehouse penetrations, 2nd floor accessories store, 6th floor finished goods store with dining). | Rooms used for storage of combustible materials shall be separated from the surrounding occupancy with a minimum 1 hour construction. | Within 3 months |

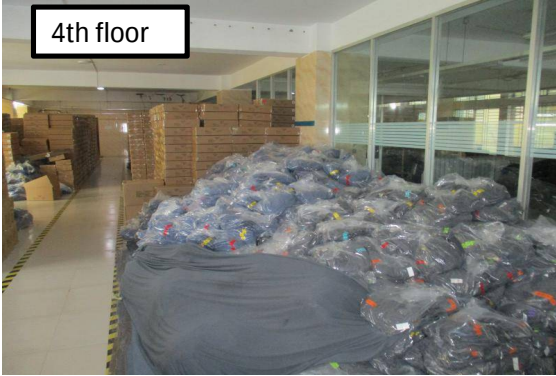
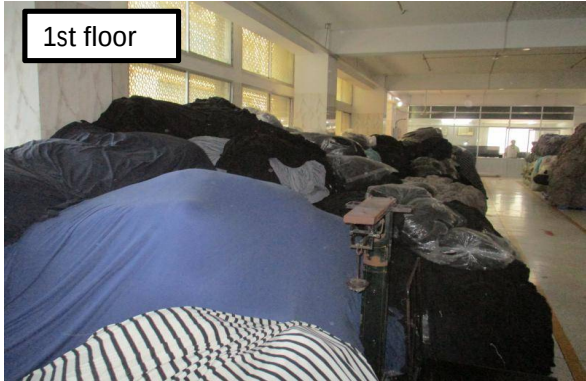
| F-2 | Fire Rated Construction | Areas used for in-process storage of combustible materials are open to the surrounding occupancy (Location: 1st floor with cutting; 4th floor with finishing & iron section) | <p>Provide defined storage areas and limit the storage arrangement as follows:-</p> <ol style="list-style-type: none"> <li>1. General Condition: Maximum height of 2.4m and maximum area of 23m<sup>2</sup>. Separate areas of unenclosed combustible storage by a minimum clear distance of 3m.</li> <li>2. If sprinkler protected: maximum height of 3.66m and maximum area of 93m<sup>2</sup>. Separate areas of unenclosed combustible storage by a minimum clear distance of 3m.</li> </ol> <p>or</p> <ol style="list-style-type: none"> <li>3. Enclose the storage area from the surrounding occupancy with a minimum 1 hour construction.</li> </ol> | Within 3 months |

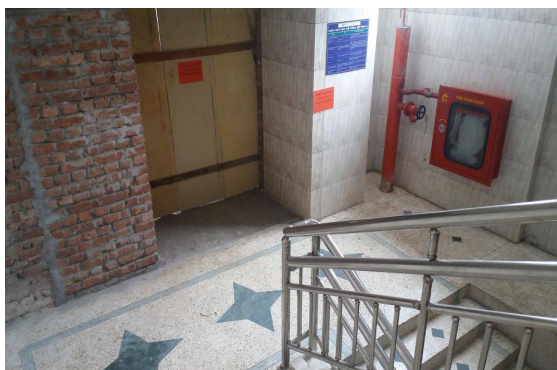
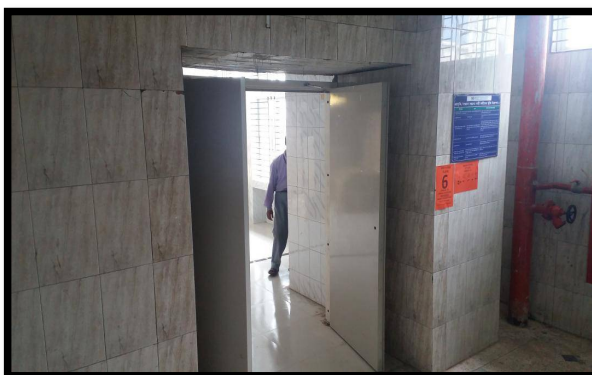
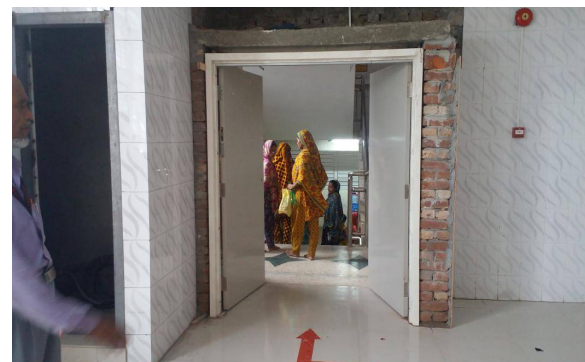
| F-3 | Fire Rated Construction | The north & south exit stairs are not fully separated from [work areas, other spaces] on each floor by fire-rated construction in some floors. Fire door installation is in progress. | Stairs shall be enclosed with a minimum 2-hr fire-rated construction. Seal all unprotected openings and provide minimum 1.5-hr fire rated doors to separate the exit stairs from work areas and other building spaces on all floor levels. Ensure that the fire doors are self-closing, positive latching and that they are provided with fire exit (panic) hardware where serving production floors. | Within 3 months |

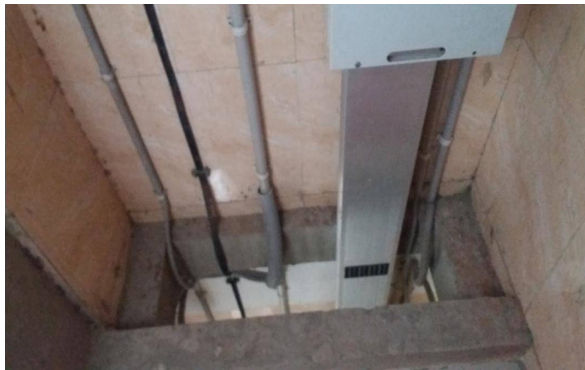
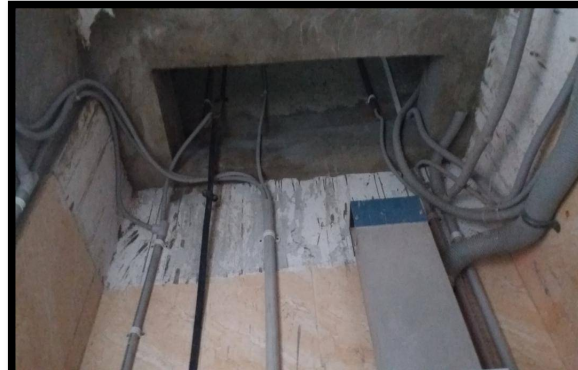
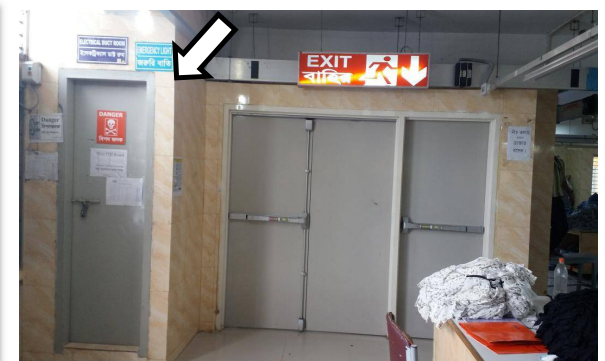
| F-4 | Fire Rated Construction | Penetrations through floor/ceiling assemblies are found unsealed.<br>(Location: Electrical riser at north side of the building) | Seal all penetrations and openings in floor/ceiling (full thickness of the floor/ceiling) assemblies by fire rated materials to maintain the fire resistance rating. Provide a minimum 2-hr fire rated shaft to separate the utility risers from each floor. | Within 3 months |

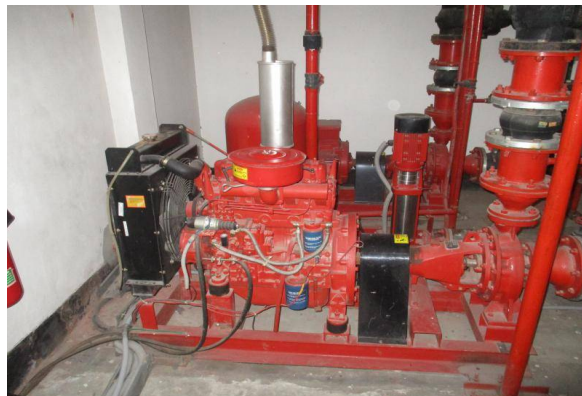
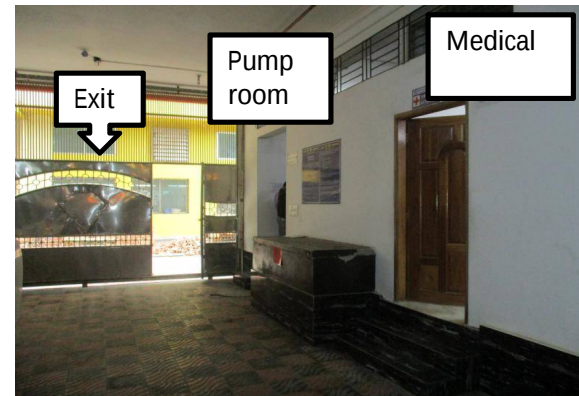
| F-5 | Fire Rated Construction | Pump room is not properly fire separated from the exit passageway by fire rated construction. (Location: Ground floor beside the medical centre) | Separate the pump room by a minimum 2-hr fire-rated construction to separate it from the exit passageway. Seal and/or protect all openings to maintain the required fire separations. Provide proper ventilation and consult a qualified engineer. | Within 3 months |

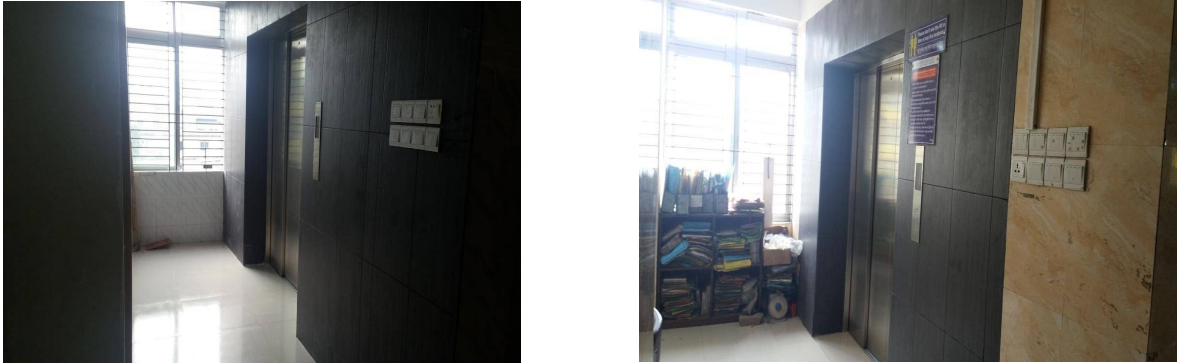
| F-6 | Fire Rated Construction | Elevator shaft is not separated from the production floor by proper fire rated construction (openings, non-rated doors) | Provide a minimum 2-hr fire rated elevator shaft to separate it from each floor. Seal and/or protect all openings to maintain fire separation. | Within 3 months |

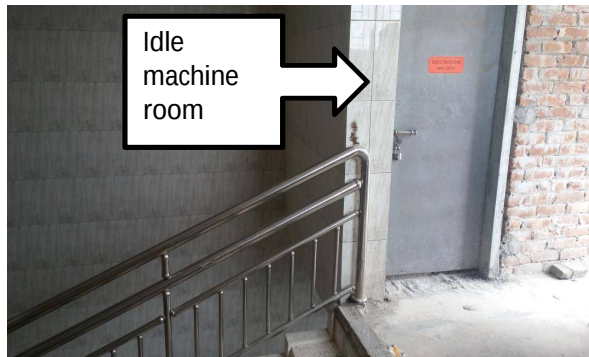
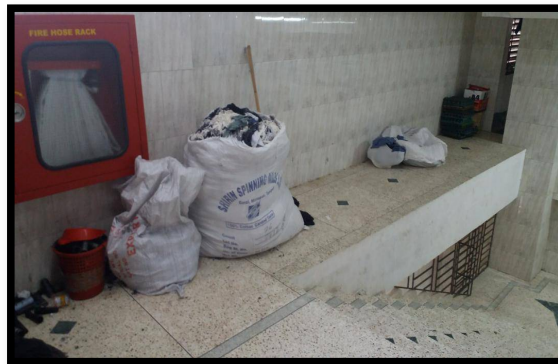
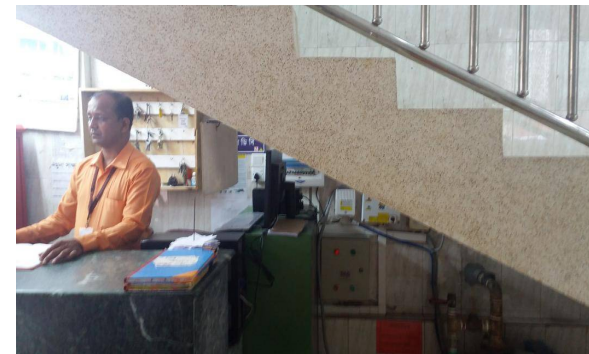
| F-7 | Egress | Storage was located in the exit stairwell. (Location: Wastage bag on stair landings of all floors, idle machine room discharges in the staircase at rooftop, reception point, pump panel board at ground under the staircase) | Remove all storage from exit stairs and egress paths. | Immediate |

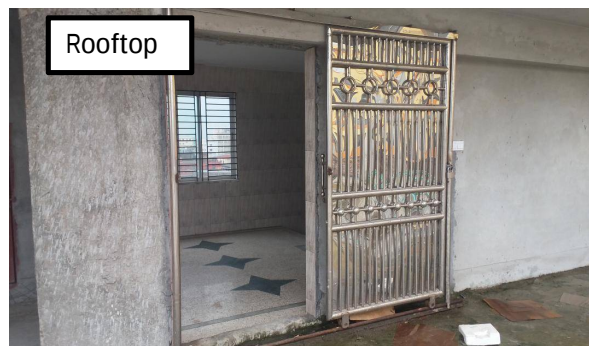
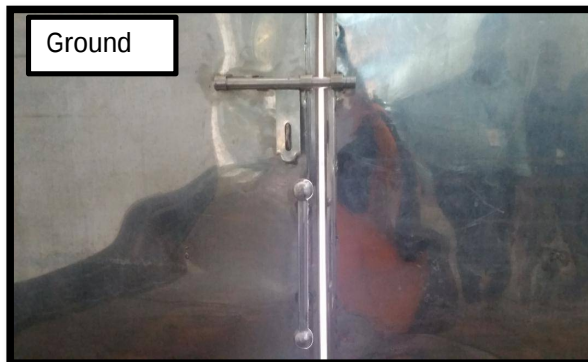
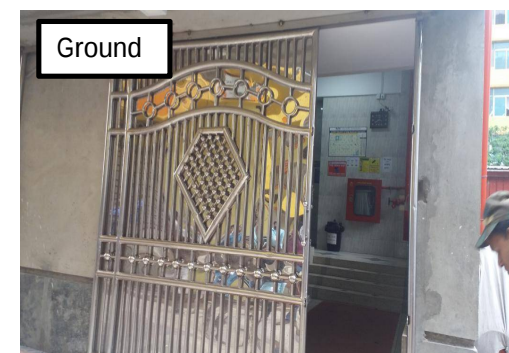
| F-8 | Egress | Non Compliant doors (sliding doors) are provided at ground floor & rooftop. | Replace all non-compliant doors along the means of egress with side-hinged, swinging egress doors.<br>If locks are required for security reasons, utilize specialized door locking features complying with NFPA 101. | Within 1 month |

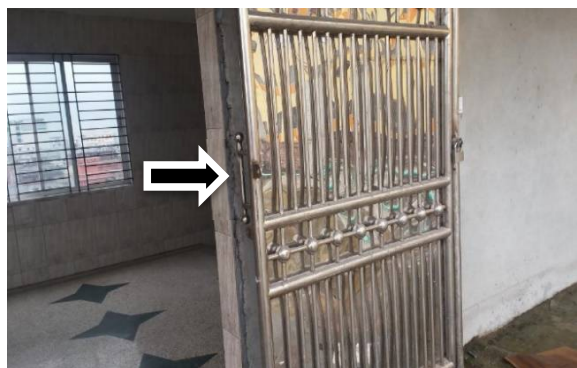
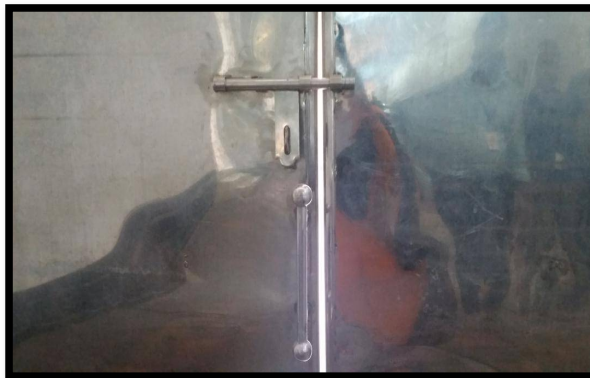
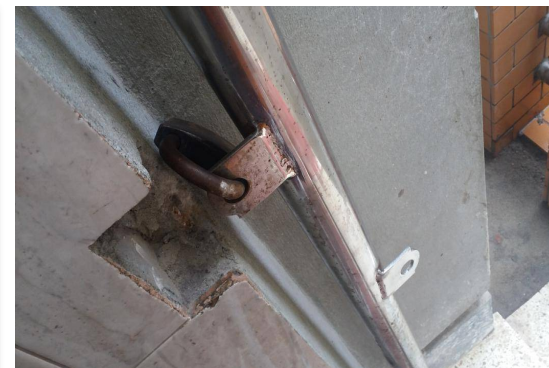
| F-9 | Egress | Egress doors/gates with locking features not complying with NFPA 101 are provided at rooftop & ground floor. | Remove locking features from all egress doors/gates. If locks are required for security reasons, utilize specialized door locking features complying with NFPA 101. | Immediate |

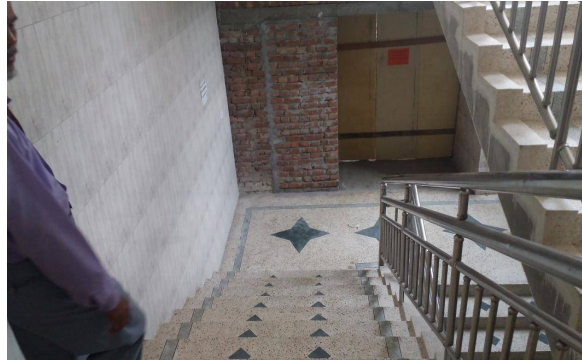
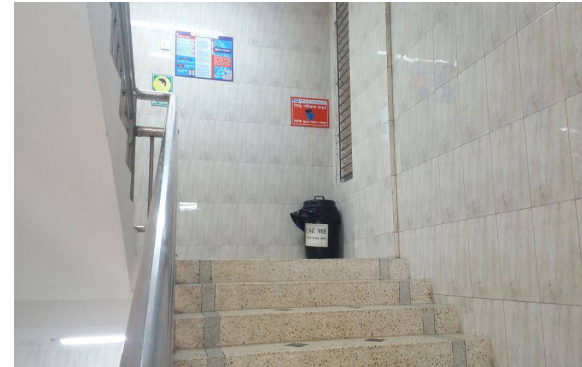
| F-11 | Egress | Handrails are not provided in both side of the exit stairs. | Provide handrails on both sides of the exit stair. New handrails shall have a minimum height of 865mm (34 in.) and a maximum height of 965 mm (38 in.) as measured from the leading edge of the tread. Intermediate handrails shall be provided when the stair width exceeds 2.2 m (87 in.) | Within 3 months |

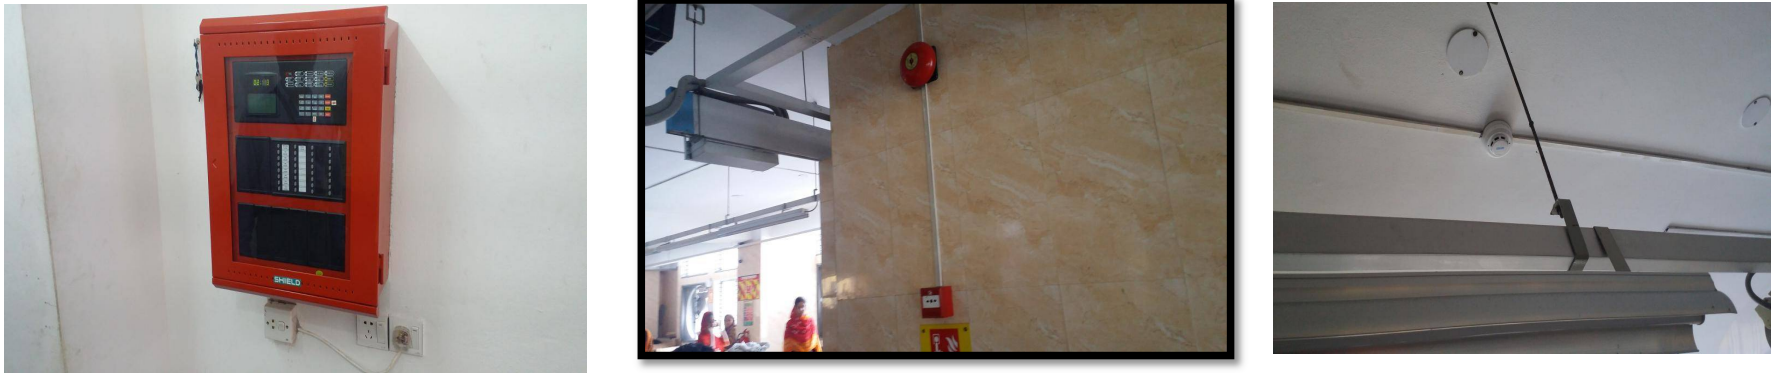
| F-14 | Fire Detection System | Fire detection system installation requires detailed review to confirm compliance with NFPA 72 and ACCORD standards | Submit drawings, testing records, equipment certification and other relevant documentation to the ACCORD for review and approval, modification shall have to done as per the reviewed design (if required) | Design within 2 month;<br>Modification of the system (if required) within 6 months |

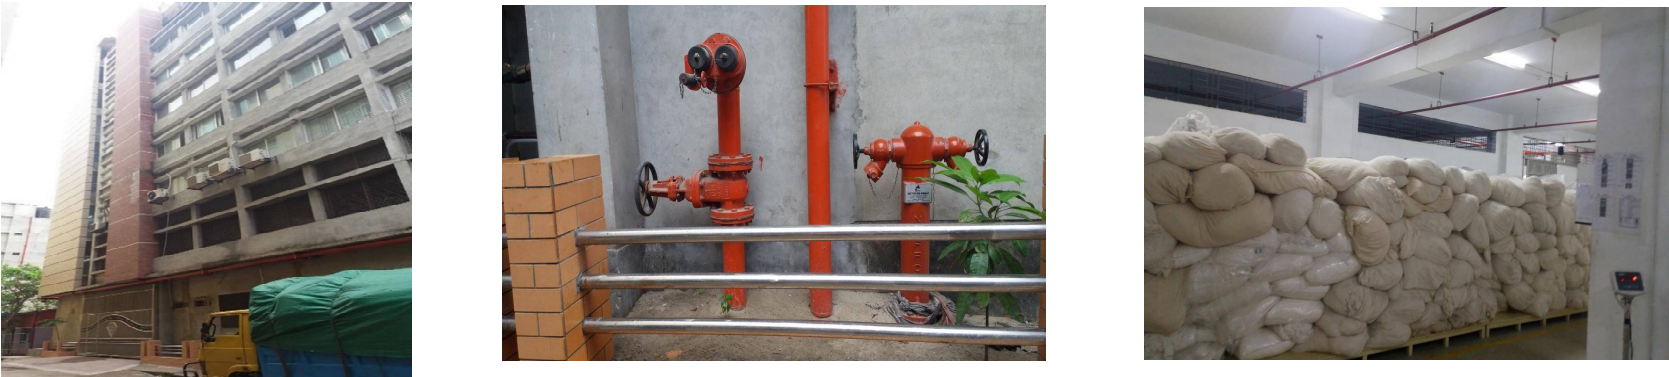
| F-16 | Fire Protection System | The existing high-rise building with an occupiable floor greater than 23 m (75 ft) above the finished grade is not protected with an approved automatic sprinkler system. The large occupant loads, anticipated extended egress times warrant sprinkler protection. | Provide an automatic sprinkler protection throughout the building in accordance with NFPA 13. | Design within 6 months, install within 12 months |

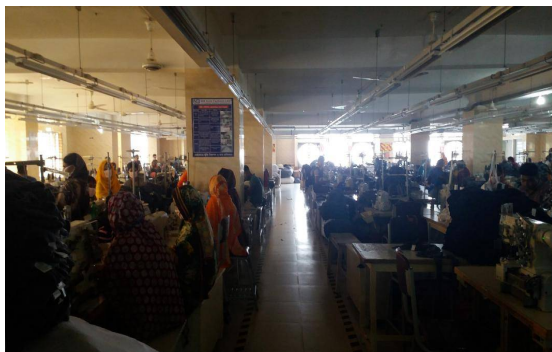
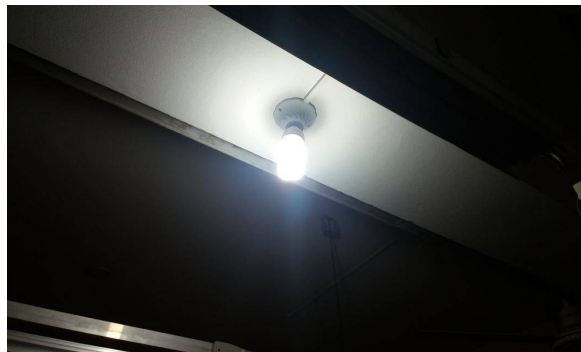
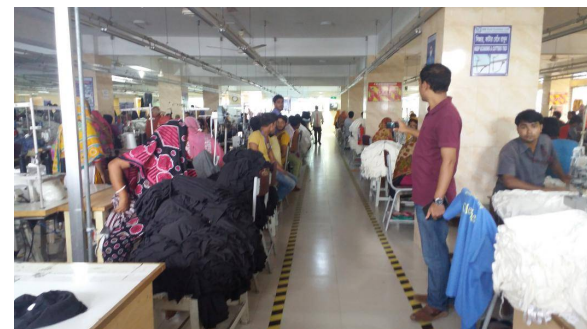
| F-18 | Egress Lighting | Based on the number and location of emergency lights observed, adequate illumination levels are not anticipated along egress routes. Location: All floors | <p>Test the emergency lighting system on each floor and provide additional emergency fixtures to provide adequate illumination along the means of egress. Provide a minimum illumination of 10 lux at the floor level within exit stairs and exit discharge paths and minimum 2.5 lux along exit access aisles.</p> <p>Illuminated directional signs shall be provided where there is a change in the direction for the path of travel and the direction to an exit is not obvious.</p> | Within 3 months |
