# Azmeri Composite Knit Ltd

20<sup>th</sup> May 2014

# Observations

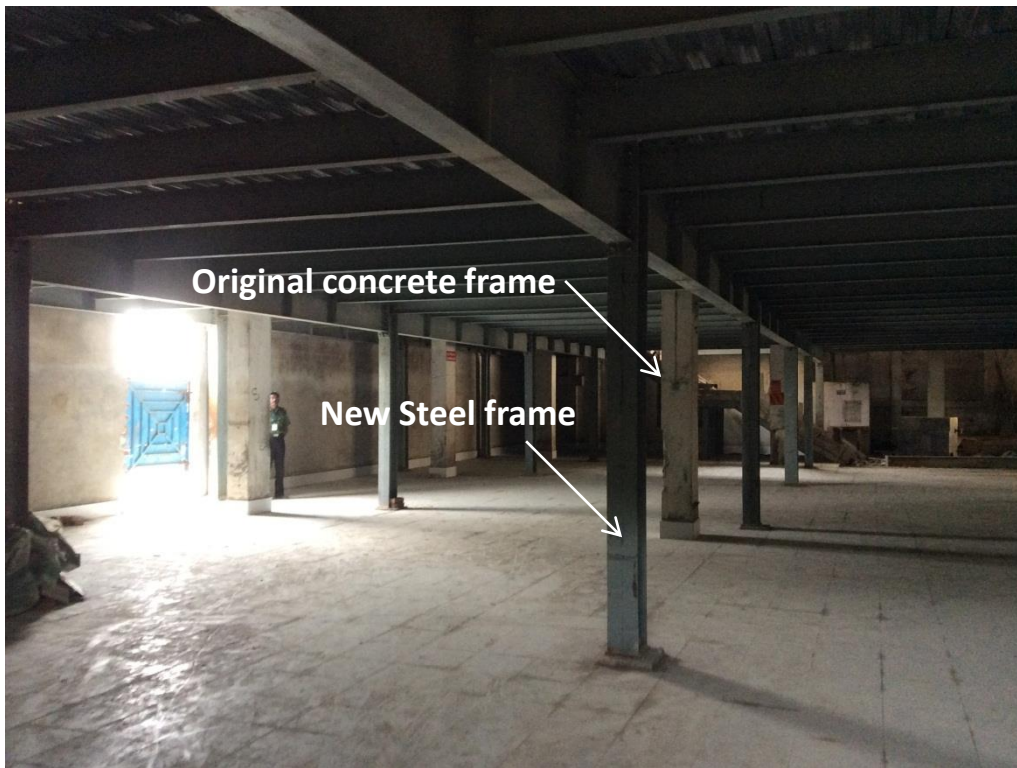
Original Shed with new steel mezzanine infill.

- New steel columns appear to be founded on existing ground floor slab, i.e. not on new foundations.
- Connection details of steel frame are poor, with bent plates and gaps between connecting elements.
- There was no evidence of fireproofing to the steelwork supporting the mezzanine floors.
- No design details for the steel frame were available.

| Item No. | Observation | Recommended Action Plan | Recommended Timeline |
|---|---|---|---|
| 1 | Building 2 – Damage to structural concrete elements and lack of design information for new steelwork | Construction work in Building 2 to cease immediately pending the outcome of the assessment / review. | <b>Immediate - Now</b> |
| 3 | Building 2 – Damage to structural concrete elements and lack of design information for new steelwork | Building Engineer to review all steelwork details to check if the steel frame are capable of carrying the proposed building loads, both vertical and horizontal, including the preparation of calculations. | <b>Immediate - Now</b> |
| 4 | Building 2 – Damage to structural concrete elements and lack of design information for new steelwork | Building Engineer to assess the requirement for providing fire protection to the steel frame. | <b>Immediate - Now</b> |
| 5 | Building 2 – Damage to structural concrete elements and lack of design information for new steelwork | Building Engineer to check the need for pad footings under the steel columns, including the preparation of calculations. | <b>Immediate - Now</b> |

| Item No. | Observation | Recommended Action Plan | Recommended Timeline |
|---|---|---|---|
| 7 | Building 2 – Damage to structural concrete elements and lack of design information for new steelwork | Carry out any necessary remedial works to steelwork, including new foundations, arising from Building Engineer's review. | 6-weeks |

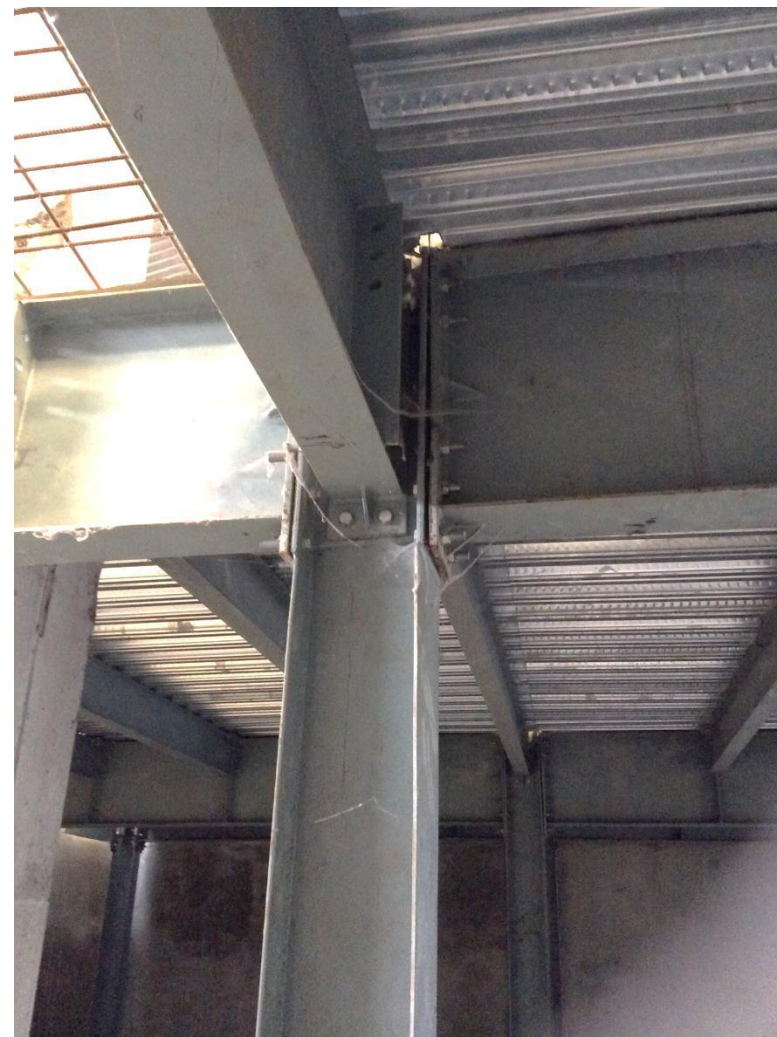
Large gaps between end plates and columns; generally poor connections throughout.

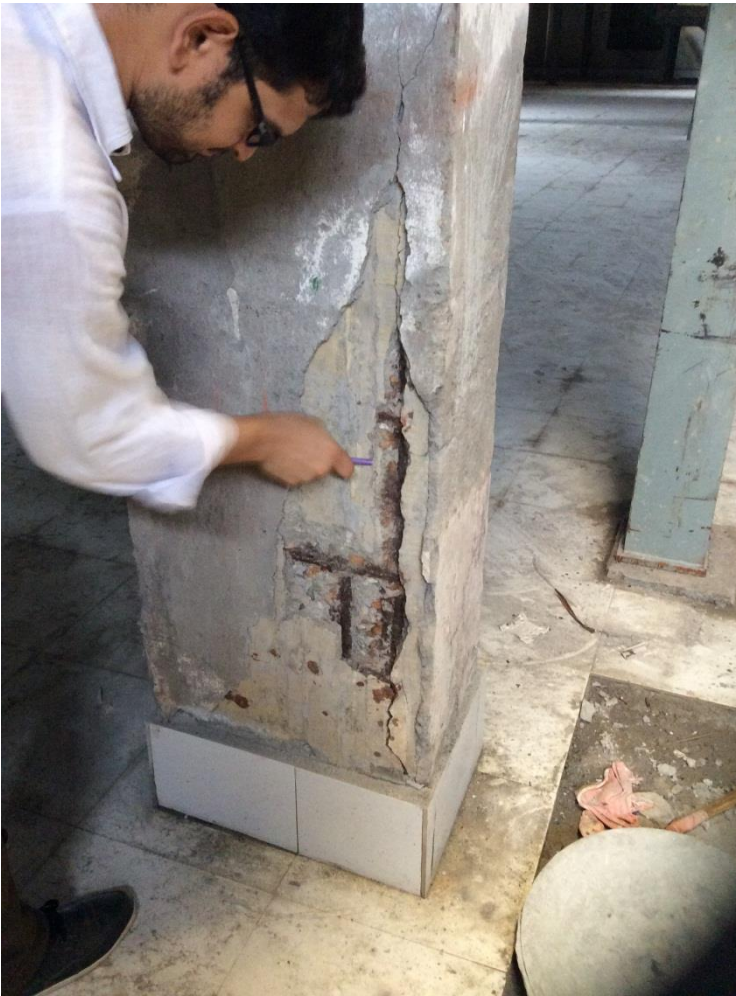
Corroded steel in concrete columns.

| Item No. | Observation | Recommended Action Plan | Recommended Timeline |
|---|---|---|---|
| 6 | Building 2 – Damage to structural concrete elements and lack of design information for new steelwork | Carry out any necessary repairs / strengthening works to the RC structure arising from Building Engineer's assessment. | <b>6-weeks</b> |

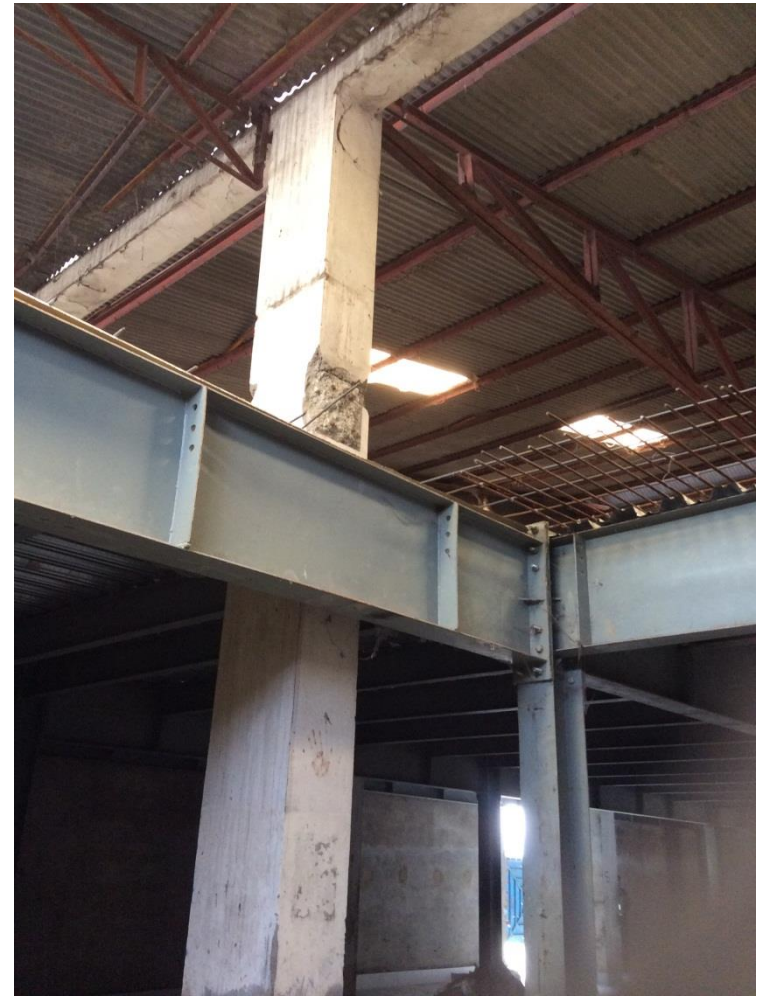
Concrete beam removed for installation of new steel.

Existing RC frame has been damaged.

| Item No. | Observation | Recommended Action Plan | Recommended Timeline |
|---|---|---|---|
| 2 | Building 2 – Damage to structural concrete elements and lack of design information for new steelwork | Building Engineer to assess the effect of the demolition of RC elements on the remaining structure, including the preparation of calculations. | <b>Immediate - Now</b> |

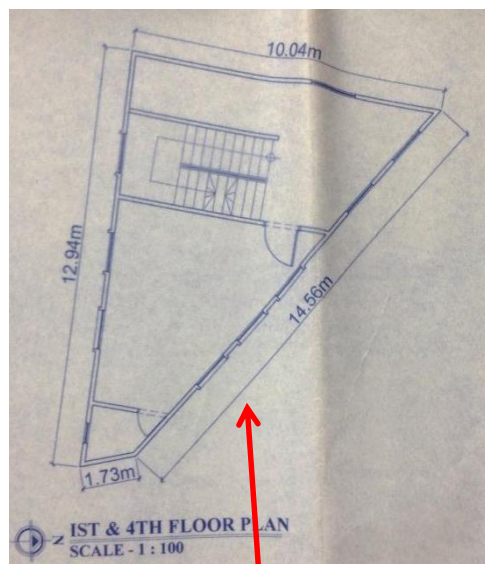
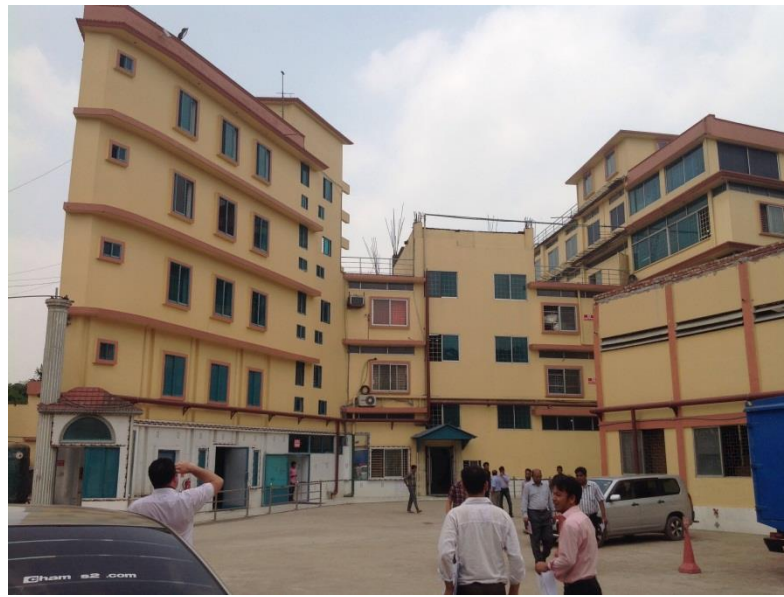
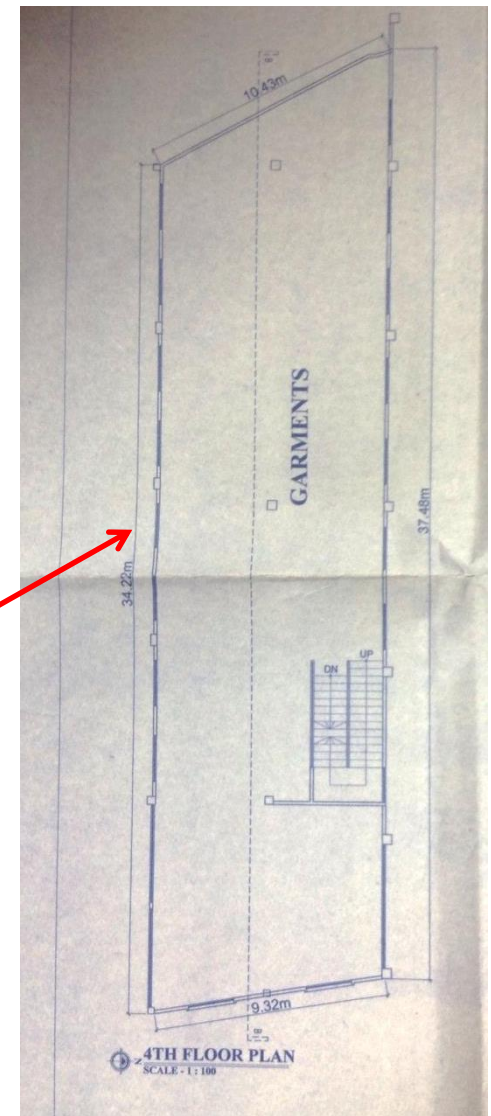
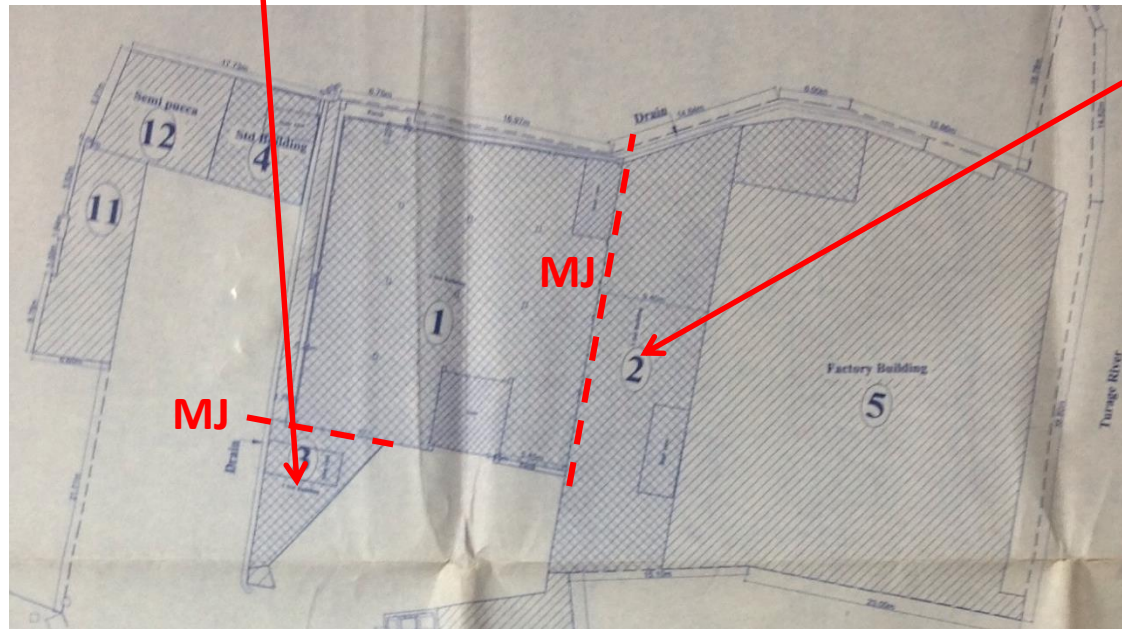
## Building 1 – Lateral stability of 5 storey Narrow Buildings

# **Building 1 – Lateral stability of 5 storey narrow buildings**

| Item No. | Observation | Recommended Action Plan | Recommended Timeline |
|---|---|---|---|
| 9 | Building 1 – Lateral stability of narrow 5 storey buildings | Building Engineer to assess by calculation the capacity of the narrow 5-storey structures to withstand lateral loads in accordance with Code values. | 6-weeks |
| 10 | Building 1 – Lateral stability of narrow 5 storey buildings | Implement any actions arising from assessment. | 6-months |

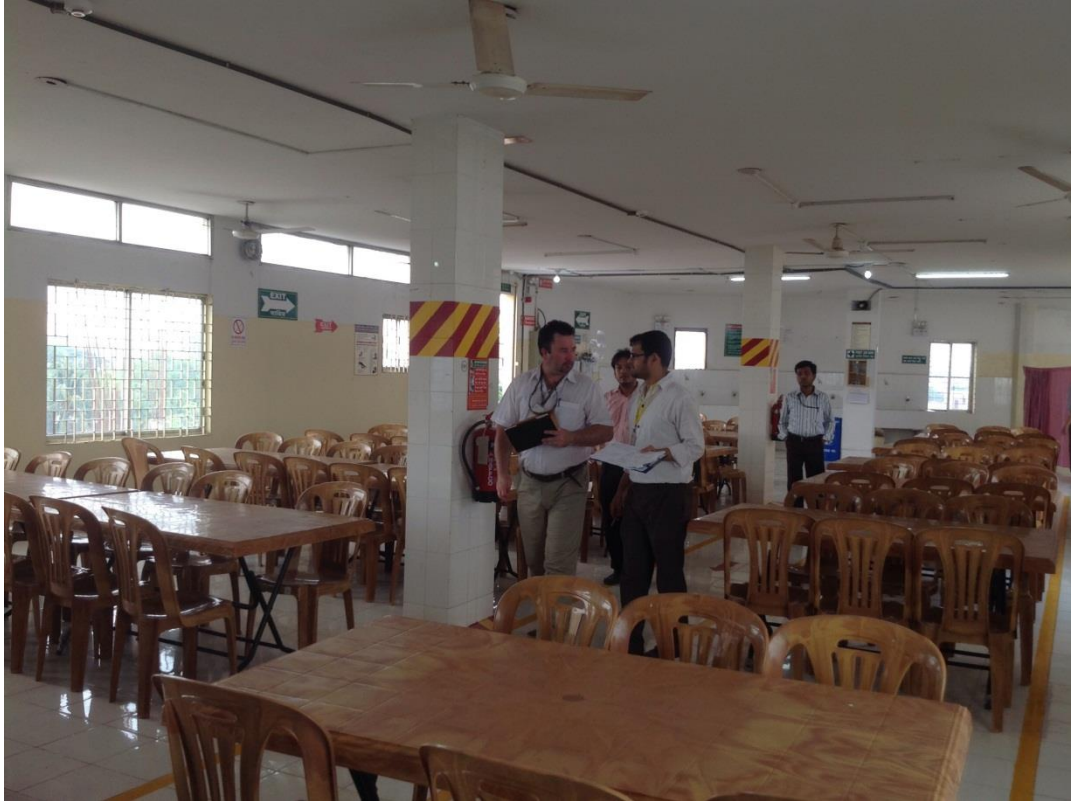
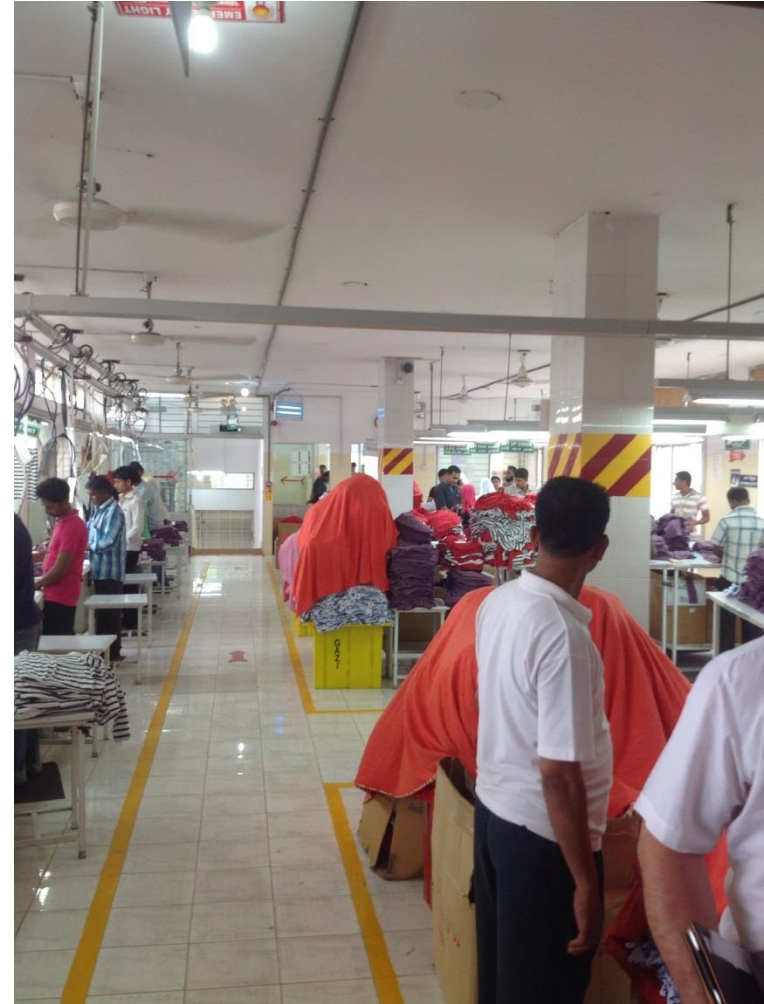
## Building 1 – Possible punching shear in Flat Slabs

# **Building 1 – Possible punching shear in flat slabs**

| Item No. | Observation | Recommended Action Plan | Recommended Timeline |
|---|---|---|---|
| 11 | Building 1 - Punching Shear in flat slabs | Building Engineer to review the design, loads and punching shear stresses of all flat slabs in the building. | 6-weeks |
| 12 | Building 1 - Punching Shear in flat slabs | Verify insitu concrete stresses in the flat slabs either by 100mm diameter cores, or existing cylinder strength data for cores, from min. 4 locations that will not adversely affect the slabs. | 6-weeks |
| 13 | Building 1 - Punching Shear in flat slabs | Produce and actively manage a loading plan for all floor plates within Building 1, giving consideration to floor capacity and column capacity. | 6-weeks |
| 14 | Building 1 - Punching Shear in flat slabs | Following results of calculations/cores, any strengthening works required are to be completed. | 6-months |

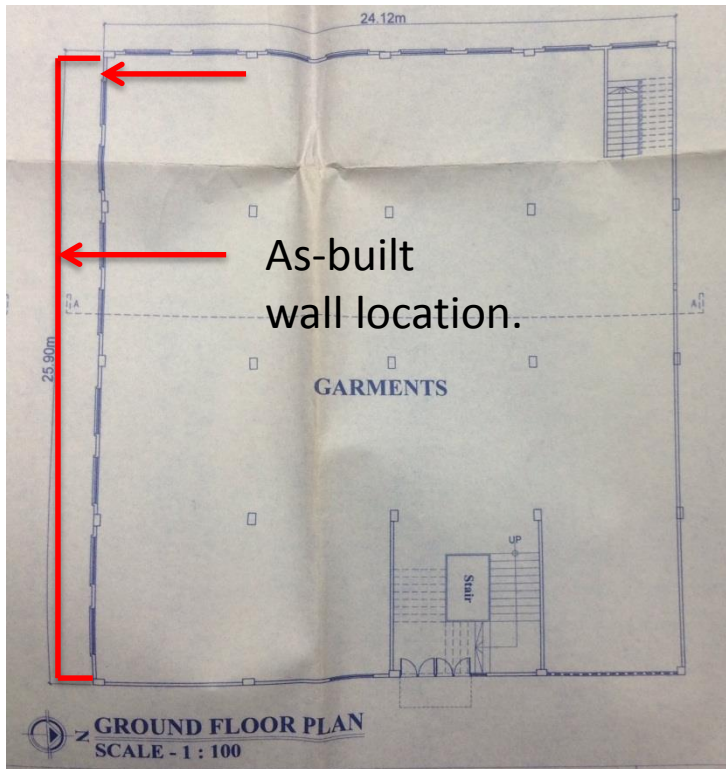
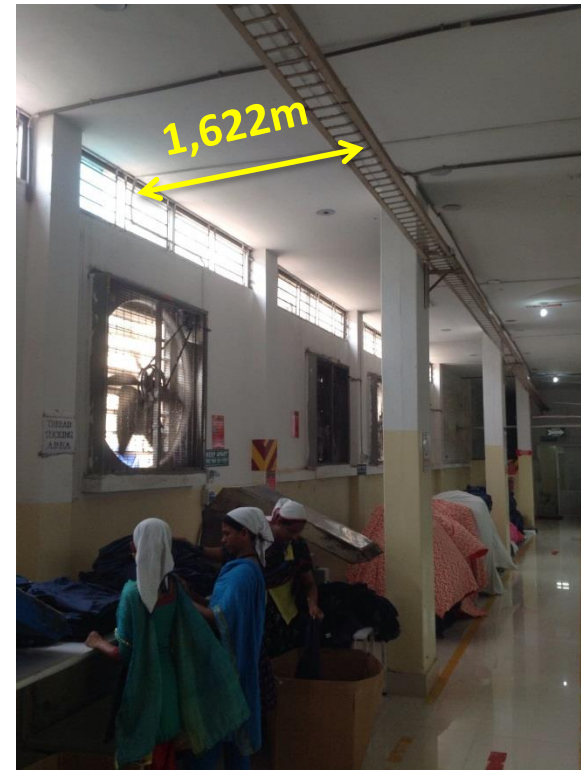
## Building 1 - Discrepancies between Permit drawings and as-built structure

# **Building 1 - Discrepancies between Permit drawings and as-built structure**

| Item No. | Observation | Recommended Action Plan | Recommended Timeline |
|---|---|---|---|
| 16 | Building 1 - Discrepancies between permit drawing and as-built structure | Building Engineer to survey the as-built structure. | 6-weeks |
| 17 | Building 1 - Discrepancies between permit drawing and as-built structure | There should be no further additions to Building 1 without full design and approval documentation. | 6-weeks |
| 18 | Building 1 - Discrepancies between permit drawing and as-built structure | Produce design calculations and accurate as-built drawings for Building 1. | 6-months |

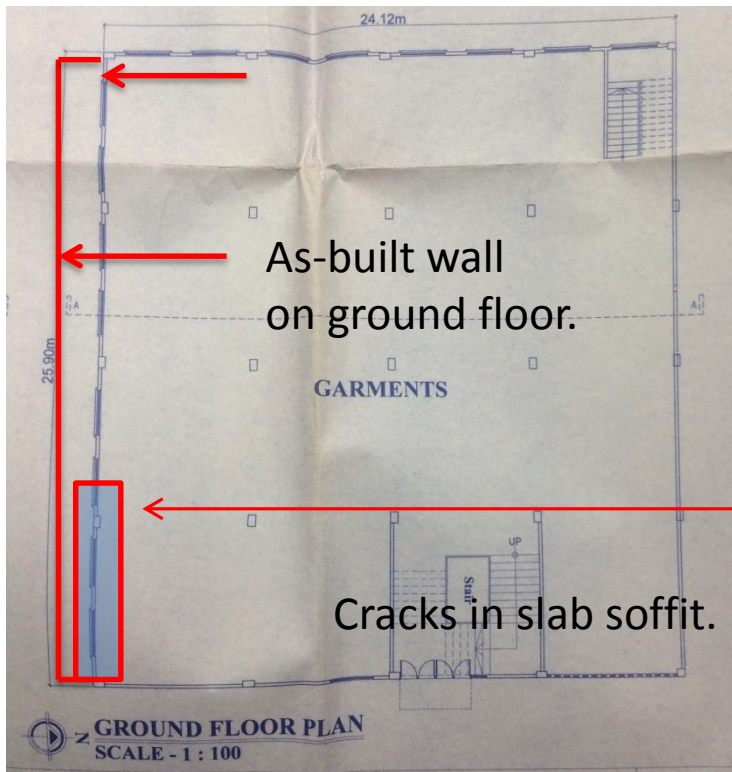
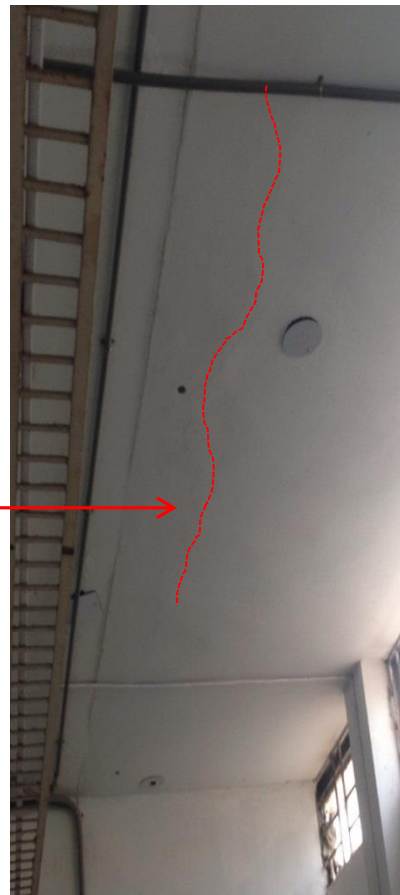
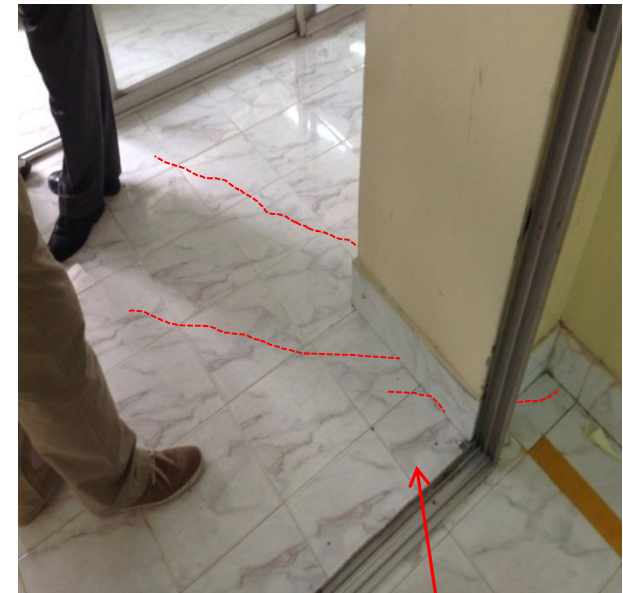
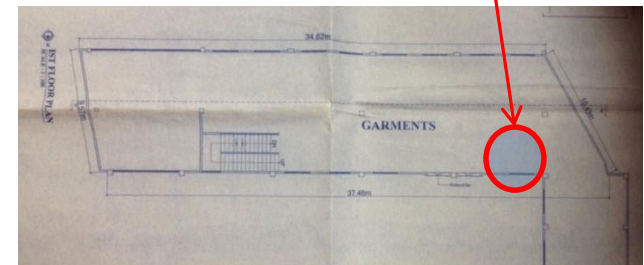
First floor

Cracks in slab.  
These cracks should be monitored over time for any further signs of distress.

| Item No. | Observation | Recommended Action Plan | Recommended Timeline |
|---|---|---|---|
| 19 | Building 1 - Localised cracks in slab soffit and facade | Building Engineer to confirm if cracks are of a structural nature | 6-weeks |
| 20 | Building 1 - Localised cracks in slab soffit and facade | Carry out any structural repairs as deemed necessary. | 6-months |
| 21 | Building 1 - Localised cracks in slab soffit and facade | Continue to monitor for cracking. | 6-months |

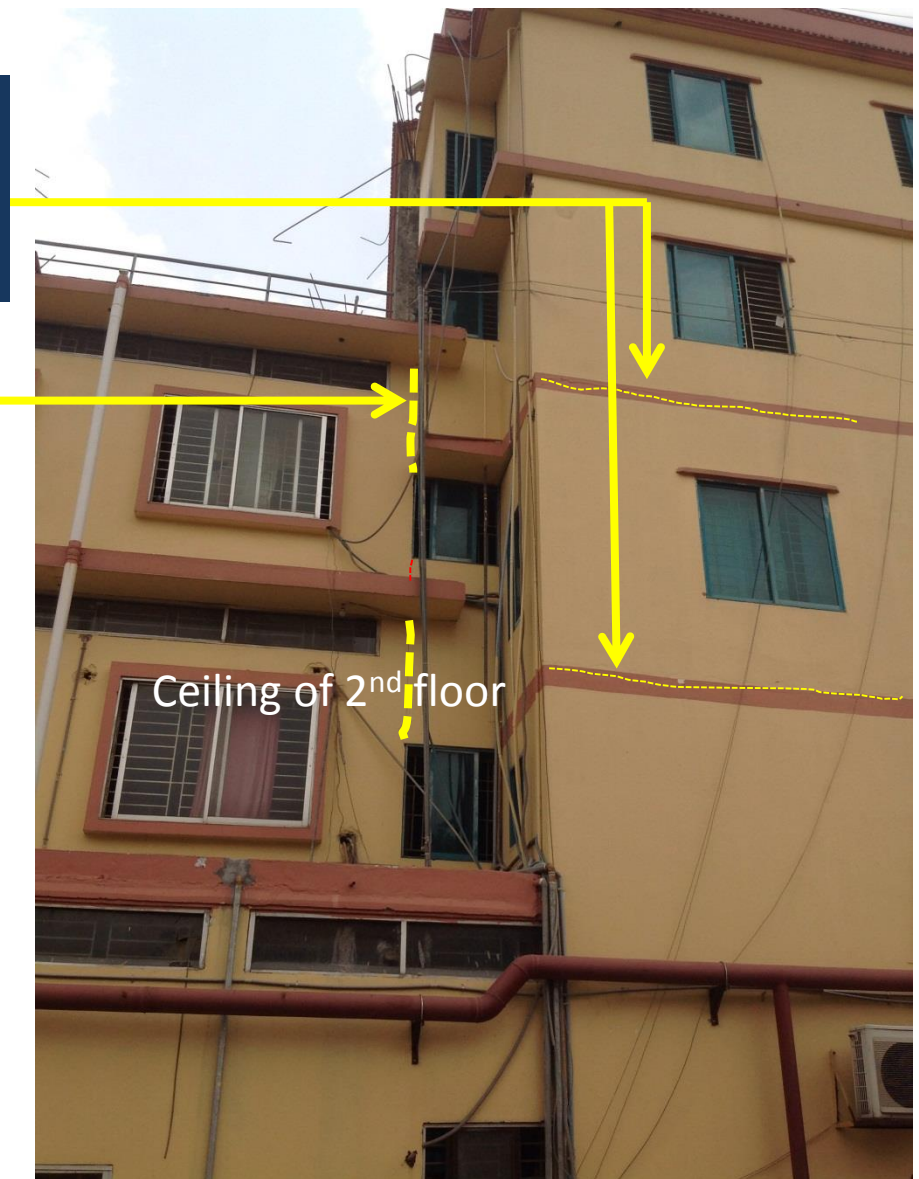
Building 1

Horizontal plaster cracking, possibility of exposed reinforcement in slab behind leading to possible corrosion of the reinforcement.

Vertical crack at movement joint. Joint should be sealed to avoid water ingress leading to possible damage to building structure.

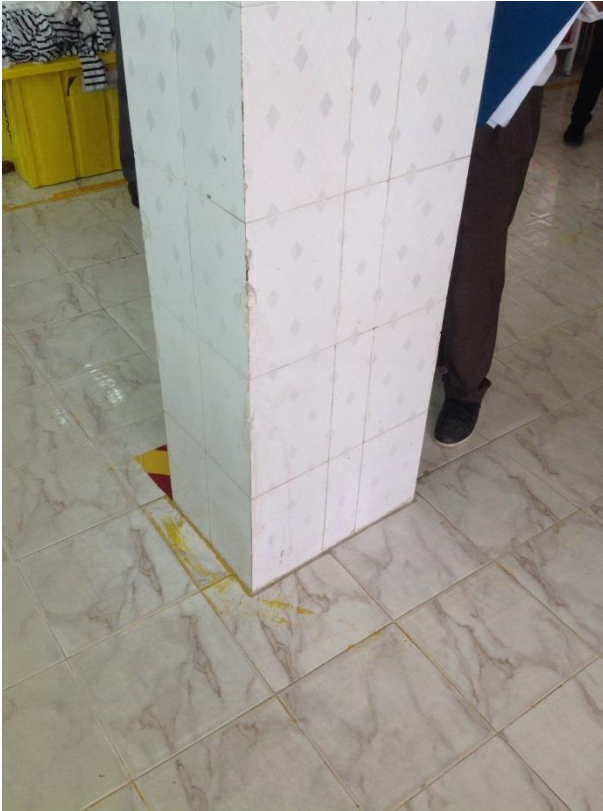
**Twisted column on the second floor.**

| Item No. | Observation | Recommended Action Plan | Recommended Timeline |
|---|---|---|---|
| 22 | Building 1 - Twisted column | Building Engineer to assess by measurement whether the columns are aligned vertically. | 6-weeks |
| 23 | Building 1 - Twisted column | Implement actions arising out of assessment. | 6-months |

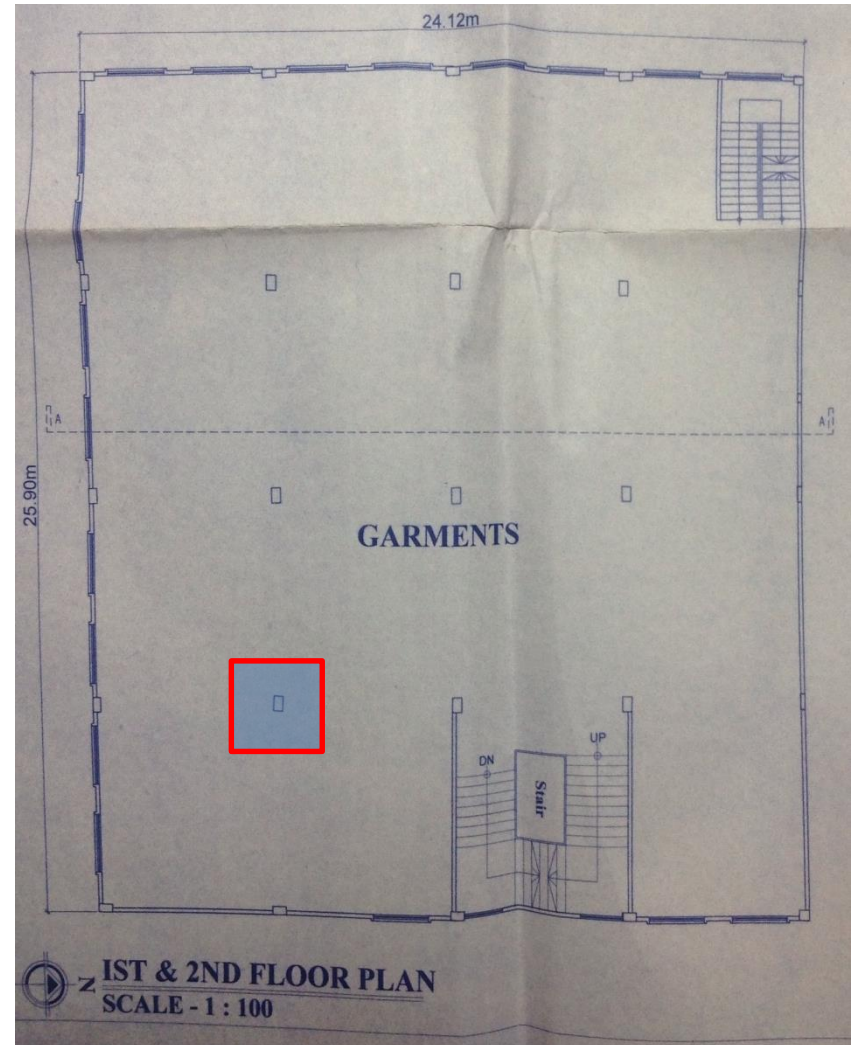
**Twisted column**

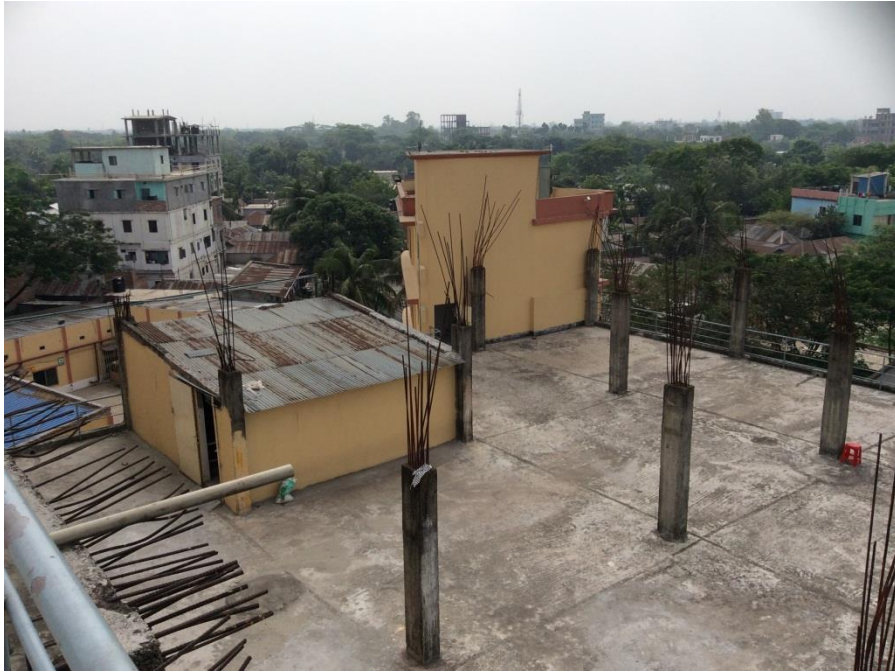
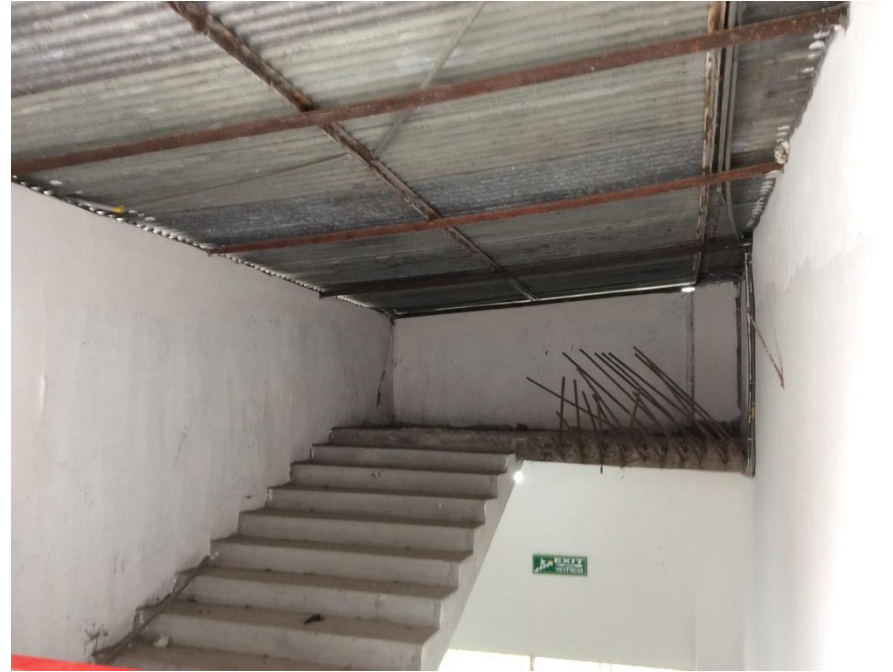
## Building 1 – Roof Level

**Lightweight corrugated steel roof**

| Item No. | Observation | Recommended Action Plan | Recommended Timeline |
|---|---|---|---|
| 24 | Building 1 - Non-engineered steel roof and metal roof over stair core | Lightweight roof structure to be analysed by Building Engineer to ensure adequacy for code vertical and wind loads. | 6-months |
| 25 | Building 1 - Non-engineered steel roof and metal roof over stair core | Implement any remedial / strengthening works arising from analysis. | 6-months |

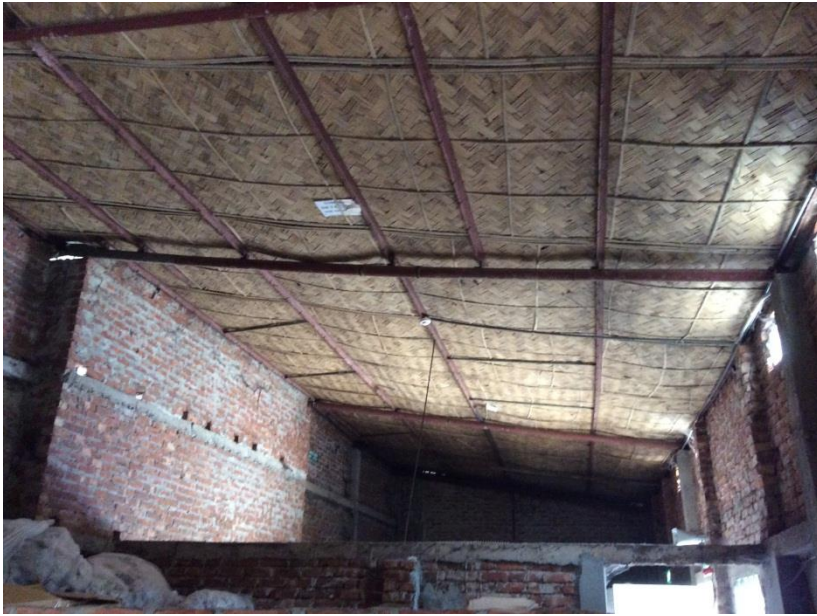
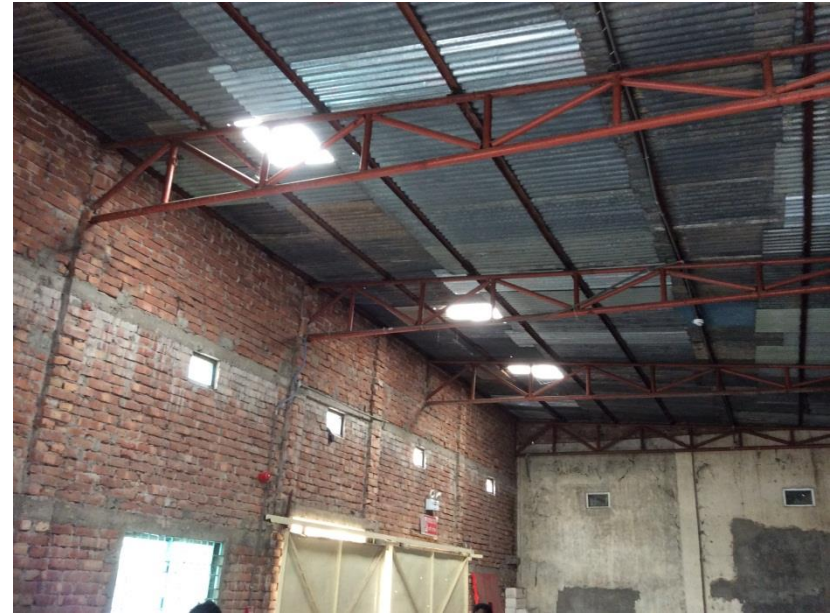
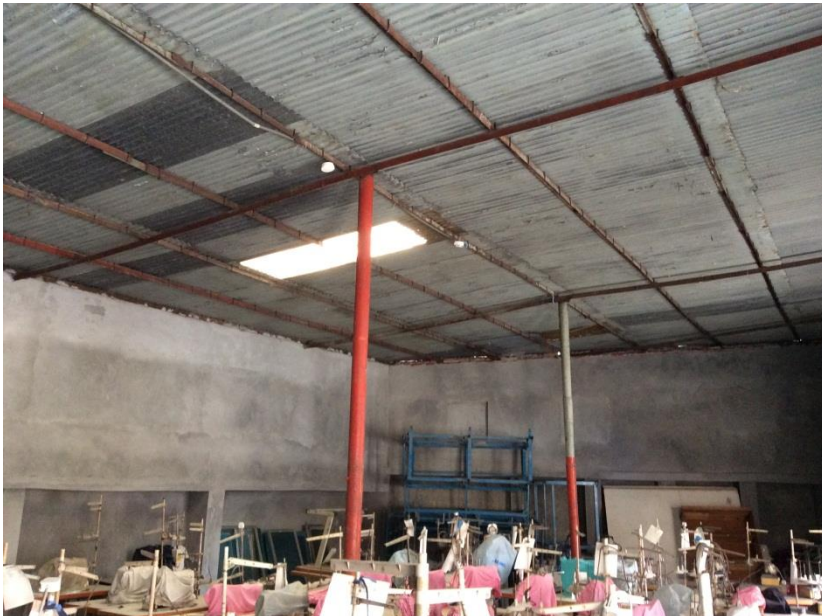
Ancillary buildings are brick construction with lightweight non-engineered steel roofs.

| Item No. | Observation | Recommended Action Plan | Recommended Timeline |
|---|---|---|---|
| 26 | Non-engineered steel roof and metal roof in Ancillary Buildings | Lightweight roof structures to be analysed by Building Engineer to ensure adequacy for code vertical and wind loads by the Building Engineer. | 6-months |
| 27 | Non-engineered steel roof and metal roof in Ancillary Buildings | Implement any remedial / strengthening works arising from analysis. | 6-months |
