# JL Sweaters Ltd

Mouza, Toiyabpur, Savar, Dhaka, Bangladesh.

18<sup>th</sup> May 2014

# Observations

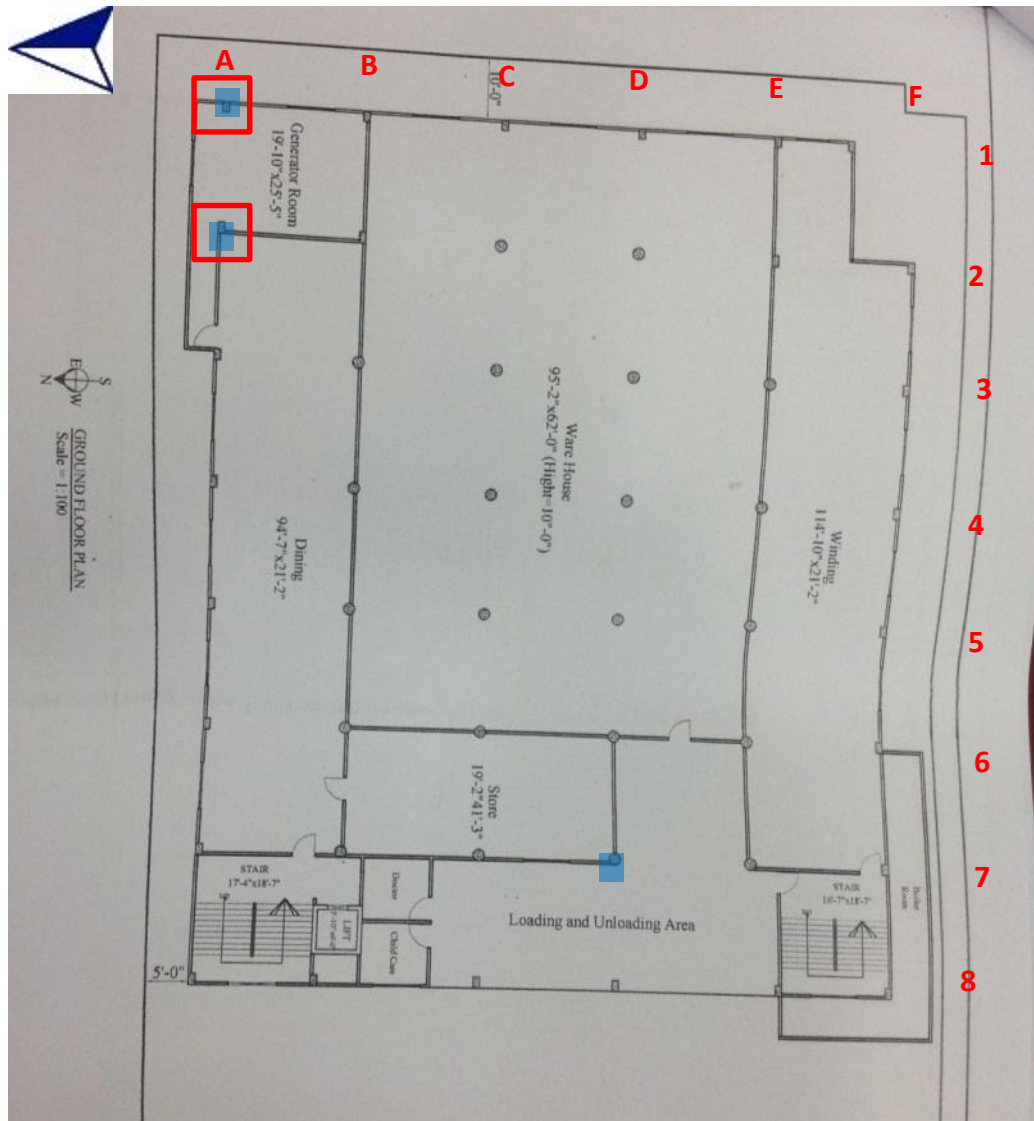
Ground floor plan

- Column investigations indicated stone aggregate.
- Reinforcement was investigated using a ferros scanner.
- Cursory calculations indicate that the working stresses in the columns are at a high level.

Ferrosan columns

Critical Columns requiring immediate action

| Item No. | Observation | Recommended Action Plan | Recommended Timeline |
|---|---|---|---|
| 1 | Stress levels in columns on grid A/1 and A/2 | Half of bay between GL A-B is to be completely vacated outside the toilets as shown above at each level, pending verification of column capacity by Building Engineer. Access only to toilets is permitted. | Immediate - Now |
| 2 | Stress levels in columns on grid A/1 and A/2 | Concrete water tank on roof is to be perforated / provided with weep holes, pending verification of column capacity by Building Engineer. | Immediate - Now |
| 3 | Stress levels in columns on grid A/1 and A/2 | Building Engineer to review design, loads and column stresses in the area identified plus the toilet area. | Immediate - Now |
| 4 | Stress levels in columns on grid A/1 and A/2 | Verify in-situ concrete strength either by 100mm dia. cores from min. 4 columns. | Immediate - Now |
| 5 | Stress levels in columns on grid A/1 and A/2 | Produce and actively manage a loading plan for all floor plates within the Main Factory Building, giving consideration to floor capacity and column capacity. | 6-weeks |
| 6 | Stress levels in columns on grid A/1 and A/2 | Continue to implement load plan. | 6-months |

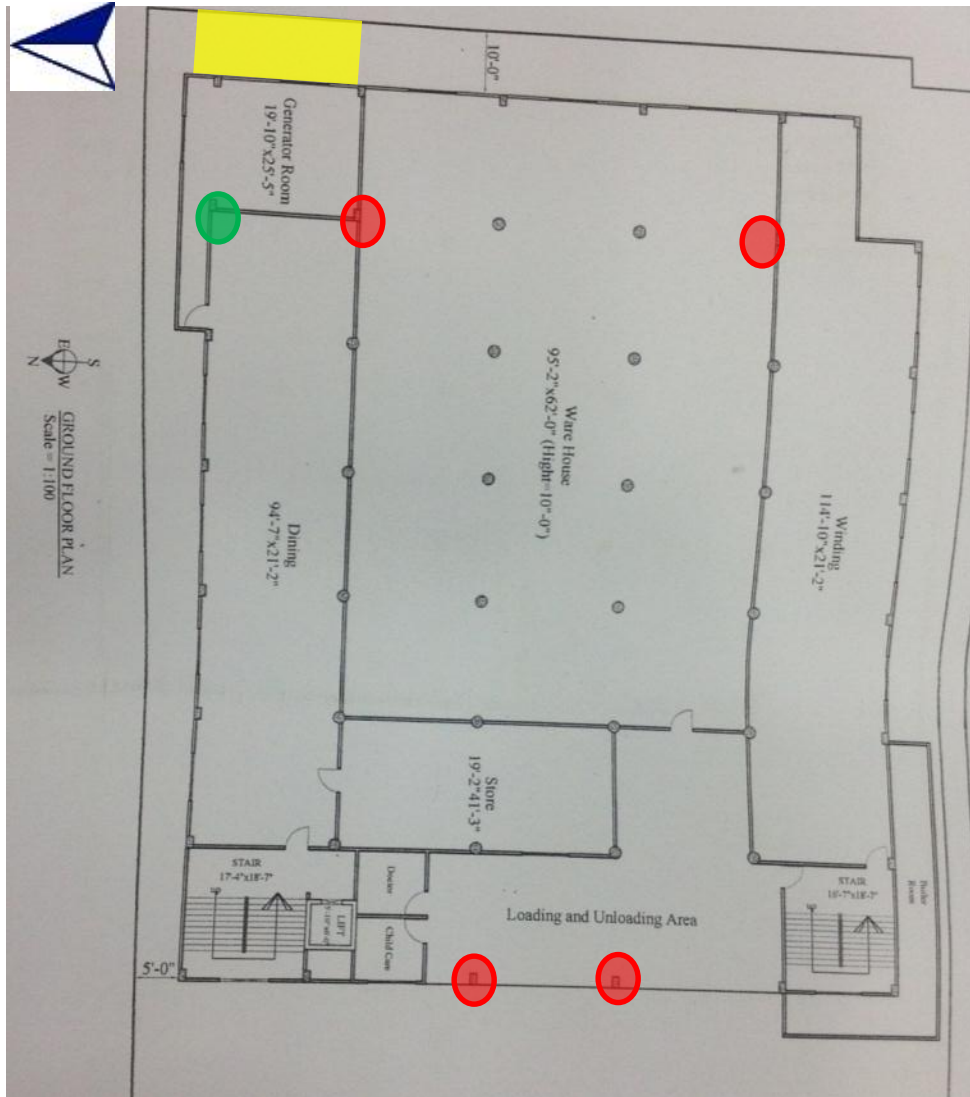
Several observations in the factory building did not correlate with the information presented on the structural drawings.

A non-exhaustive list of discrepancies include:

- Larger column size than that shown on drawings, highlighted in green.
- Circular column constructed instead of rectangular, highlighted in red.
- 'Generator Room' as shown in drawings extends Eastwards by approx. 1.5m, highlighted in yellow.

| Item No. | Observation | Recommended Action Plan | Recommended Timeline |
|---|---|---|---|
| 7 | Discrepancies between drawings and actual observations | Correction of the columns' annotation (shapes & sizes) should be made on the drawings. | 6-months |

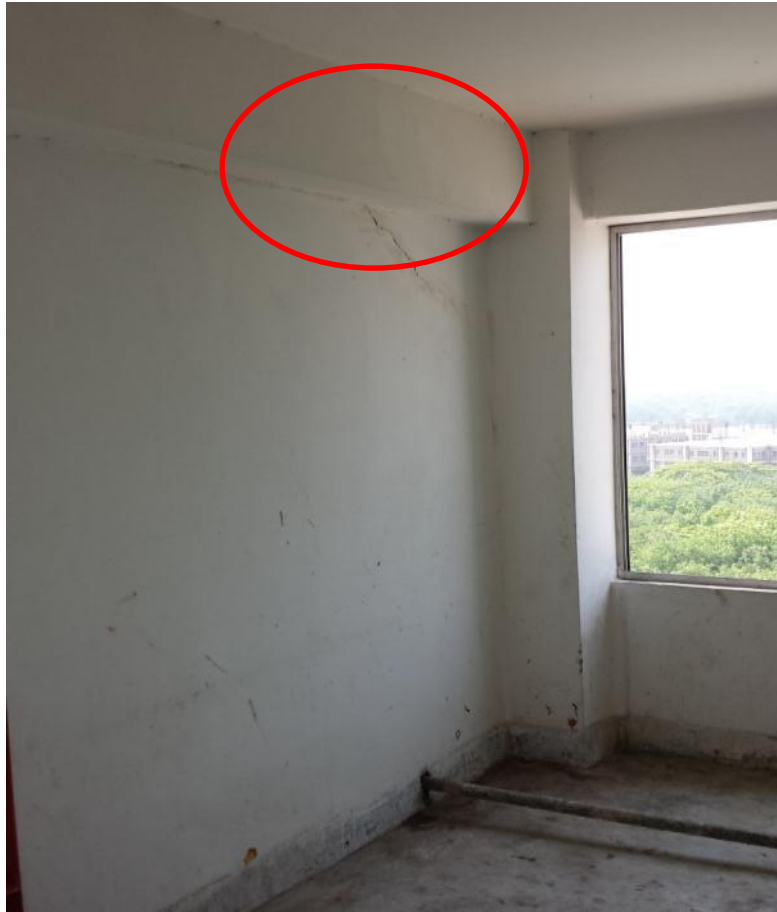
Cracks in penthouse and in stair-cores may be as a result of inadequate restraint at head of masonry.

Penthouse Masonry Cracking

| Item No. | Observation | Recommended Action Plan | Recommended Timeline |
|---|---|---|---|
| 8 | Cracking in stair-core and penthouse masonry | Affected masonry walls to be repaired. | 6-months |

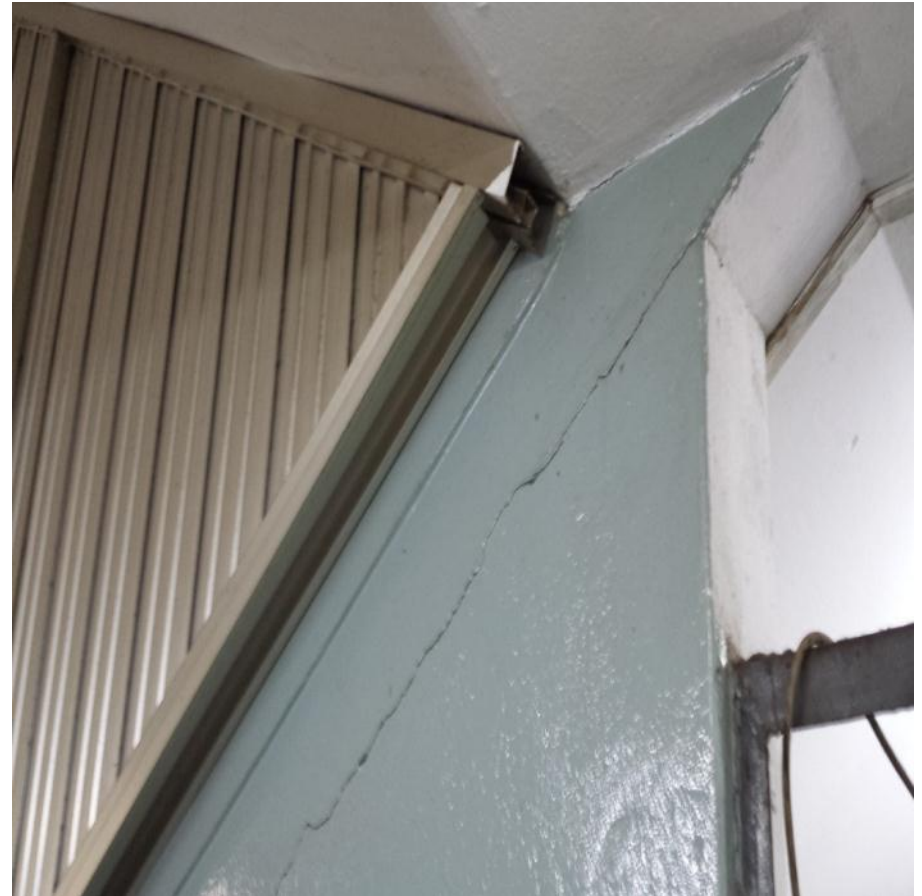
Cracking in stair-core Masonry
