# Pentagon Knit Com Ltd. Global Apparel Park Ltd.

17<sup>th</sup> January, 2017

# Observations

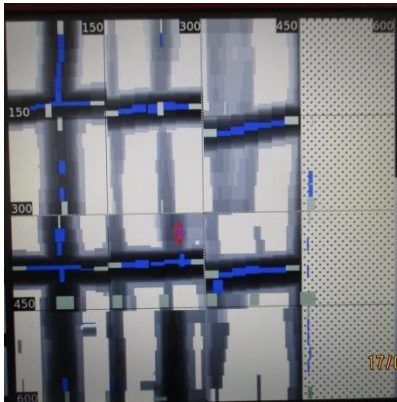
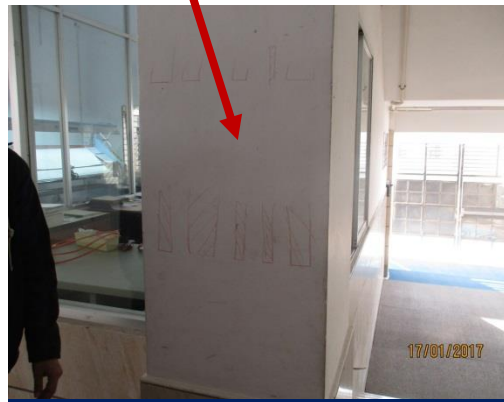
The number of reinforcement does not match with column schedule . 16 number of rebar was found where column schedule shown 20 rebar. Factory engineer is required to be checked and update as built drawing.

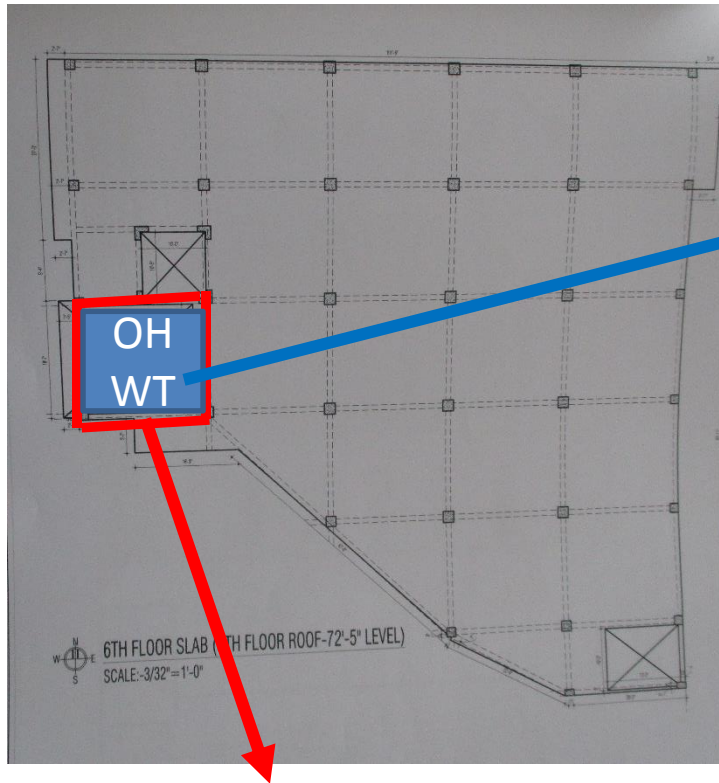
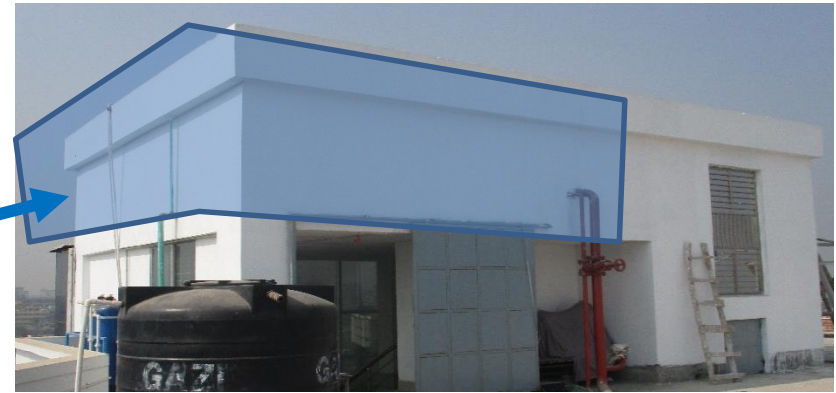
Location of OHWT

No beams were observed at 7<sup>th</sup> floor/roof in these locations under the OHWT. 55000 liters capacity water tank resting on slab. The capacity of slab is required to be checked.

| Item No. | Observation | Recommended Action Plan | Recommended Timeline |
|---|---|---|---|
| 2 | Adequacy of slab under OHWT needs to be checked | Building engineer to review that slab under OHWT is designed to carry the imposed load . | 6-weeks |
| 3 | Adequacy of slab under OHWT needs to be checked | Implement any actions arising from review. | 6-months |

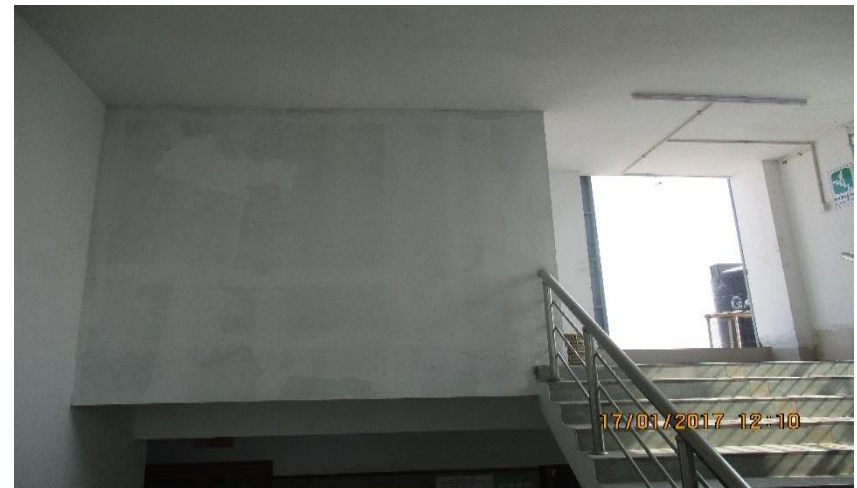
Bottom slab of OHWT

Adequacy of slab under OHWT needs to be checked

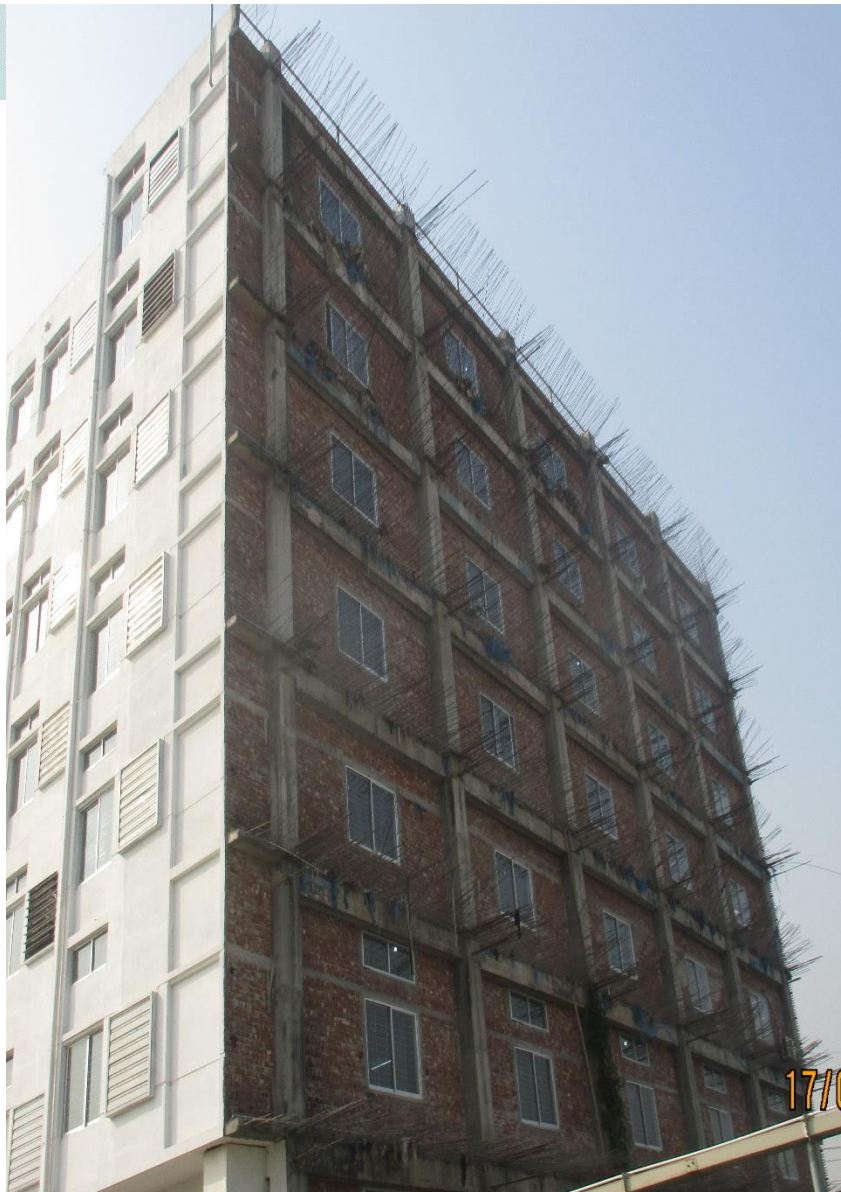
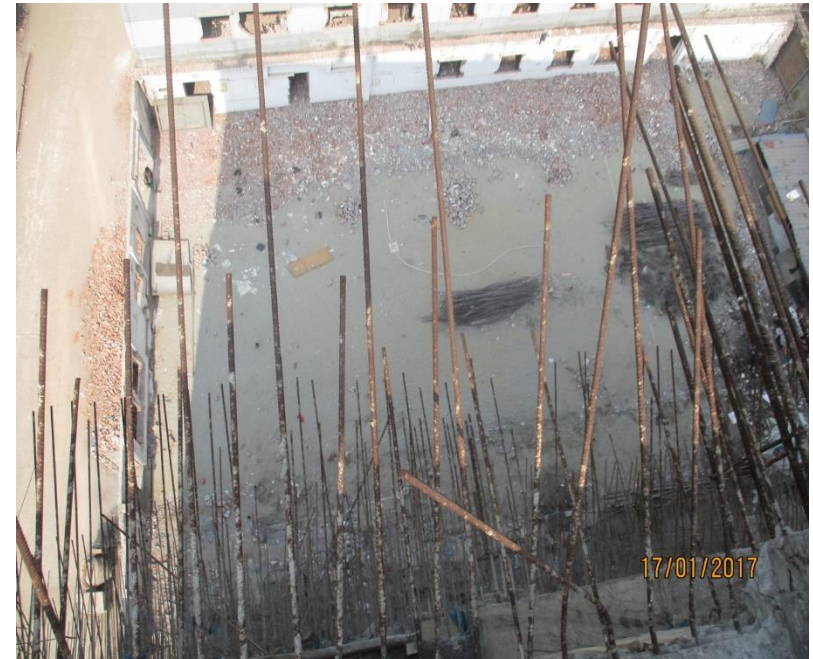
## **Exposed Rebar**

**Exposed rebar's were observed along the northern facade. Factory management informed that they are planning for horizontal extension in future. Rebar's were found in corroded condition.**

| Item No. | Observation | Recommended Action Plan | Recommended Timeline |
|---|---|---|---|
| 4 | Exposed and corroded rebar | If further construction is intended, factory engineer to verify if the rebar's are in good condition and replace them if necessary. | 6-weeks |

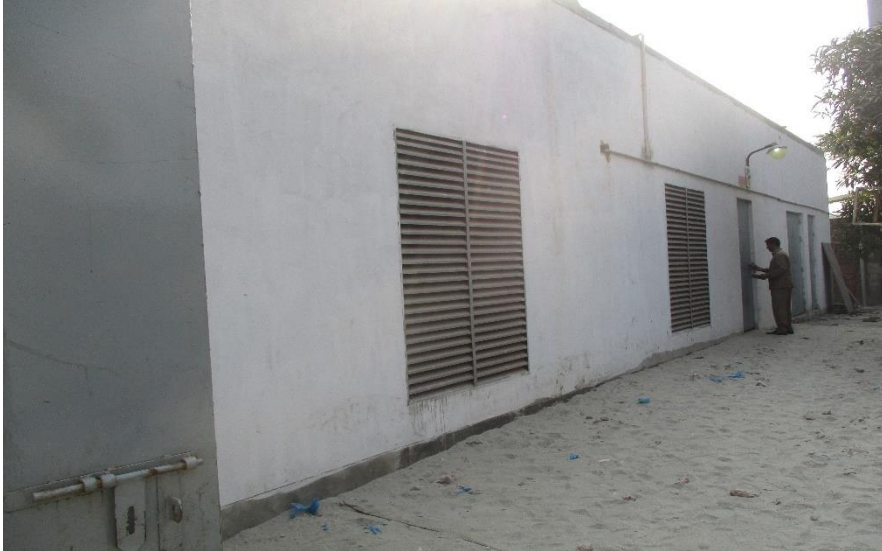
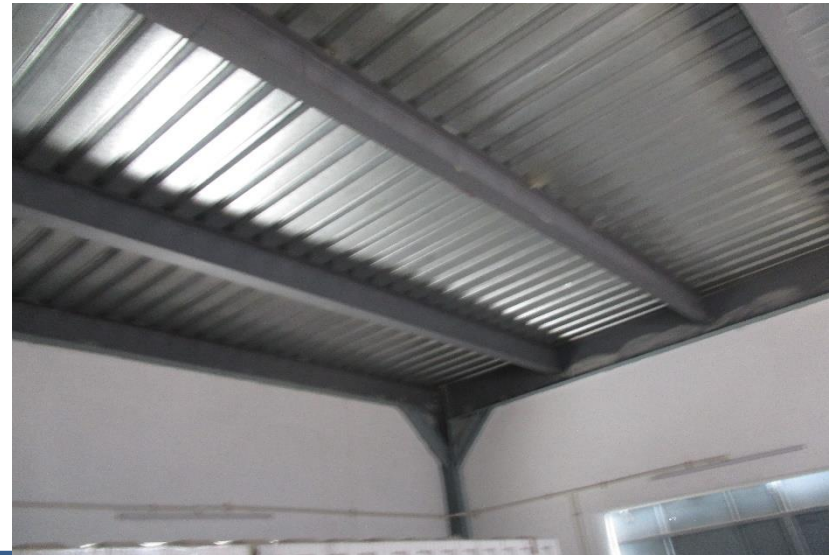
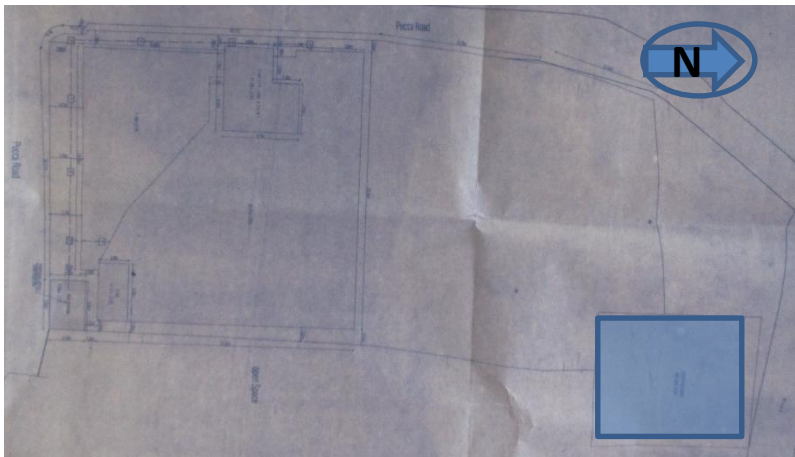
No detail drawing (As-built structural) was available during inspection.

| Item No. | Observation | Recommended Action Plan | Recommended Timeline |
|---|---|---|---|
| 1 | As- Built Structural Drawing of Utility Building was not available | Building Engineer to produce a set of As Built drawing Utility building. | 6-weeks |
