Oeko-Tex Limited

Yasin Knittex Ind. Ltd

16 April 2014

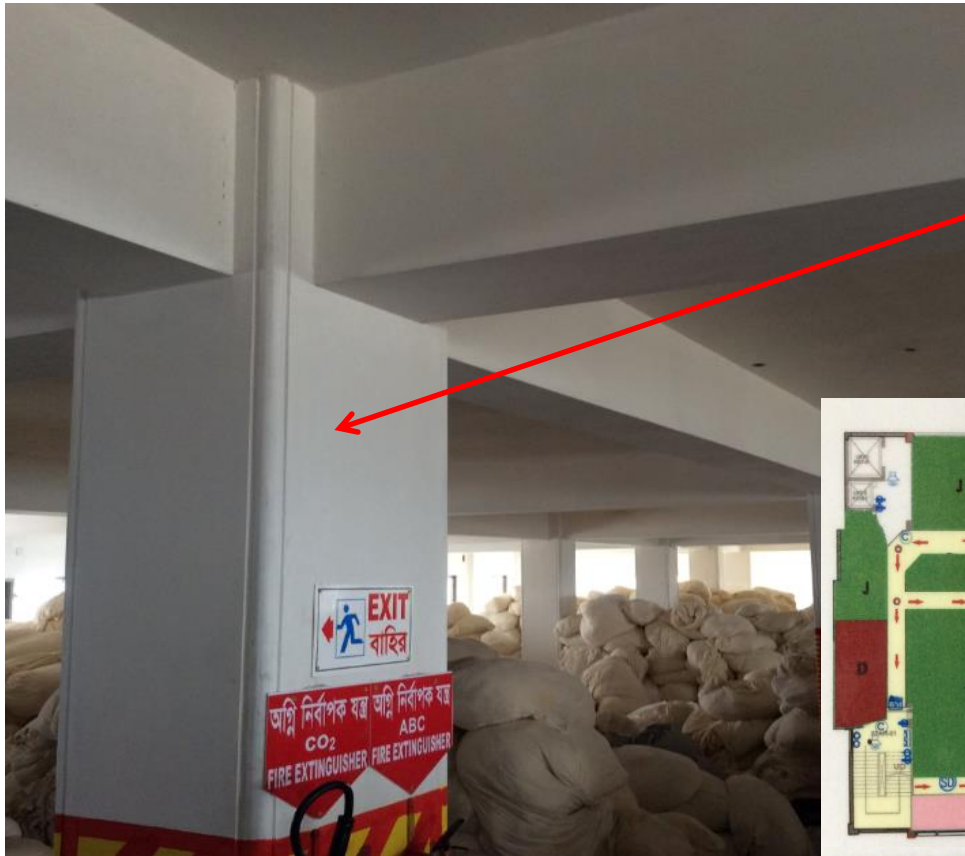
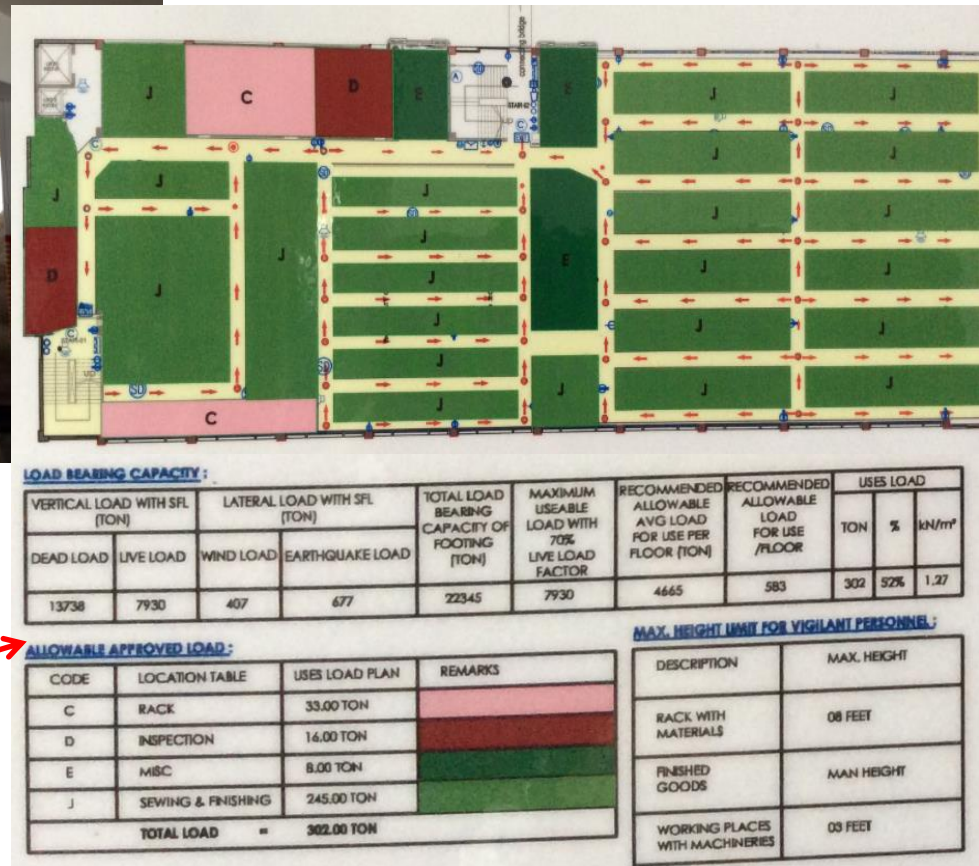
**High stress in columns in Okeo-Tex
production building, Yasin Knittex Industries
production building and Office building.**

Stress in columns at ground level in these three facilities is sufficiently high to require confirmation of the in-situ concrete strength.

Item No.	Observation	Recommended Action Plan	Recommended Timeline
1	High stress in columns in Okeo Tex production building, Yasin Knittex Industries production building and Office building	Factory Engineer to review columns stresses in buildings identified above.	6-weeks
2	High stress in columns in Okeo Tex production building, Yasin Knittex Industries production building and Office building	Verify in-situ concrete strength either by cores or existing cylinder strength data for the columns in the buildings noted above	6-weeks
3	High stress in columns in Okeo Tex production building, Yasin Knittex Industries production building and Office building	Continue to actively manage the loading plans for all floor plates within the factory giving consideration to floor capacity and column capacity.	6-months
4	Cracking to beams in Yasin Knittex Industries production building and slab in the utility building	A Building Engineer should investigate if cracks are in the structure or only in the plastering.	6-weeks

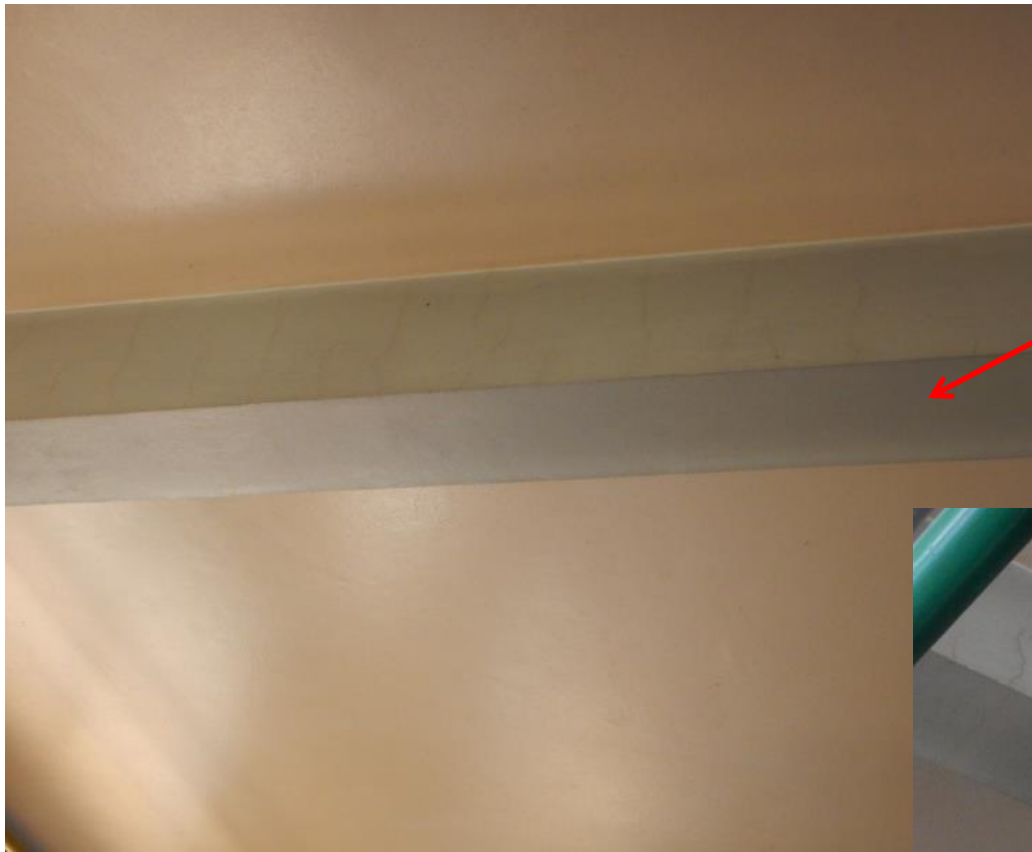
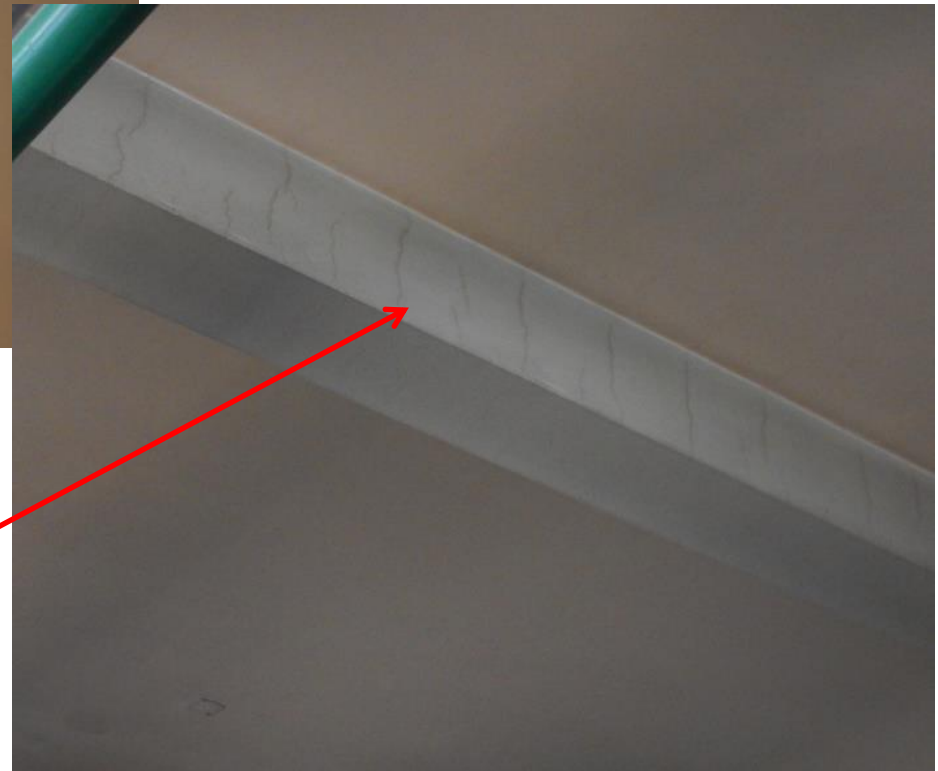
Cracking to beams – Yasin Knittex Ind.

Cracking to beams in the Yasin Knittex Industries Production building at ground floor.

Building Engineer to inspect and monitor these cracks, and check if they are in the structure beneath the plaster.

5	Cracking to beams in Yasin Knittex Industries production building and slab in the utility building	If the cracks are in the structure, Building Engineer to carry out assessment of structure, accounting for as-built reinforcement in element (from scan data) and current loading conditions.	6-weeks
6	Cracking to beams in Yasin Knittex Industries production building and slab in the utility building	Monitor cracks in the slab and beams in the areas noted above. Conduct regular inspection of these cracks.	6-months
7	Cracking to beams in Yasin Knittex Industries production building and slab in the utility building	If cracks grow larger, remove all items above the slab and close working areas below the affected areas. Engage an engineer to investigate, repair and strengthen the slab.	6-months

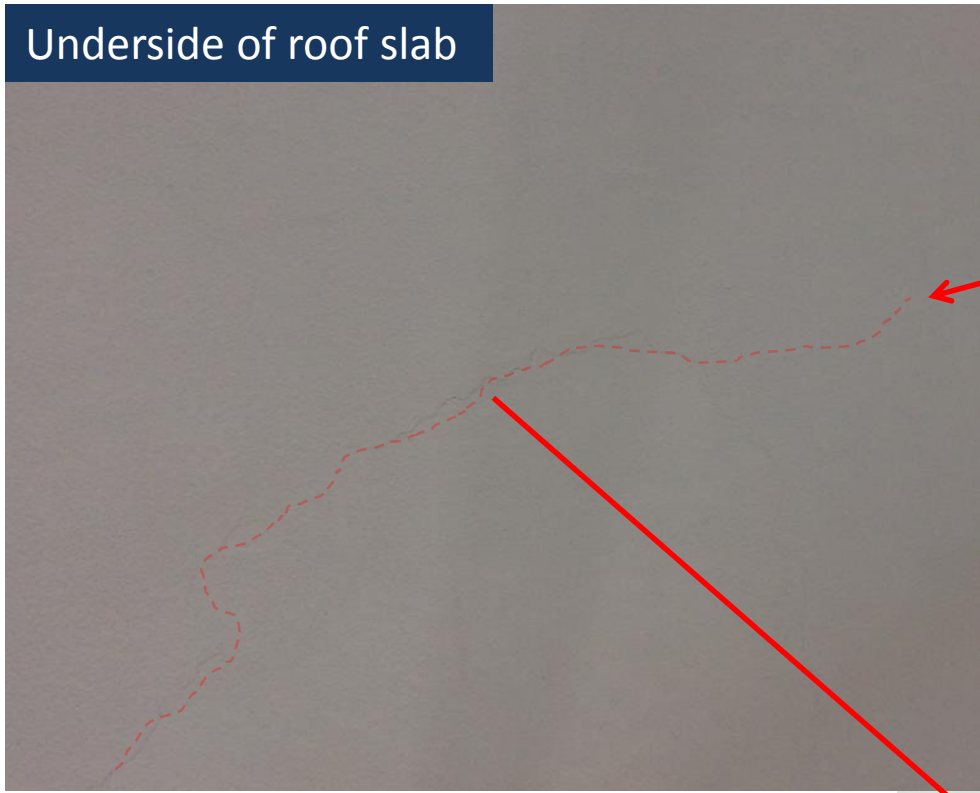
Underside of roof slab

Cracking to the underside of roof slab in the utility building.

Building Engineer to inspect and monitor these cracks. Also to check the slab capacity and load from water cooler above on roof.

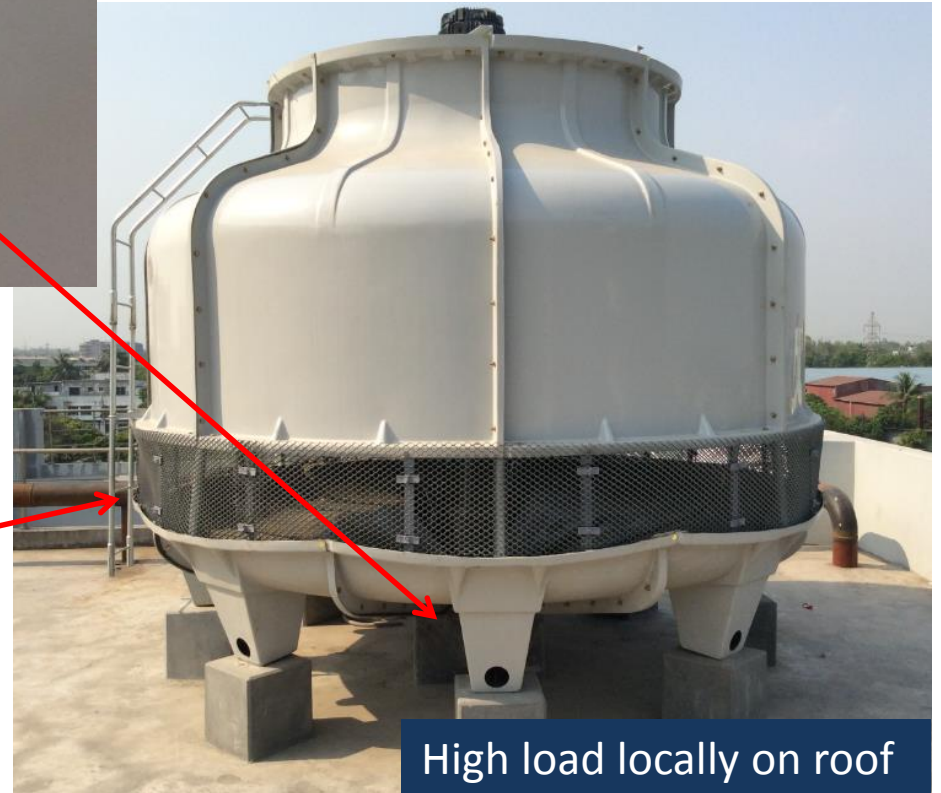
Cracking to beams – Utility Building

High load locally on roof

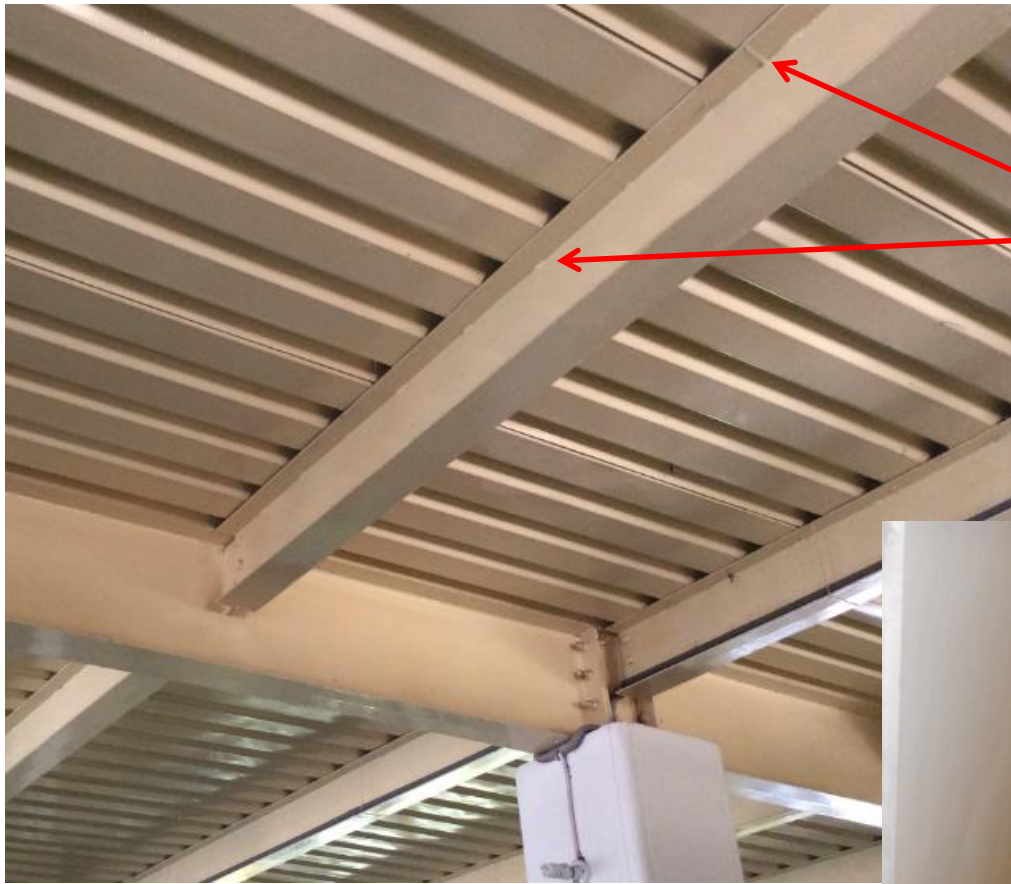
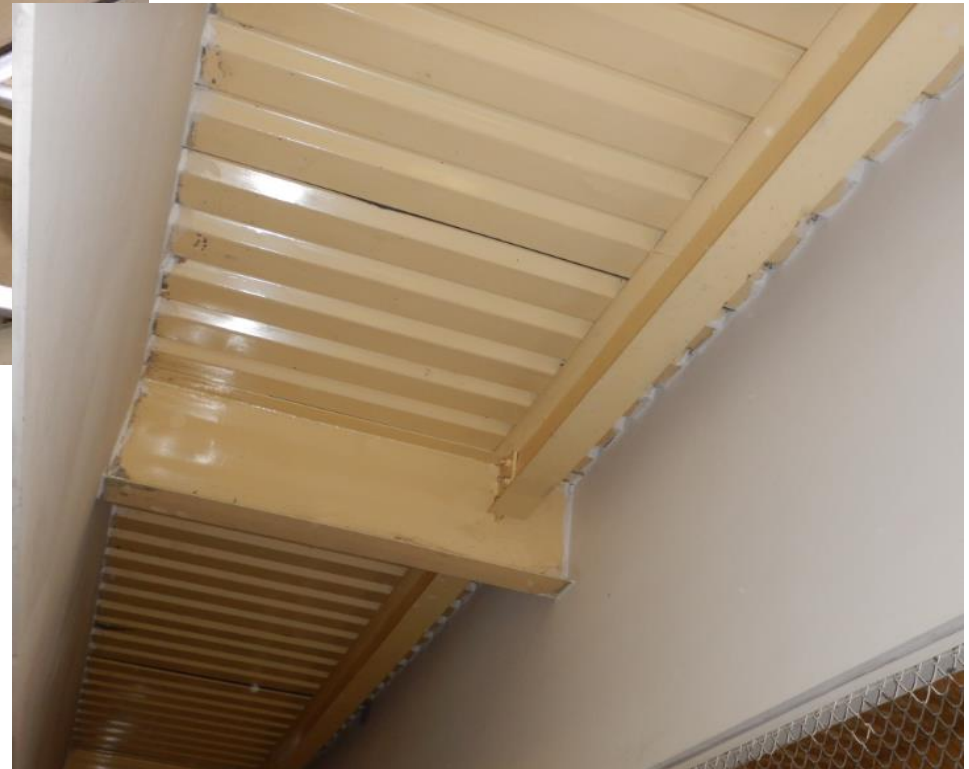
Quality of steel construction at roof of Okeo-Tex production facility

Steel beams in roof construction are made from steel plates welded together. These in turn are welded to create an I-Section. The secondary beams are tack-welded only.

Building Engineer to inspect the construction of the steel sections at roof level and make recommendations to factory.

Item No.	Observation	Recommended Action Plan	Recommended Timeline
8	Quality of steel construction at roof of Okeo Tex production facility	Loading on roof is not to be increased (currently empty).	6-months
9	Quality of steel construction at roof of Okeo Tex production facility	Building Engineer to inspect the quality of the constructed steel sections in the roof, with particular attention to section capacity for tack welded beam sections.	6-months
10	Quality of steel construction at roof of Okeo Tex production facility	Factory to Implement any recommendations made by the Building Engineer for the steel roof.	6-months
