# Pakiza Knit Composite Ltd.

A-1/5, Mojidpur (Borobolimeher), Savar, Dhaka, Bangladesh  
(23.841370N, 90.258353E)

30th March 2017

# Observation

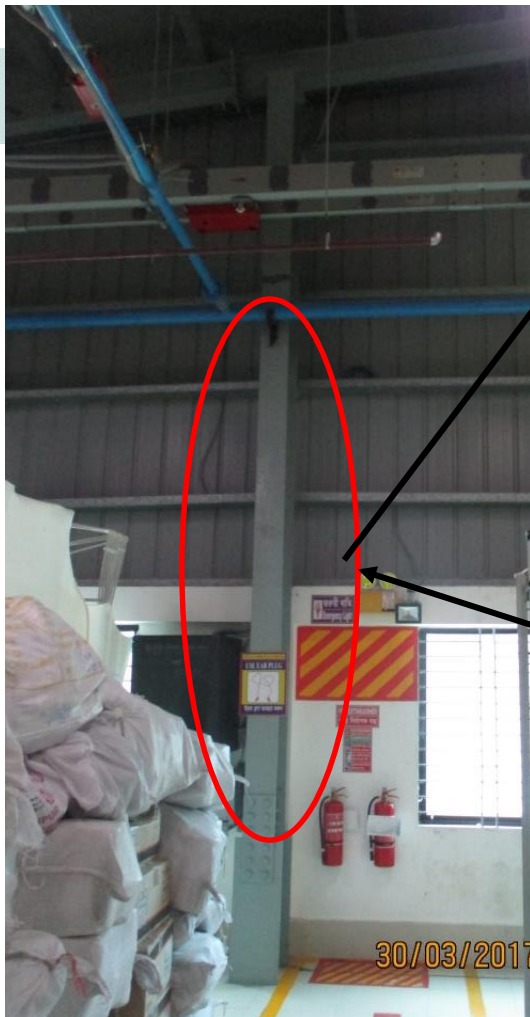
Width of flange was found  
200mm instead of 225 mm on  
1<sup>st</sup> floor

| Item No. | Observation | Recommended Action Plan | Recommended Timeline |
|---|---|---|---|
| 1 | Knitting Building<br>Discrepancies between site observations and provided drawings | Building engineer to survey the whole building and produce as-built documentation reflecting the as constructed condition. | 6-weeks |

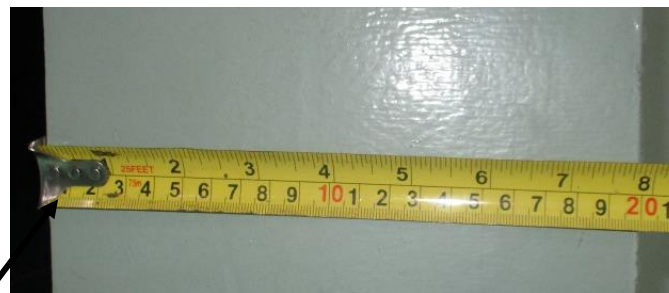
200mm width was measured on 1<sup>st</sup> floor

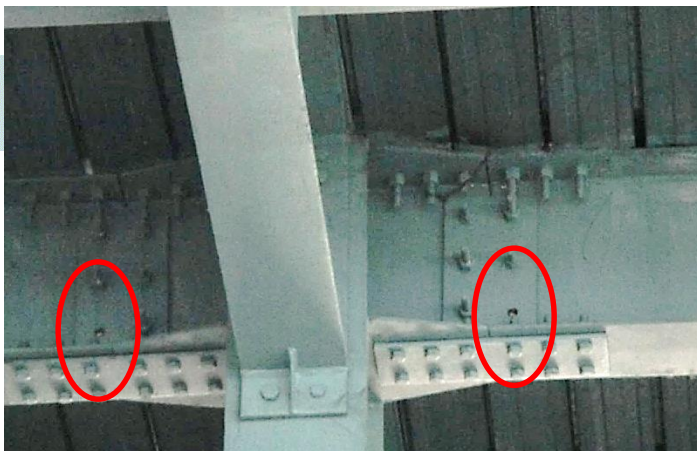
Missing bolts were found on internal column & beam joint on 1<sup>st</sup> floor

| Item No. | Observation | Recommended Action Plan | Recommended Timeline |
|---|---|---|---|
| 2 | Knitting Building:<br>Missing bolts and bracings | Building Engineer to identify all the omissions and supervise remedial works to the joint to ensure structural adequacy. | 6-weeks |

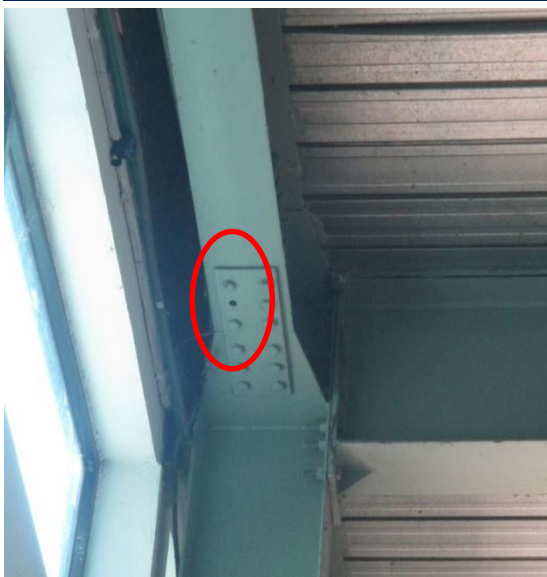
Missing bolts were found on edge column & beam joint on 1<sup>st</sup> floor

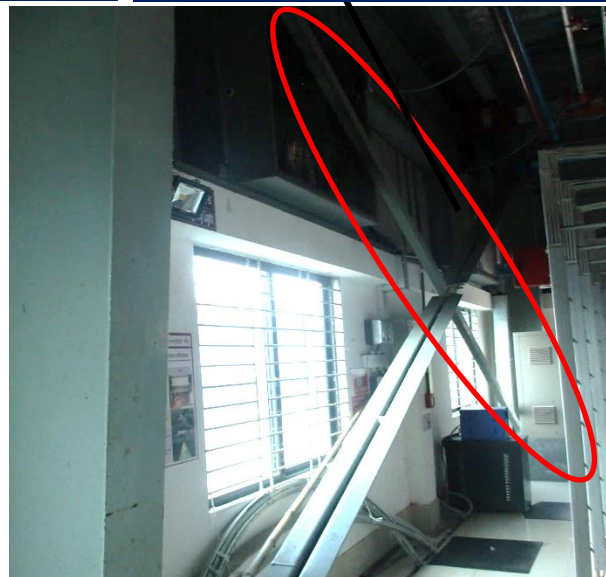
Single angle bracing was found instead of double angle bracing on south-west corner of 1<sup>st</sup> floor

| Item No. | Observation | Recommended Action Plan | Recommended Timeline |
|---|---|---|---|
| 3 | Knitting Building:<br>Missing bolts and bracings | Reinstate disconnected bracing in braced bays | 6-weeks |

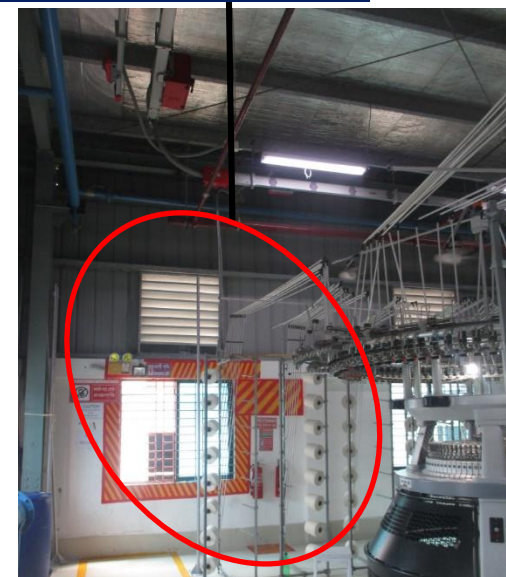
No vertical bracing was found at south-east corner of 1<sup>st</sup> floor

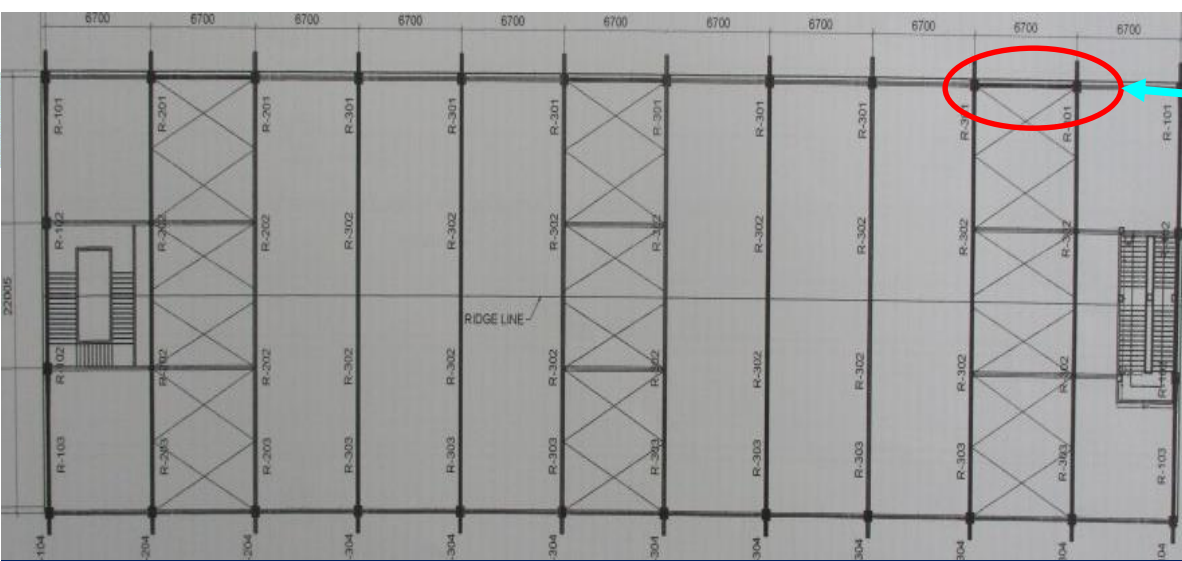
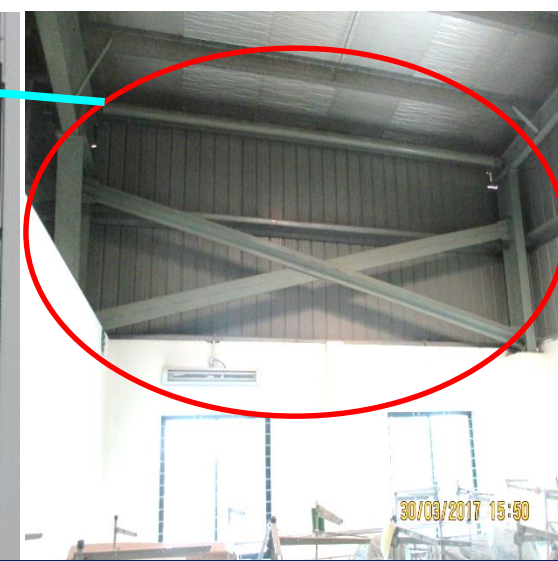
Vertical bracing with compression strut was observed at east & west side on 1<sup>st</sup> floor but not shown in provided bracing layout drawing

| Item No. | Observation | Recommended Action Plan | Recommended Timeline |
|---|---|---|---|
| 6 | Dyeing Building:<br>Lack of Information in Drawings | Building engineer to survey the whole building and produce as-built documentation reflecting the as constructed condition. | 6-weeks |

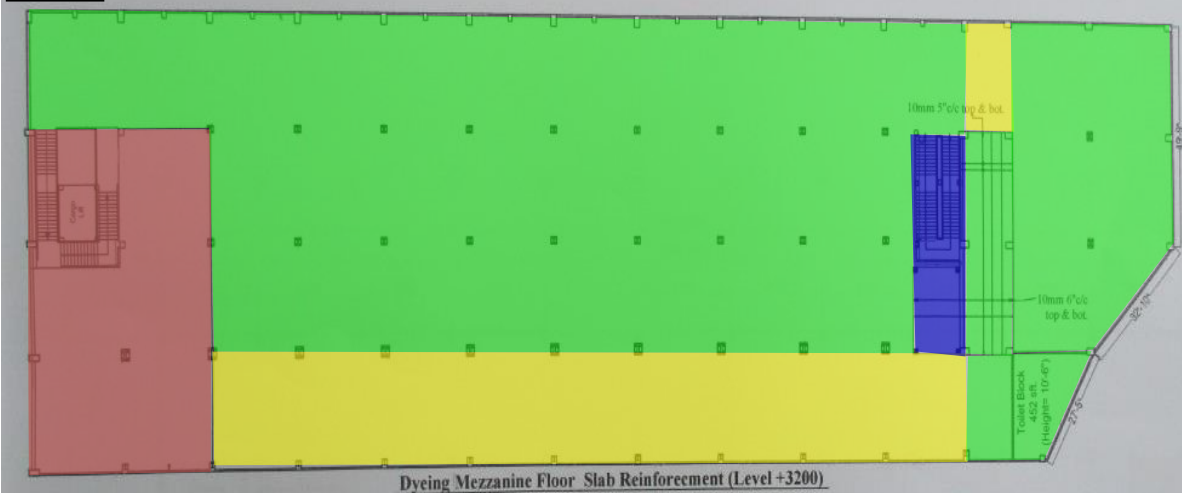
The shed has different elevation but in provided drawing, no information was found regarding different elevation. Only mezzanine floor was shown in provided drawing.

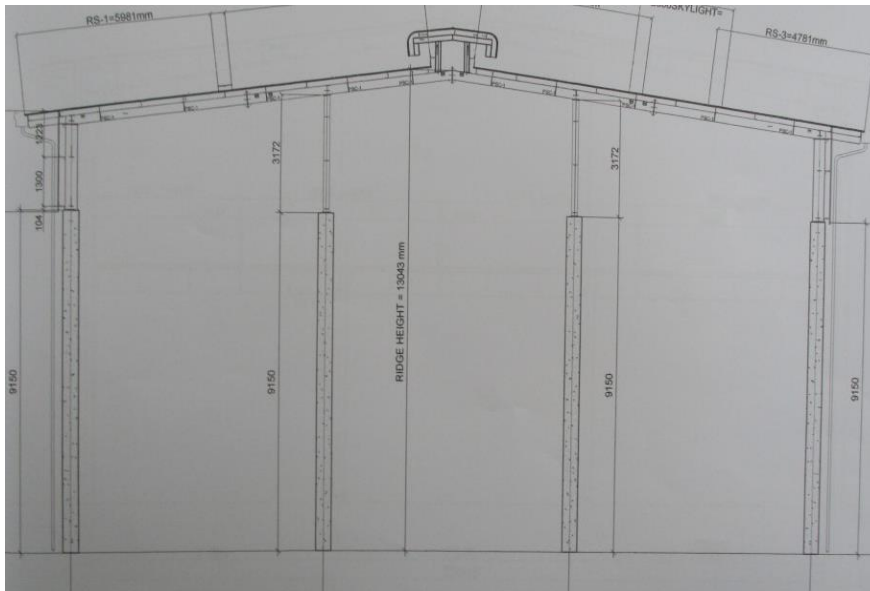
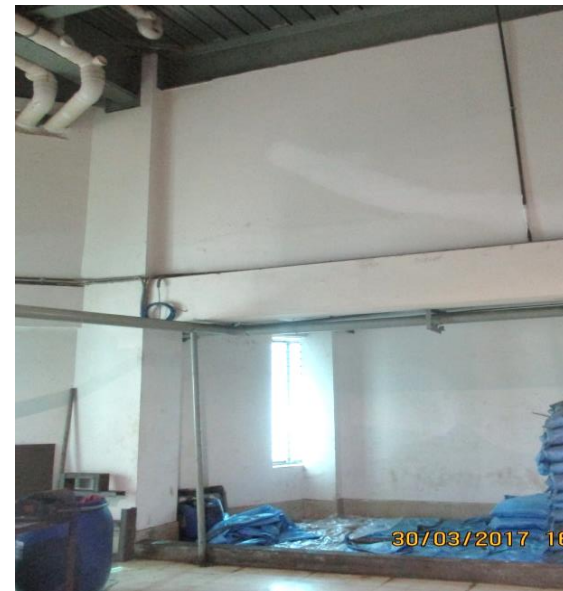
Part-B(Utility block) of the Shed has RC tie beam and column on ground floor for which information was not found in provided drawing

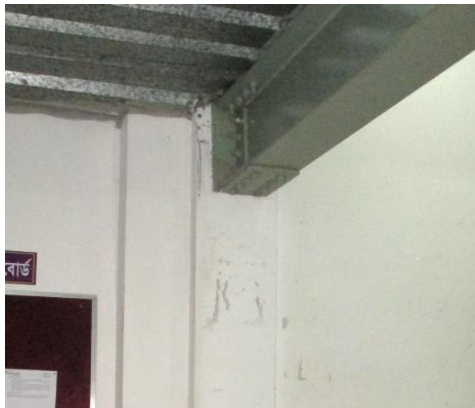
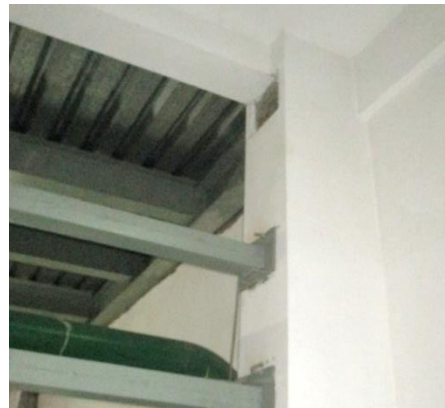
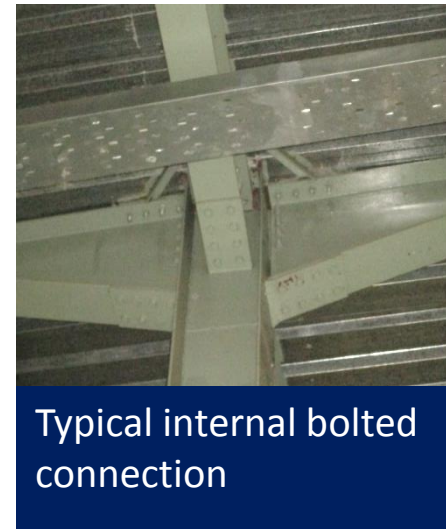
RC column & steel beam bolted connection

Welded connection between RC column and Steel beam

Typical internal bolted connection

No detail drawing of the connections was found in provided drawing

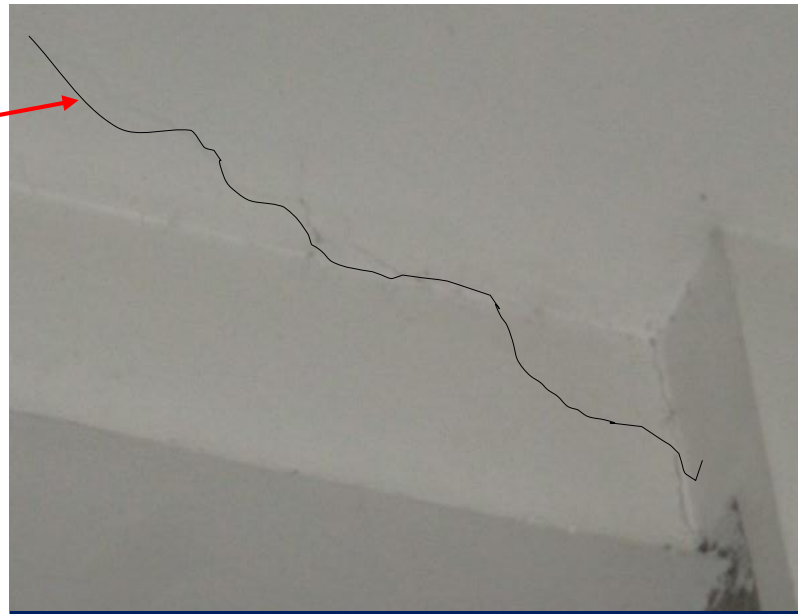
Crack on beam and landing slab

Crack was found on south side stair's beam and adjacent slab. This crack is required to be investigated and repair with appropriate method

| Item No. | Observation | Recommended Action Plan | Recommended Timeline |
|---|---|---|---|
| 9 | Dyeing Building:<br>Crack on Beam and Slab | Sections of plaster finish to be removed to investigate if cracks penetrate the building structure. | 6-weeks |
| 10 | Dyeing Building:<br>Crack on Beam and Slab | Factory Engineer to prepare the investigation report as part of the Engineering Assessment. | 6-weeks |
| 11 | Dyeing Building:<br>Crack on Beam and Slab | Carry out remedial works resulting from engineering assessment if necessary. | 6-months |

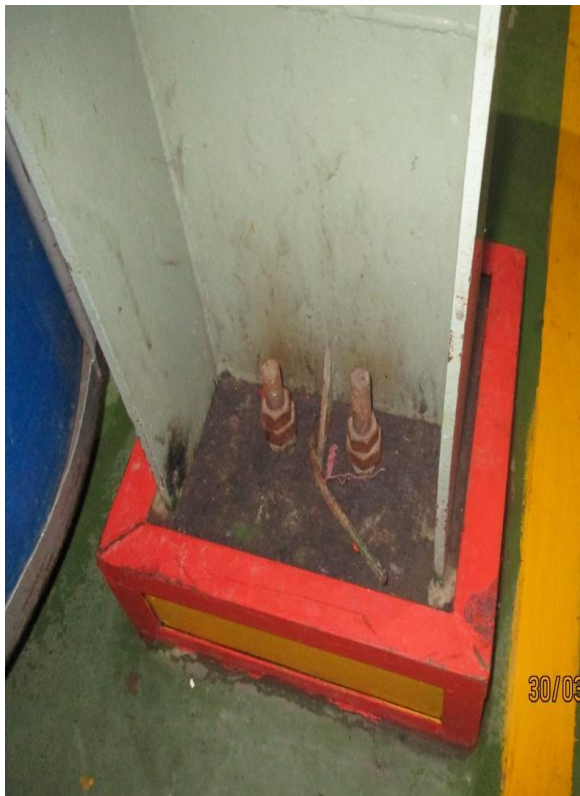
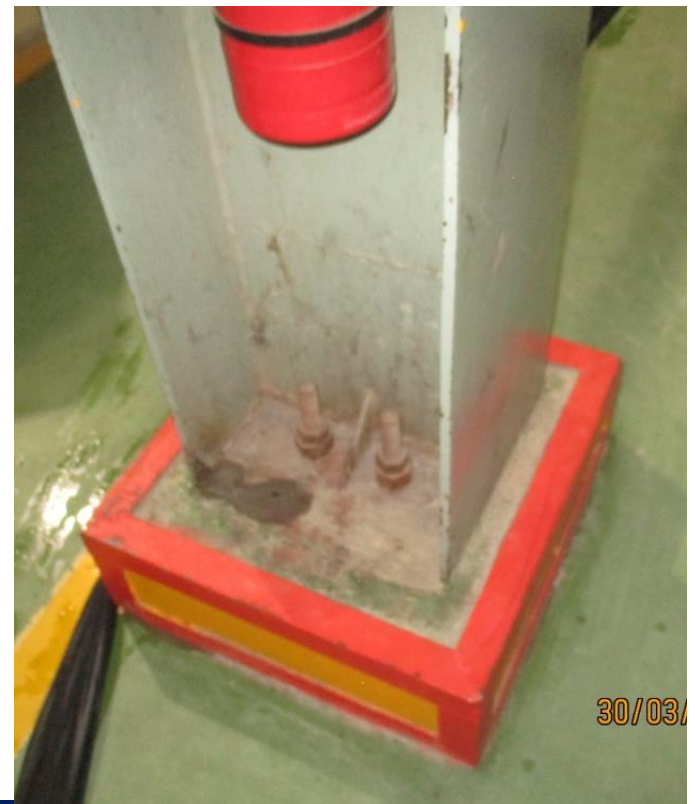
Corrosion was observed at Steel column to pedestal connection in dyeing section

Long term corrosion may cause serious damage on structural members. Factory is required to protect the members from corrosion .

| Item No. | Observation | Recommended Action Plan | Recommended Timeline |
|---|---|---|---|
| 12 | Dyeing Building:<br>Corrosion observed on structural steel members | Building Engineer to suggest and implement proper remedial measures to protect steel sections from corrosion. | 6-weeks |

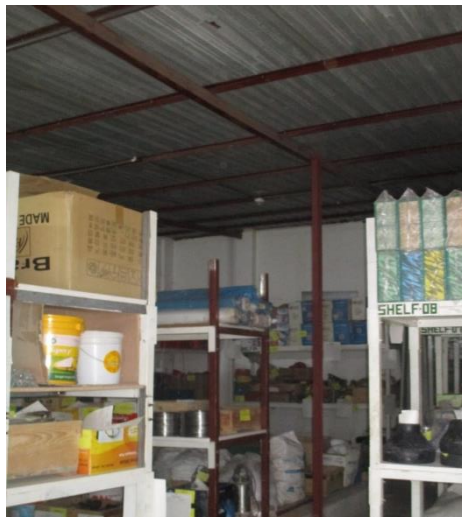
Light weight steel frame system

The support condition of those steel sheds were vulnerable and non engineered due to poor detailing of connection between members

| Item No. | Observation | Recommended Action Plan | Recommended Timeline |
|---|---|---|---|
| 13 | Medical & Day care shed and Storage & Dining shed:<br>Apparently non-engineered light weight roof shed | Building engineer to check the capacity of the lightweight steel roofs under lateral and vertical loading. | 6-weeks |
| 14 | Medical & Day care shed and Storage & Dining shed:<br>Apparently non-engineered light weight roof shed | Carry out remedial works resulting from engineering assessment if necessary. | 6-months |

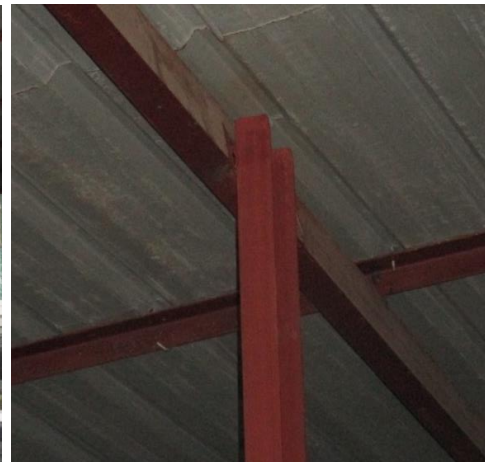
Welded connection between Steel 'I' section and angle

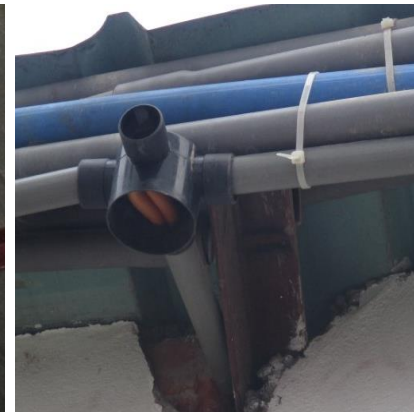
Steel roof angle was supported on edge by brick wall
