# Viyallatex Ltd.

297 Khairtul, Tongi, Gazipur, Bangladesh  
(23.921026N,90.387509E)

7 December 2013

# Observations

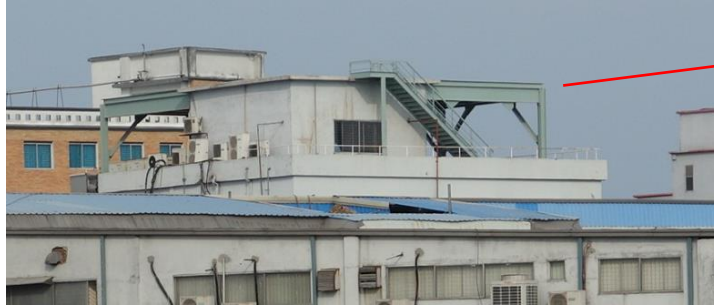
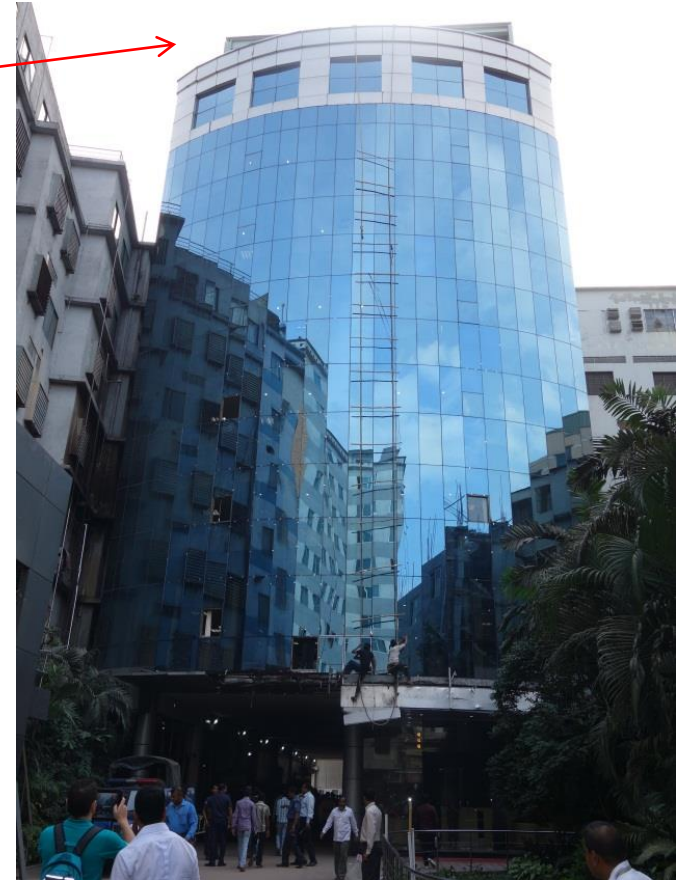
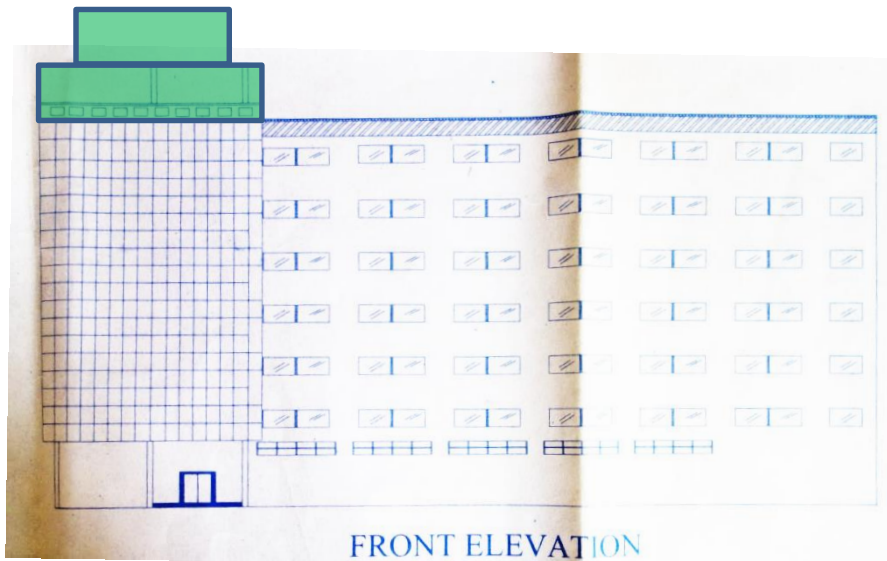
## Additional storey

**No Permit documentation for 8 storeys + helipad**

Permit drawings show a 7 storied building.  
2 additional floors have been built (extension occupies 10% roof area)  
The jacketed columns are not below this area

**ITEM 3:** Additional 2 levels above office area in Unit-1 are not on the permit drawings

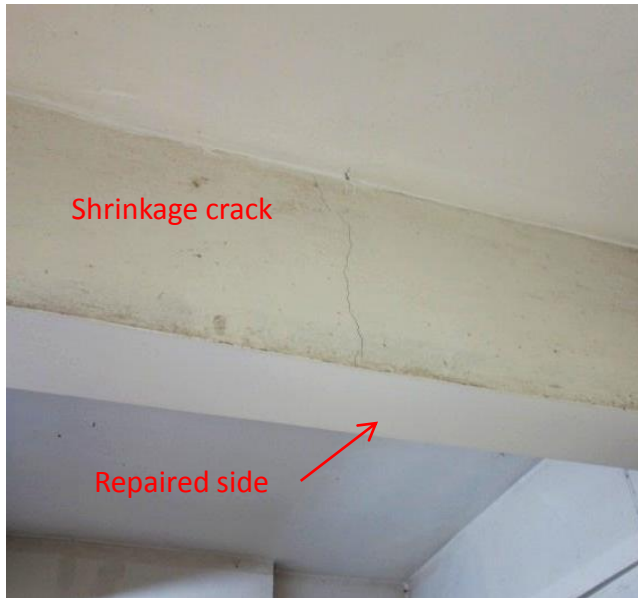
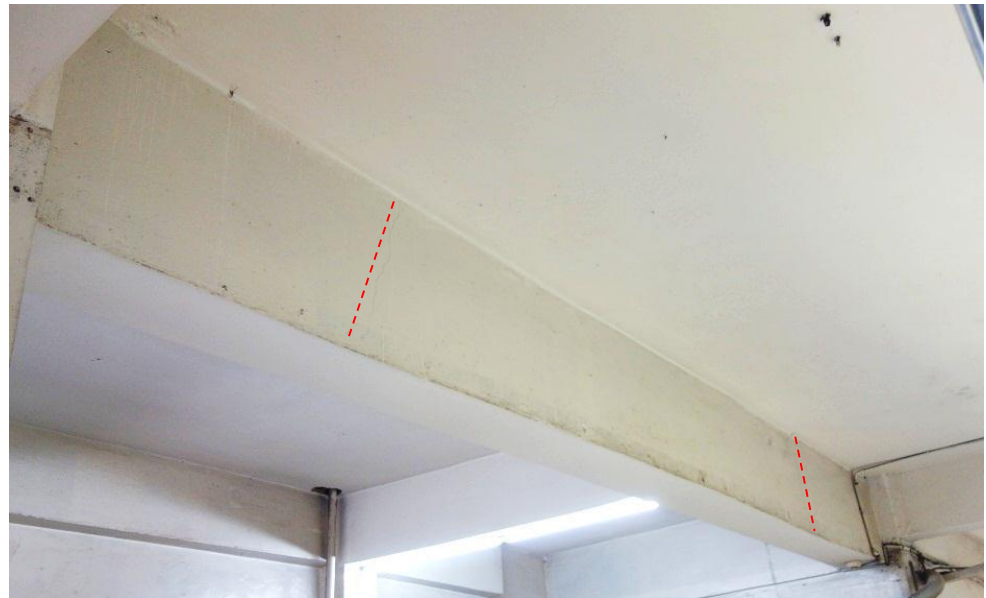
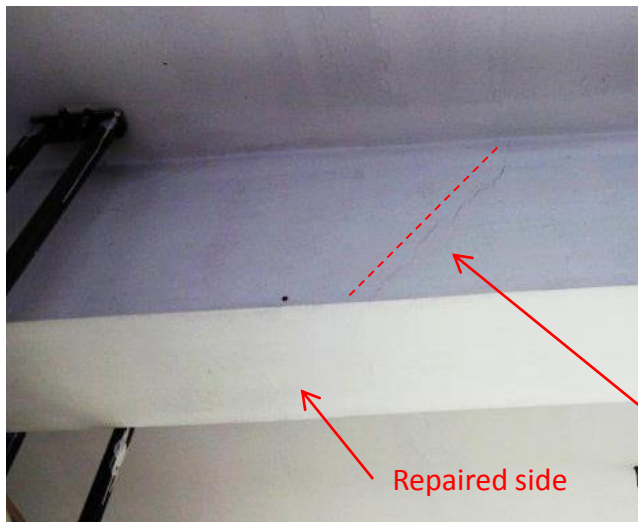
# Cracking on beam and slabs in Unit 1

Some cracks on beams detected. General repair and painting on cracks made recently. Most beams with new plaster on bottom side.

Factory has certificates indicating crack are in plaster not in concrete. Many of the cracks appear to be shrinkage related - others not. Building Engineer to ensure inclined cracks on beams are only in the plaster

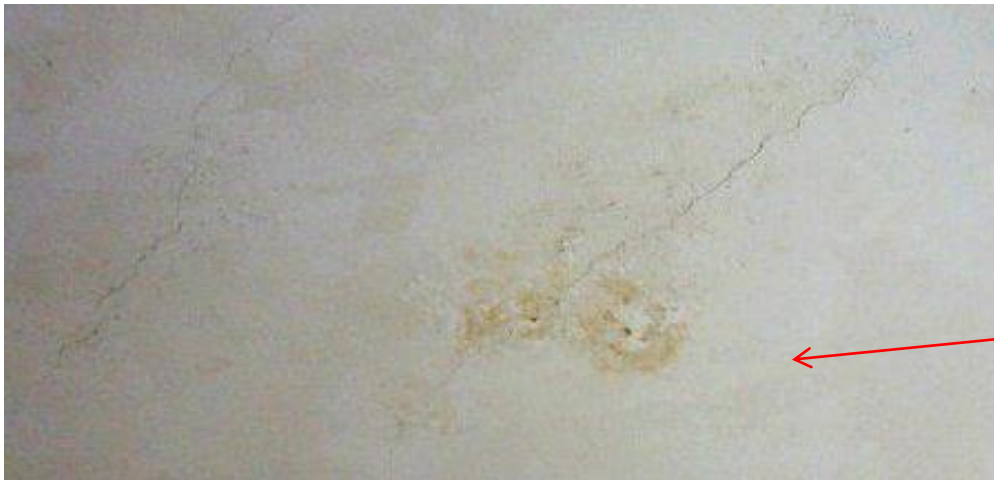
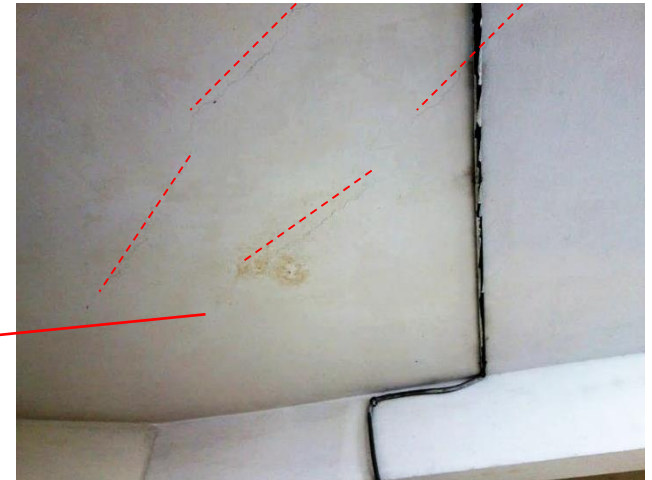
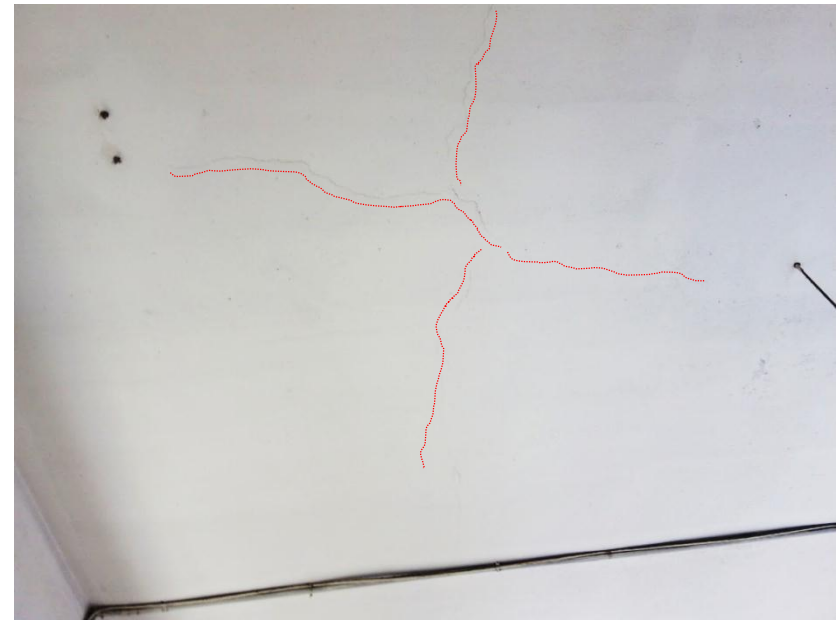
## Cracking in beams and slabs

Moisture indicates cracking is not only in plaster. Water comes from upper floor

Building Engineer to check cracks in slabs and define a repair system if required

13	Cracking on beam and slabs: Beam at level 5 Roof flat slab bottom side at levels 4, 3 and 2	If cracks grow larger, removing all items above the slab and close working areas below the affected areas . Engage an engineer to investigate, repair and strengthen the slab.	6-months

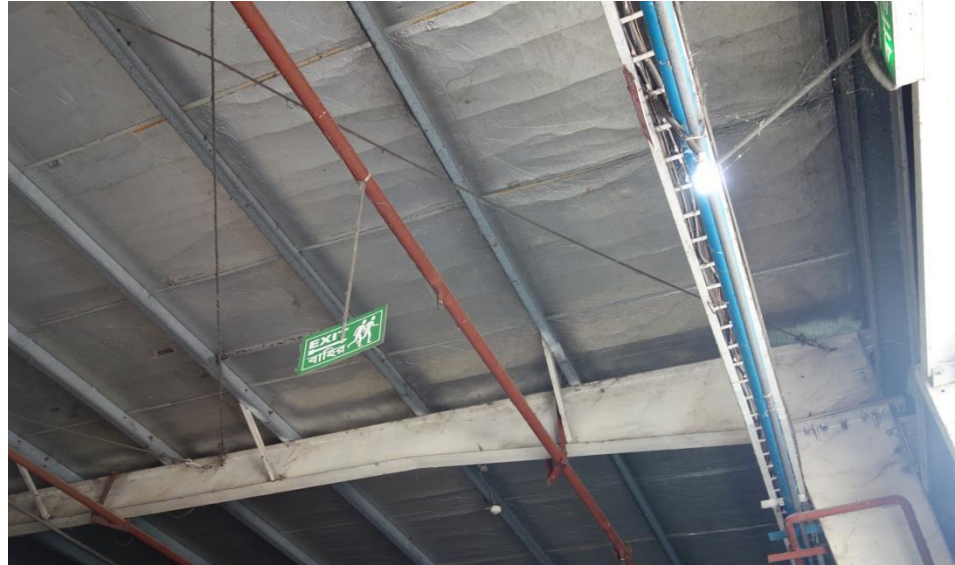
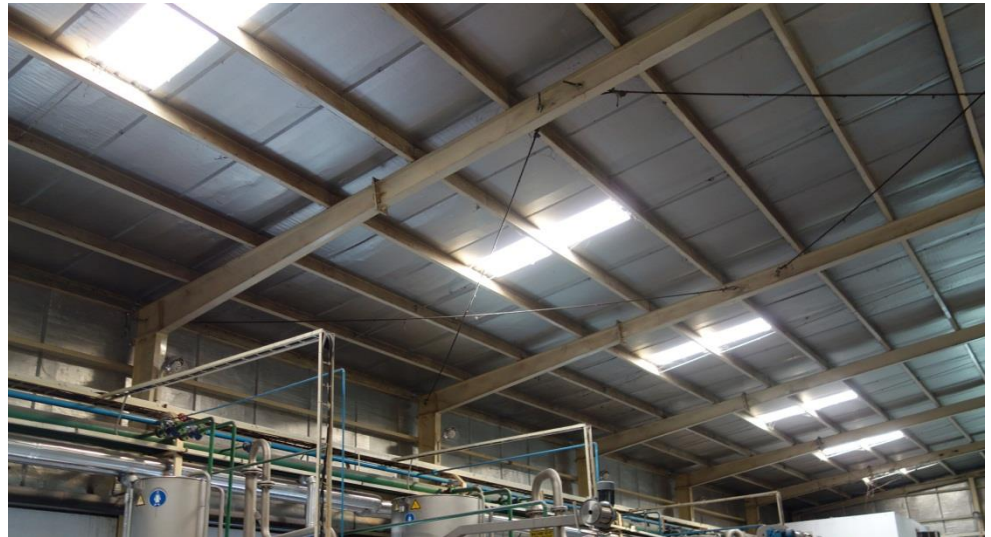
## Stability system

Knitting shed and Dyeing sheds have no vertical bracing system. Bracing system on roof does not continue vertically to column base.

Stability system of these sheds are incomplete  
Vertical stability system in the vertical planes required

Building engineer to carry out a stability analysis and provide additional stability system

Item No.	Observation	Recommended Action Plan	Recommended Timeline
14	Horizontal stability of steel frames for sheds	Building engineer to carry out a stability analysis and provide additional stability system	6-months
15	Non engineered structure in landing for cargo lift in Unit-2	Building engineer to check the structures and propose additional reinforcements and stability system if it is required	6-months
16	Documentation issues Steel structures design were not shown for sheds and steel roofs for both concrete buildings Unit-1 and Unit-2	Building engineer to collect information and complete documentation	6-months

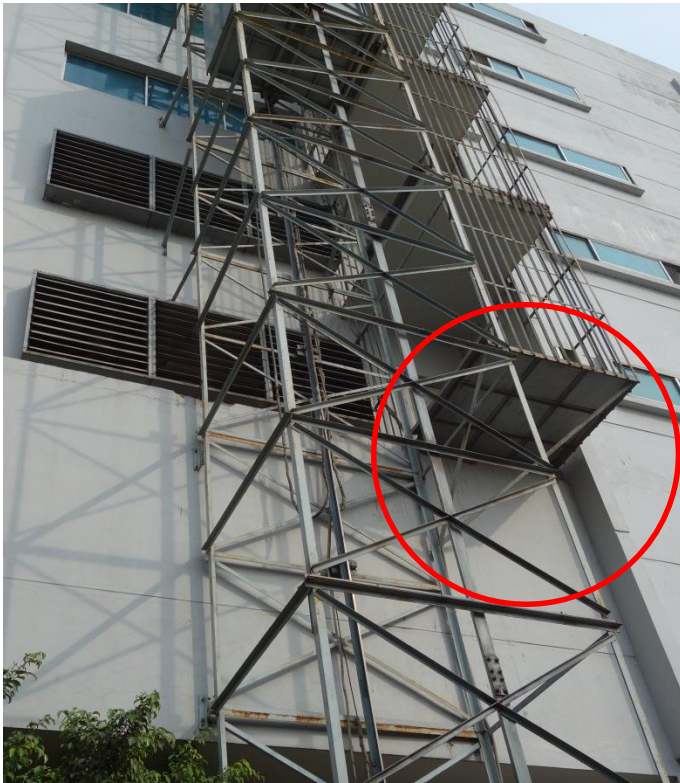
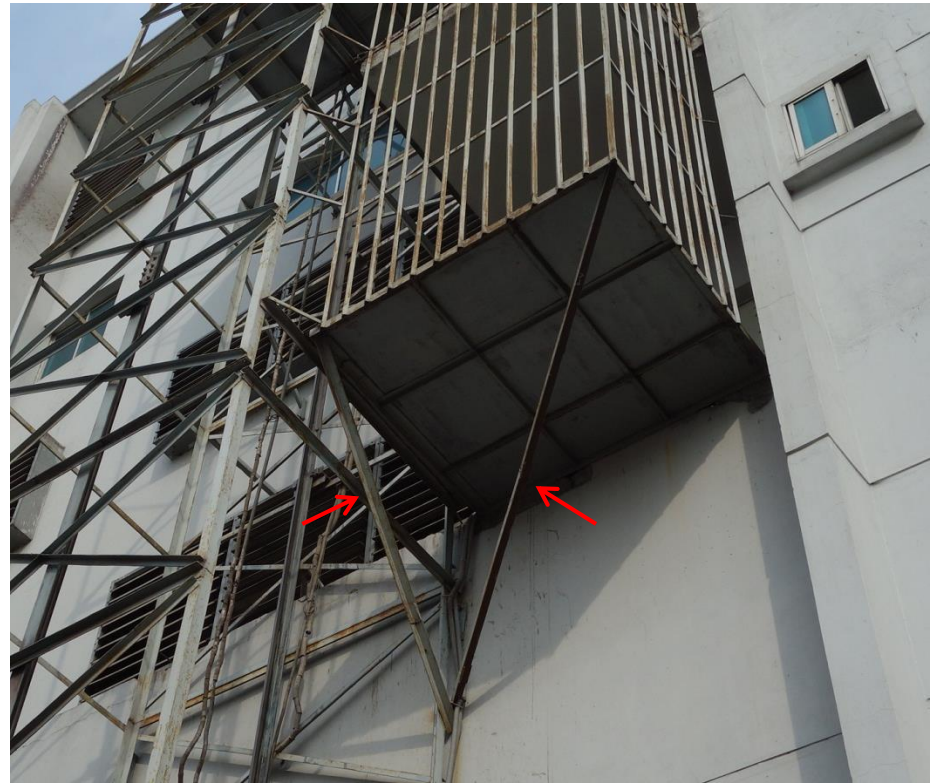
## Non engineered structure

Lift landing structure does not appear to have been engineered  
Weak weld connections and unstable slender supports  
Building Engineer to check design and propose reinforcement.

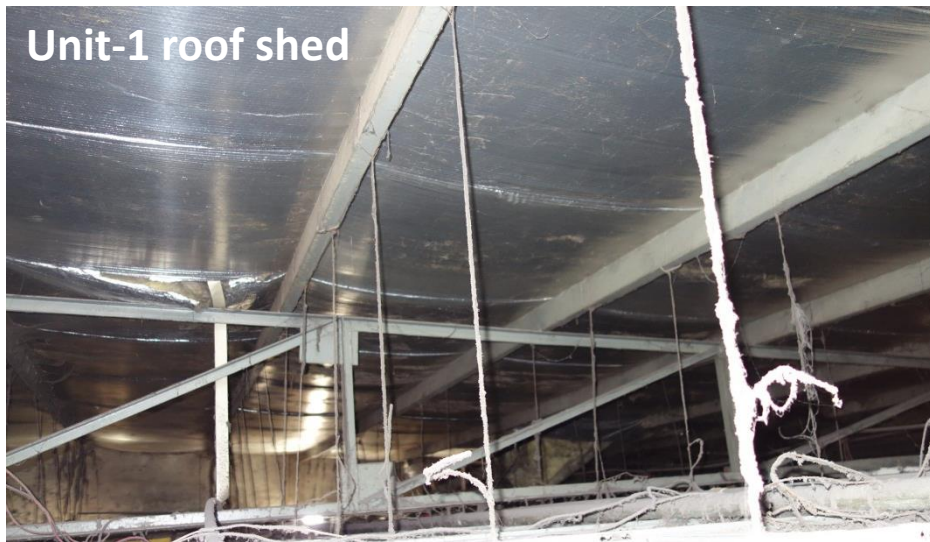
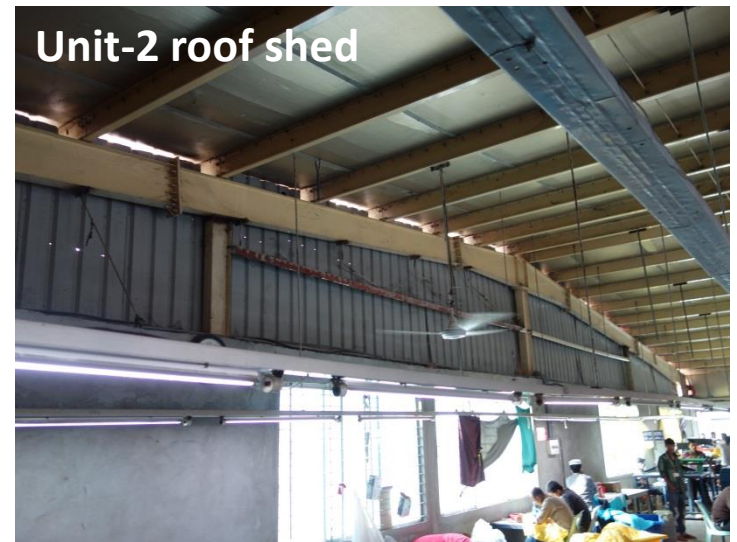
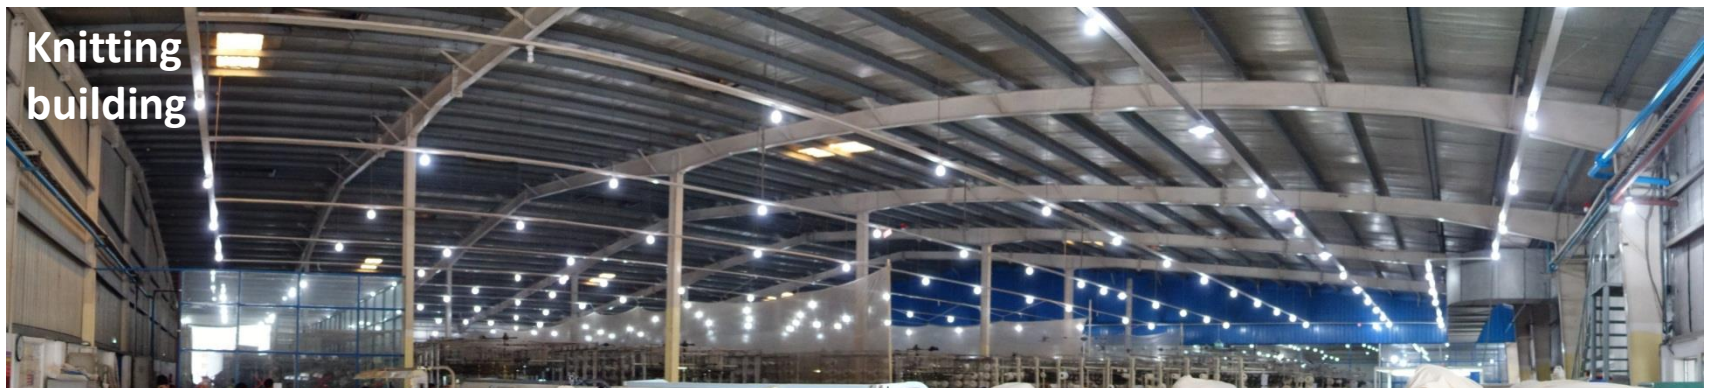
**Structural drawings were not shown for sheds, Unit-1 roof and Unit-2 roof**
