Hi-Fashion Composite Textiles Ltd.

04.MARCH.2014

ACC RD
on Fire and Building Safety in Bangladesh

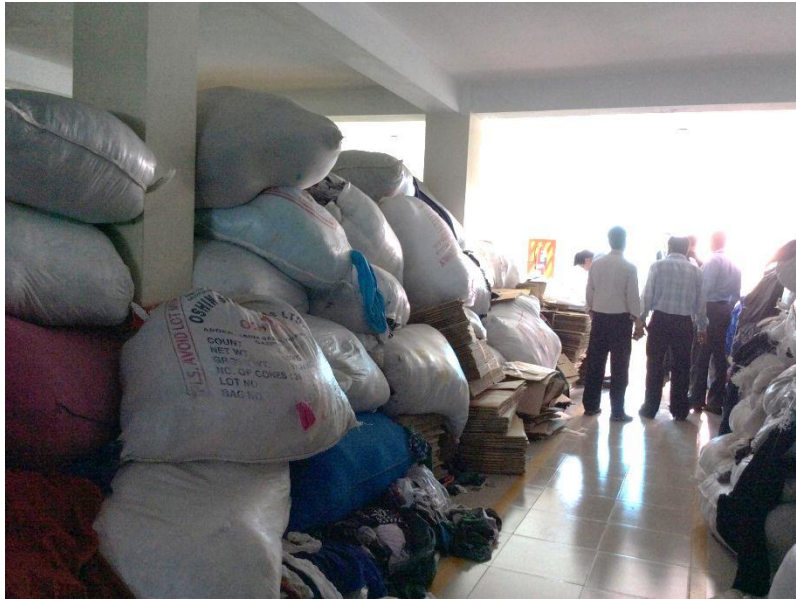
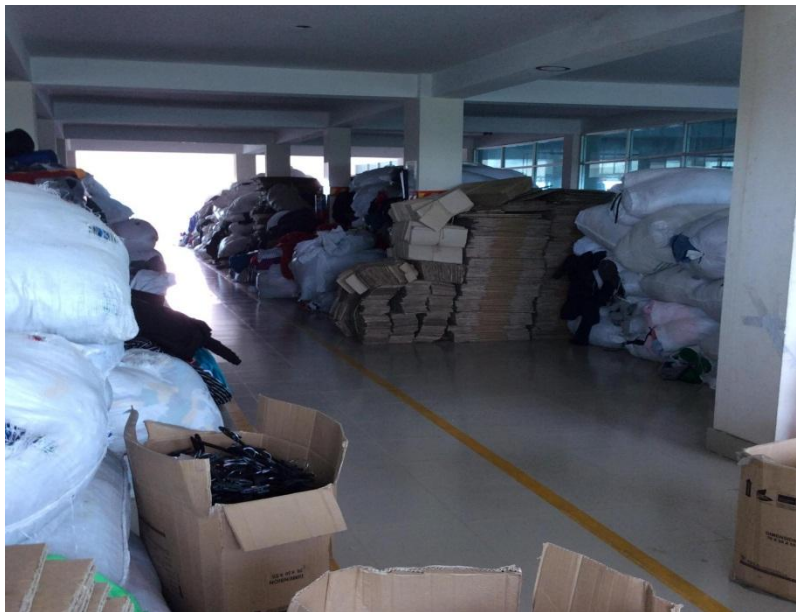
Uncontrolled Heavy Storage Loading

Priority 2 Concern

Uncontrolled heavy storage loading on 5th floor. It is required to reduce in height to no more than 4 bags (considering a single bag to have a total weight of approx. 50kg)

- Removed immediately reduced in height to no more than 4 bags (considering a single bag to have a total weight of approx. 50kg)

- Adopt some sort of signage/staff guidance to ensure that the maximum height of storage is not exceeded .

- Maintain standards of quality control to ensure that storage procedures are correctly followed so that overloading problems do not arise in the future.

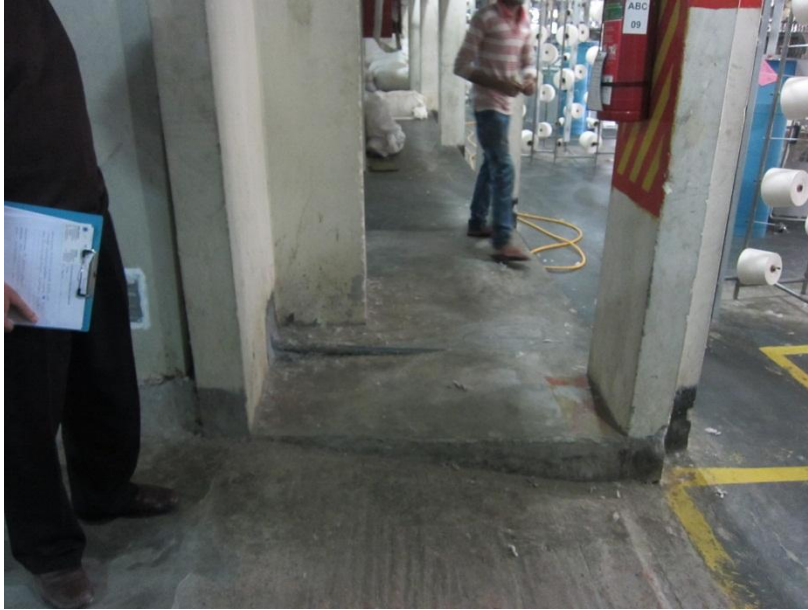
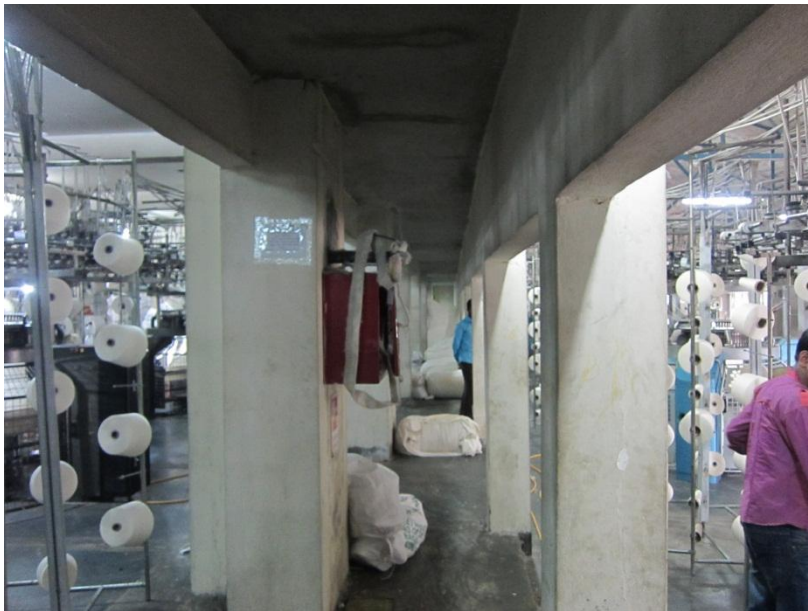
Priority 3 Concern

The main factory building seems to be separated with one storey building at the back which is composed of knitting section. From the survey, the ground and roof slab as shown in the picture has been casted continuously with out any movement joint provided. Therefore, in order to maintain the structural stability, a proper movement joint is required.

- The Factory's Building Structural Engineer should carry out a Detailed Engineering Assessment to prove the capacity of the building in its existing state, a further building approval should be gained for the building as it exists, as altered since the original approval. Alternatively, the extension building should be separated by a non-structural joint and allowed to act as a fully structurally independent structure.

- Do not construct any further buildings connected to the existing factory, without thorough structural design and full building approval.

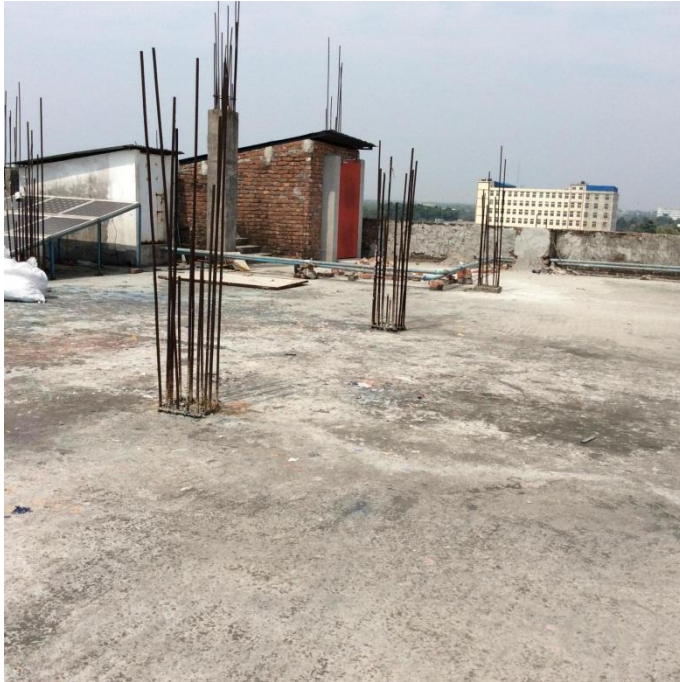
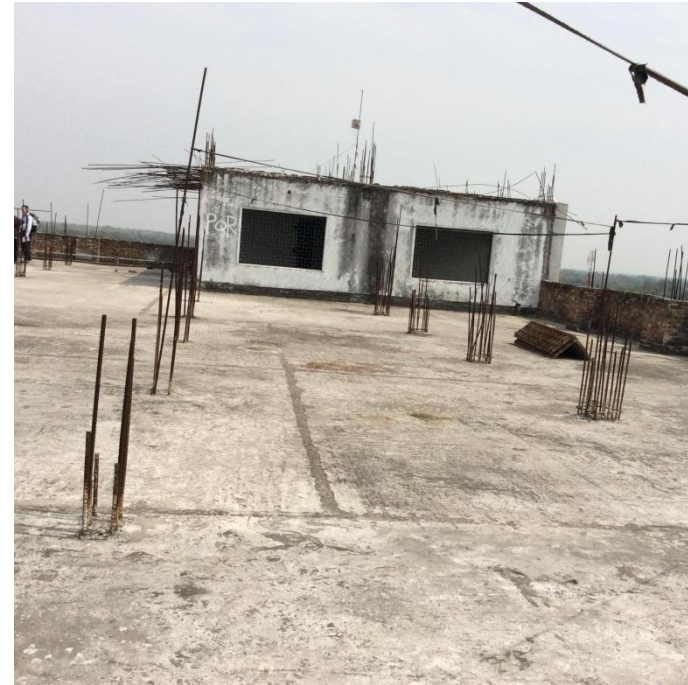
No movement joint provided to separate these two main buildings at ground floor level and no waterproofing material applied at roof level including the reinforcement left exposed .

Priority 3 Concern

An appropriate layer of waterproofing needs to be applied including rust-proof paint for the exposed reinforcement.

- The existing roof level does not have any waterproofing. This is not a long-term problem as another level is currently being constructed above. However, it should be considered as an on-going action to apply temporary waterproofing measures during construction, while the 6th floor acts as a roof level.

- Ensure that an appropriate layer of waterproofing is included in the build-up of the final roof level, once construction is complete.

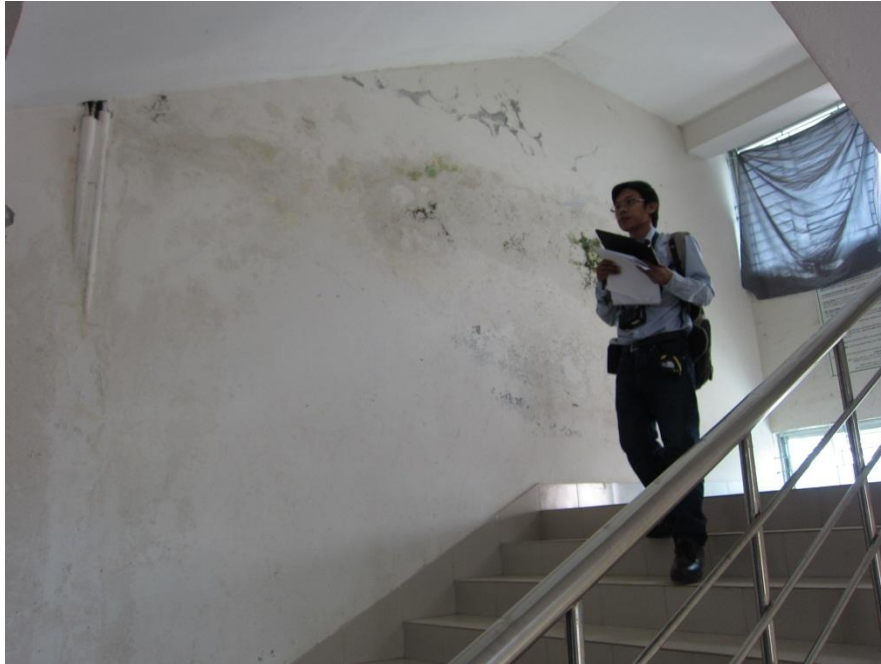
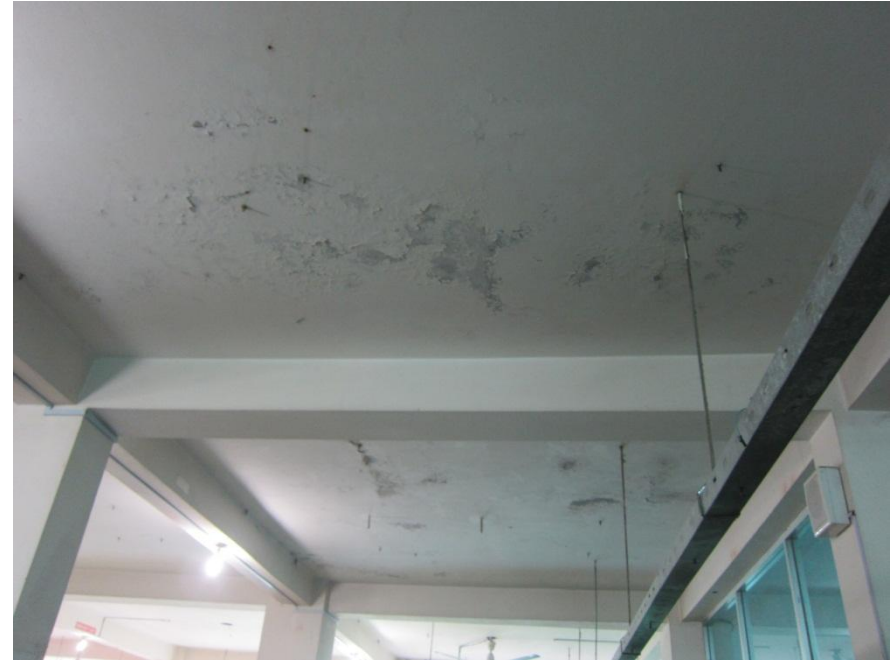
Water ingress causing damage and corrosion

It is found that water ingress at an interior wall, adjacent to the toilet may cause deterioration to structural elements.
