INITIAL STRUCTURAL INTEGRITY ASSESSMENT REPORT (SIAR)

Factory Name: **CROWN WEARS (PVT.) LIMITED**
Address: **Zamirdia, Habirbari Union, Bhaluka, Mymensingh
Mymensingh Dhaka Bangladesh**
Assessor: **Walter P. Moore**
Date: **22 Jun 2013**

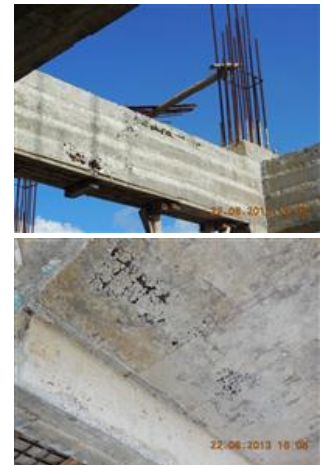
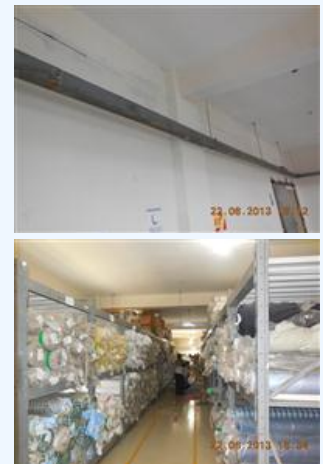
Question:	Have all areas of needed maintenance, including areas with efflorescence, dampness, standing water on rooftops, and corrosion been addressed.
Priority Level:	Medium
Non-Compliance Level:	1
Description:	There is water seepage on the underside of the slab supporting the water tank built above the stairs in Building 2.
Source of Findings:	Visual Assessment: Visual assessment of slab.
Suggested Plan of Action:	Under guidance from a qualified structural engineer, address all areas of needed maintenance by correcting the identified issues.
Suggested Deadline Date:	31 Dec 2014
Standard:	Alliance Standard Part 8 Section 8.26 Durability and Maintenance
