INITIAL STRUCTURAL INTEGRITY ASSESSMENT REPORT (SIAR)

Factory Name: **Hemple Rhee Mfg Co (BD) Ltd**

Assessor: **EIMS**

Date: **23 Mar 2014**

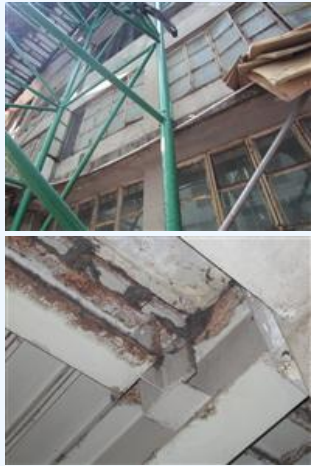
Priority Level:	Medium	
Non-Compliance Level:	3	
Description:	In base plate, steel member joint, fire stair and roof slab corrosion was found.	
Source of Findings:	Visual Assessment: Photograph of corrosion in fire stair, steel member joint and base plate	
Suggested Plan of Action:	Under guidance from a qualified structural engineer, address all areas of needed maintenance by correcting the identified issues.	
Suggested Deadline Date:	18 Jun 2014	
Standard:	Alliance Standard Part 8 Section 8.26 Durability and Maintenance
