# INITIAL STRUCTURAL INTEGRITY ASSESSMENT REPORT (SIAR)

Factory Name: **MAX SWEATER (BD) LTD**

Assessor: **Emkay Enterprises LTD**

Date: **03 Apr 2014**

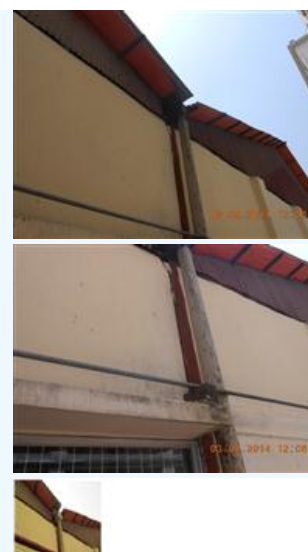
Question:	Are any structural elements constructed with MCAC exposed to rainfall or other sources of water sealed with a protective coating to prevent water intrusion?
Priority Level:	Medium
Non-Compliance Level:	2

Description:	The roof slab is made of MCAC and has not been provided with protective water sealing or drainage slope based on Reference Alliance Standards Part 7 Building Materials Section 7.2 Masonry-chip aggregate concrete (MCAC).
Source of Findings:	Photograph: Exposed roof slab.
Suggested Plan of Action:	Provide a protective coating at the structural elements constructed with MCAC exposed to rainfall or other sources of water. Have protective coating approved by the Alliance or a qualified structural engineer.
Suggested Deadline Date:	30 Jun 2014
Standard:	Alliance Standards Part 7 Building Materials Section 7.2 Masonry-chip aggregate concrete (MCAC).
