# INITIAL STRUCTURAL INTEGRITY ASSESSMENT REPORT (SIAR)

Factory Name: **Anowara Fashions Ltd**

Assessor: **Bureau Veritas**

Date: **07 Jun 2014**

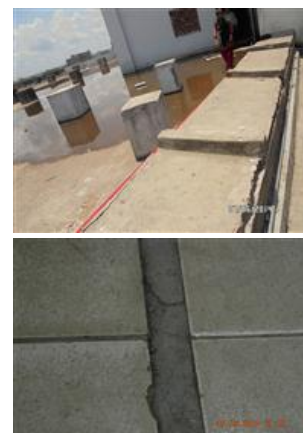
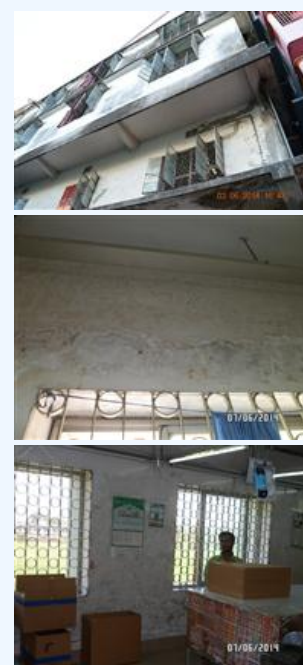
Question:	Is the building free of active signs of water intrusion or ponding due to lack of performance of the façade system?	
Priority Level:	Low	
Non-Compliance Level:	1	
Description:	Dampness has been observed on the exterior walls of the buildings. Water stains were spotted on interior walls of 1st floor and 2nd floor of legacy fashions ltd.	
Source of Findings:	Visual Assessment: Confirmed visually.	
Suggested Plan of Action:	Repair the exterior façade system to prevent water intrusion.	
Suggested Deadline Date:	17 Aug 2014	
Standard:	Alliance Standard Part 8 Section 8.26 Durability and Maintenance
