INITIAL ELECTRICAL ASSESSMENT REPORT (EAR)

Factory Name: **Coast To Coast (Pvt) Ltd**

Assessor: **Sumerra**

Date: **27 Feb 2014**

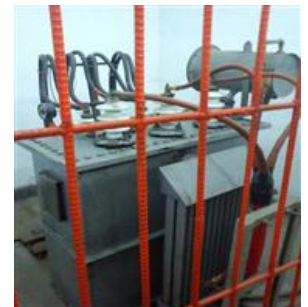
Question:	The substation room has the required fire rating/protection and is physically separated from the remainder of the building.
Priority Level:	High
Non-Compliance Level:	3
Description:	The main service transformer and sub-station were located within the same room separated from the remainder of the building by a steel grill. The steel door does not provide the required fire rating per Alliance Standard 3.4.2.1.4.
Source of Findings:	Photograph: Photo of transformer
Suggested Plan of Action:

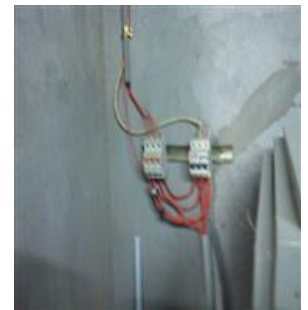
Question:	No multi looping of wiring/cables observed at circuit breakers within switchboards and/or distribution boards.	
Priority Level:	High	
Non-Compliance Level:	3	
Description:	There is improper looping of wiring/cables at circuit breakers as per BNBC 2006 Part 8 in the following locations: - SW Distribution Board Ground Floor - SW Distribution Board First Floor	
Source of Findings:	Photograph: Circuit breaker looping	
Suggested Plan of Action:		
Suggested Deadline Date:		
Standard:	Alliance Standard Part 10 Section 10.3 Electrical Wiring and Cabling

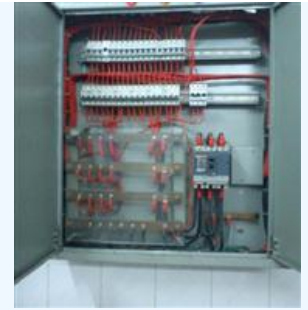
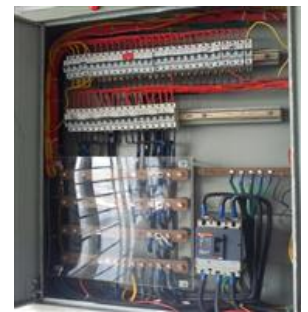
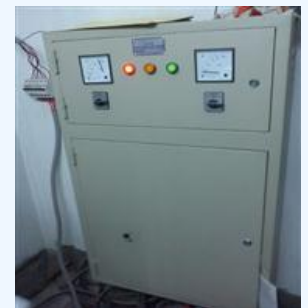
Question:	Do switchboards and/or distribution boards have clear identification markings?
Priority Level:	Medium
Non-Compliance Level:	3
Description:	None of the switchboards or distribution boards in the factory are clearly and permanently identified i as per BNBC Part 8 Section 2.11.5.4
Source of Findings:	Photograph: No labeling at the DB box in the factory
Suggested Plan of Action:	
Suggested Deadline Date:	
Standard:	Alliance Standard Part 10 Section 10.7 BNBC Part 8 Section 2.11.5.4

Question:	Do switchboards and/or distribution boards have capacity information labels?
Priority Level:	Medium
Non-Compliance Level:	3
Description:	Switchboards and/or distribution boards have no capacity information labels.
Source of Findings:	Photograph: Switchboards and distribution boards have no capacity information labels
Suggested Plan of Action:	
Suggested Deadline Date:
