# INITIAL STRUCTURAL INTEGRITY ASSESSMENT REPORT (SIAR)

Factory Name: **CHITTAGONG KNITWEARS (PVT) LTD**

Assessor: **BD Technologies**

Date: **22 Mar 2015**

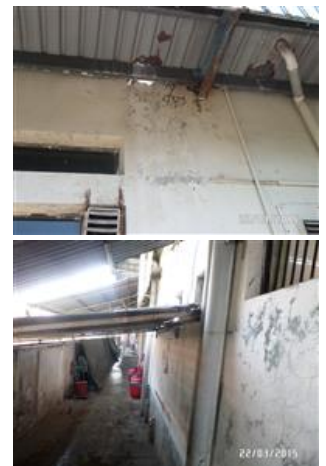
Question:	Have all areas of needed maintenance, including areas with efflorescence, dampness, standing water on rooftops, and corrosion been addressed.
Priority Level:	Medium
Non-Compliance Level:	3
Description:	The following areas of needed maintenance are not addressed: Dampness in ground floor brick wall Corrosion in Steel shed
Source of Findings:	Photograph: Wall dampness, steel shed corrosion.
Suggested Plan of Action:	Under guidance from a qualified structural engineer, address all areas of needed maintenance by correcting the identified issues.
Suggested Deadline Date:	15 Jul 2015
