# INITIAL STRUCTURAL INTEGRITY ASSESSMENT REPORT (SIAR)

Factory Name: **Canvas Garments (Pvt.) Ltd**

Assessor: **Bureau Veritas**

Date: **18 May 2014**

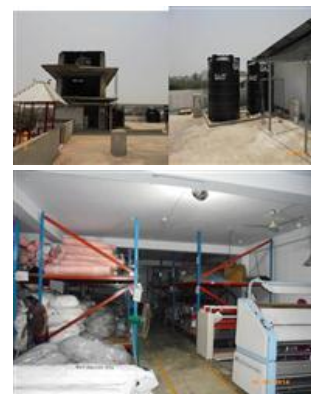
| Description: | There are six undocumented overhead plastic water tanks having a total capacity of $(4 \times 5000 + 2 \times 2000) \text{Ltr} = 22000 \text{Ltr}$ . Besides there are storage racks at ground floor. These tanks and storage racks need proper bracing and anchorage. |

| Suggested Plan of Action: | Adequately anchor and brace all non-structural elements to resist earthquake forces to comply with the BNBC and Alliance Standard. |
