# INITIAL STRUCTURAL INTEGRITY ASSESSMENT REPORT (SIAR)

Factory Name: **SGWICUS (BD) LTD.**

Assessor: **BD Technologies**

Date: **10 Apr 2014**

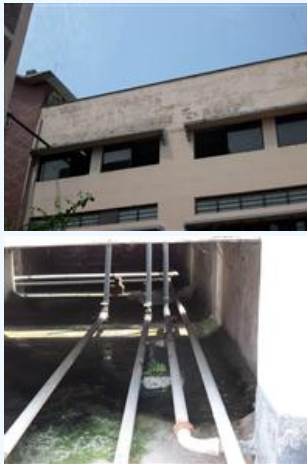
| Description: | yes. But there is a crack in a beam which should be addressed. see photo | |

| Suggested Plan of Action: | engage a qualified structural engineer to confirm structural performance of the structure. | |
