# INITIAL STRUCTURAL INTEGRITY ASSESSMENT REPORT (SIAR)

Factory Name: **Next Collections Limited**

Assessor: **Walter P. Moore**

Date: **16 May 2013**

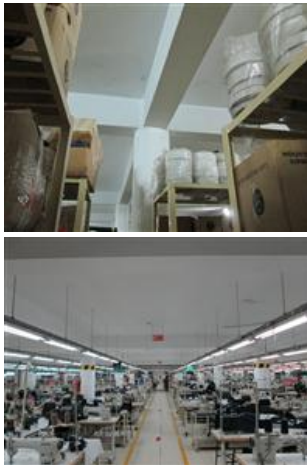
| Description: | Various non-structural elements throughout the building are not adequately anchored and braced to resist earthquake forces. These elements include: storage racks, equipment and pipes. | |

| Suggested Plan of Action: | Adequately anchor and brace all non-structural elements to resist earthquake forces to comply with the BNBC and Alliance Standard. | |
