# INITIAL STRUCTURAL INTEGRITY ASSESSMENT REPORT (SIAR)

Factory Name: **Glory Fashionwear Ltd**

Assessor: **Emkay Enterprises LTD**

Date: **26 Feb 2014**

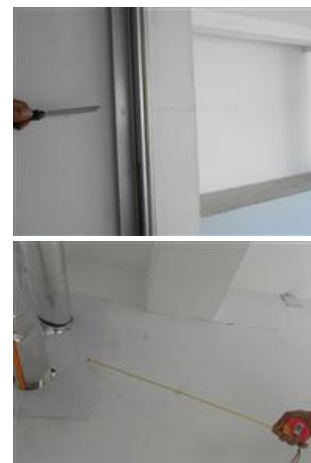
| Description: | Horizontal crack at 5" brick wall at Brick-Lintel Joint in the reception area. In the Cantilever portion, between interface of beam and wall, crack in plaster have been found in all levels above grade except top level. (Grid Location → between (I), (J) and (3), (2); (C), (B) and west to (1). (Canti.) (B), (C); (3) |
| Source of Findings: | Photograph: Horizontal crack in Brick wall Brick-Lintel interface Horizontal crack in beam-wall interface |

| Suggested Plan of Action: | Have a qualified structural engineer provide further testing and analysis of distress, settlement, shifting, or cracking in columns or walls and provide a remediation plan to correct noted issues. |
